# Assessing and Controlling Corrosion in Air-cooled Condensers

*Ninth International Conference on  
Cycle Chemistry in Fossil and  
Combined Cycle Plants with Heat  
Recovery Steam Generators*

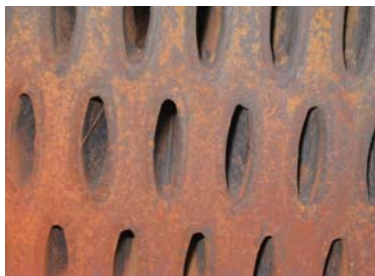
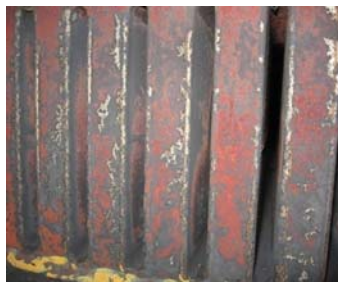
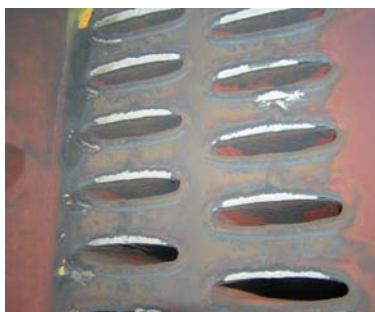
### Variations of ACC Damage

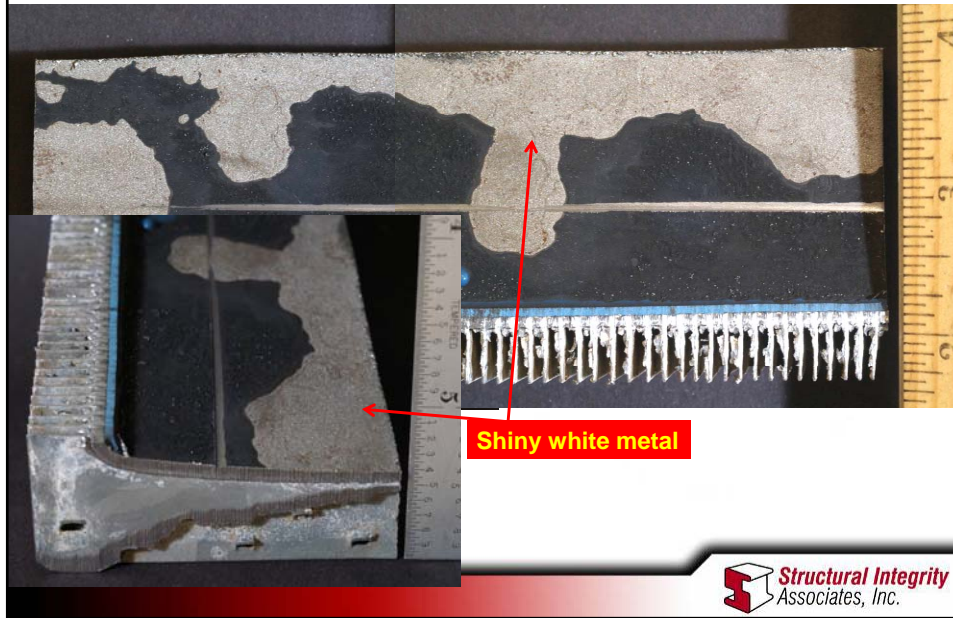
### Inside diameter of first ACC tube analyzed

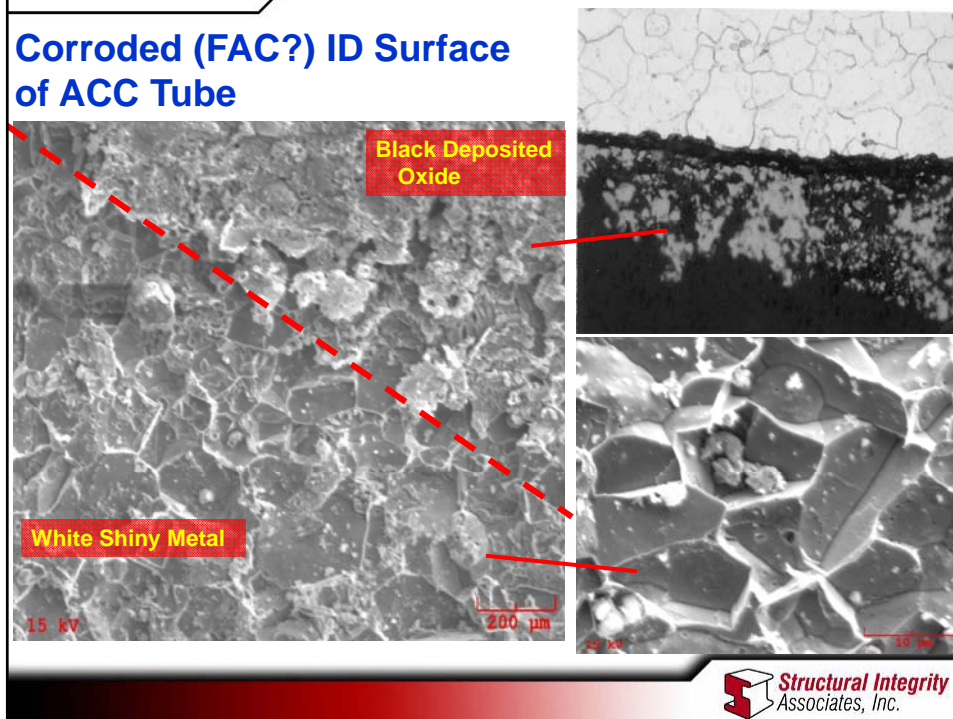
### Corroded (FAC?) ID Surface of ACC Tube

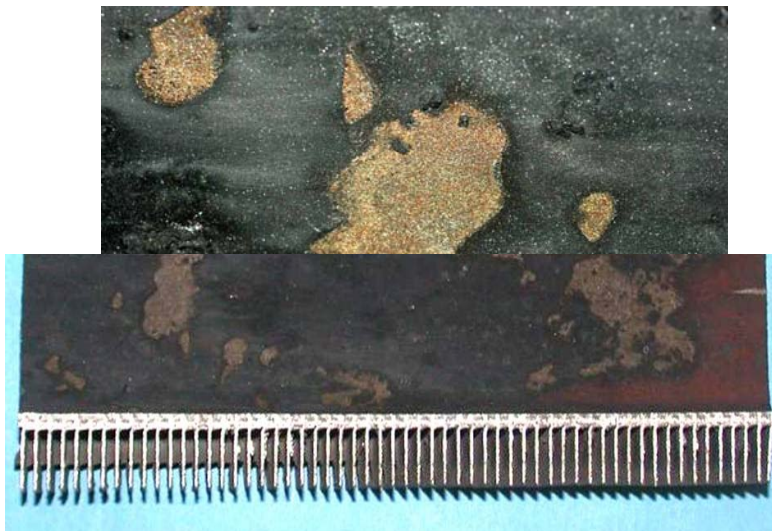
### Inside diameter of second ACC tube analyzed

6 inch section of ACC tube and detail of the surface showing black deposits and white "bare" metal areas

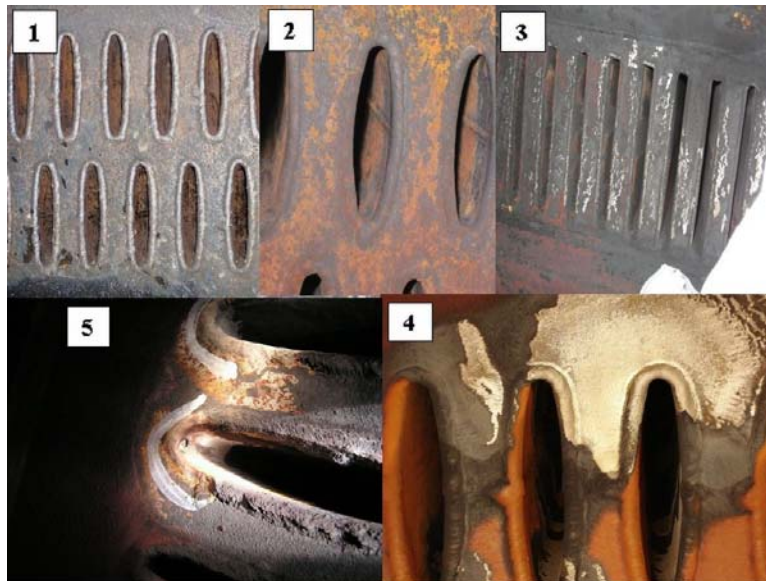
- 1. Tube entries in relatively good shape (maybe some dark deposited areas). No corrosion/FAC.**
- 2. Various black/grey deposits on tube entries as well as flash rust areas, but no white bare metal areas**
- 3. Few white bare metal areas on a number of tube entries. Some black areas of deposit**
- 4. Serious white bare metal areas on/at numerous tube entries. Extensive black areas of deposition adjacent to white areas**
- 5. Most serious. Holes in the tubing or welding. Obvious corrosion on many tube entries**

## DHACI for Tube Inlets

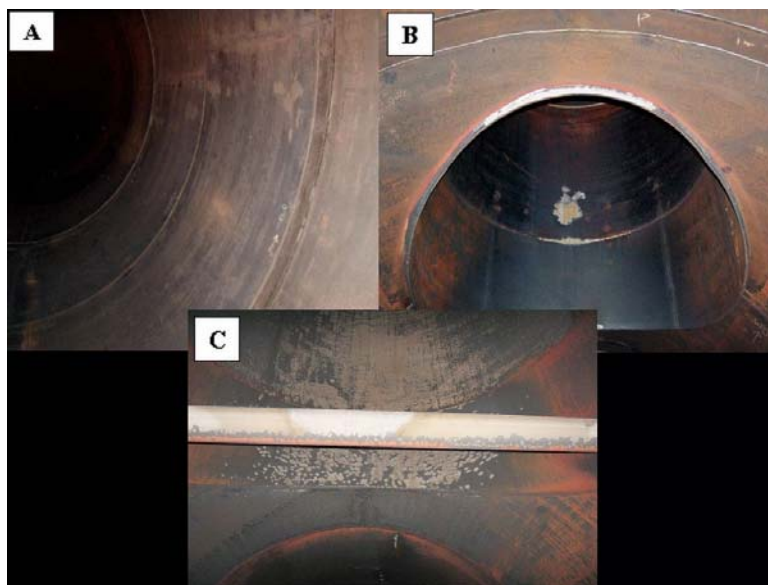
- A. Ducting shows no general signs of two-phase damage and are generally grey**
- B. Minor white areas on generally grey ducting. Maybe some tiger striping with darker grey/black areas of two-phase damage**
- C. Multiple white bare metal areas in the turbine exhaust and at changes of direction (eg. at intersections of exhaust ducting to vertical riser). White areas are obvious regions of lost metal.**

## DHACI for Lower Ducts

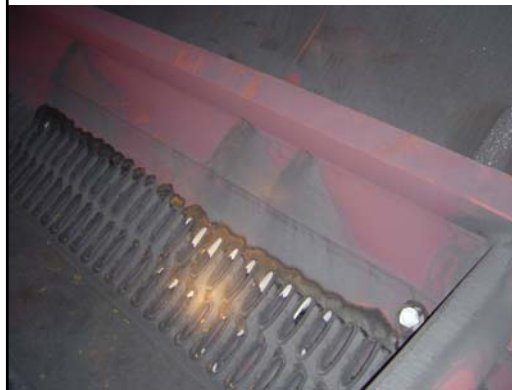
**DHACI 1.**  
Iron in the 5 -10 ppb range

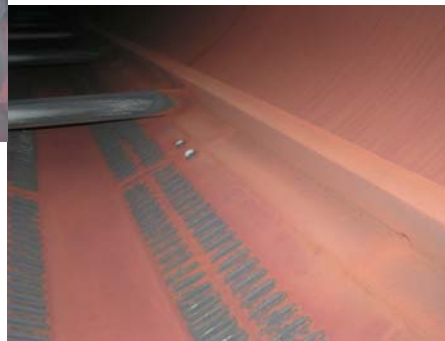
**DHACI 3.**  
Iron in 30 – 40 ppb range
