# Kogan Creek Power Plant's Air Cooled Condenser

Update For ACC User Group  
September 2011

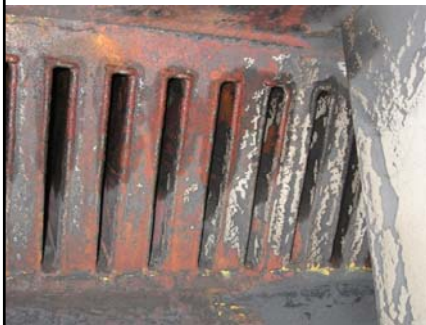
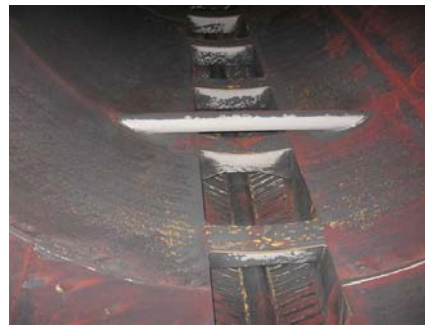
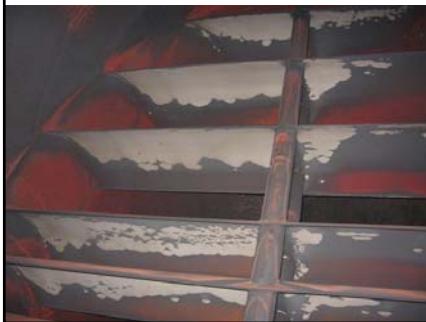
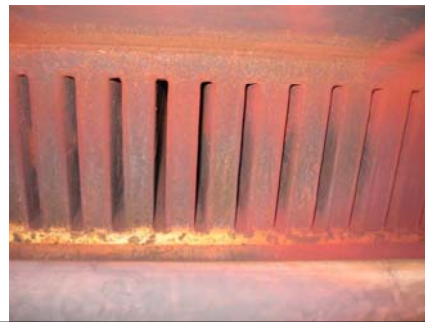
## 4000 Hour Inspection

- An early inspection in May 2008 (~4000hrs of operation) was undertaken
- Severe corrosion identified from LP Turbine exhausts through steam ducting and ACC inlets.
- 2 Phase FAC identified as the cause of the corrosion
- Suspicions about the design chemistry confirmed
- Concerns about downstream impacts (boiler, turbine) ongoing

- Corrosion damage in the ACC very severe after just 4000hrs of operation (pH ~9.0).
- Increasing pH takes months to realise full benefits
- Corrosion damage still evident in ACC after >2 years operation at pH ~9.8, appearance continuing to improve over time.
- Application of oxygenated water to tube inlets appears to protect from FAC experienced in ACC at the tube inlets, but not further down the tube (Unit make-up water sprayed into ACC inlet header)

- Increase in feedwater/condensate pH to reduce 2 phase FAC in the ACC – initially to 9.5 and then to 9.8
- Operate condensate polishers in ammonium form to allow practical operation at elevated pH
- Replace condensate filter elements with a more suitable design
- Allow operation of condensate polishers at elevated temperature (above 62.5C) until condensate filters are replaced
