# Gateway Generating Station – Overview and ACC Operating Issues Discussion

# ACC Information

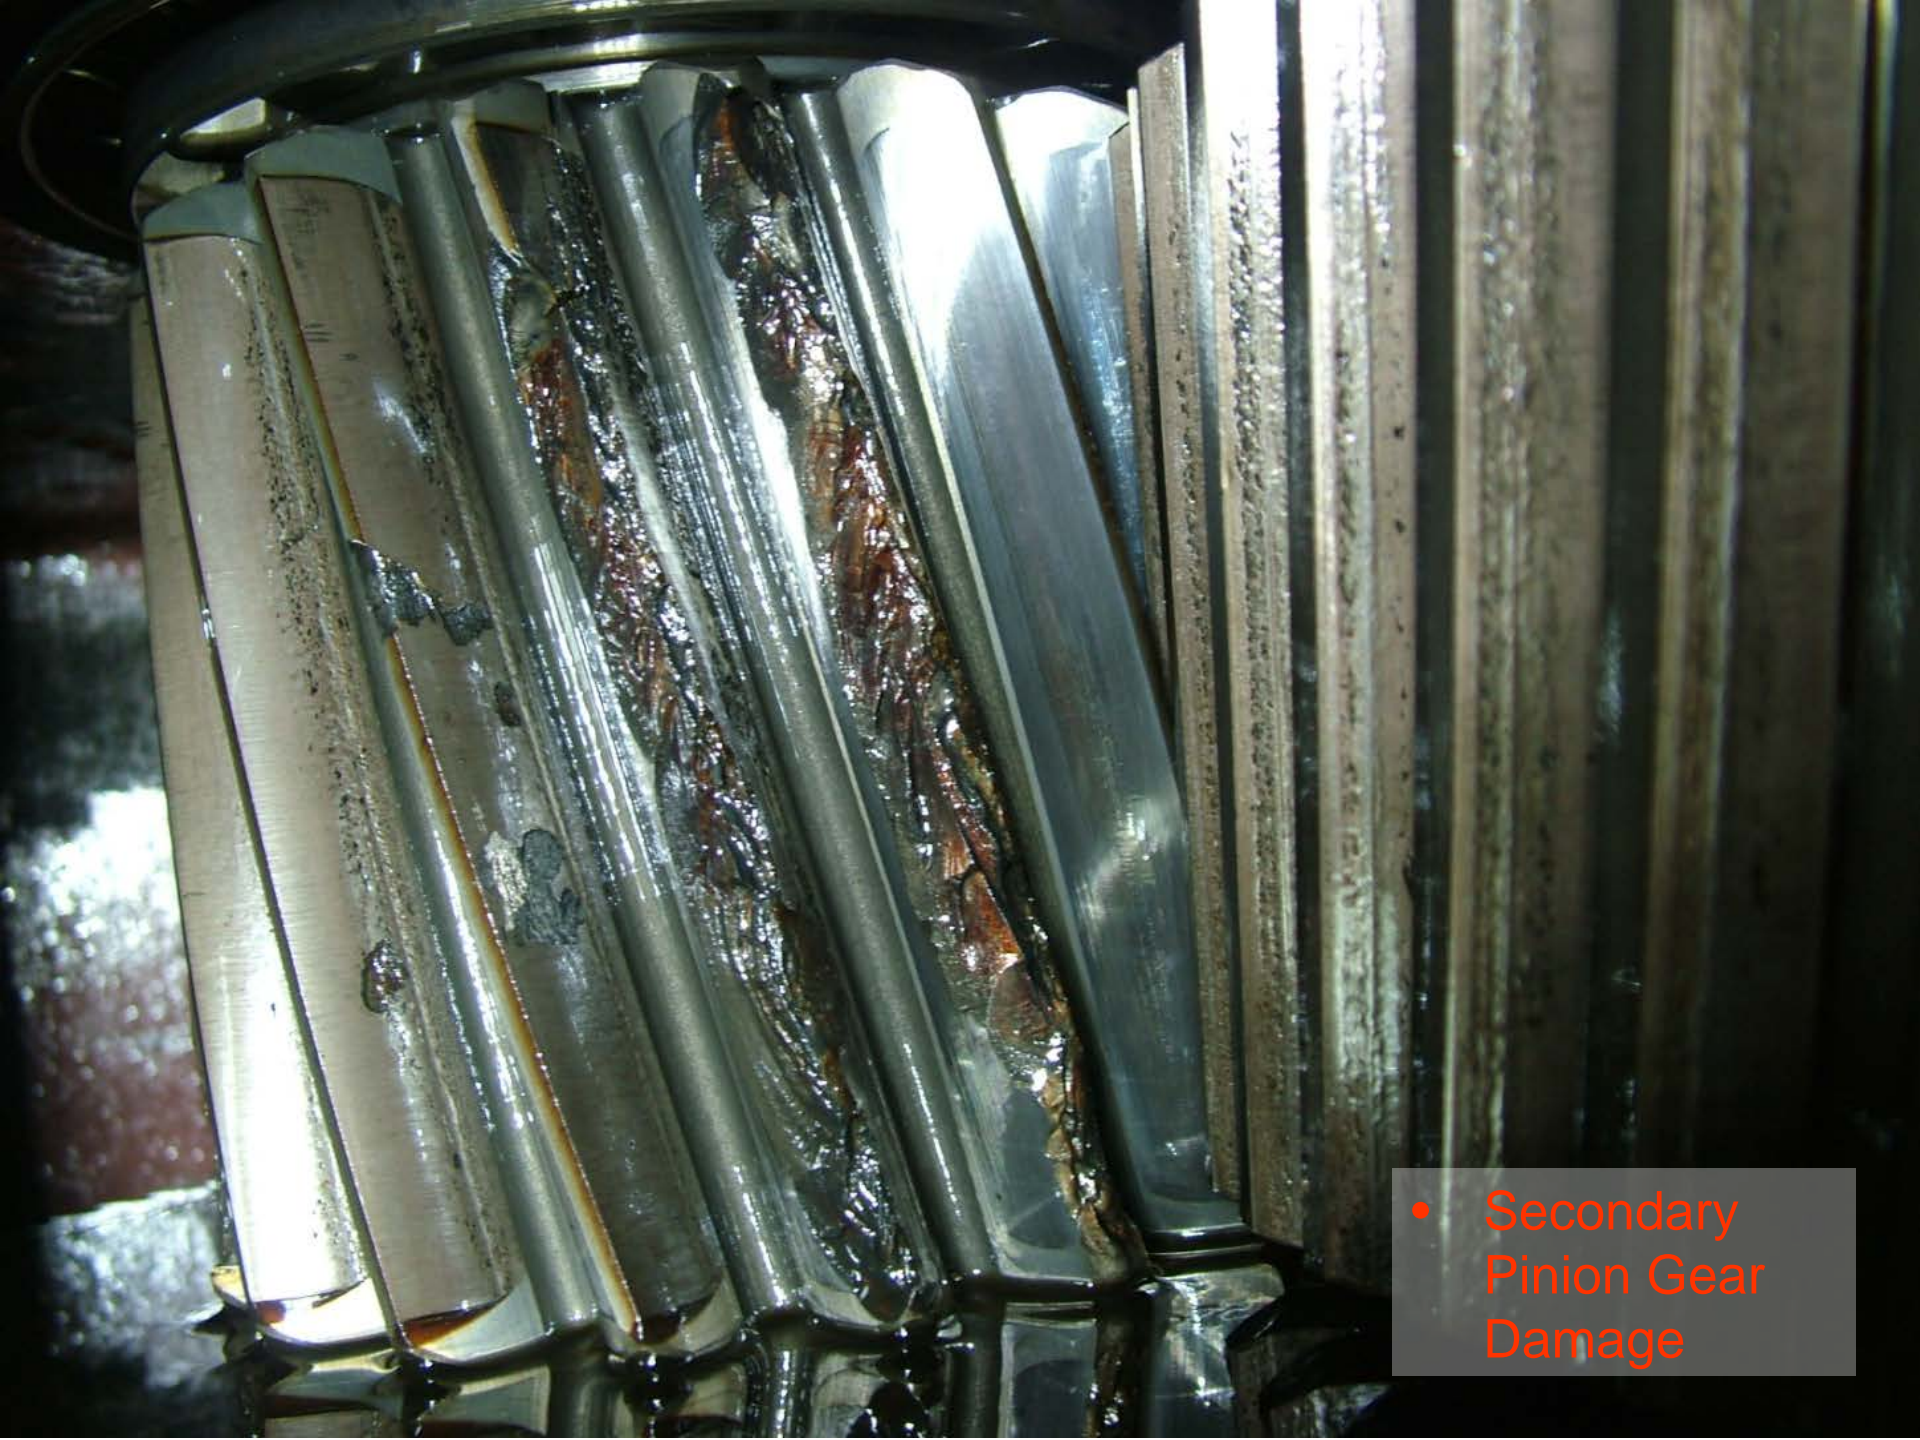
- In the fall of 2010, gearbox lube oil sampling analysis were reporting metal particulate and vibration readings were trending up. This was occurring on 10 of the 36 fans. In December the fans were drained of oil showing obvious chunks of metal debris on several fans. The inspection cover was removed on all 10 gearboxes and 5 of the 10 had severe damage to the secondary pinion gear.
- Possible issues for discussion
  - Vibration
  - Gear tooth hardness
  - High starting torque
  - Fan “stall” due to wind gusts and high winds
- Still under investigation by the manufacturer and PG&E.

- Secondary Pinion Gear Damage

- Recommendations to current users
  - Regular Predictive Maintenance Monitoring (vibration and oil analysis)
  - Create PM to check for loose bolts, brackets, fasteners, etc.
- New users
  - Wind study / Proper placing of wind screens.
  - Proper scoping of fans for expected wind conditions
  - QC during construction and commissioning period
  - Proper iron filter during commissioning
  - Expect to clean out drip pot
  - Change out gearbox oil at recommended interval (especially new oil that should only be used for the first 100-400 operating hours)

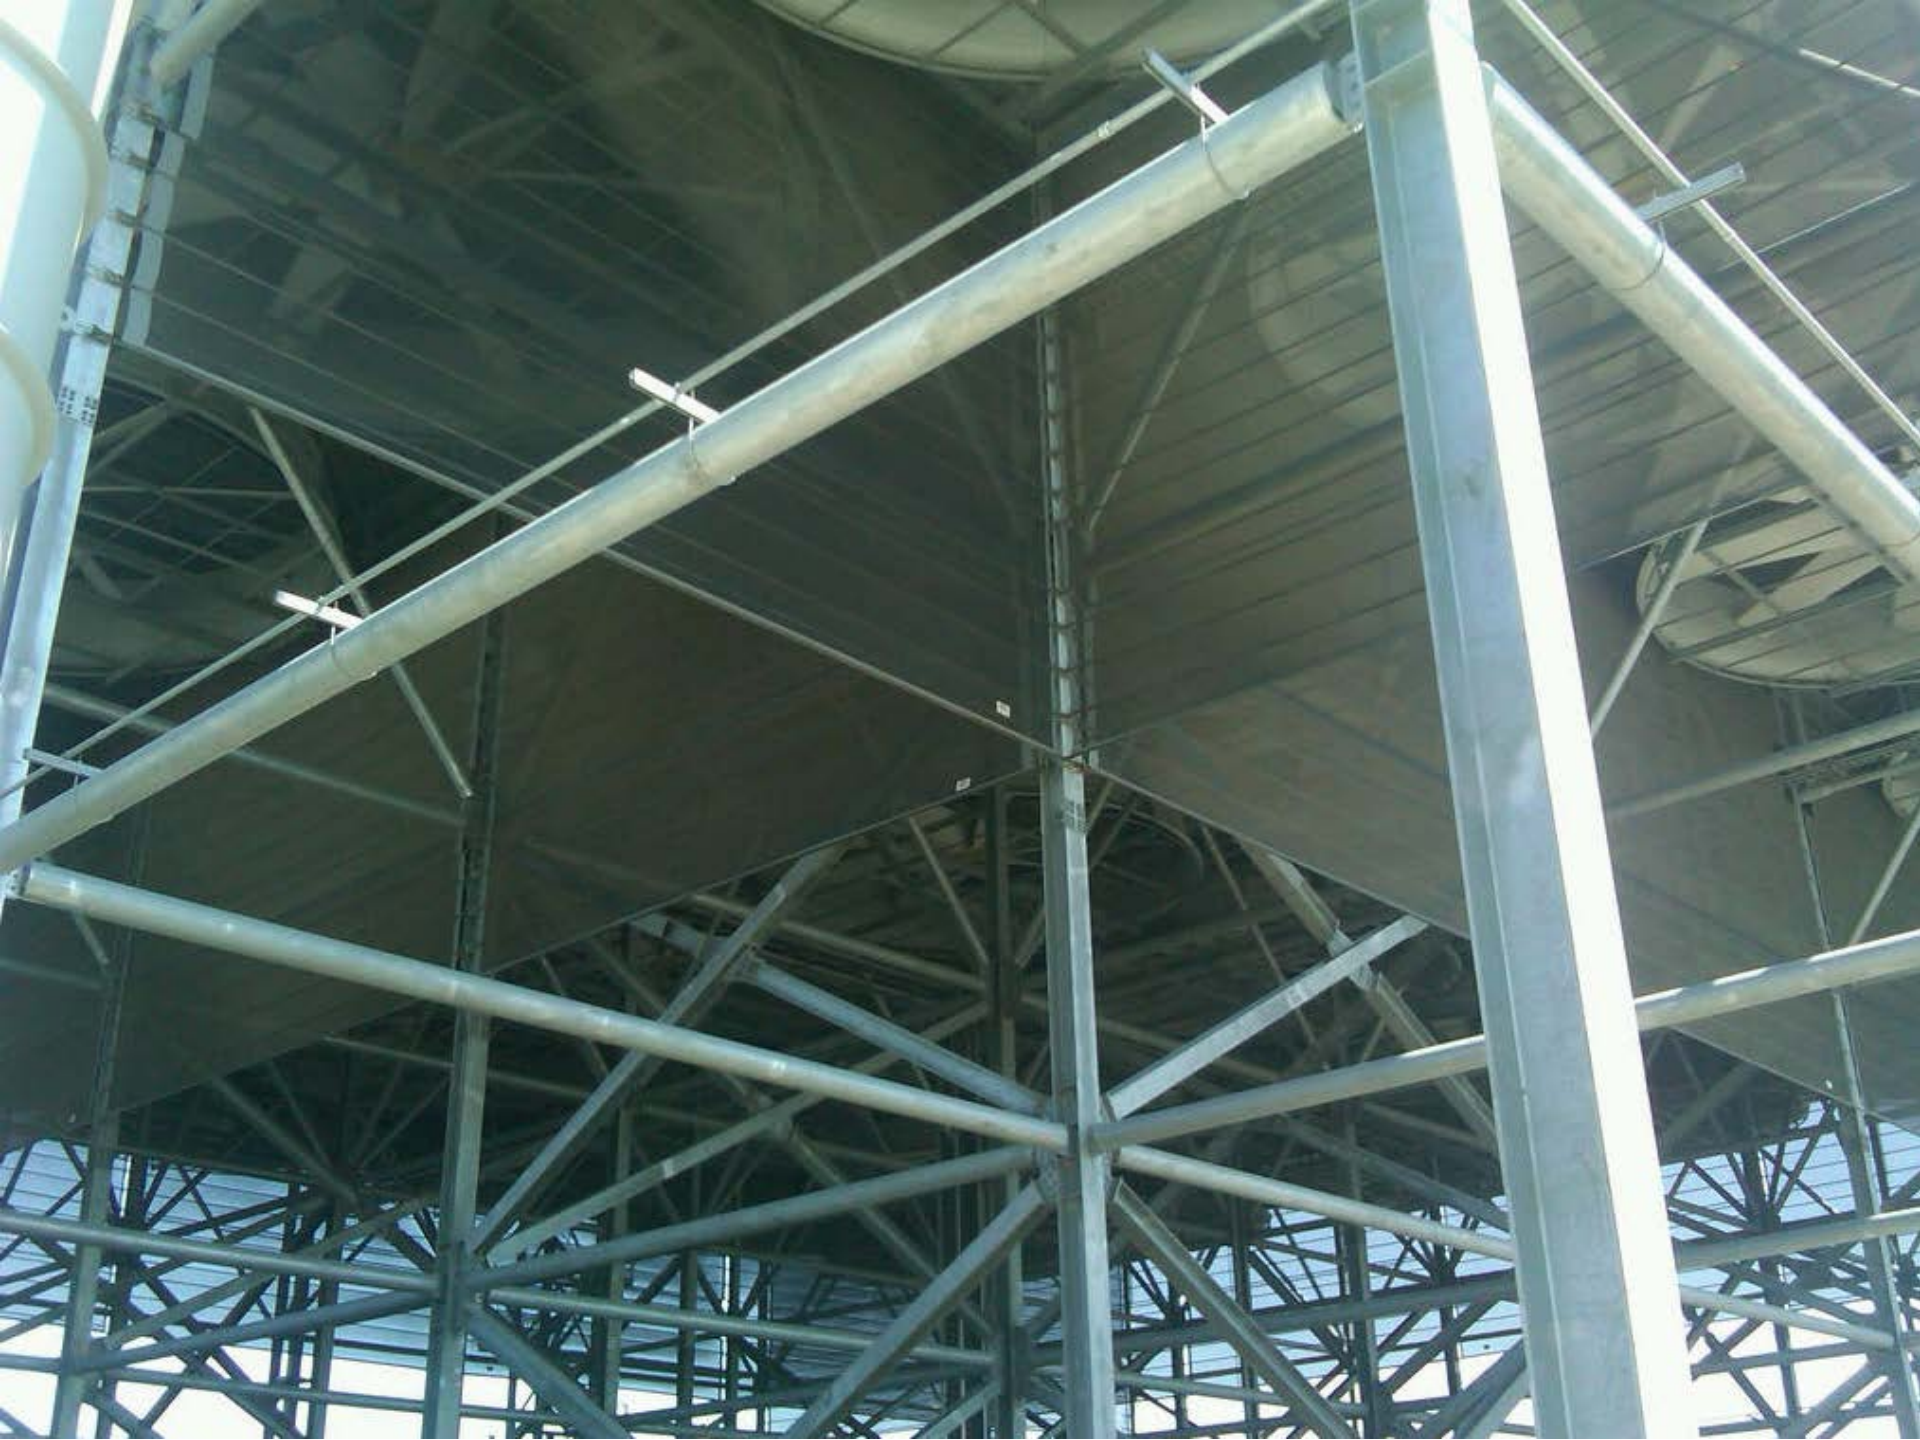
- Original wind design
  - Avg. wind speed per SPX Specification > 3 m/s.
  - Gateway site specific design wind speed can be 5.21 m/s (11.654 mi/hr)
    - Strong winds typical of the area.
    - Prevailing winds are from the west.
    - Afternoon wind speeds of 15 to 20 mph are common throughout the straits region, accelerated by the venturi effect setup by the surrounding hills. Annual average wind speeds are and 9.5 to 10 mph.
- Screen placement
  - Screens were installed to break up the wind, but were placed only based on other installations and not as a result of a specific study.
- Vibration
  - Creates loose hardware / fasteners. This is a hazard to personnel and equipment.
  - Loose items may (or have) fallen into fan blades (causing impact damage). Some blades have been replaced due to this.
  - Could be a major contributor to gearbox failures.
