By David Rettke
Maintenance Specialist
WALTER M. HIGGINS III
GENERATION STATION
PRIMM NEVADA

WHAT IS THE CONDITION OF YOUR ACC SYSTEM?

HOW TO DISCERN THE CONDITION OF YOUR ACC SYSTEM ACCURATELY AND EFFECTIVELY,
USING CONDITION BASED MAINTENANCE, ROOT CAUSE ANALYSIS, AND OTHER PROACTIVE
MAINTENANCE APPROACHES.

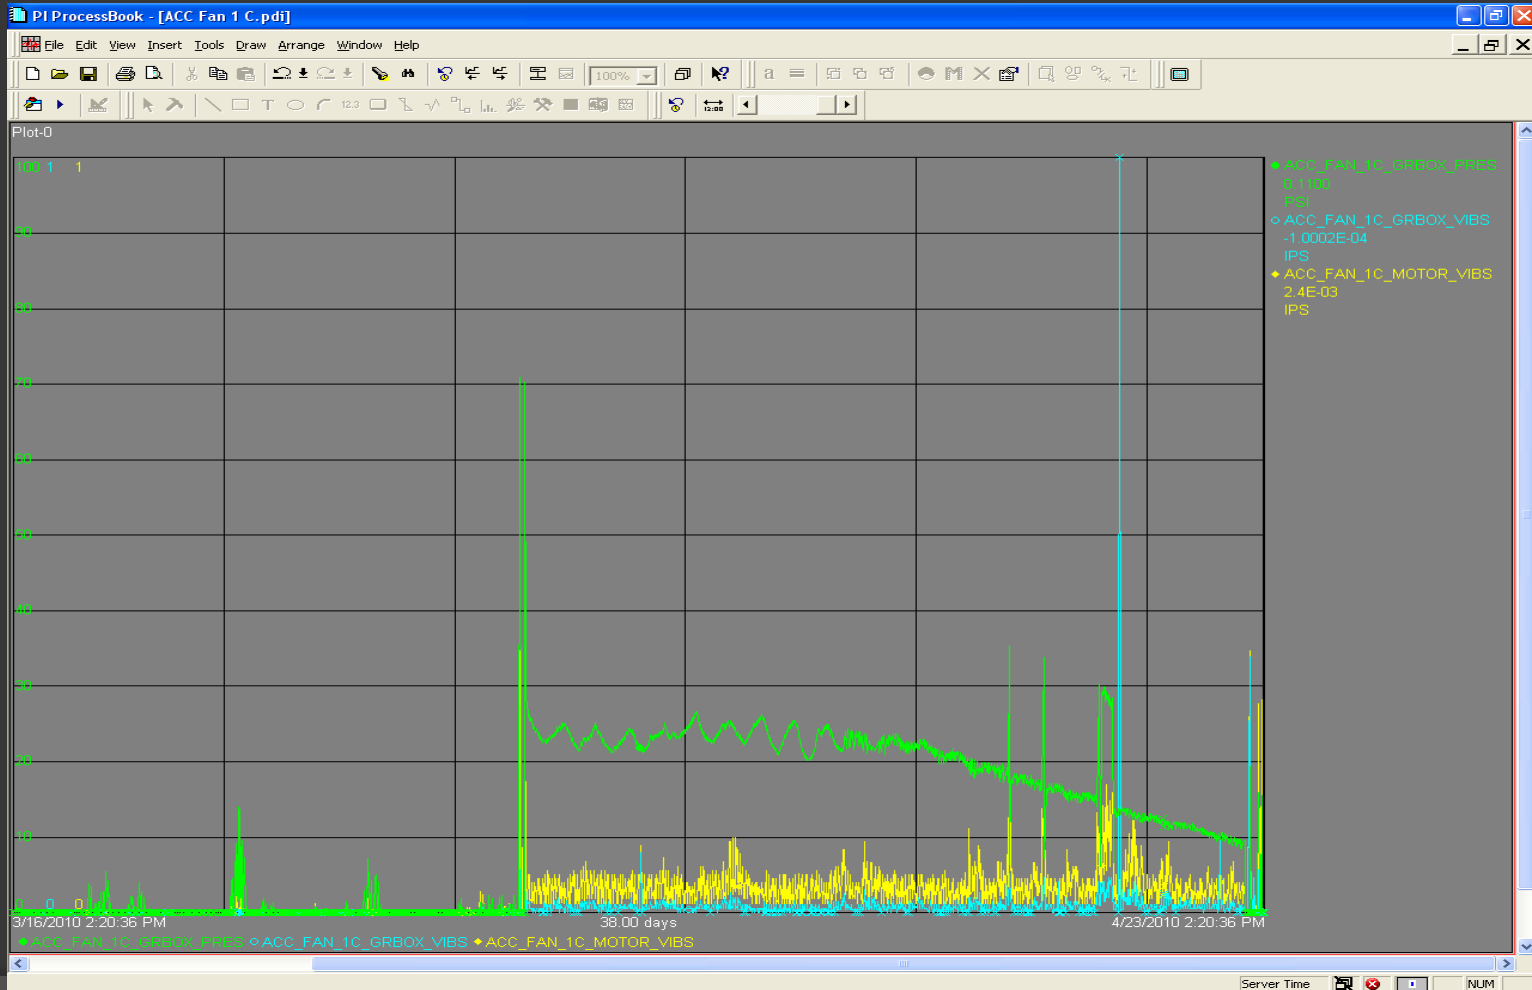
Typical trend showing lube oil pressure drop off due to clogging filter.

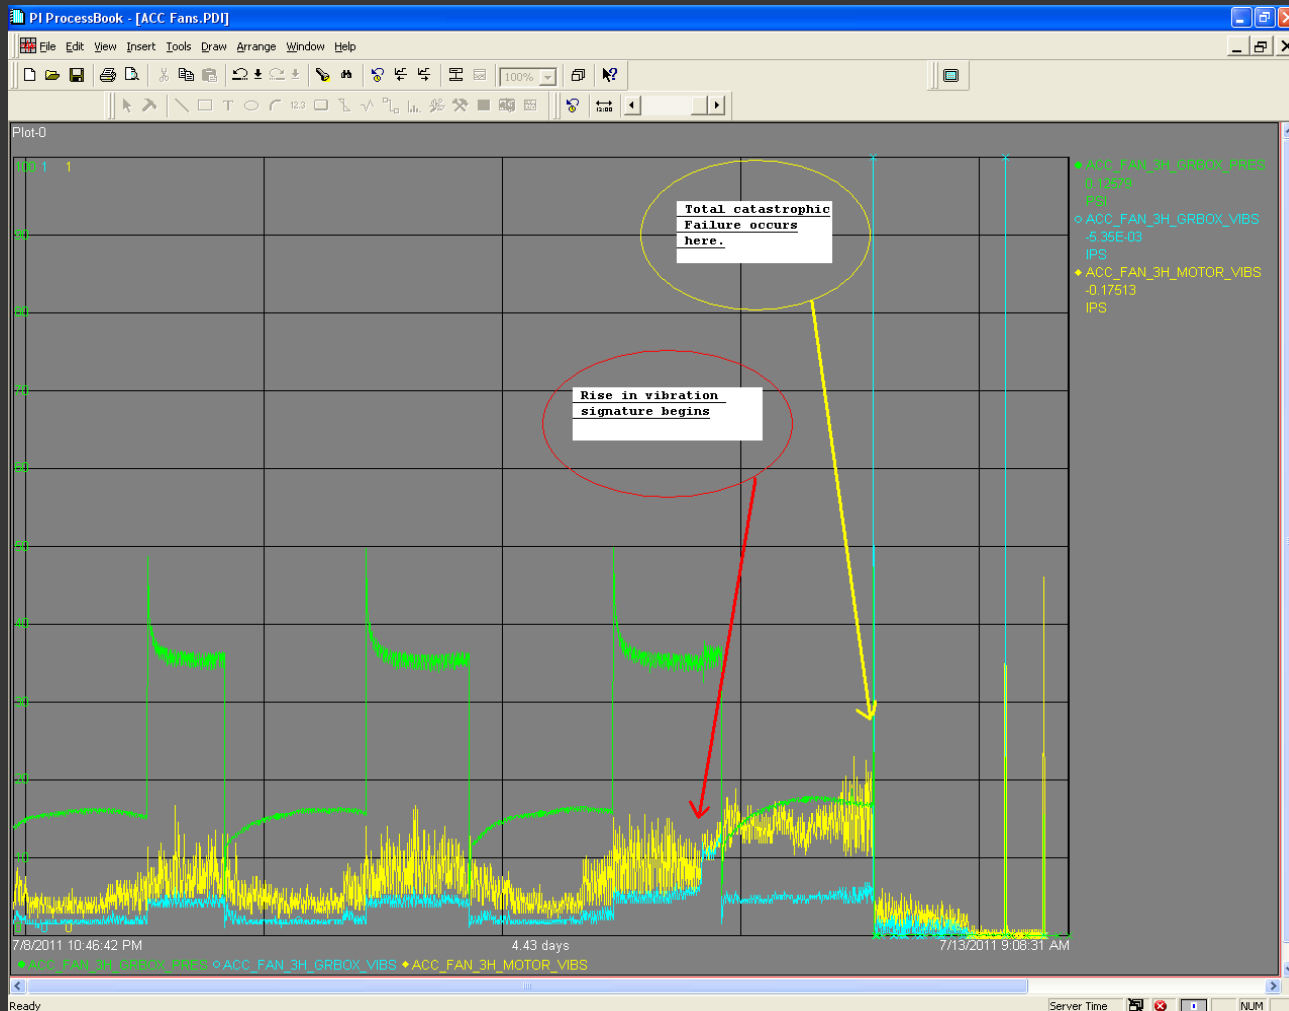
Catastrophic Gear reducer failure

- ① Because we can monitor our ACC unit's individually, we were able to trend this issue two weeks before failure.
- ① The time gained allowed us to gear up for the change, ensure parts were onsite and set up outside assistance for the job and to schedule unit for down time.
- ① Gave us a background on vibration and oil pressure signatures for future troubleshooting.

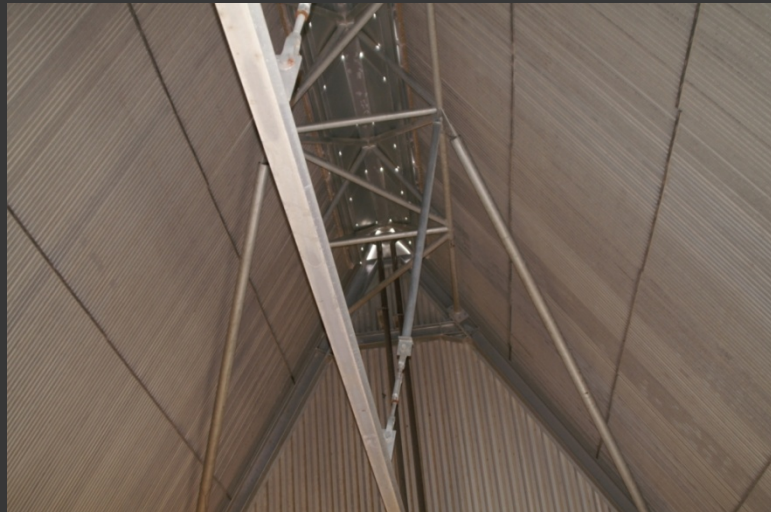
Finding structural issues

- ⦿ Noted that over time turnbuckles loosen up. Walk-downs catch these and repairs are scheduled to fix.
- ⦿ Lock nuts on turnbuckles are marked when tightened now for easier visual check.
