DRY FORK STATION

Plant Report

2012 ACC Users Group

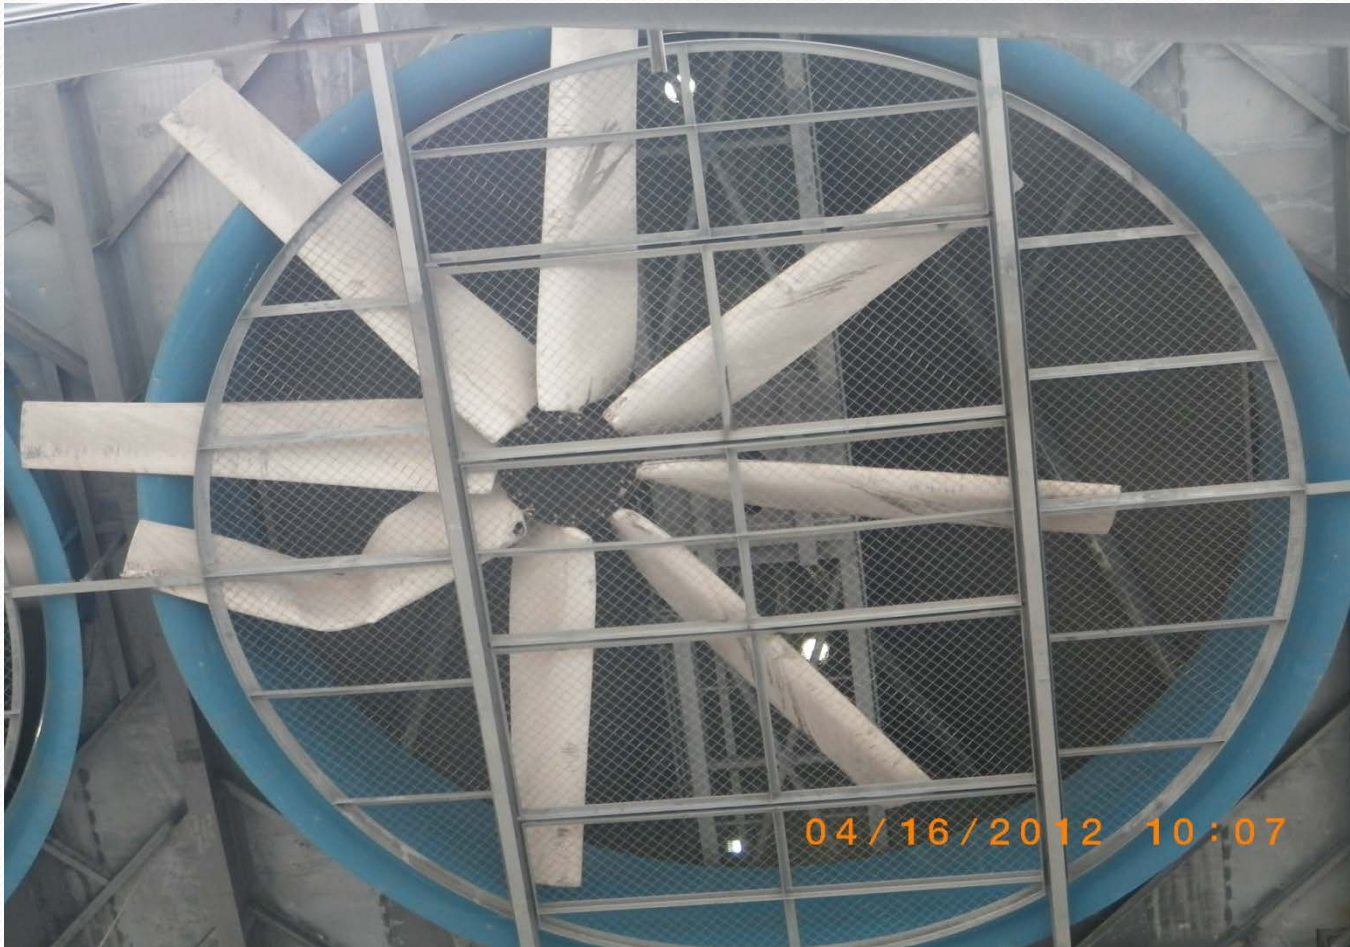
- Fan hub failures

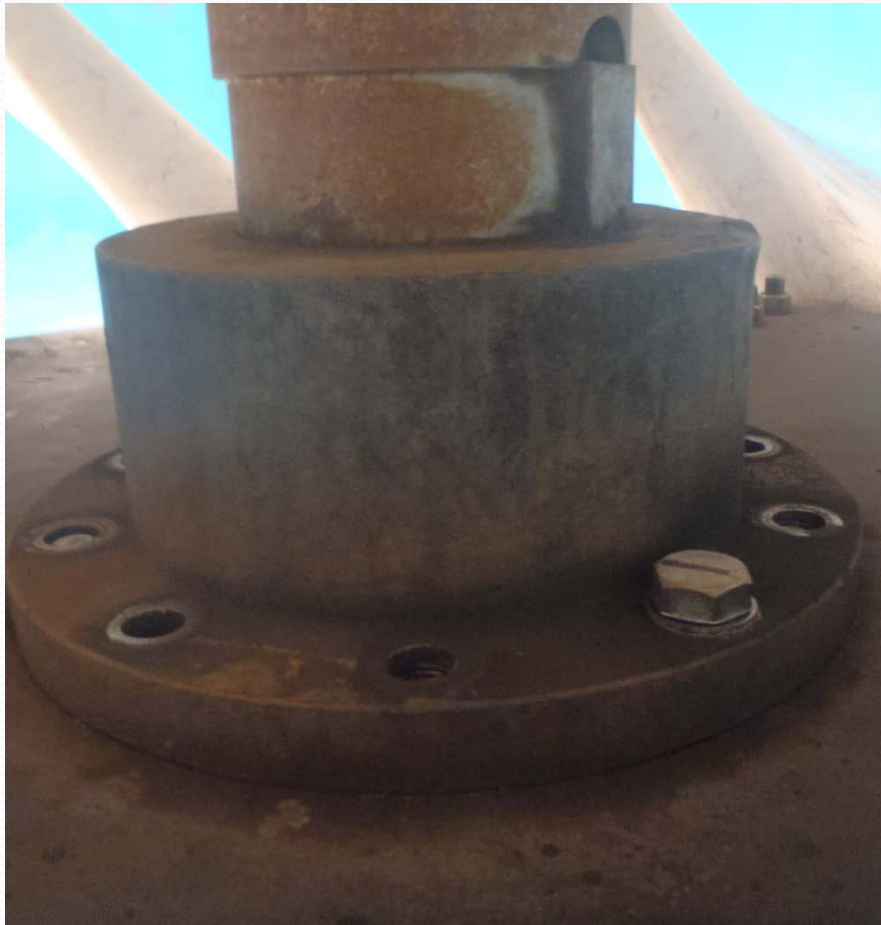
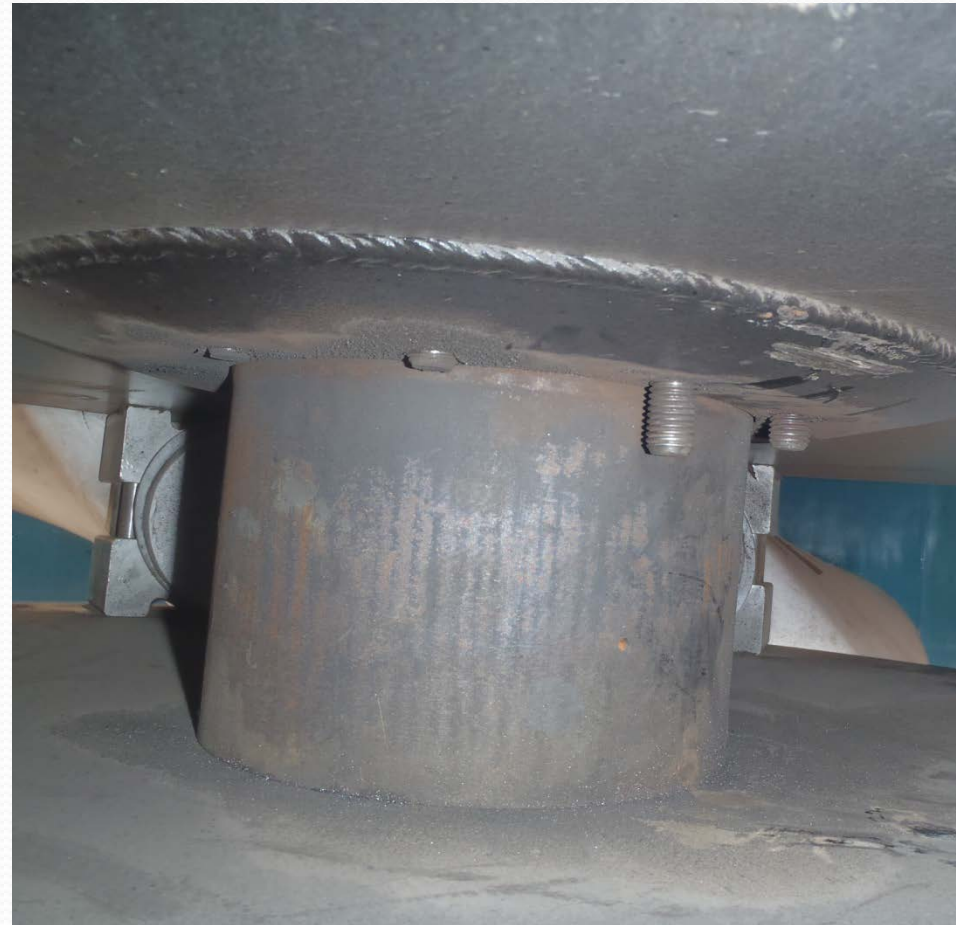
- Fan hub failures

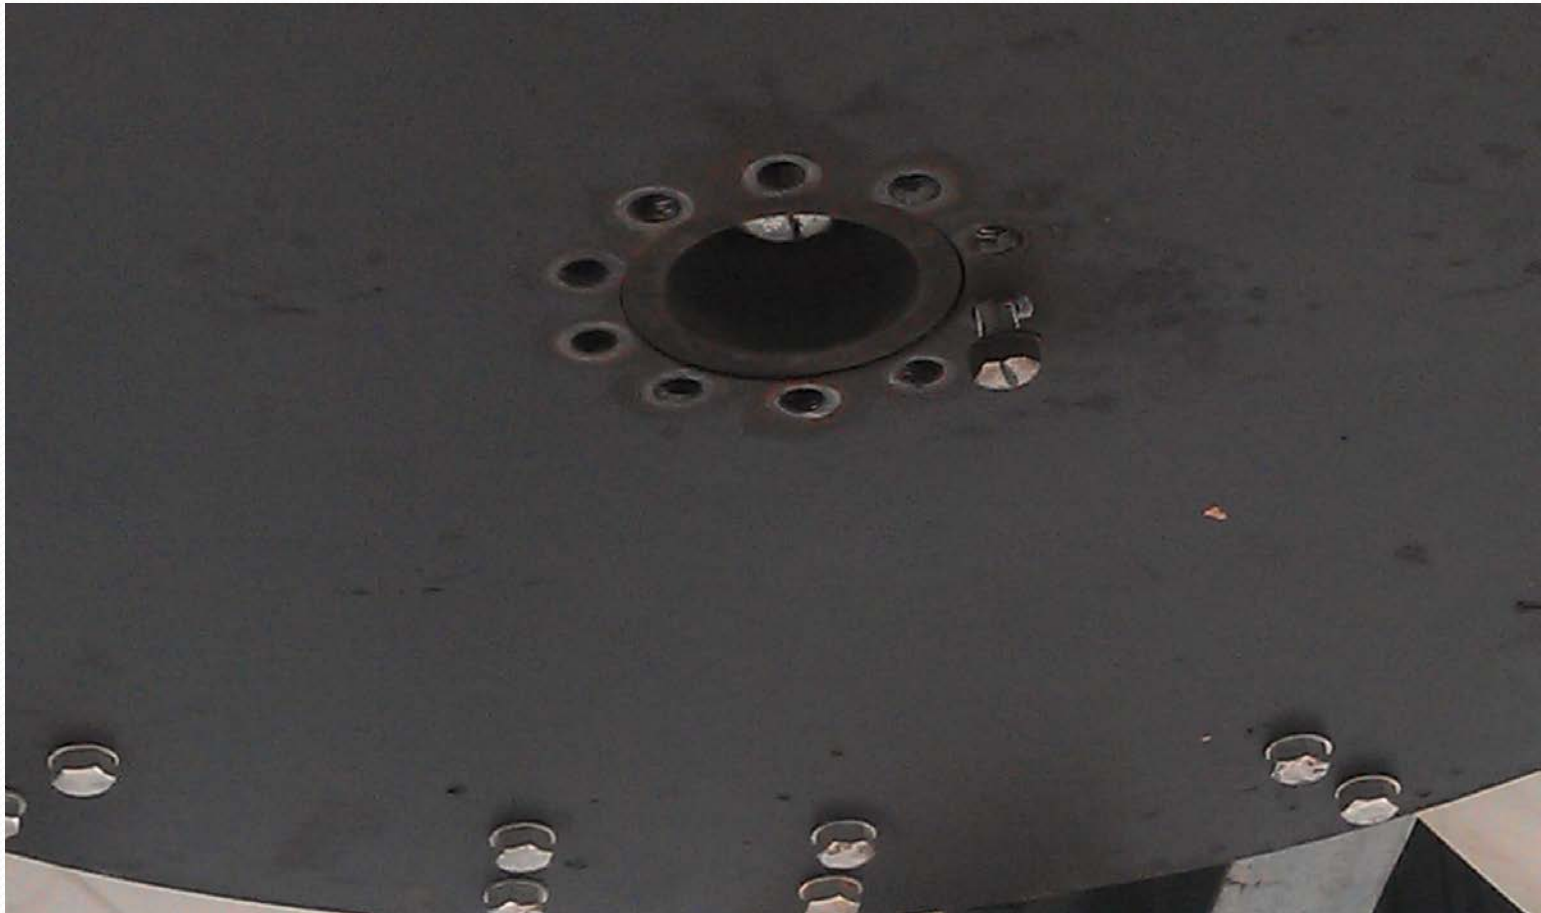
- Fan hub failures

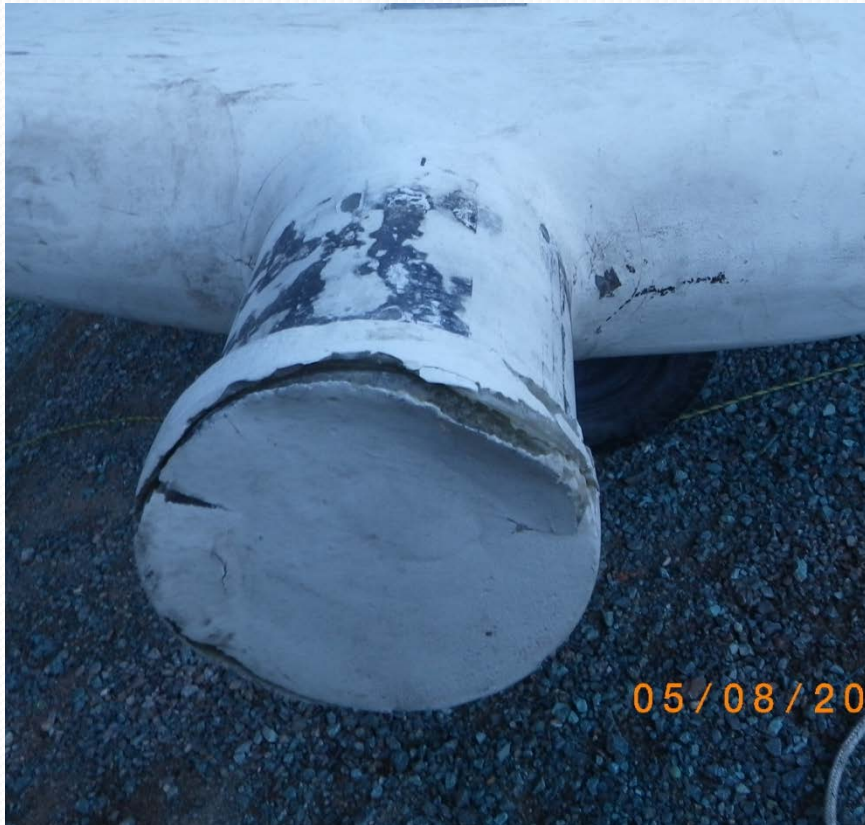
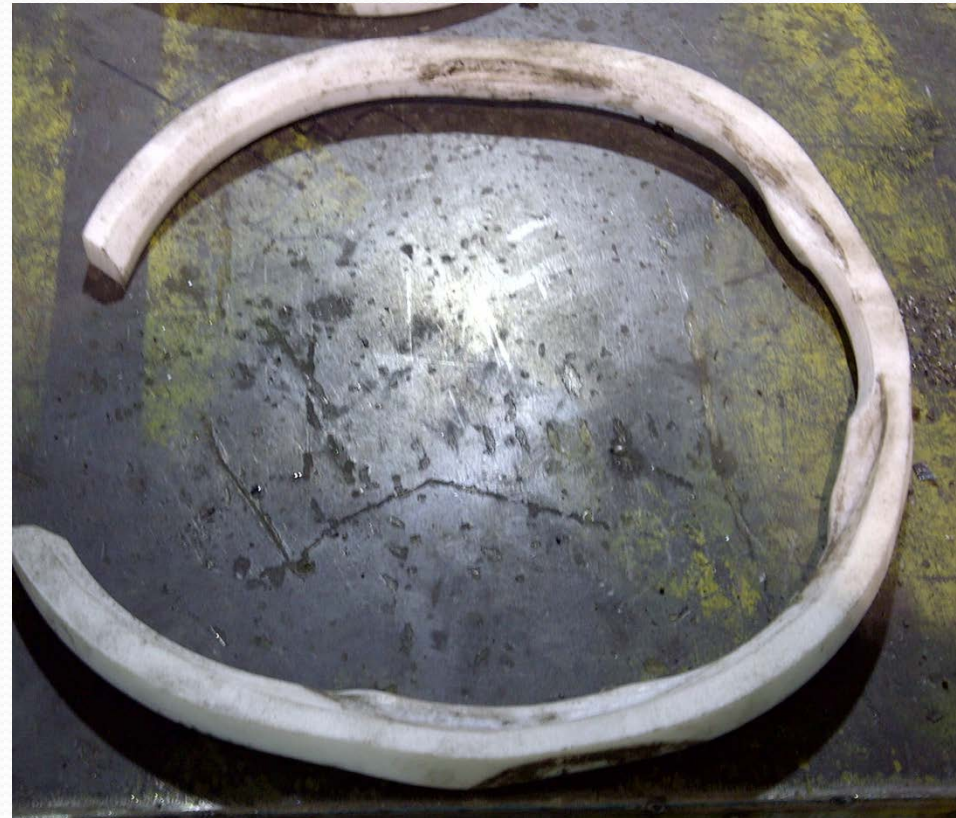
- Fan blades being crushed due to over torquing

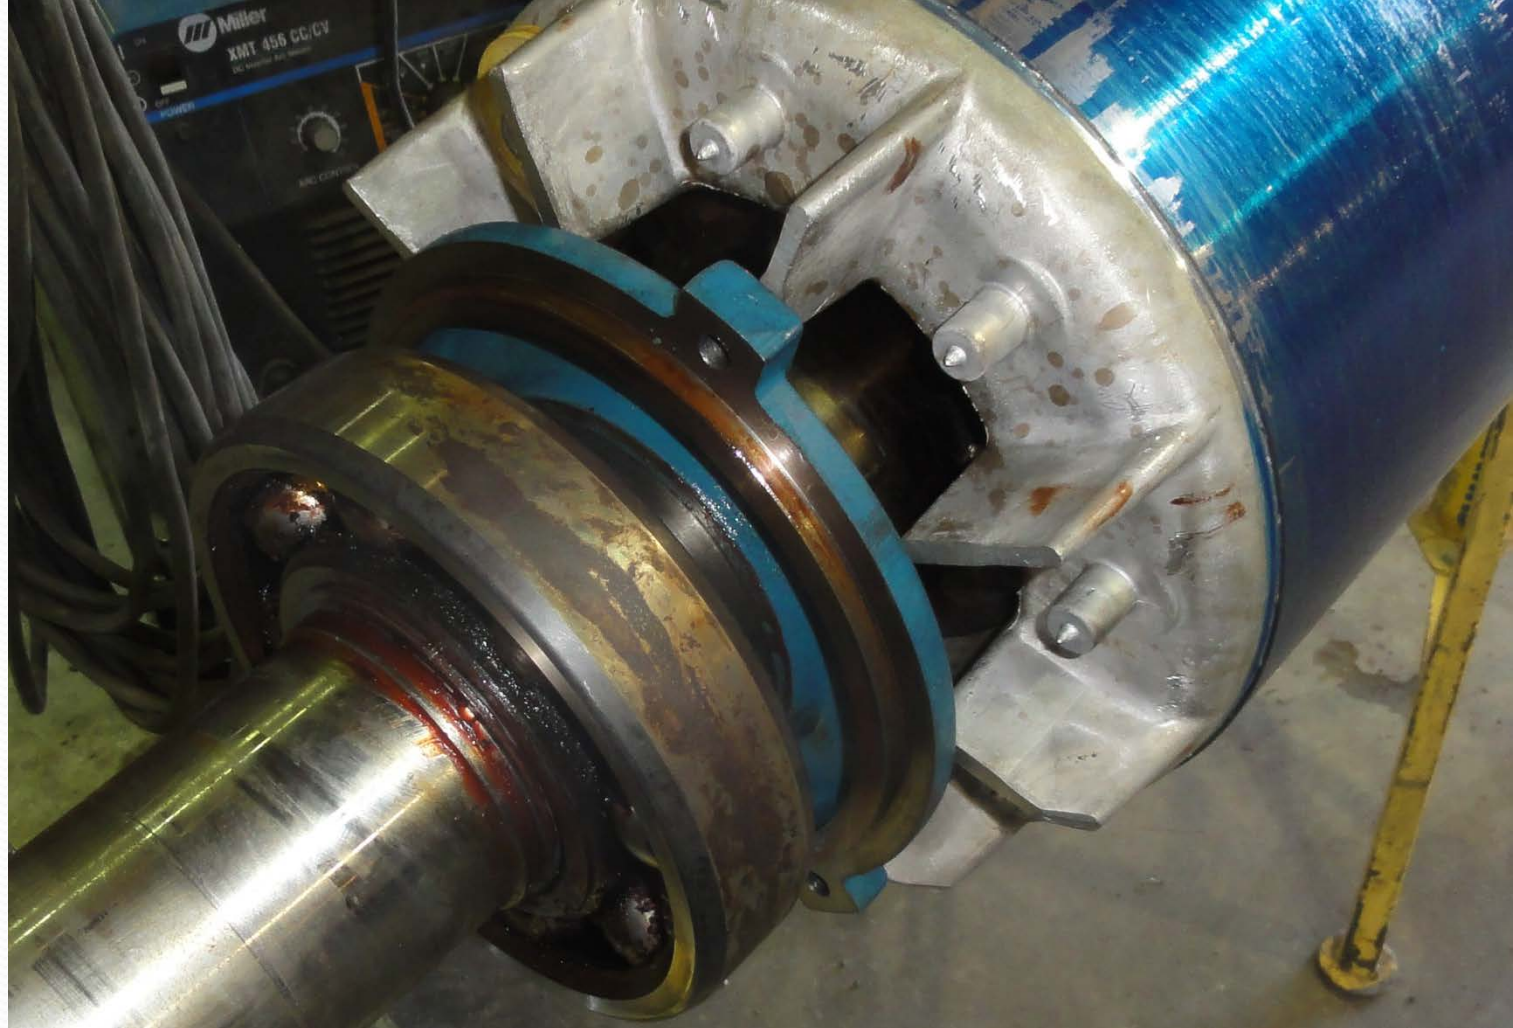
- Motor Bearing failures in all 45 motors

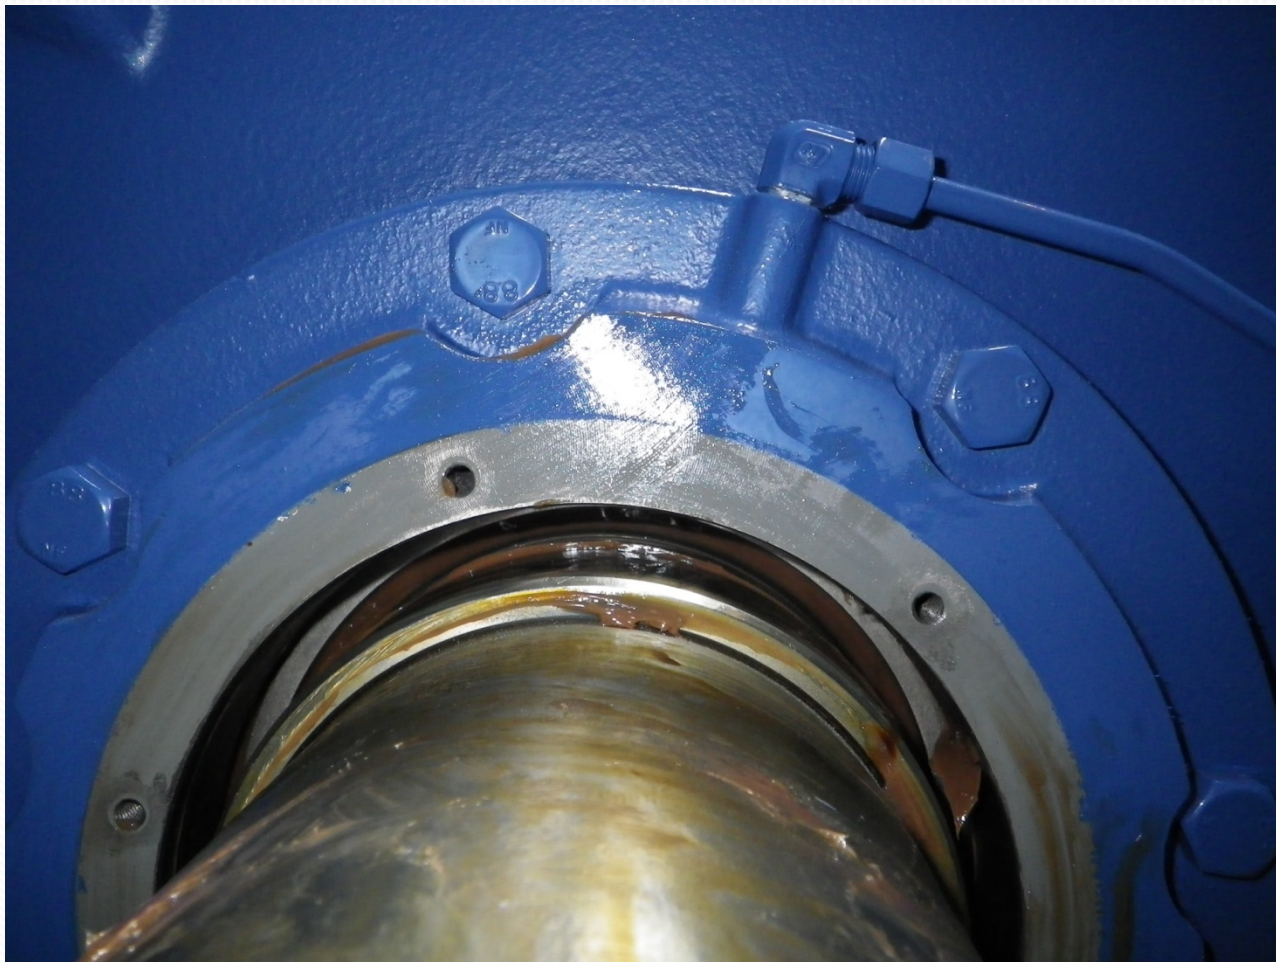
- No O&M manuals for gearboxes
- Leaky shaft seals around gearbox input shaft

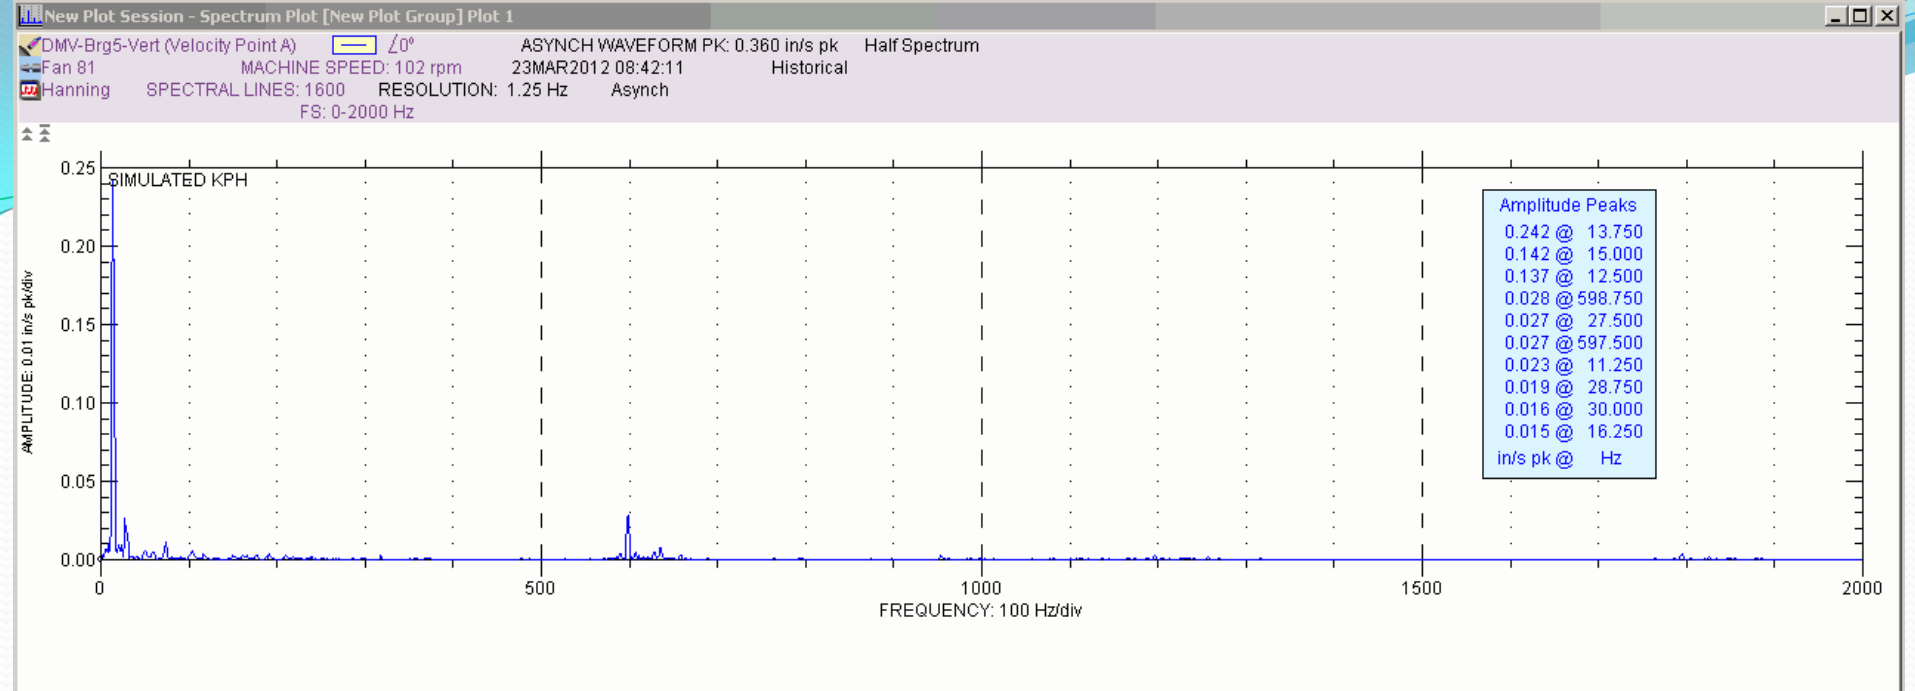
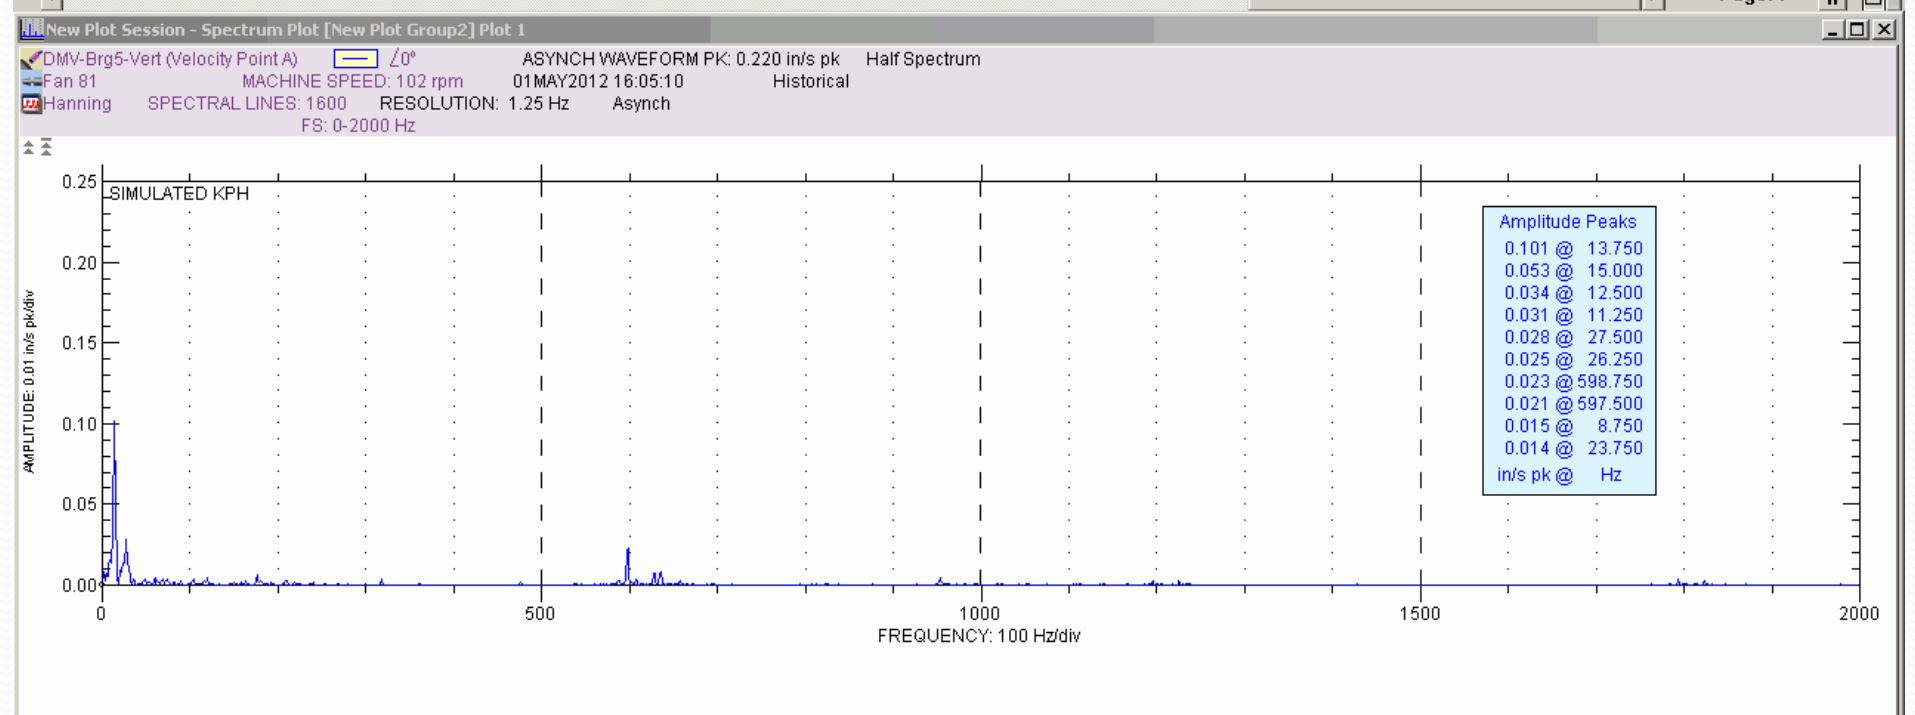
- ACC performance enhancements
 - Re-pitched the blades from 32.4° to 39° approach angle
 - Blade re-pitch resulted in lowering the overall vibrations of each fan by 10 to 50%
