By David Rettke
Maintenance Specialist
WALTER M. HIGGINS III
GENERATION STATION
PRIMM NEVADA

WHAT IS THE CONDITION OF YOUR ACC SYSTEM?

HOW TO DISCERN THE CONDITION OF YOUR ACC SYSTEM ACCURATELY AND EFFECTIVELY,
USING CONDITION BASED MAINTENANCE, ROOT CAUSE ANALYSIS, AND OTHER PROACTIVE
MAINTENANCE APPROACHES.

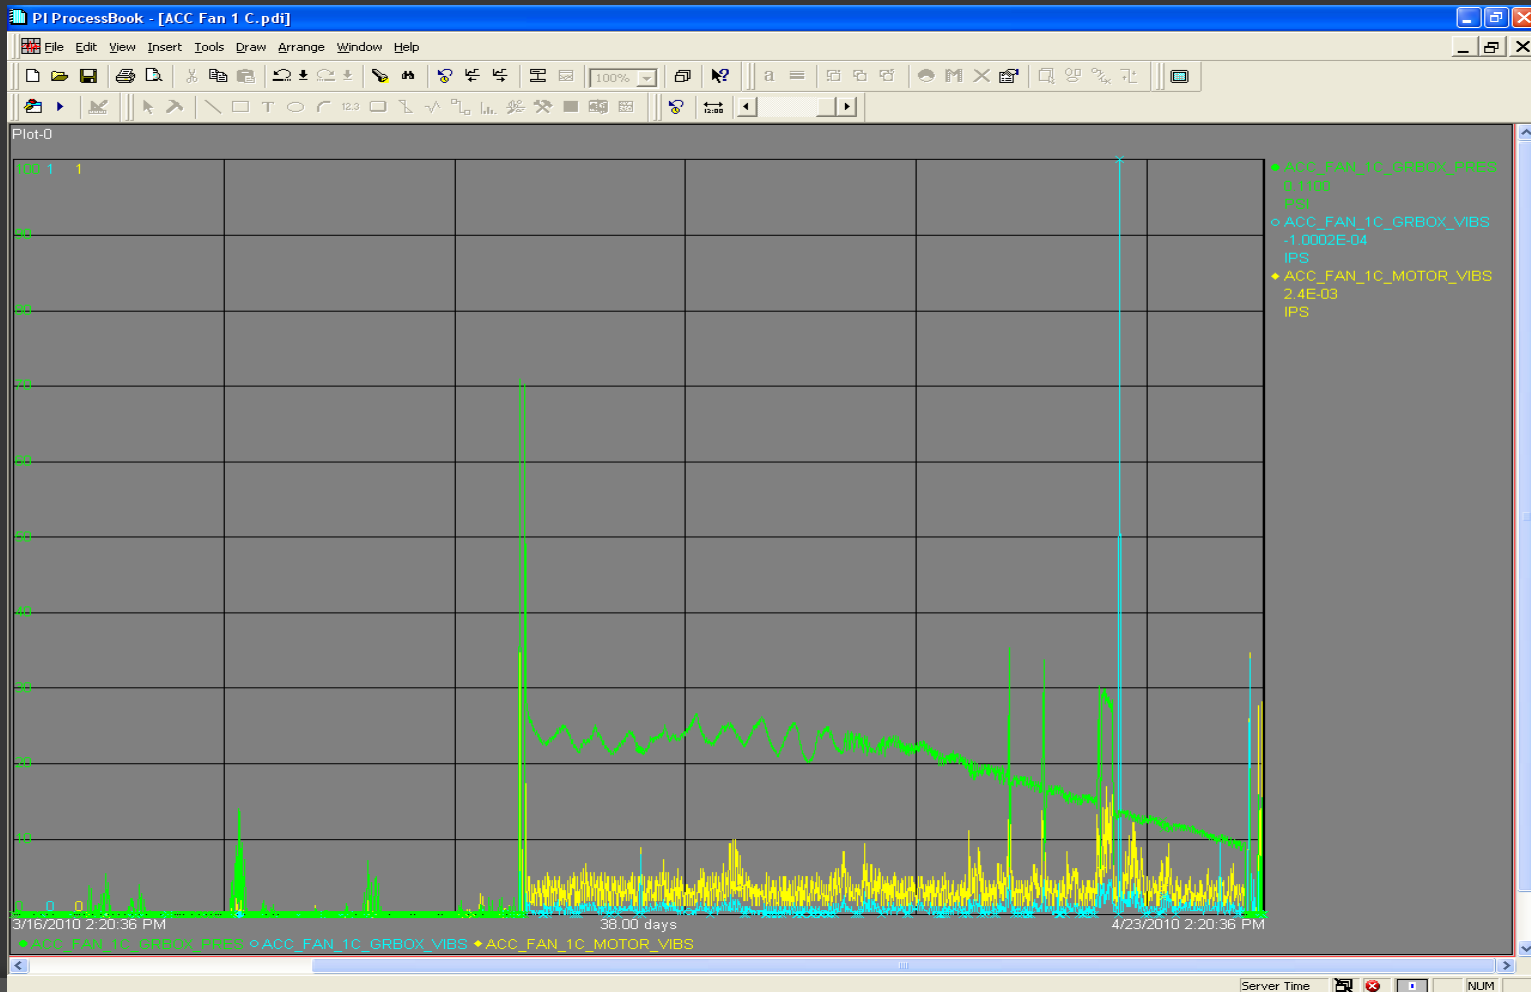
Typical trend showing lube oil pressure drop off due to clogging filter.

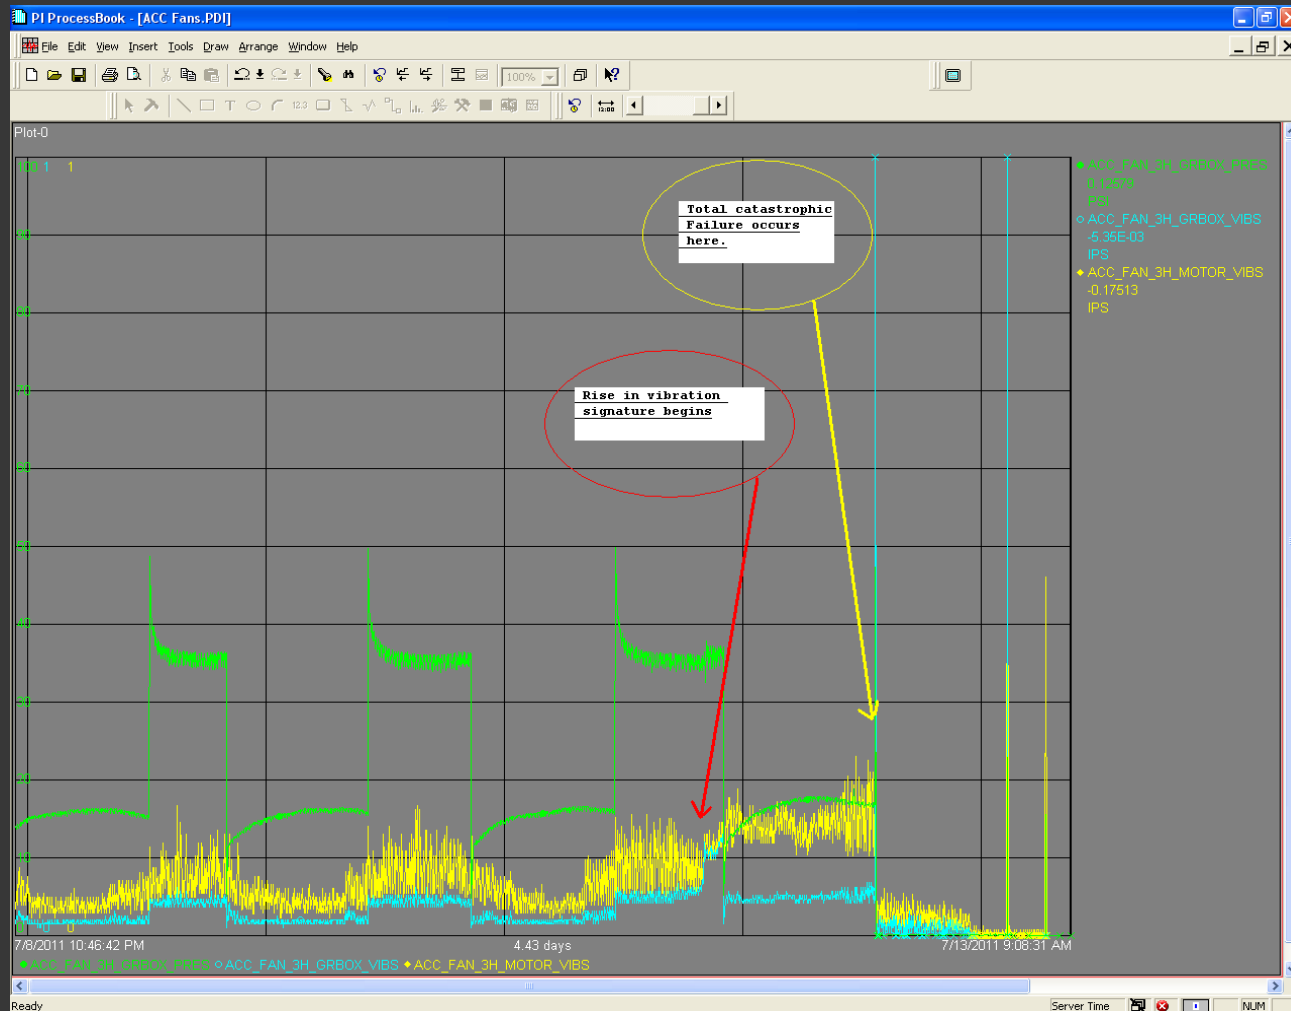
Catastrophic Gear reducer failure

- ⦿ Because we can monitor our ACC unit's individually, we were able to trend this issue two weeks before failure.
- ⦿ The time gained allowed us to gear up for the change, ensure parts were onsite and set up outside assistance for the job and to schedule unit for down time.
- ⦿ Gave us a background on vibration and oil pressure signatures for future troubleshooting.

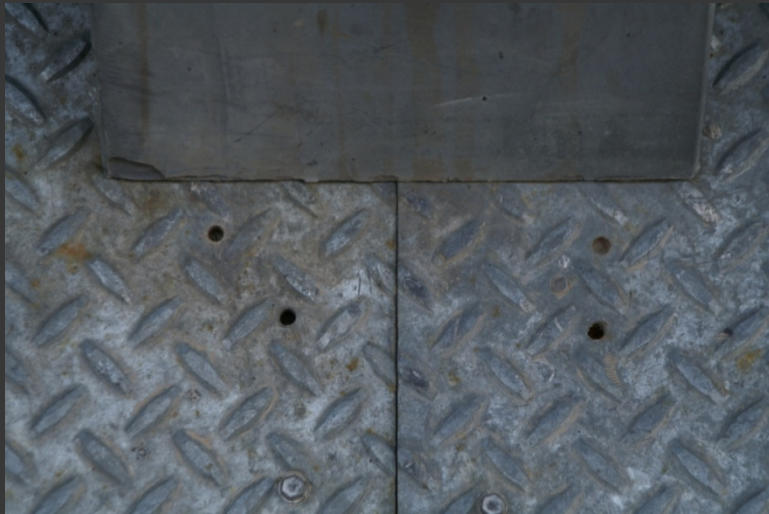
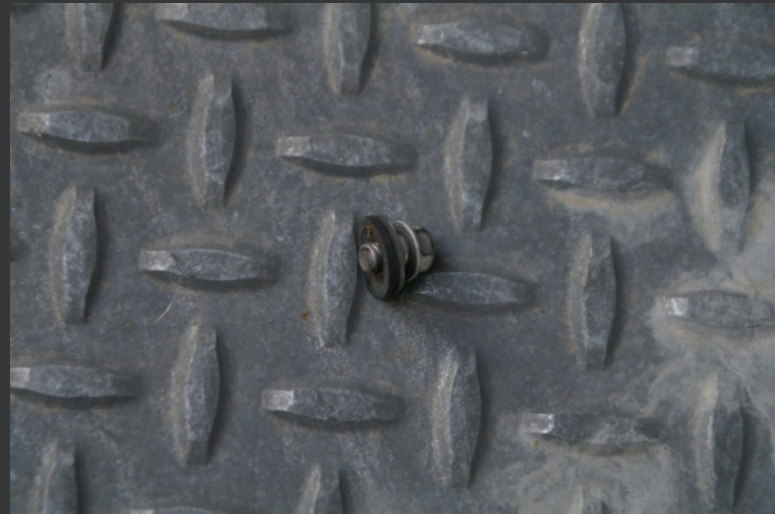
Decking issue caught by walk-downs

- A 3/8" hole drilled in deck plate.
- A 1/4" pan head bolt threaded into deck support beam.
- A 'Fender-washer' used to complete fastening, allows for movement between deck plate and support beam
- Bolt is lock-tite held in position

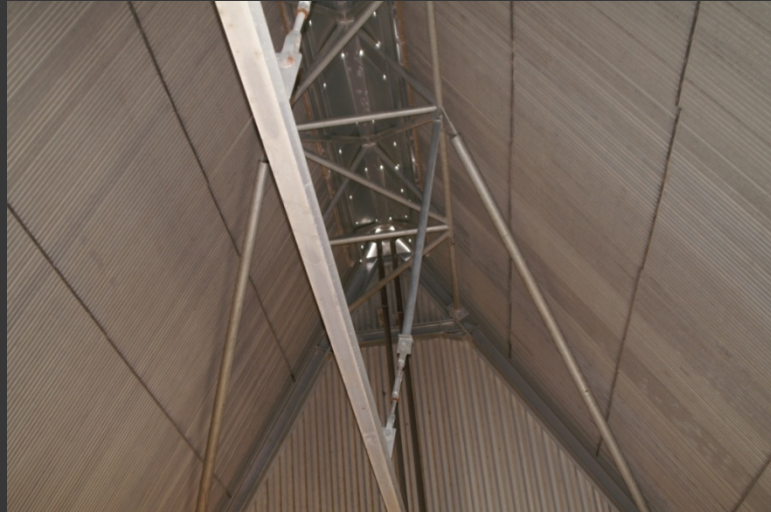
Finding structural issues

- Noted that over time turnbuckles loosen up. Walk-downs catch these and repairs are scheduled to fix.
- Lock nuts on turnbuckles are marked when tightened now for easier visual check.
