COMANCHE ACC IMPROVEMENT PROJECT

Xcel Energy – Comanche Station Pueblo, Colorado

- **Coal Fired Plant**
 - **(2) 350 MW (Units 1 & 2)**
 - **(1) 800 MW (Unit 3)**
 - **Unit 3, Utilizes Hybrid Cooling with a GEA 45 Cell, 9X5 ACC**
 - **Unit 3, Commercial Operation July 2010**
-

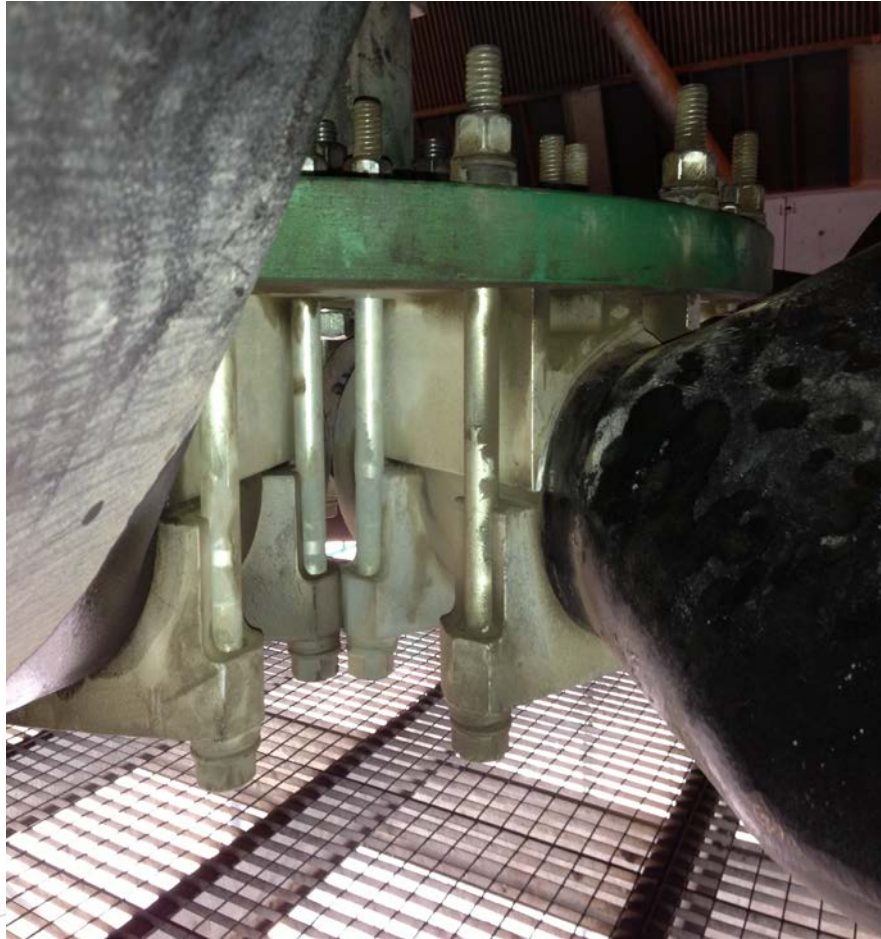
Re-Designed *Blade Clamp*

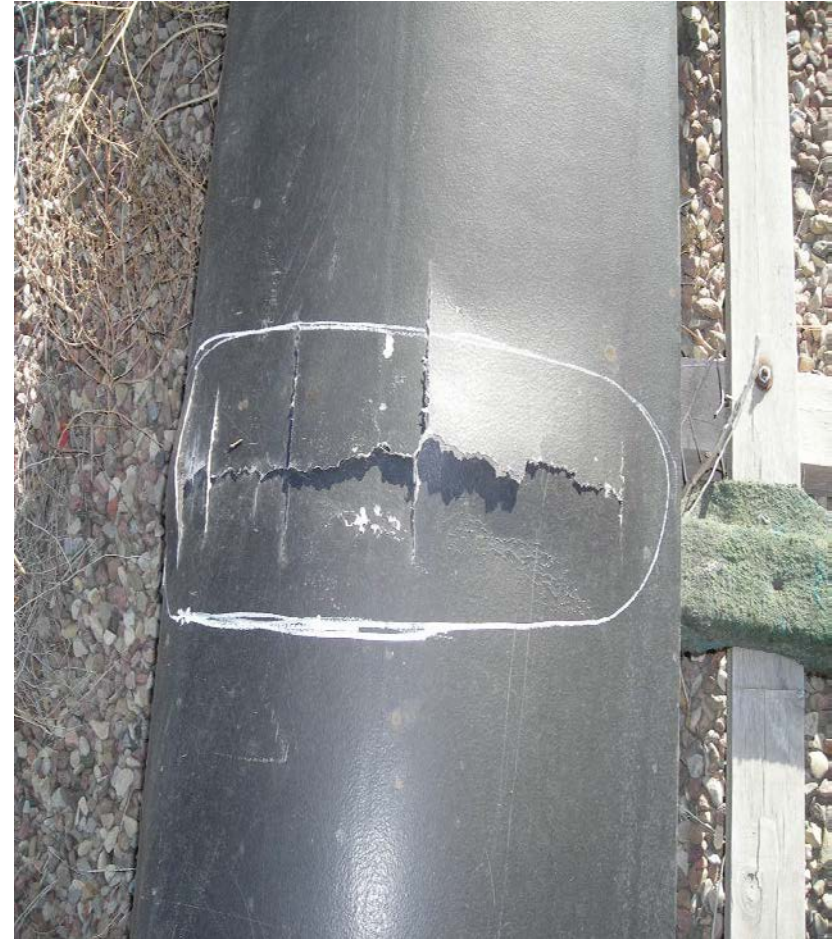
Cracked Blade

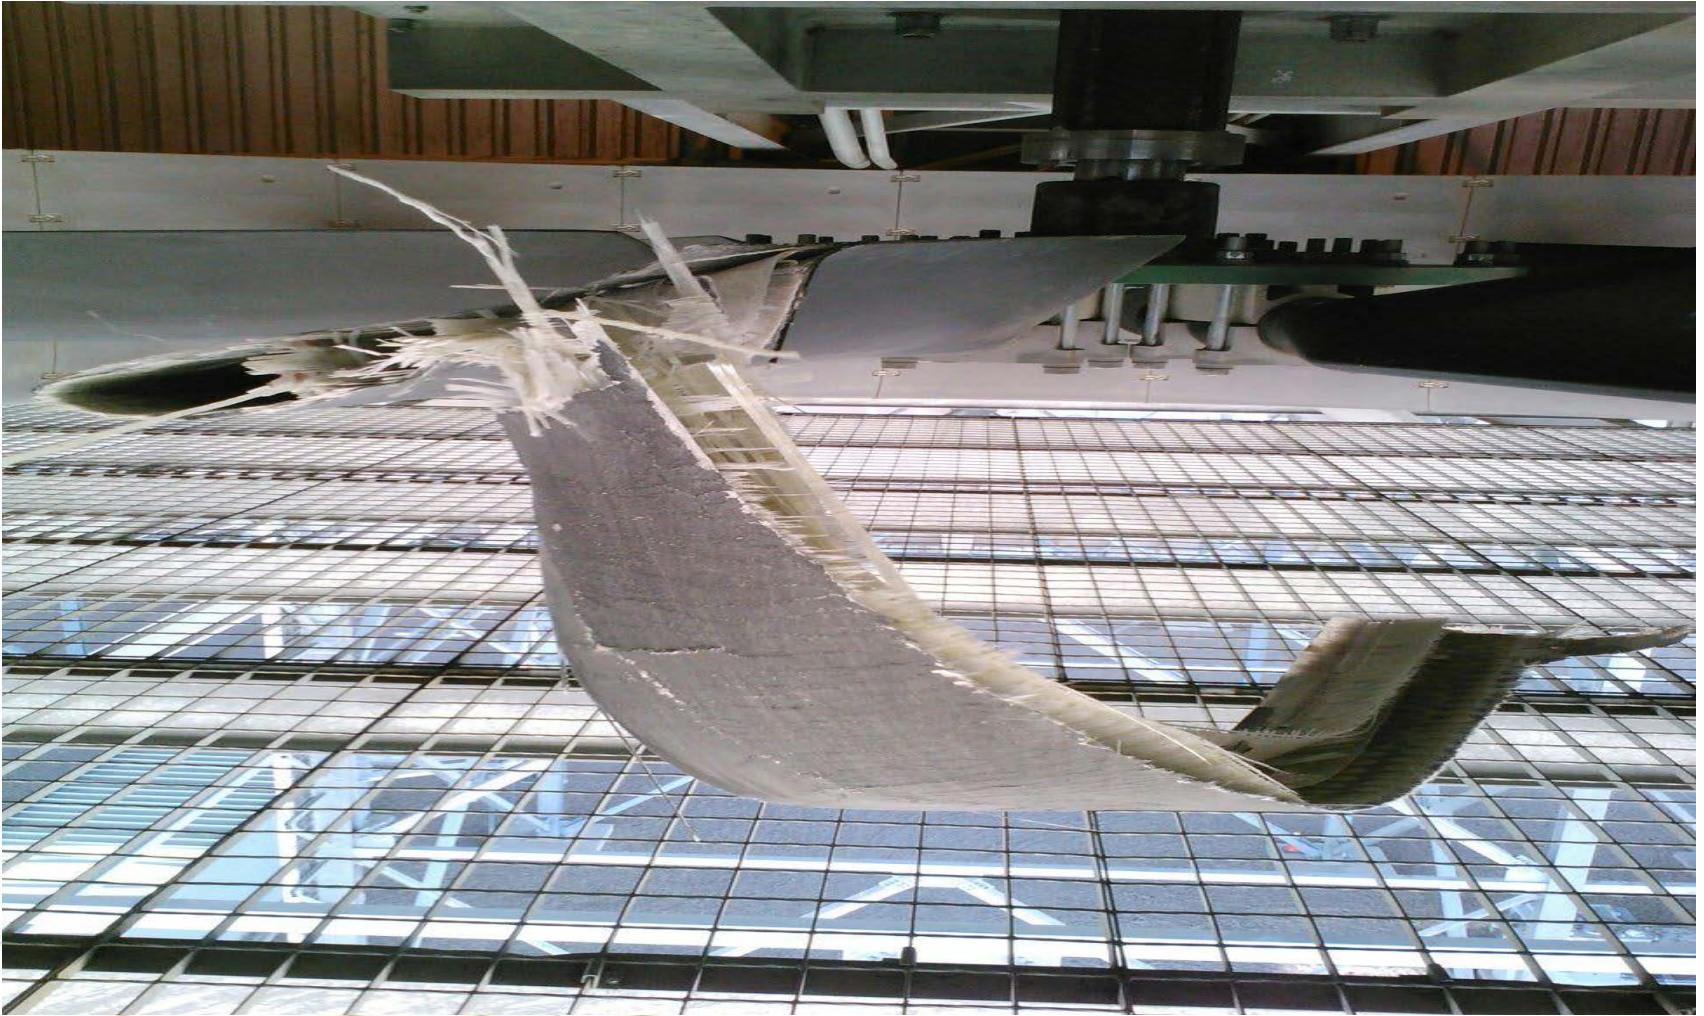
Catastrophic Blade Failure

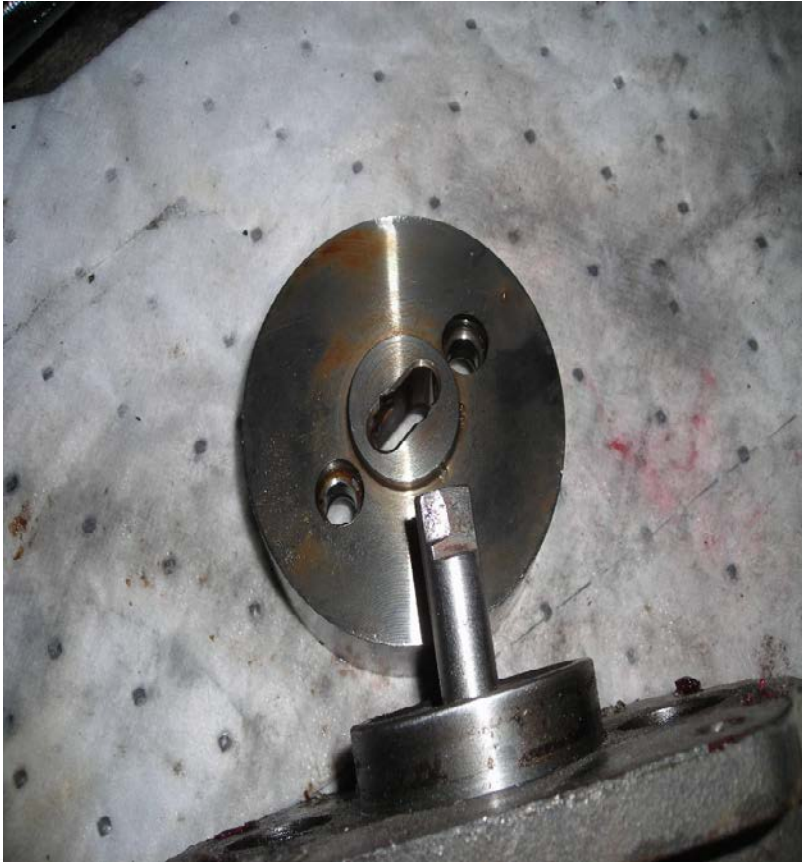
Shaft Driven Oil Pump Wear Area

- **Redesigned Retaining Ring on Top and Bottom of Hub Gear Utilizing an O-ring to Eliminate Keyway Oil Leaks**
 - **Removal of the Shaft Driven Oil Pumps**
 - **Addition of Externally Mounted Viking Electric Driven Oil Pumps**
 - **Changed to Synthetic Oil rather than Mineral Based**
-  
- The bottom of the slide features a decorative graphic consisting of several overlapping, wavy lines in shades of gray and yellow, creating a sense of motion or a stylized horizon.

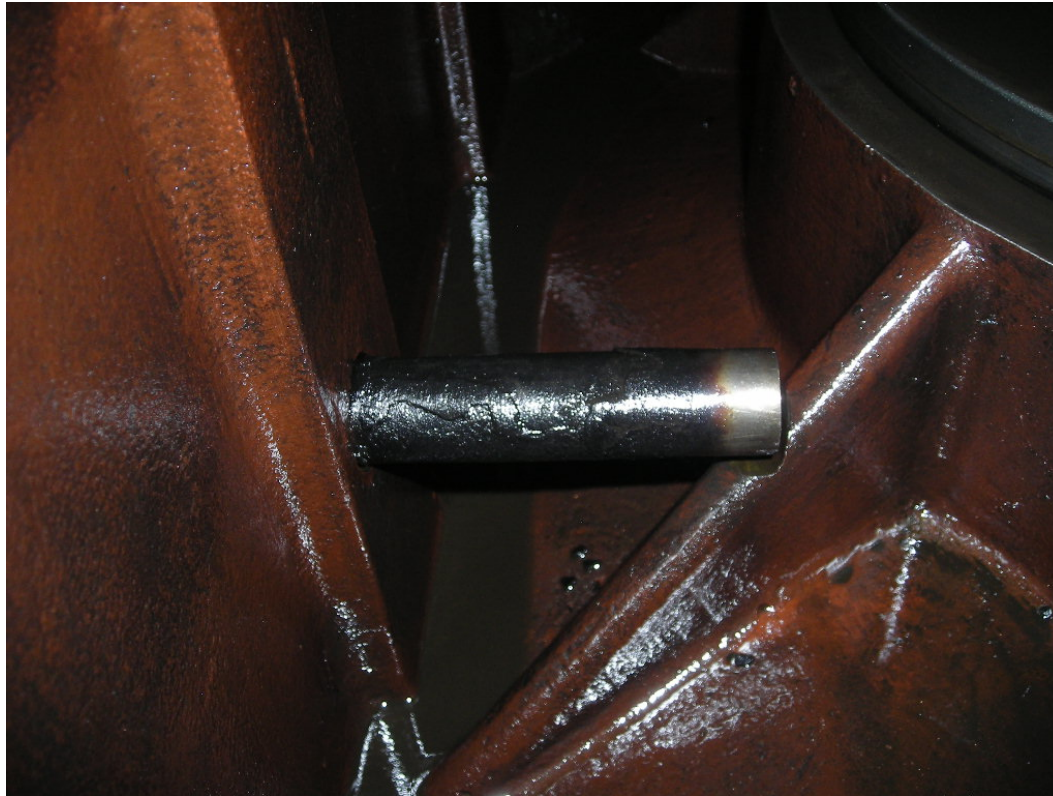
Gear Box Oil Heater Fouling

- **(6) Month Oil Sampling Program**
 - **On-line Filtering Program**
 - **(6) Month PM Program for Blade Torque, Blade Crack Inspections and Gear Box Bolting**
 - **Seasonal Shut Off of Gear Box Heaters**
-

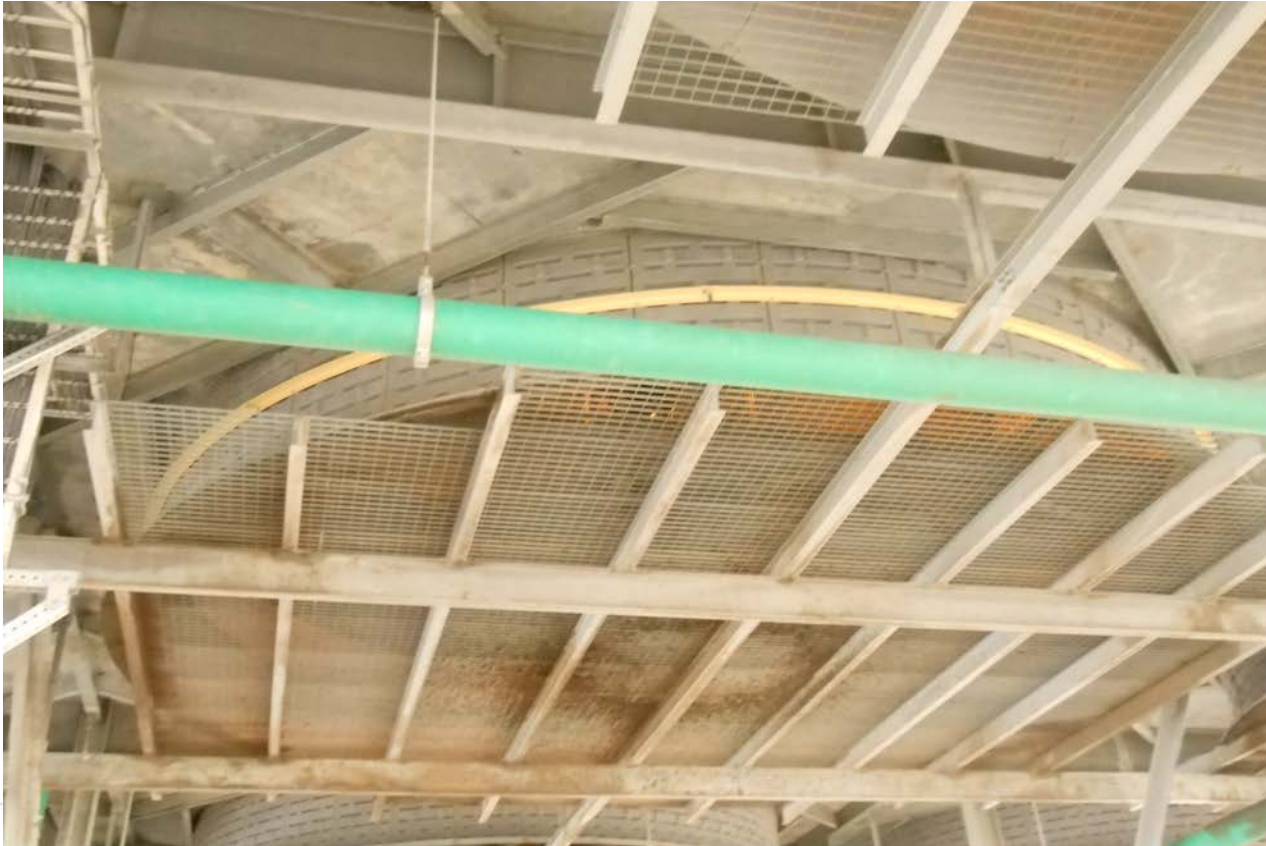
Fan Shroud Stiffening Ring

- **GEA's Engineering Study Concluded Excessive Fan Shroud Movement**
 - **Evaluated Stiffening Ring Quotes from Howden**
 - **Utilized a Local Contractor to Fabricate and Install Stiffening Rings**
-

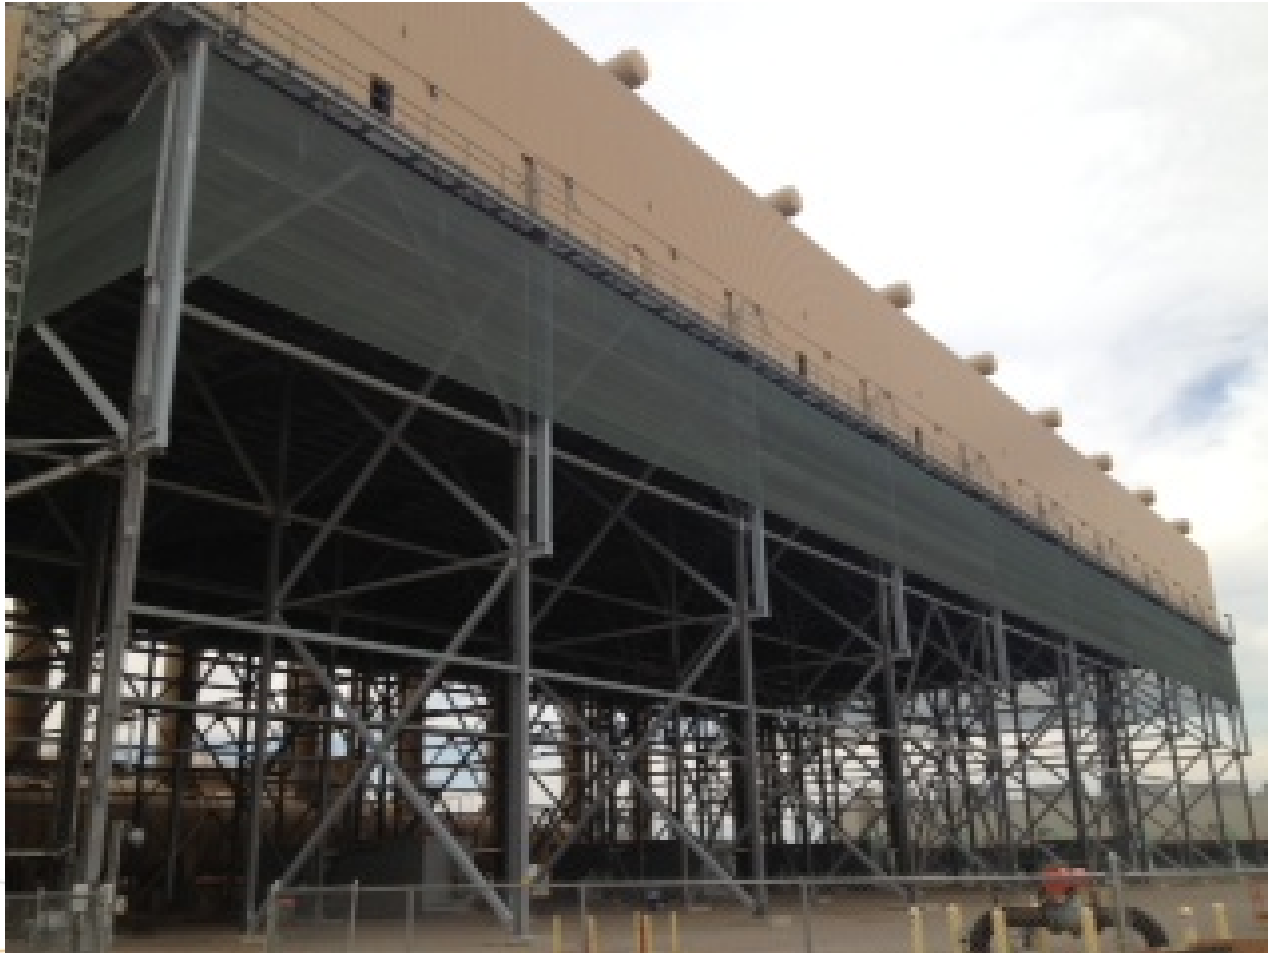
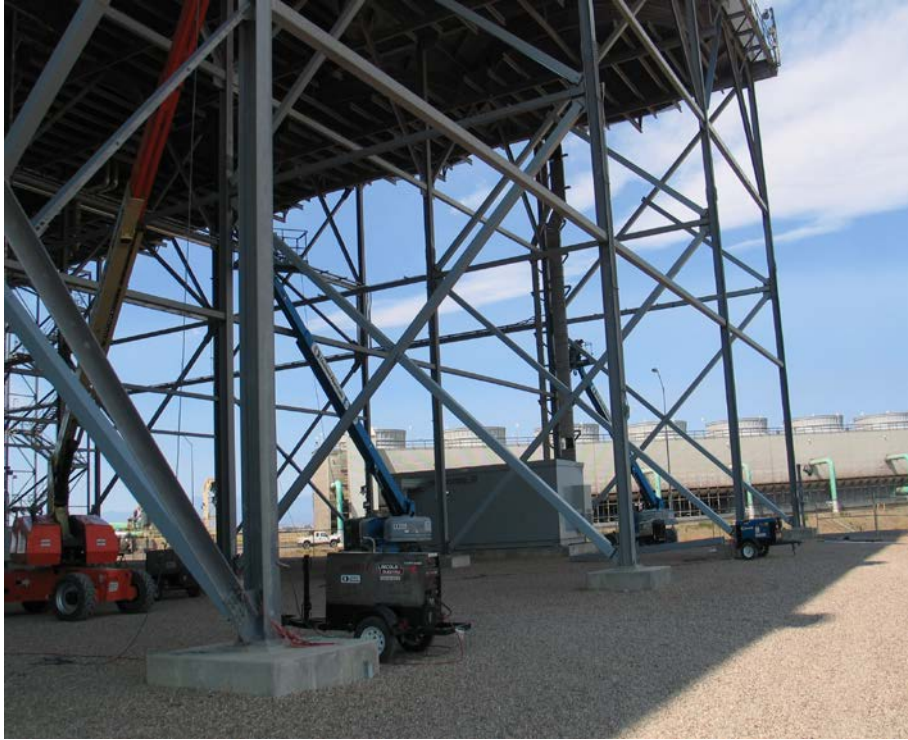
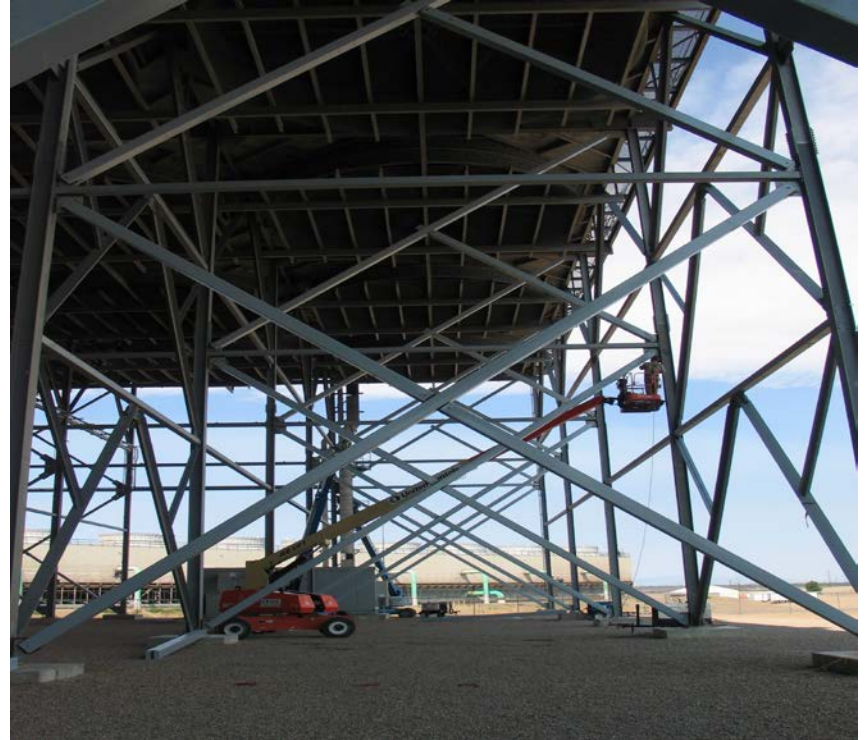
ACC Wind Screen Installation

- **Goal was to Minimize Fan Blade Cracking**
 - **Worley-Parsons Engineering Study Conducted on the ACC Structure**
 - **Results Concluded that Extensive Cross Bracing was needed for any type of Wind Screen Material**
 - **Bracing Installed**
 - **Non-movable Screen Installed**
-

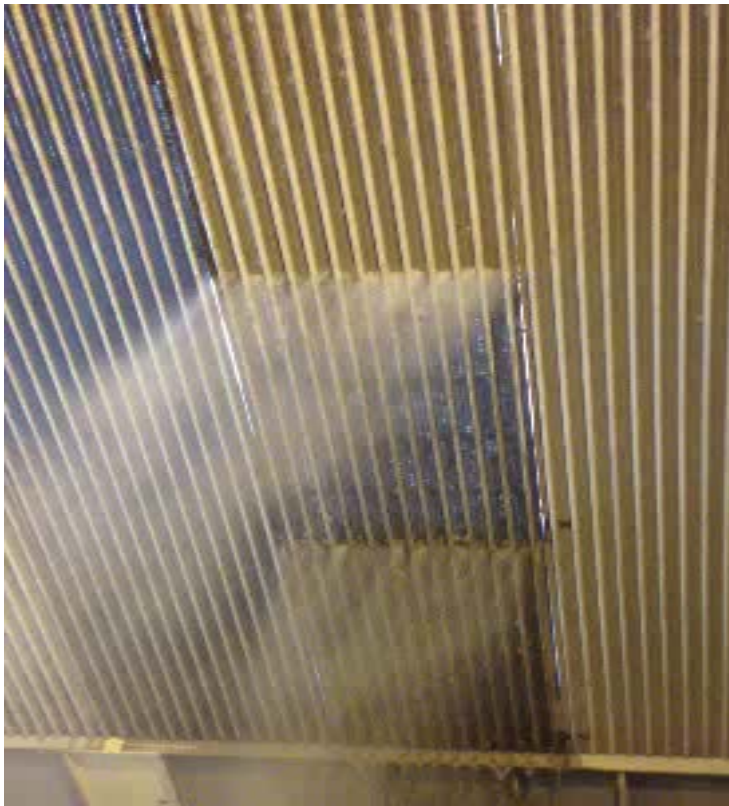
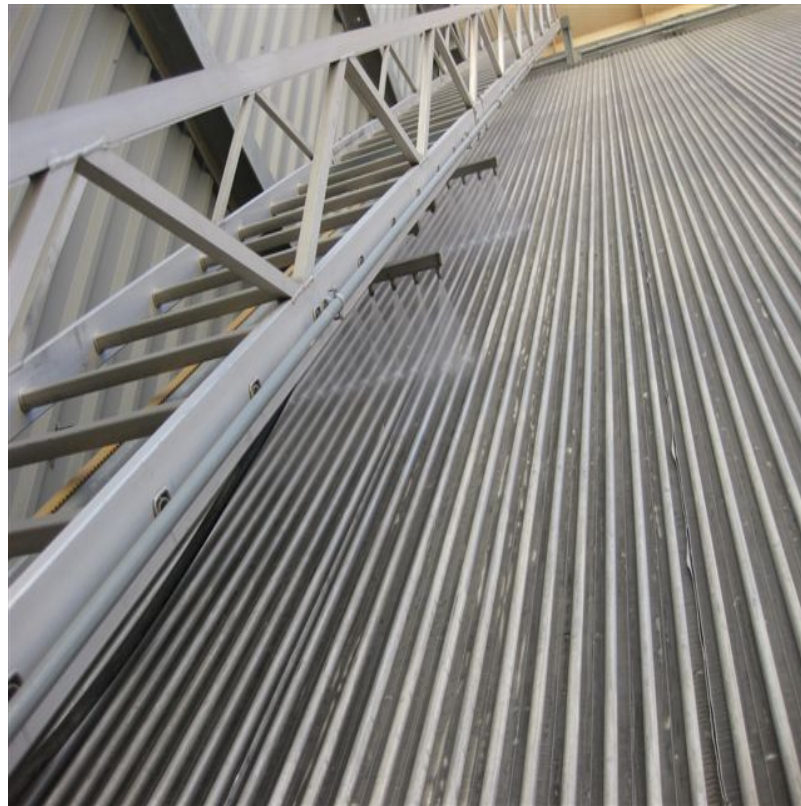
Tube Cleaning

- **Tube Cleaning System Was Never Completed and Commissioned by Shaw**
 - **Extensive Oil Film on Tubes from Seal Leaks Which Increased the Amount of Dirt and Build-up on Tubes**
 - **Significant Performance Loss of ACC Due to Lack of Cleanliness**
 - **Tube Cleaning Performed Summer 2013**
-
