# Walter Higgins Generation Station

By David Rettke  
Maintenance Specialist  
WALTER M. HIGGINS III  
GENERATION STATION  
PRIMM NEVADA

# WHAT IS THE CONDITION OF YOUR ACC SYSTEM?

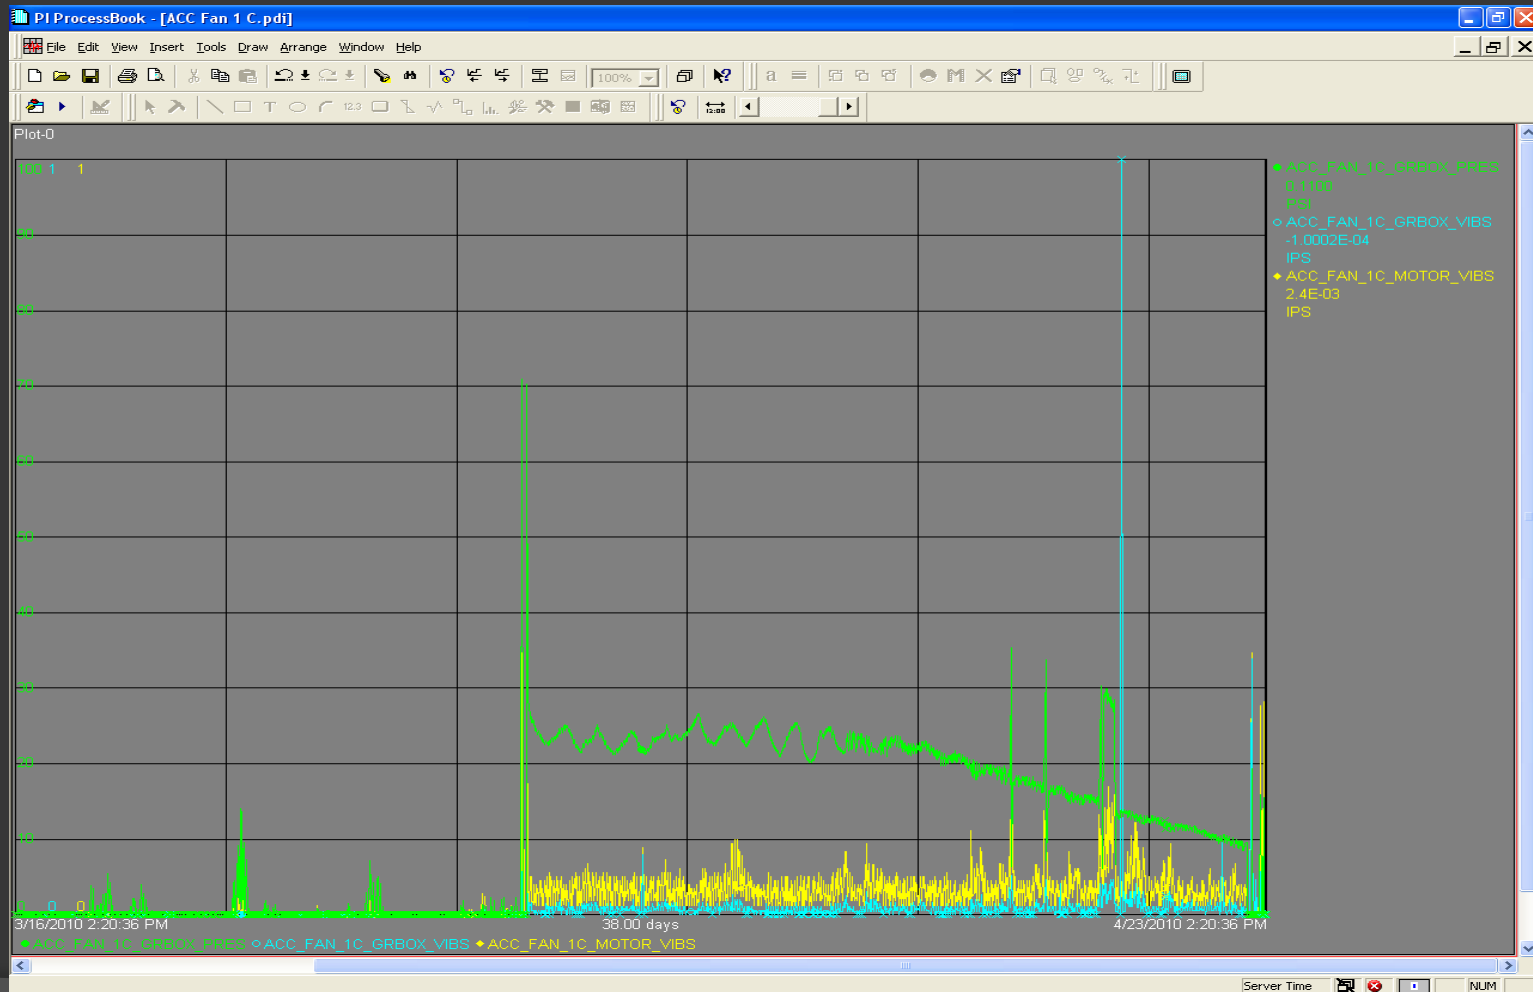
- Right after installation of the oil pressure/vibration units we caught a gear-reducer oil pump failure. It showed up as a sudden and immediate drop in oil pressure.
- We've trended eight gear-reducer filter clean/change's. (as seen in next slide) These are seen as a gradual dropping of oil pressure in operation.

# Typical trend showing lube oil pressure drop off due to clogging filter.

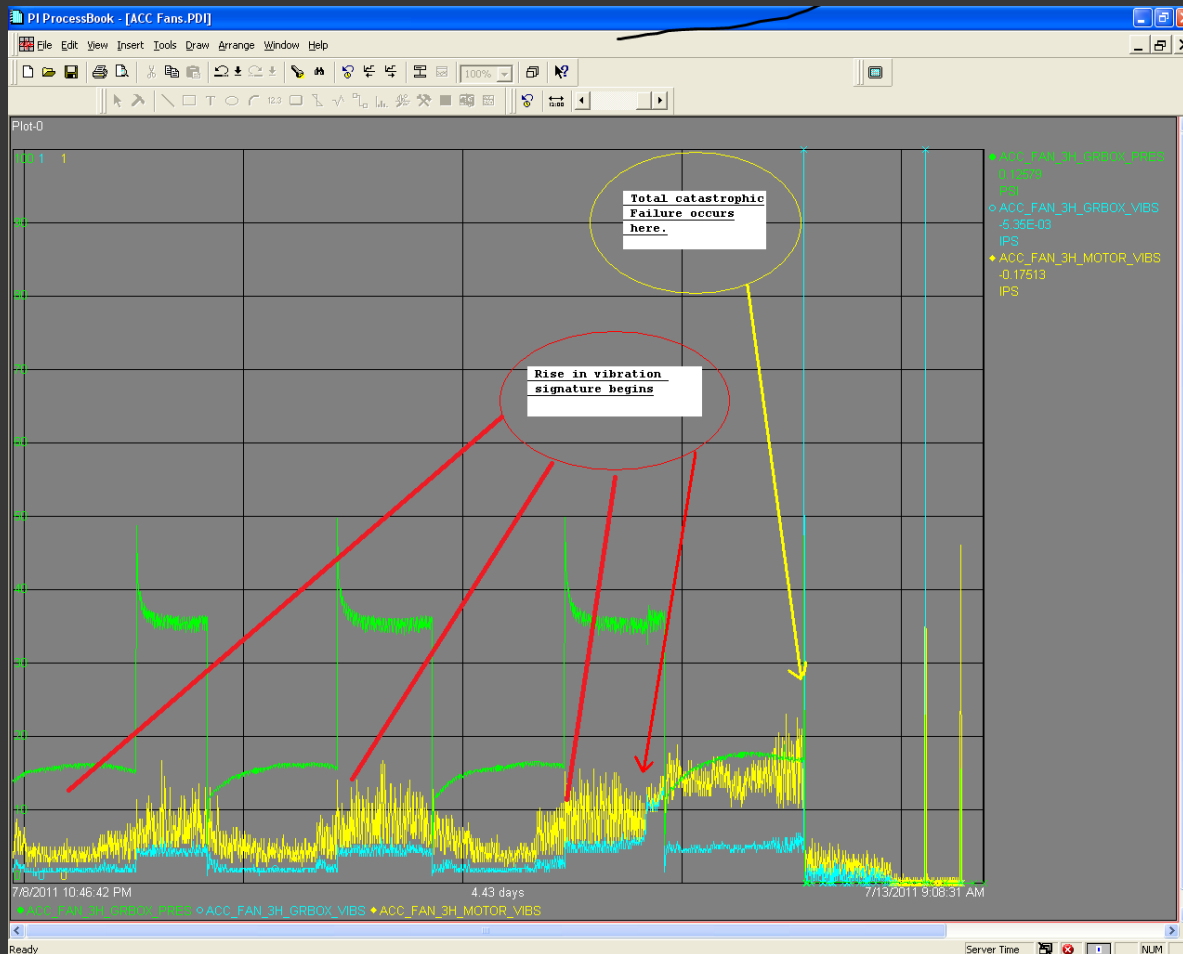
# Catastrophic Gear reducer failure

- ⦿ Because we can monitor our ACC unit's individually, we were able to trend this issue weeks before failure.
- ⦿ The time gained allowed us to gear up for the change, ensure parts were onsite and set up outside assistance for the job and to schedule unit for down time.
- ⦿ Gave us a background on vibration and oil pressure signatures for future troubleshooting.

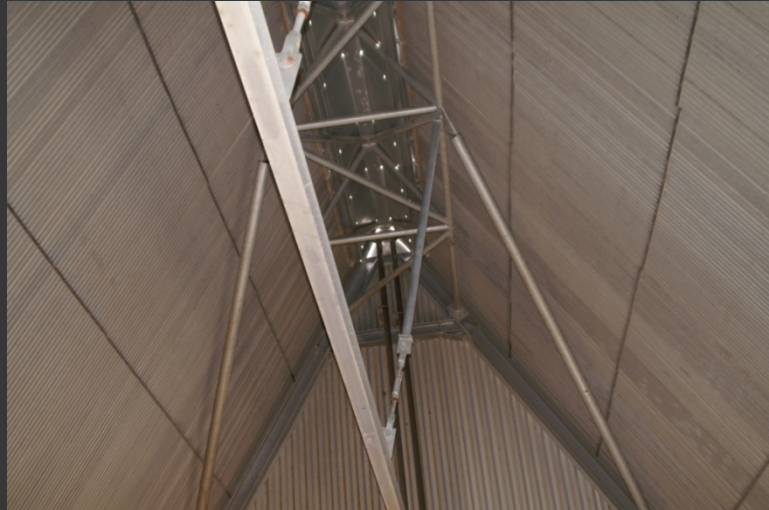
# Finding structural issues

- Noted that over time turnbuckles loosen up. Walk-downs catch these and repairs are scheduled to fix.
- Lock nuts on turnbuckles are marked when tightened now for easier visual check.

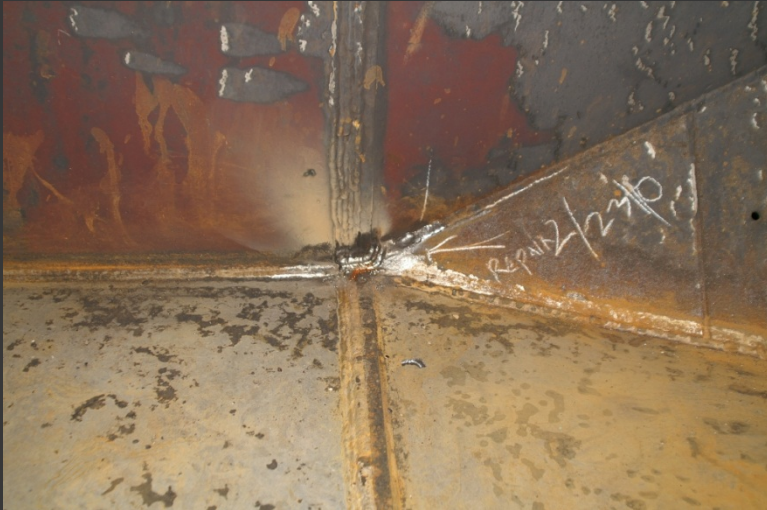
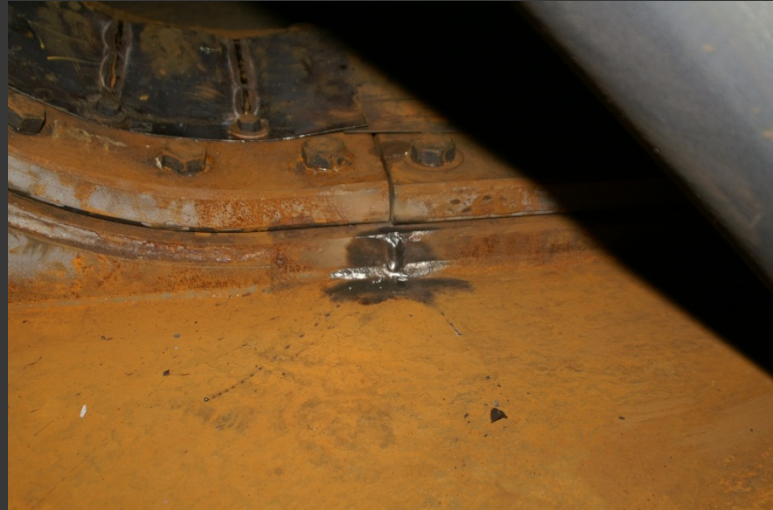
Needed weld repairs can sometimes be hard to spot.

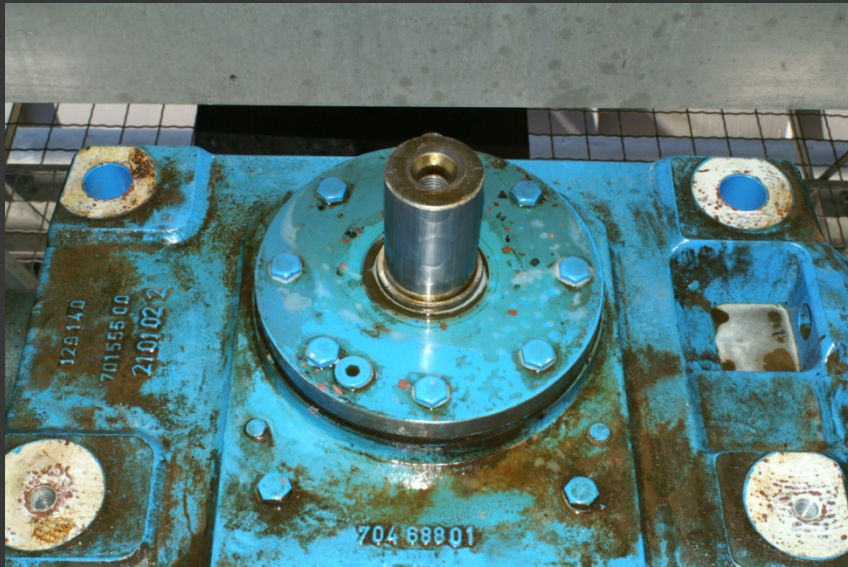
# Input Seal Repair Procedure

Wiped up

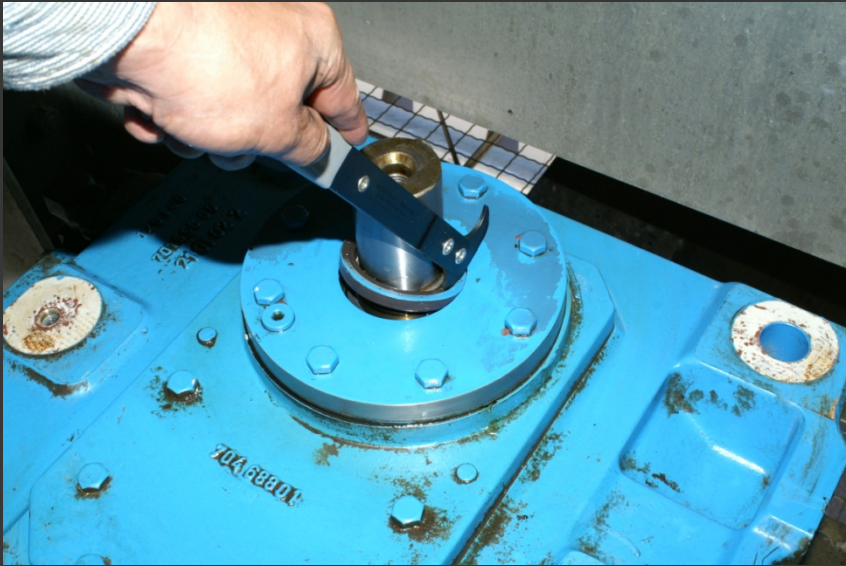
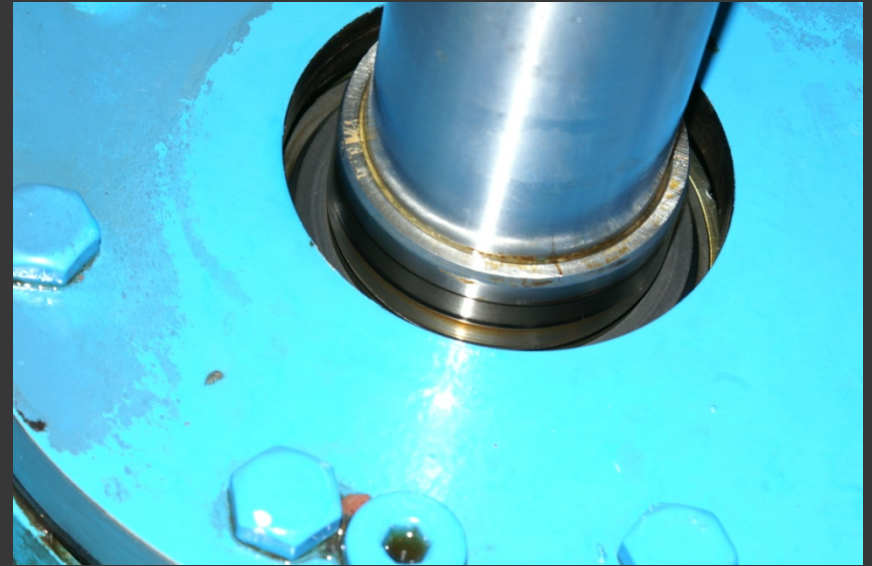
# Removal of old leaking seal

Old seal removed without removing seal plate

Close up of seal area and seal shaft sleeve.
