Improved ACC performance

How to enhance the performance with an acceptable price level

A client in The Netherland needed an ACC replacement

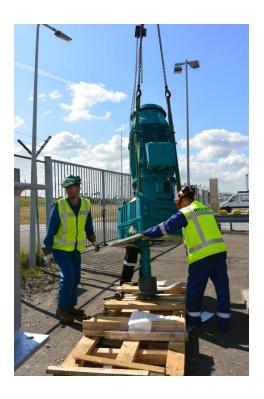
For an amount of \$3500.- per cell the gearboxes and motors were upgraded from 45 kW to 95 kW The inverters were provided by the client and had a capacity of 150 kW.

The fan was installed in a way that with 50 Hz
The specified performance was guaranteed.
By increasing the frequency to 60 Hz motor power became 90 kW with 61% more air flow.

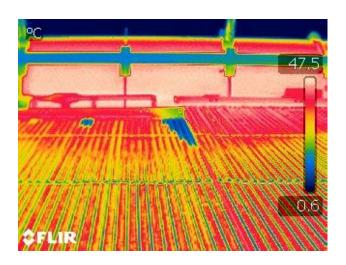
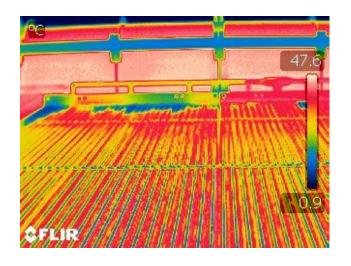
During commissioning we found an air leak of 44 mbar per minute. This was the equivalent of $44/1000 \times 100 \text{ m} 3 \times 0.075 \text{ Bara} \times 60 \text{ min} = 16.5 \text{ kg air}$

The extraction could maintain the vacuum in an acceptable way. Leaving a few black spots near the extraction points.

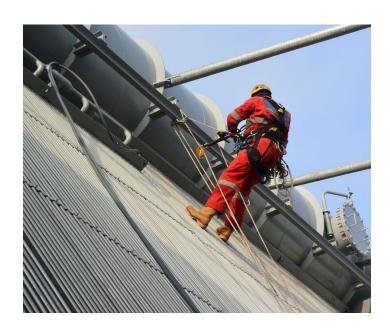
This was cleared by using a helium detection test

The leaks found were in the turbine casing and gland steam condenser ACC was completely tight.

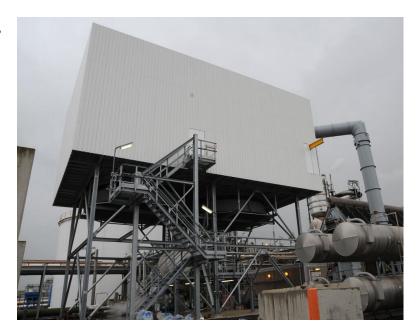
- Lifting the complete ACC 2 meters
- Using the difference in pressure of the condensate tank and ejector surface condenser to suck the condensate

From the surface condensers to the tank while condenser and tank were installed at the same height.

For drain pump a low NPSH (0.17 m) was used,

The result was a simple layout, maintenance friendly and reliable

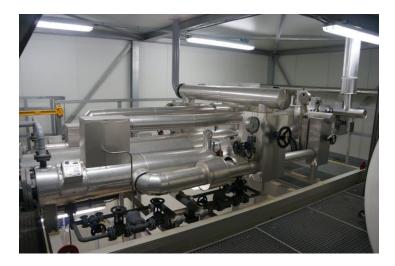
To protect the steam ejectors, pumps and valving against the element and freezing in winter, a room was build around the equipment.

Calculations on the air flow to the fans showed that the additional air flow resistance was minimal.

All piping to this space was self draining and needed no heat tracing

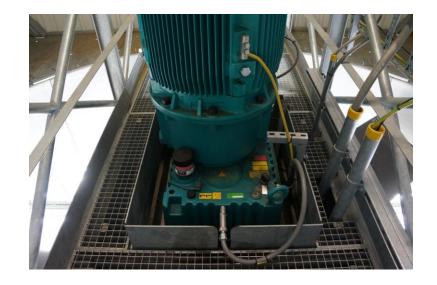
As a special request from the client the vibration swiches were replace by vibration sensors, contenuous monitoring vibrations.

The location of the sensor was very critical and was fixed together with the gearbox supplier.

Mouting on the base plate or Gear-box casing, gave 4 times heavier vibrations

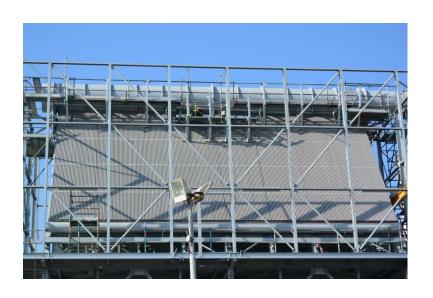
An expensive activity during construction was the welding of the steam duct on top of the bundles.

This was due to safety procedures for working on the inside of the duct. It was decided to weld the steam duct from the outside. Eliminating the safety crew and faster welding.
