Protecting An Air-Cooled Condenser from Hail Damage An Innovative Solution

ACCUG - LAS VEGAS
WESTIN HOTEL : October 2-4, 2017

Yellowstone Power Plant

Presented by Daniel Burns, Burns Engineering Services

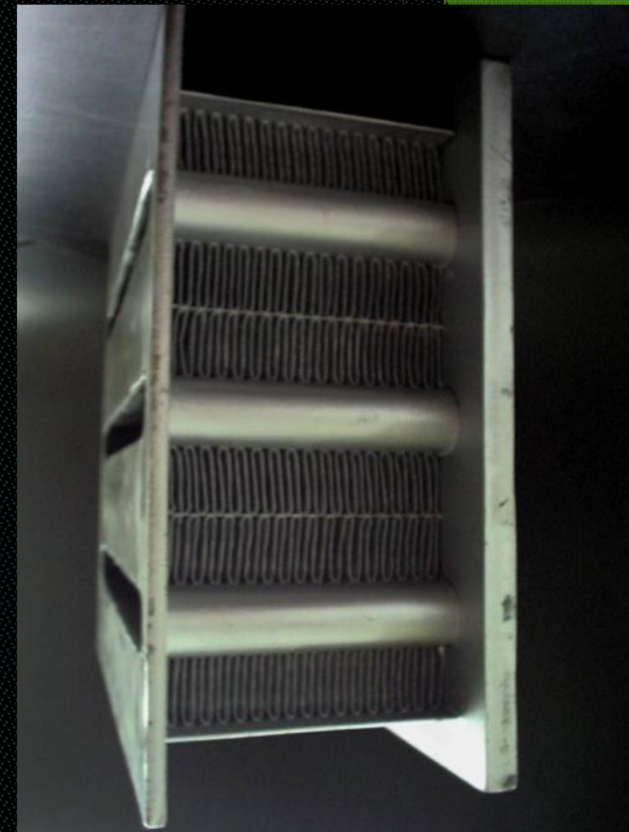
GEA ALEX Tube Bundles

- ✓ Single CS Tube coated w/alum. Backing...Alum. fins braze welded to Backing.
- ✓ Exposed Curved areas of Single CS tubes were dented by hail in many instances.
- ✓ INTEGRITY OF TUBES/FIN ATTACHMENTS FOUND UNCHANGED POST EVENT.

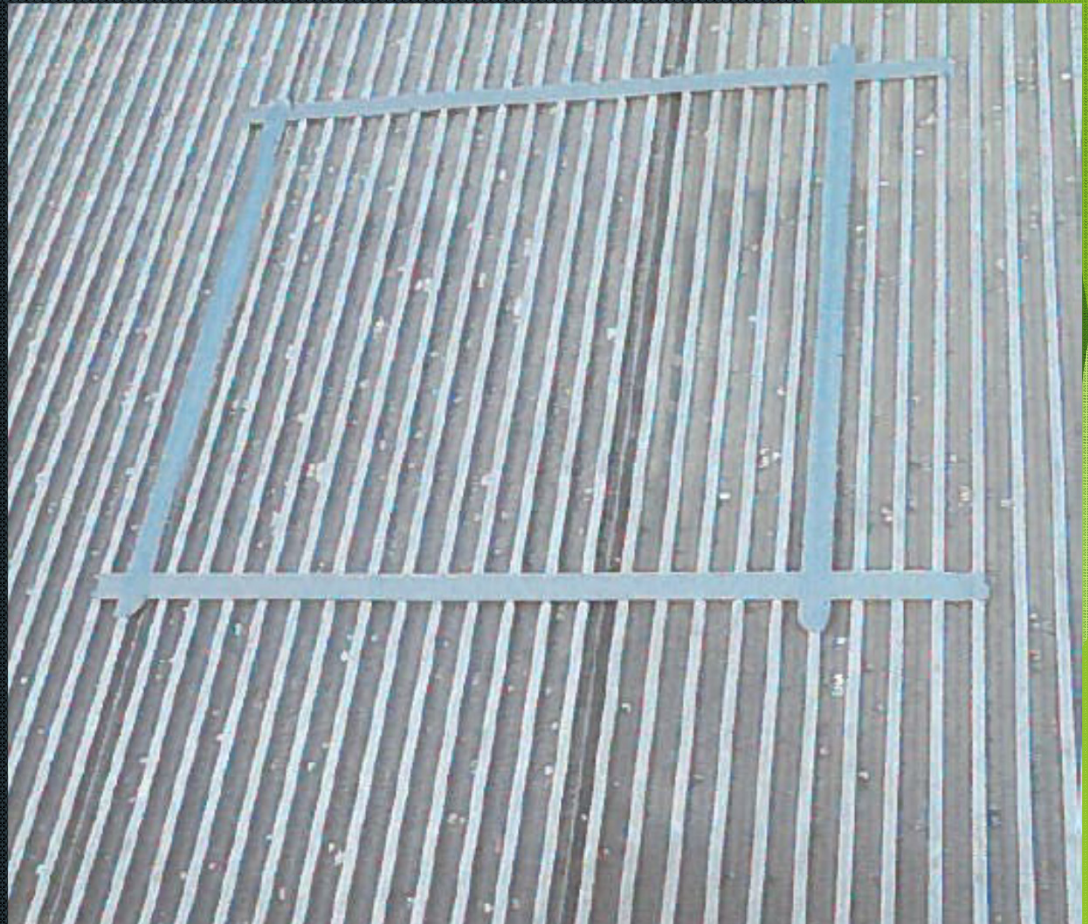
ACC Hail Damage

- Severe damage estimated between ~7% to ~10% of Aluminum finned surface area.
- Equates to a similar section (~7% to ~10%) blocked x-sect. Airflow.
- Based on examination of 4 square foot randomly selected areas in different bundles.

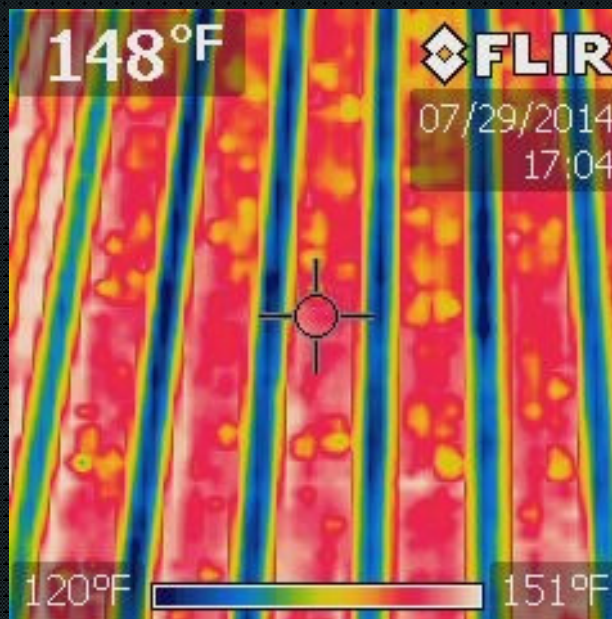
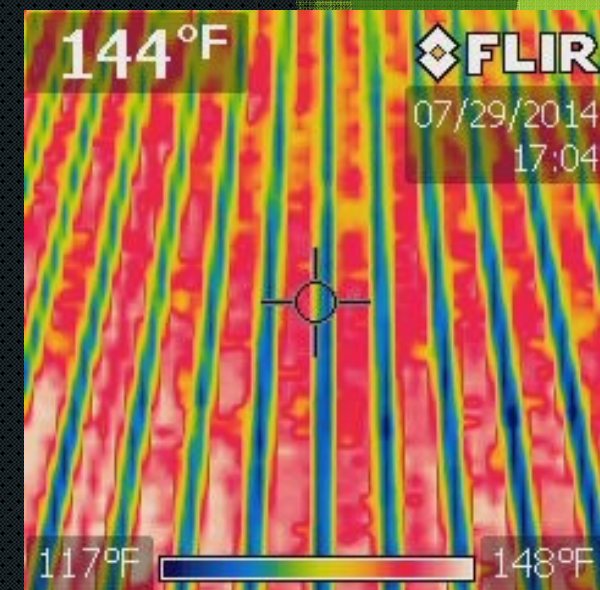
Thermographic Images of Fin Damage Distribution, Distribution, Distribution...

ACC Performance is all about distribution, air-steam dist. inter-related.

- Airflow takes path of least resistance, any local change in DP changes overall flow pattern.
- Total Fan Discharge Head typ. @ no greater than 0.5" water (ie. mainly DP across tube bundle). Damaged fins result in blockage/disturbance in flow field.
- Many local disturbances in flow field result in distribution losses/loss of heat transfer surface area...rate of condensation significantly reduced.

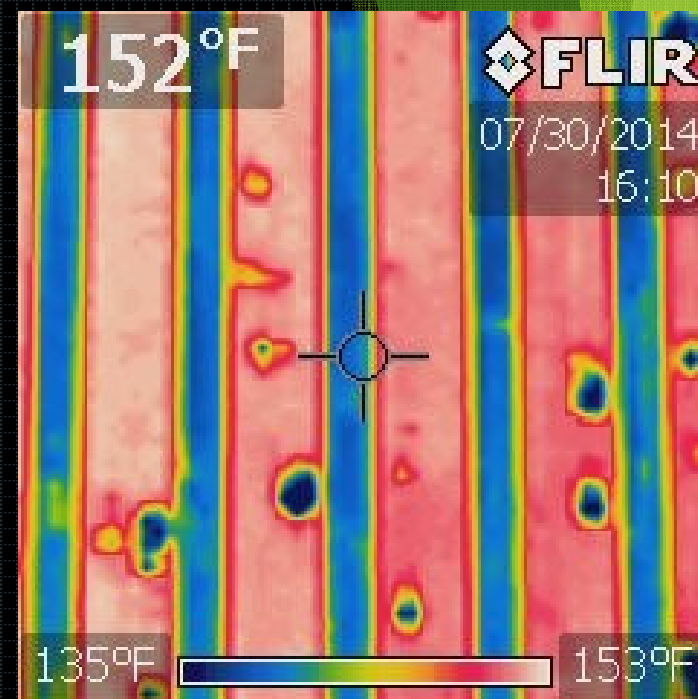
PERFORMANCE IMPACT

- Thermography Shows Much Heat **Not** Conveyed thru Damaged Fin Sections, worse @ Warmer Inlet Temps
- Condensation SET by Heat Flowing thru Finned Tubes
- A 10°F Colder FIN Surface Condition Represents an Increase in ~1.5 inhg higher BP (from 130°F steam temp (4.65 inhga). Worse @ elevated steam temp/BP.
- Higher BP estimated @ ~0.20 inhg based on reduced finned surface areas & airflow.
- Equates to ~0.30 MW or (2,628 MW-hrs/yr.)
- Lost revenue @ 2,628 MW * \$35/MW= ~\$92,000/yr.
- Not much but this is for clean unit. Once fouling begins (cottonwood, feathers, dirt) that exacerbates performance losses.
- No estimates considered for DERATING impact

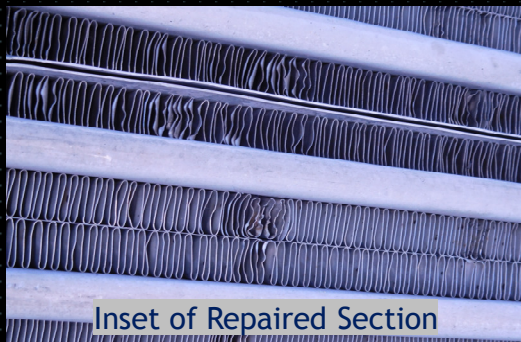
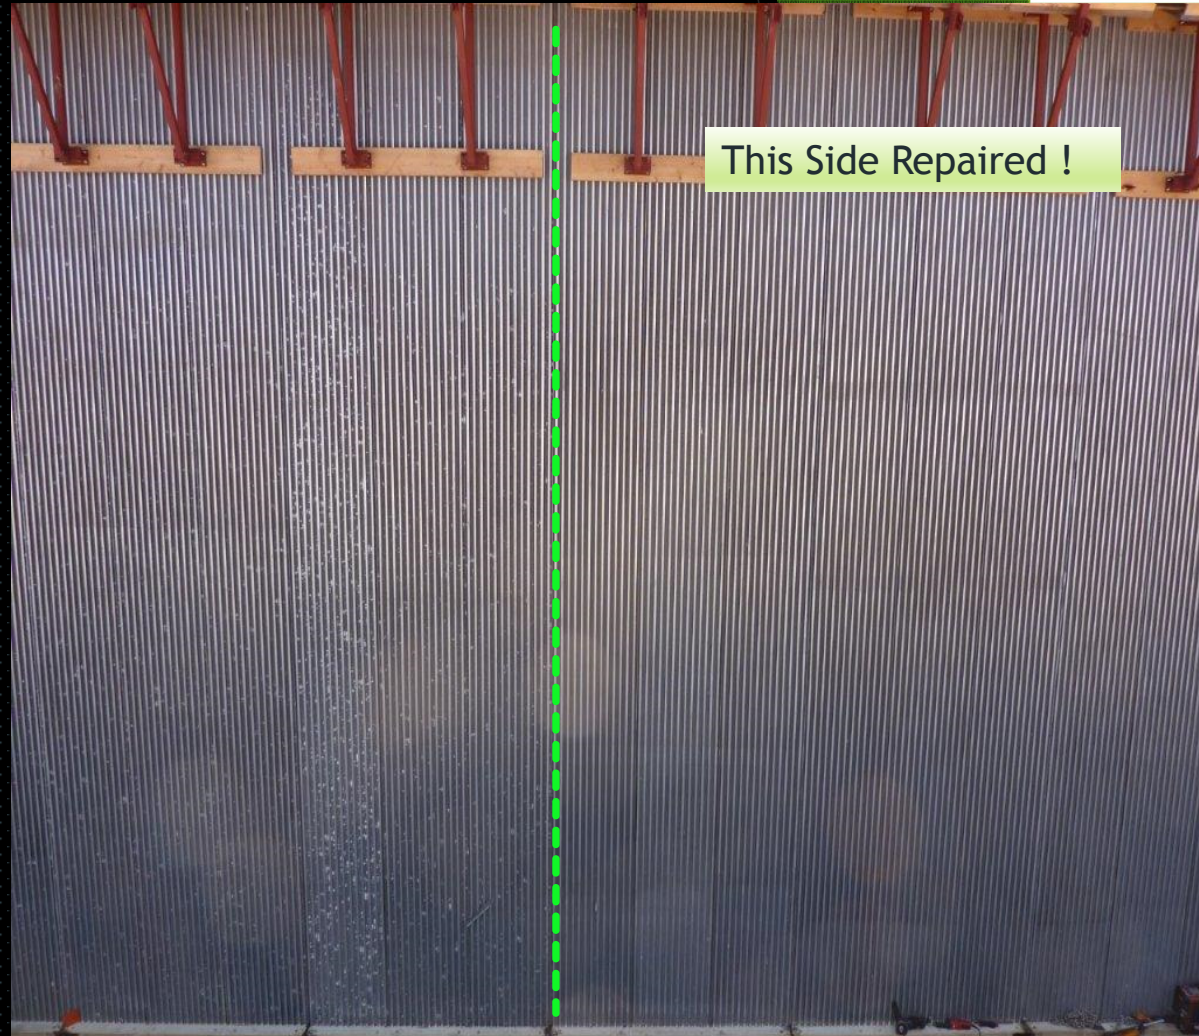
ACC Hail Damage

- Comparison of Repaired Section versus Damaged Section.
(Green Dotted Line is Border).
- Repairs time consuming
- Fins not perfect after completed.
- Repair Project Cost @ ~\$500,000
