ACC gearboxes – Eskom's experiences of the last 20 years

ACC Users Group 2017

October 2017

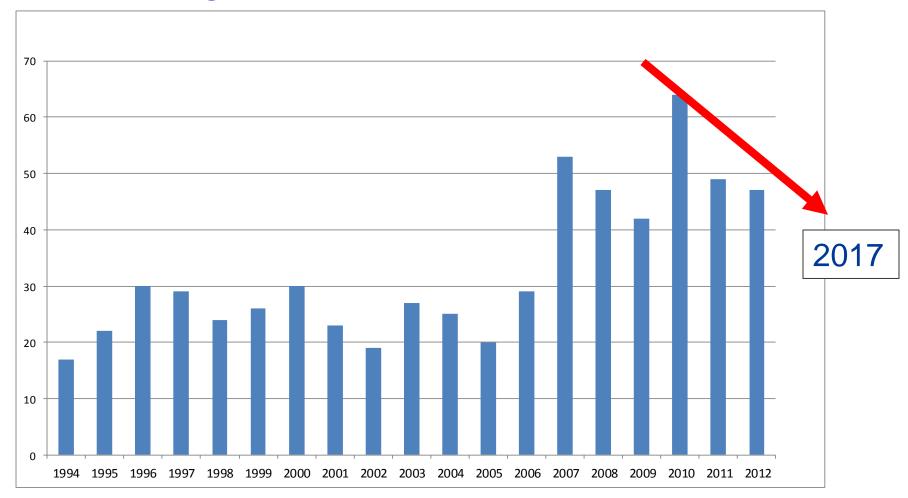
- Matimba gearbox failures
 - 48 gearboxes procured in 2009
 - 8 months later first catastrophic failures
 - Multiple problems:
 - Micro pitting
 - 40% of oil pumps failed
 - Similar trends at Medupi experienced already

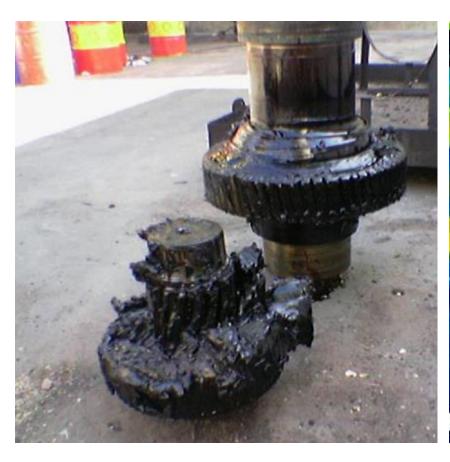
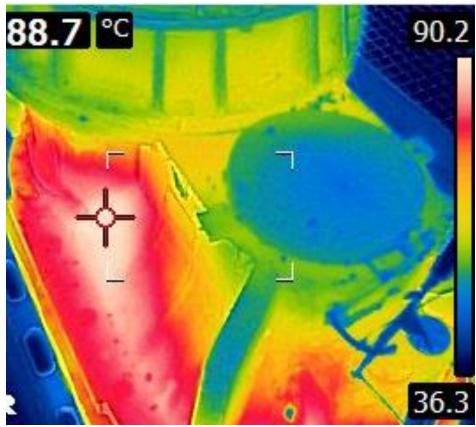
High oil temperatures

- Backstop > oil leaks
- Logic start/stop sequencing
- Oil seal leaks & over filling
- Safety concerns (e.g. loose blades/fan assemblies)
- Local manufacturing concerns (i.e. quality)

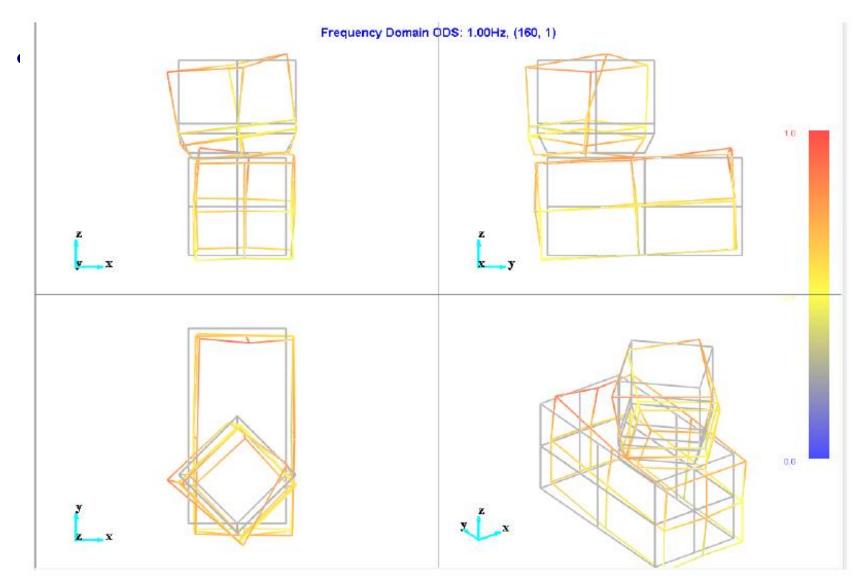
- 40% of oil pumps failed
- ODS analysis indicated continuous distortion of gearbox casing under the motor weight.
- Resulted in deflection of shaft driving oil pump
- Stiffening cradle was installed and significantly reduced oil pump failures
