Andrew Howell
ACCUG 2018
Colorado Springs, Colorado
October 8-11, 2018

# Fort Nelson Stainless Steel Air-Cooled Condenser

# First internal inspection (September 2017)

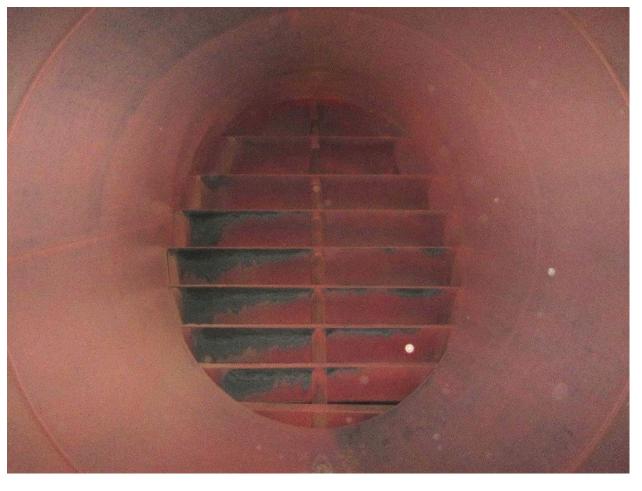
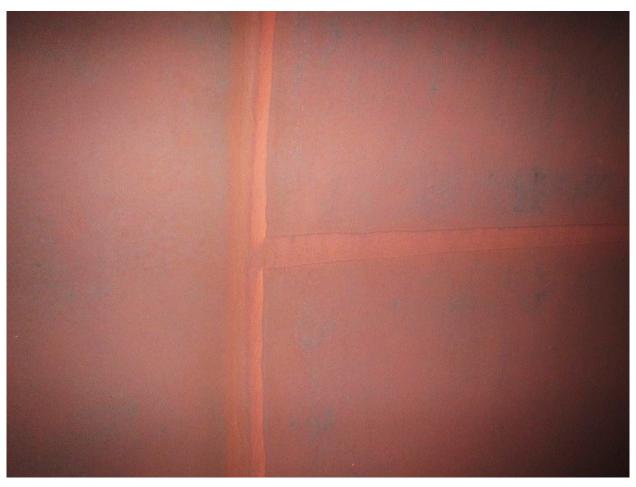
### 2017 Internal Inspection: Upper Duct carbon steel

*Inlet turning vane*

Duct wall

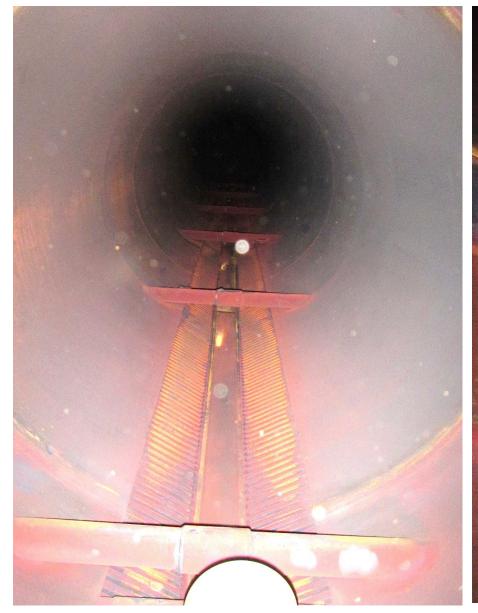
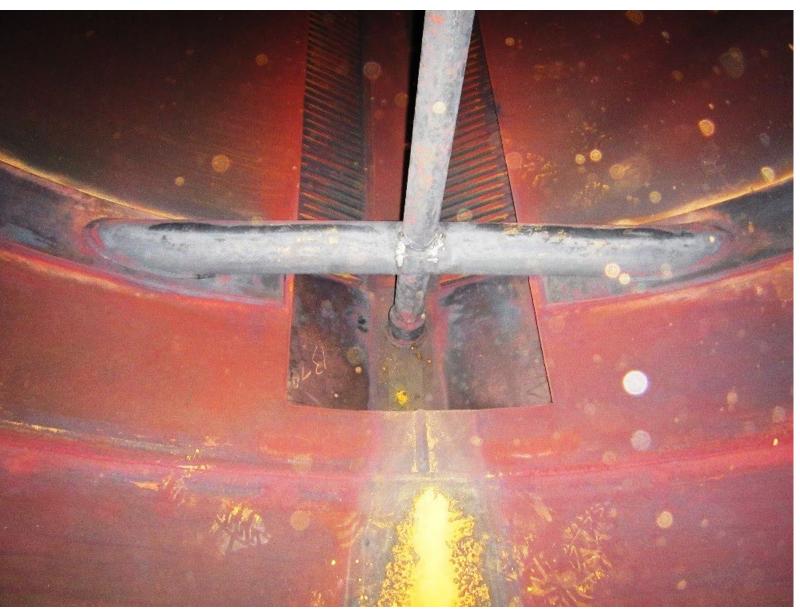
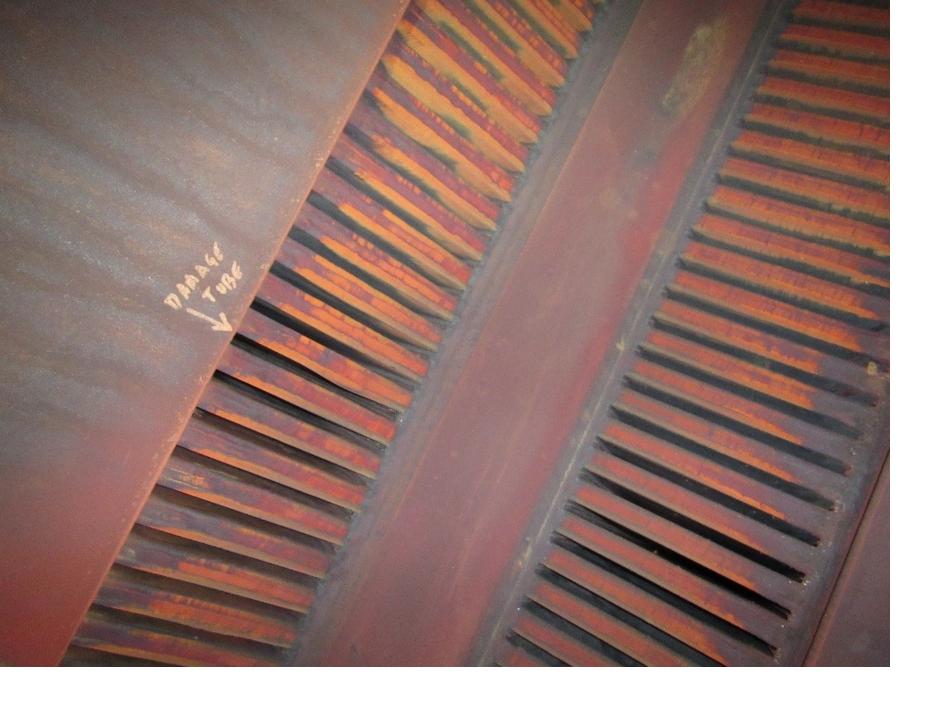
# 2017 Internal Inspection: Upper Duct

2017 Internal Inspection: HX Tube Entry
