10th Annual ACC User Group Meeting

A Vacuum Leak Odyssey

Presented by Don Wright

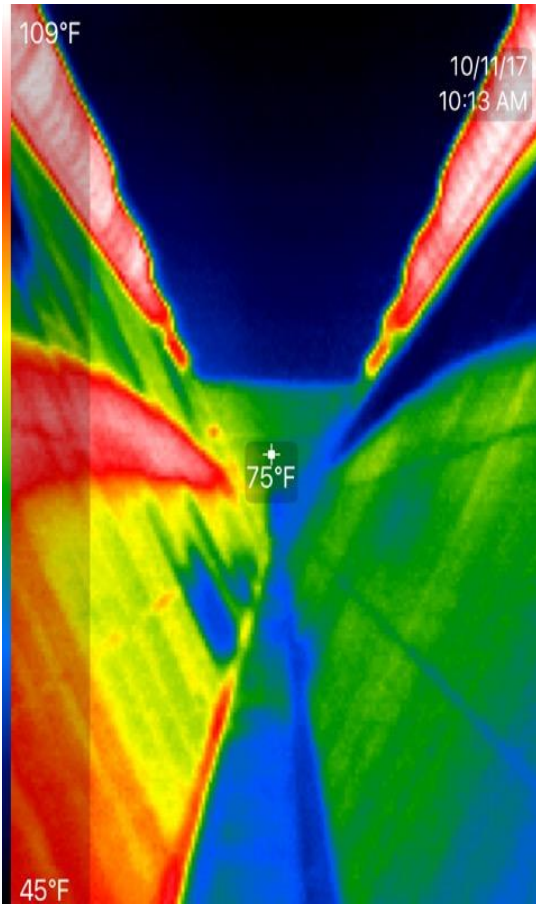
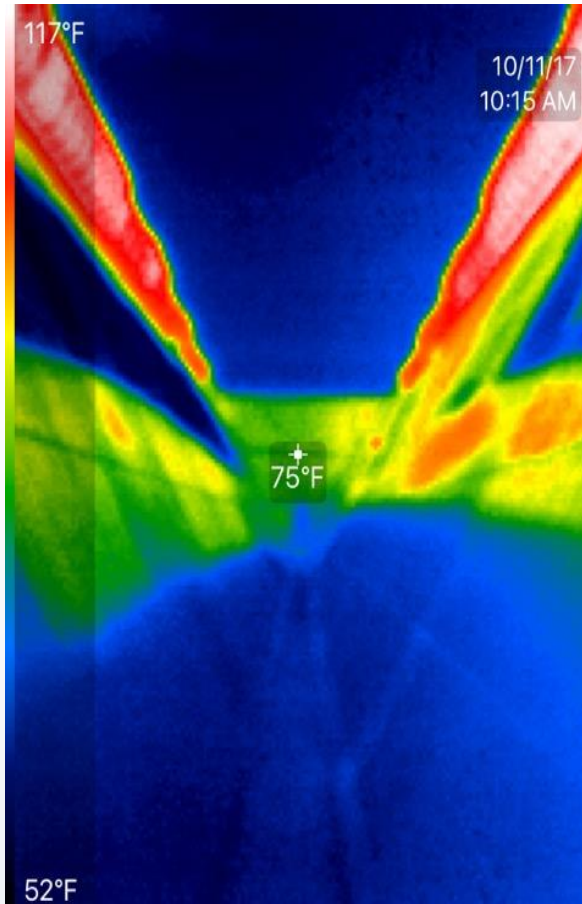
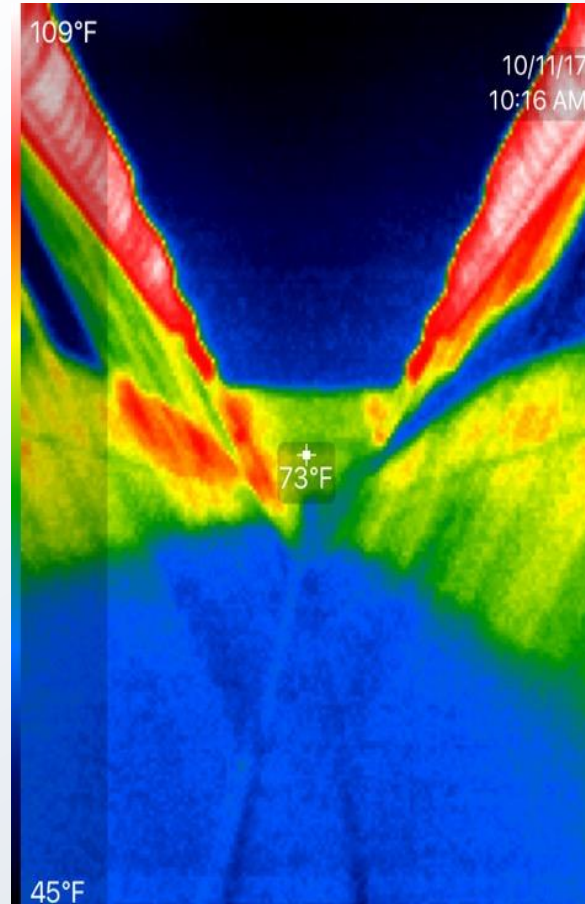
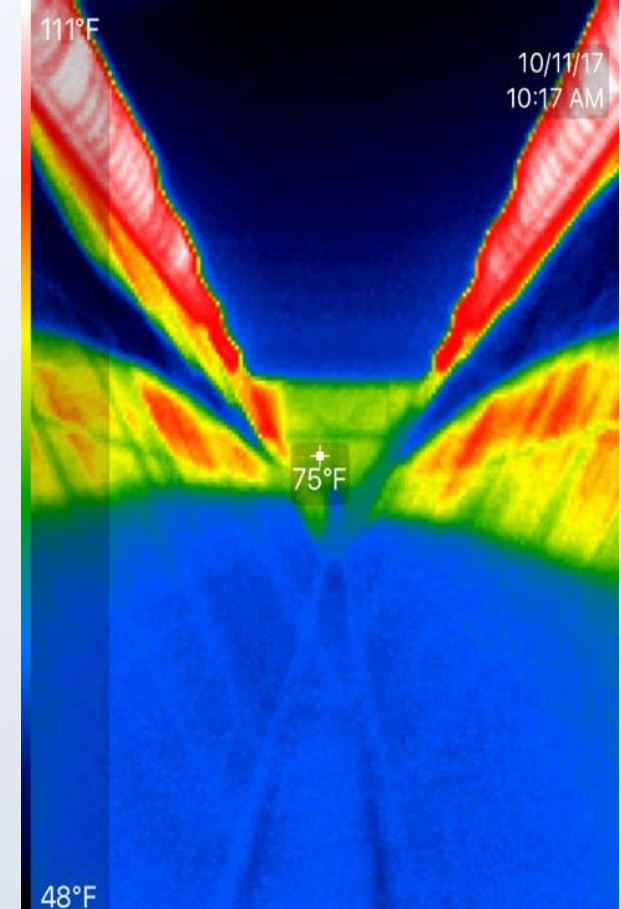
August 2017 ACC Thermography Data

Thermography reveal large cold areas in many streets

STG Load	287 MW			
	TED Temp	132 F			
Street 1	Street 2	Street 3	Street 4	Street 5	
HOT	COLD	COLD	COLD	COLD	
Street 6	Street 7	Street 8	Street 9	Street 10	Street 11
HOT	COLD	COLD	COLD	COLD	COLD

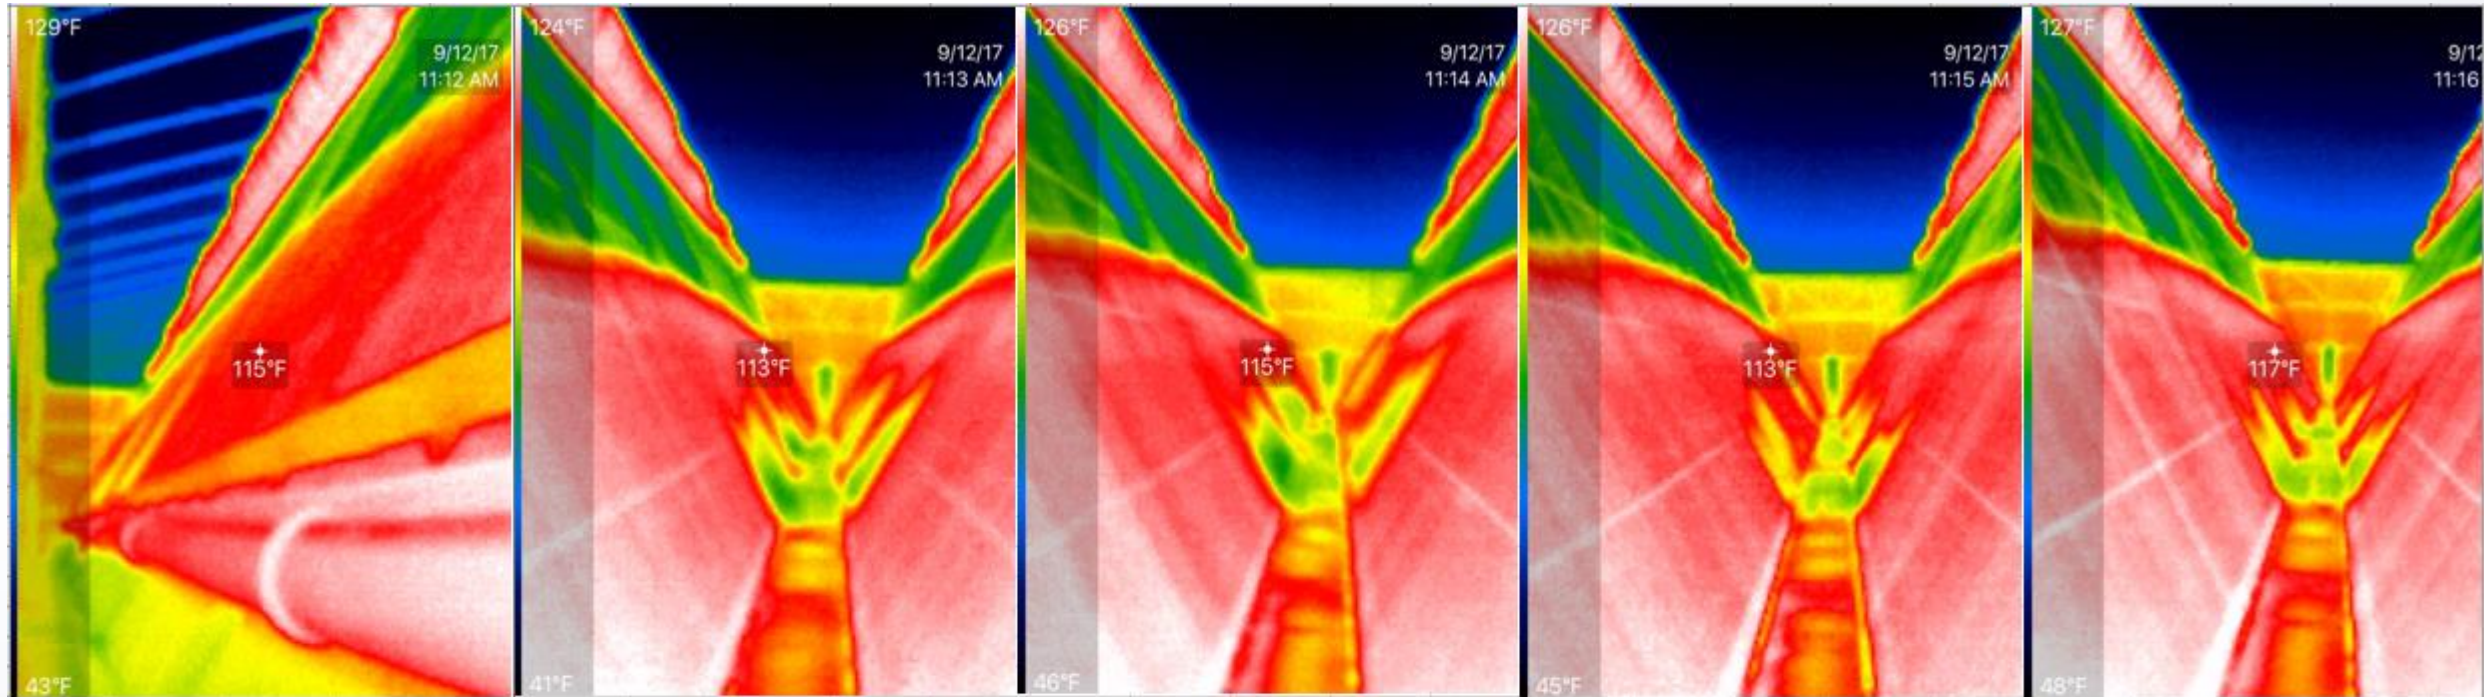
Post Hurricane Harvey Thermal Survey

Street 1	Streets 1/2	Streets 2/3	Street 3/4	Streets 4/5
	1	2	3	4	
STG Load	290 MW				
TED Temp	130 F				
Street 1	Street 2	Street 3	Street 4	Street 5	
HOT	HOT	HOT	HOT	HOT	
Street 6	Street 7	Street 8	Street 9	Street 10	Street 11
HOT	HOT	HOT	HOT	HOT	HOT

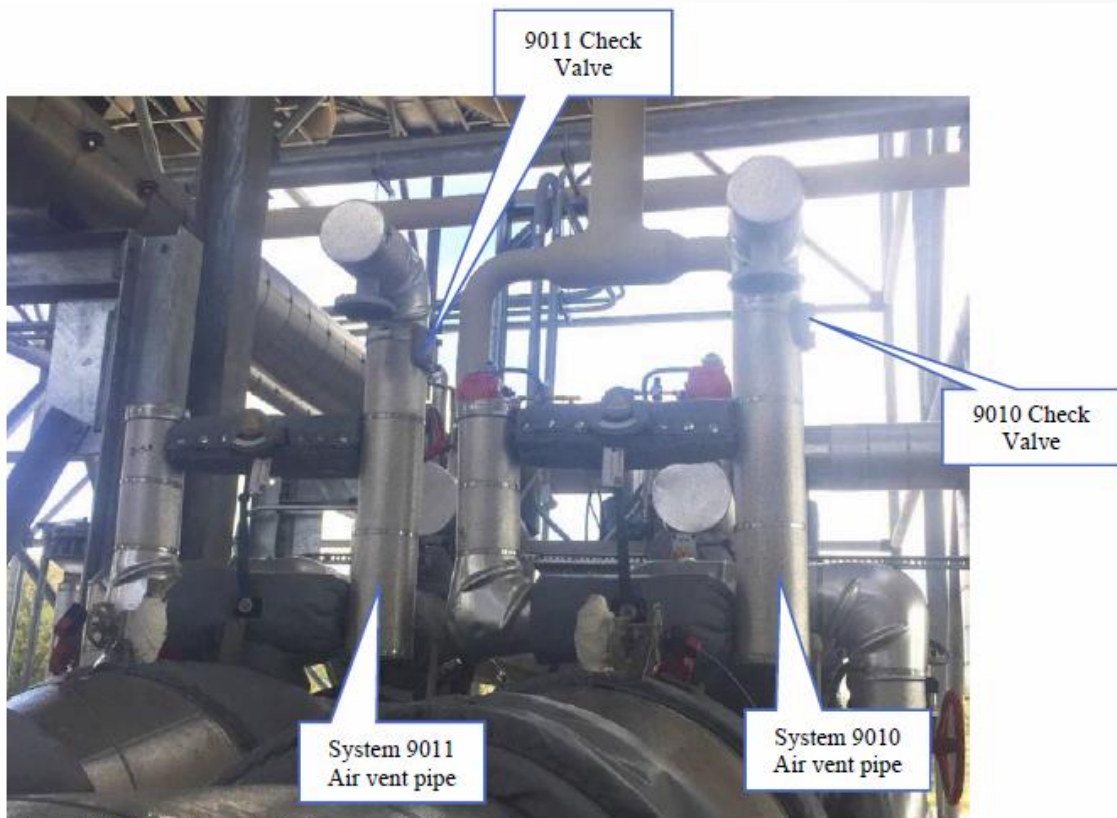
Photo #1) Air Vent lines for both systems' Aftercondensers.

November 2017 Outage - SJAE OEM Identifies stuck check valves

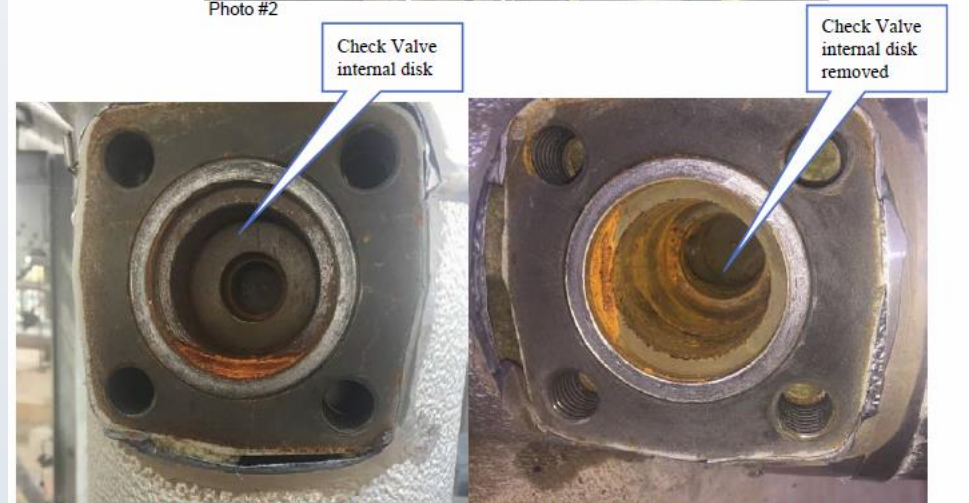
Photo #3) Check Valve Internal disk rusted in place.

Photo #4) Check Valve with internal disk & Spring removed.

- SJAE check valves removed
- SJAE now discharging
- Reduced DO (20-40 ppb)
- Vacuum improved slightly but still above design
- Hogger still needed to maintain vacuum
- Vacuum decay test resulted in immediate loss of vacuum

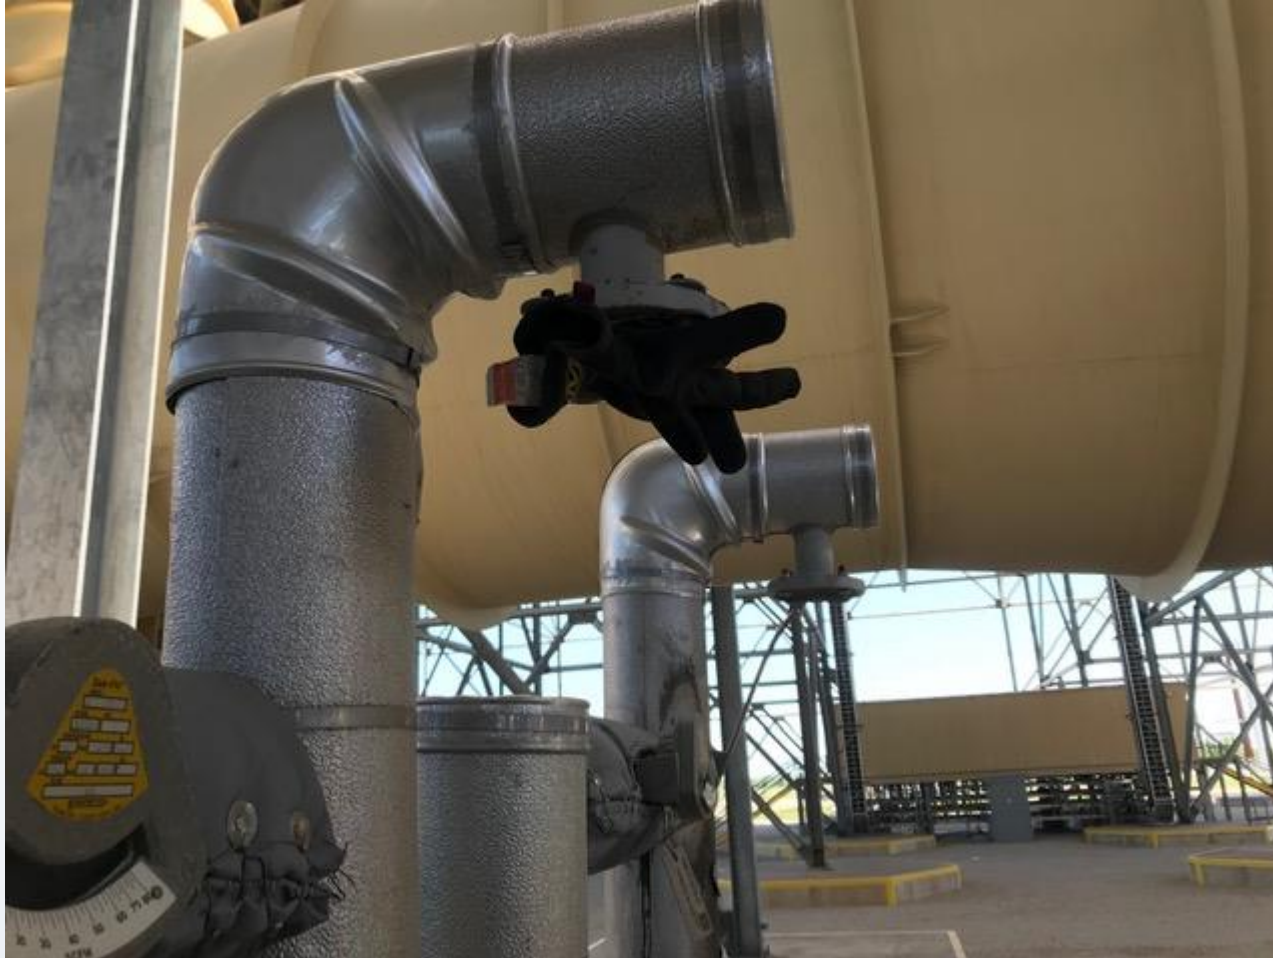
Out of Service SJAE

- ❖ Out of service SJAE not isolated (drains not closed)
- ❖ Major Leaks
 - SJAE steam ejector flanged joints
 - TED Drain Tank- Drain Valve
 - Bonnet of 4 drain valves off condensate line to deaerator
- ❖ Minor Leaks
 - Street 2 & 7 defleg section
 - LP turbine rupture disk
 - LP turbine gland seal
 - Exhaust Duct Flange

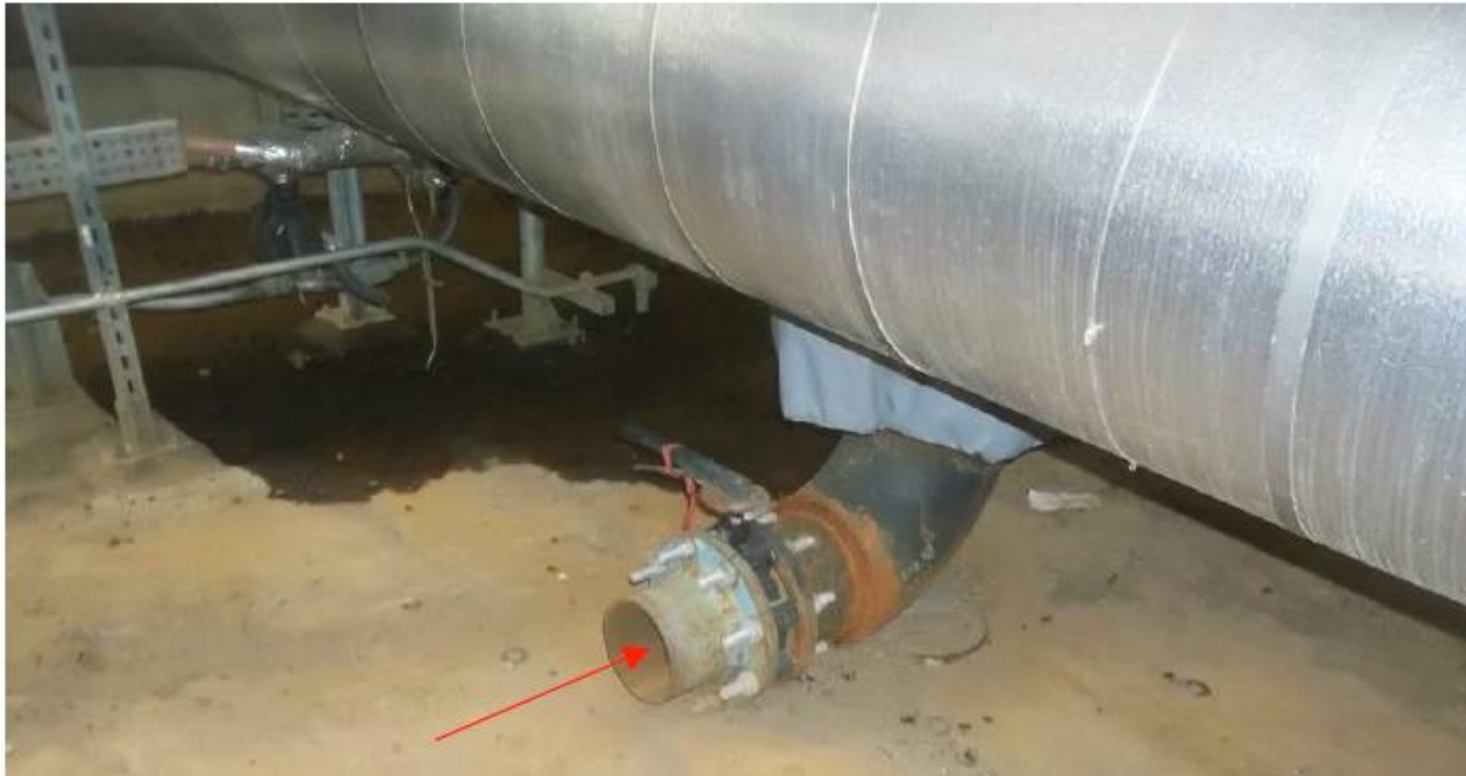
Leak 4.) Drain below exhaust duct drain tank header. Drain valve appears to have trouble sealing.

Leak response was large 60,000 Divisions until tightened.

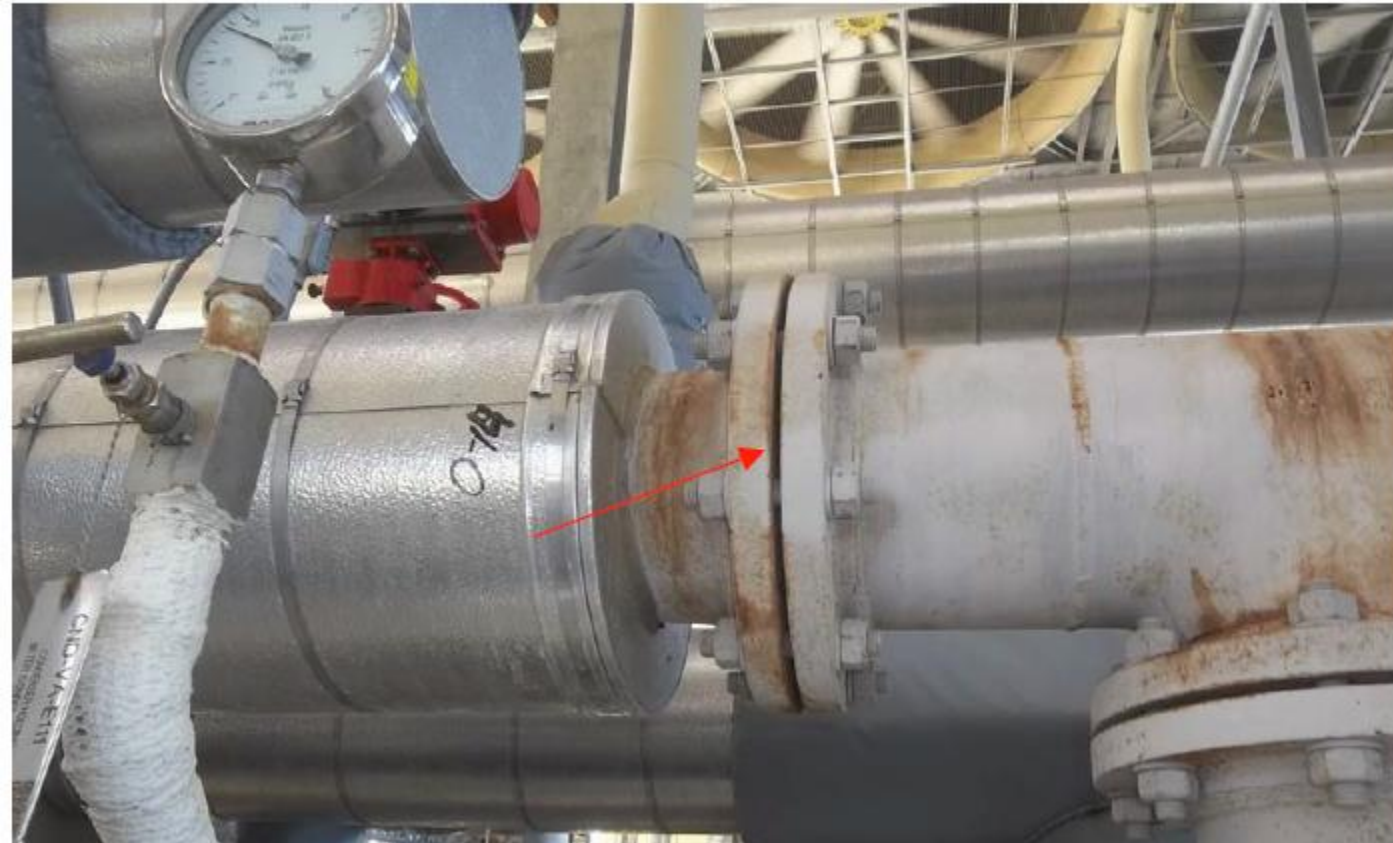
Leak 6.) South jet flange on air ejector. Gasket failing.
Leak is large 24,000 Divisions

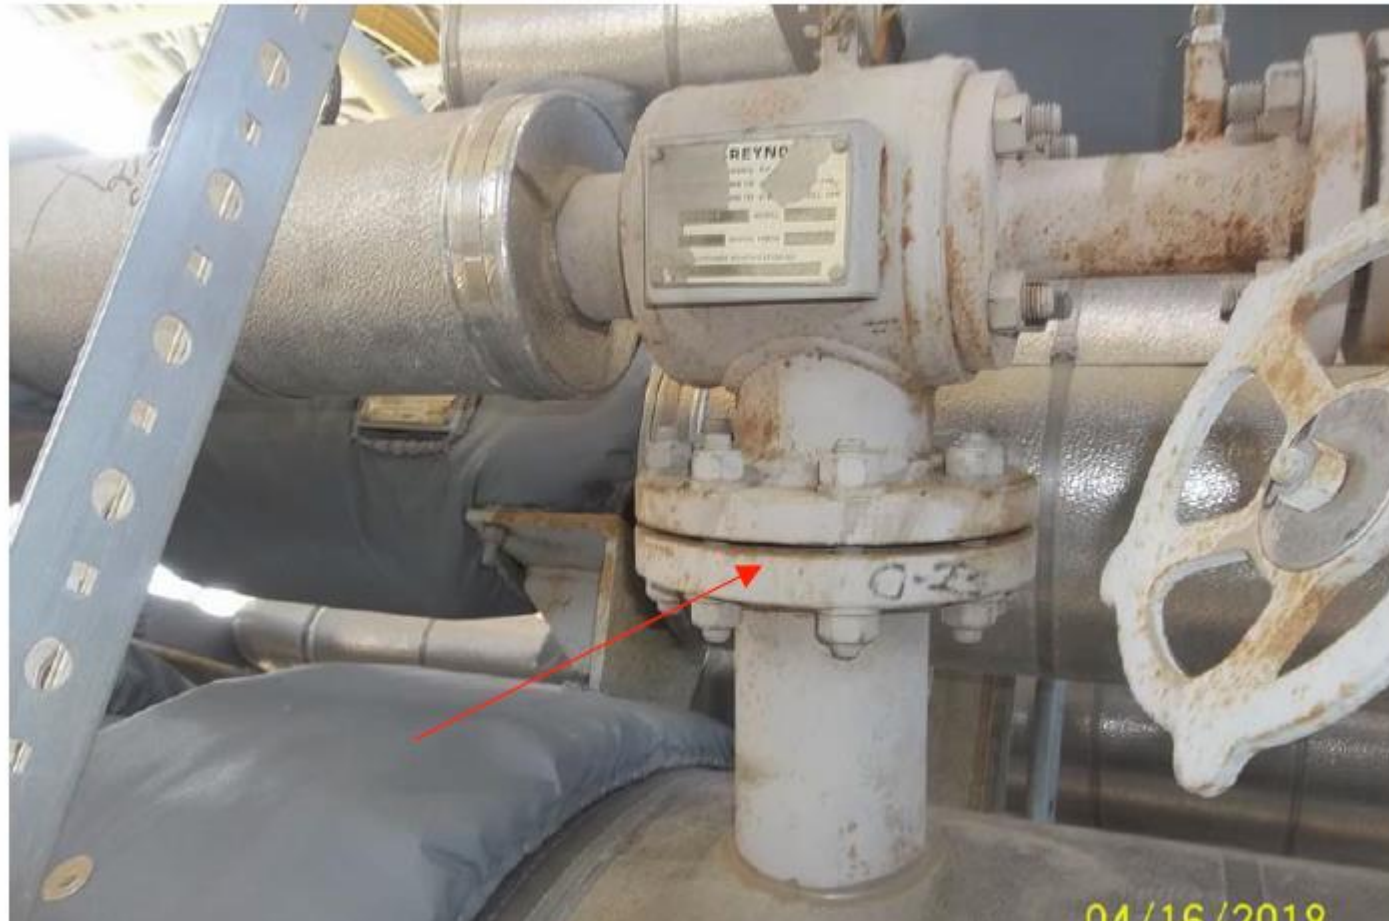
**Leak 7.) South jet flange on air ejector. Secondary jet. Gasket failing.
Leak is large 60,000 Divisions**

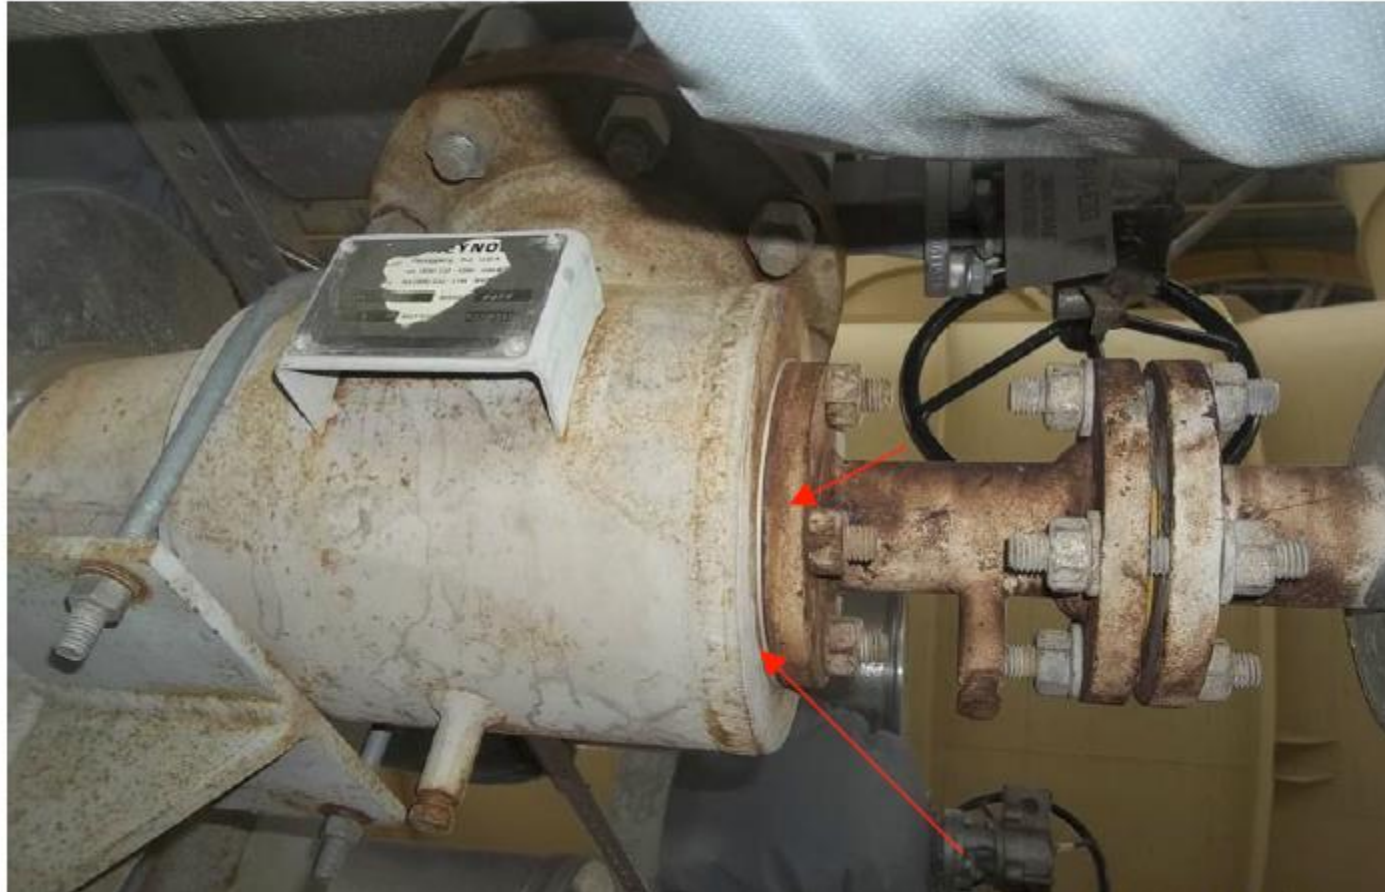
Leak 7.) North jet flange on air ejector. Flange appears misaligned. Gasket failing.
Leak is large >100,000 Divisions

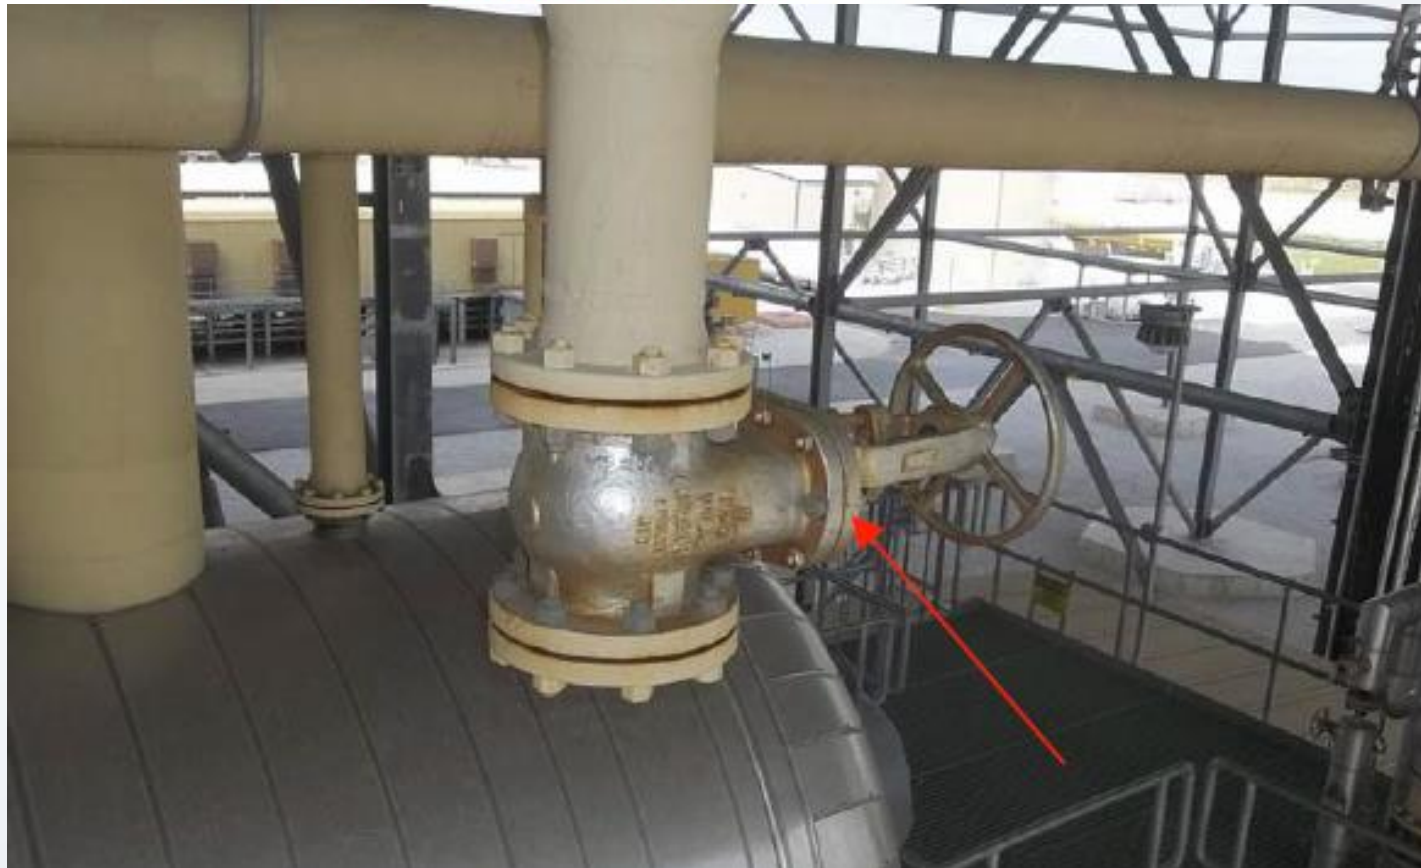
Leaks 8, 9, 10 and 11.) 4 Drain lines from ACC condensate lines to deaerator. Leaks are at bonnets on valves. Valves appear to have been installed for post construction clearing of ACC and collector lines. Leaks were not on flanges but on bonnets.

Leak responses were large, 24,000 –90,000 Divisions

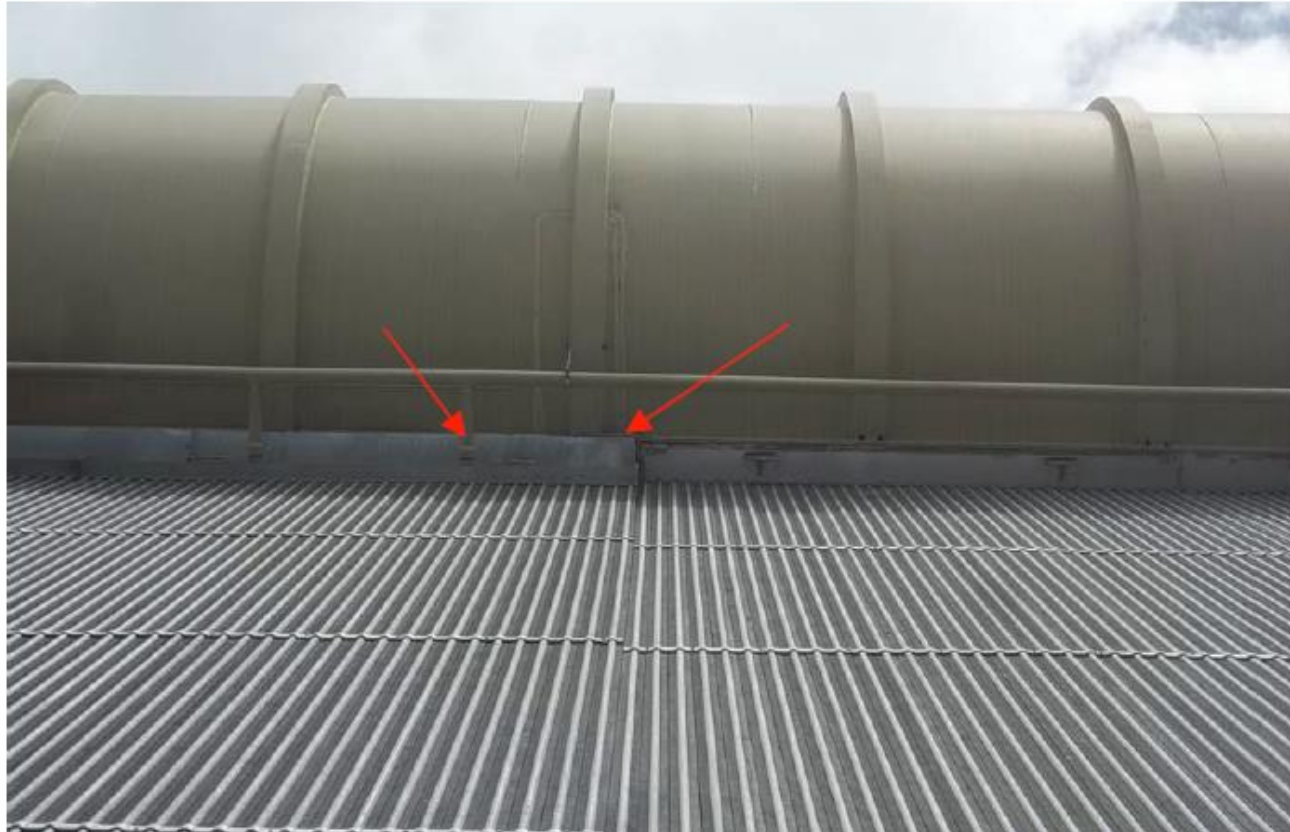
Leak 12.) Street 2, fan room B, south Defleg section, south end. Leak could not be pinpointed due to limited access and may be along base of exhaust duct to bundle weld. It is also possible that a crack on a defleg pipe weld may exist. In either case, moisture/rust marks may be present or striations where air has leaked into the duct weld may be visible.

Leak response was small but gas access was limited, 6,000 Divisions
