***COMANCHE  
ACC  
IMPROVEMENT PROJECT  
2014 Update***

# Xcel Energy – Comanche Station Pueblo, Colorado

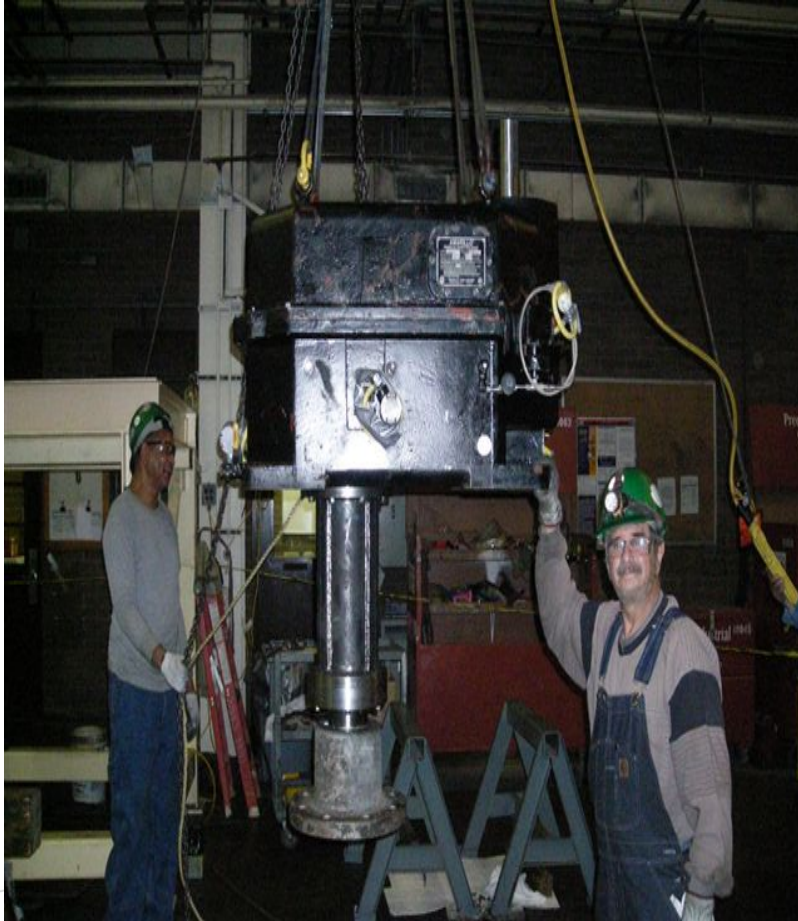
***Completed Gear Box***

- **Addition of Extended Bearing Housings with Carrier Bearings**
  - **Modification of the Input Shaft Lip Seal to an In-Pro Mechanical Seal with New Seal Carriers**
  - **Modification of the Output Shaft V-Seal to a Reinforced Viton Seal**
-

- **Redesigned Retaining Ring on Top and Bottom of Hub Gear Utilizing an O-ring to Eliminate Keyway Oil Leaks**
  - **Removal of the Shaft Driven Oil Pumps**
  - **Addition of Externally Mounted Viking Electric Driven Oil Pumps**
  - **Changed to Synthetic Oil rather than Mineral Based**
-  
- The bottom of the slide features a decorative graphic consisting of several overlapping, wavy lines in shades of orange, yellow, and grey, creating a modern, flowing aesthetic.

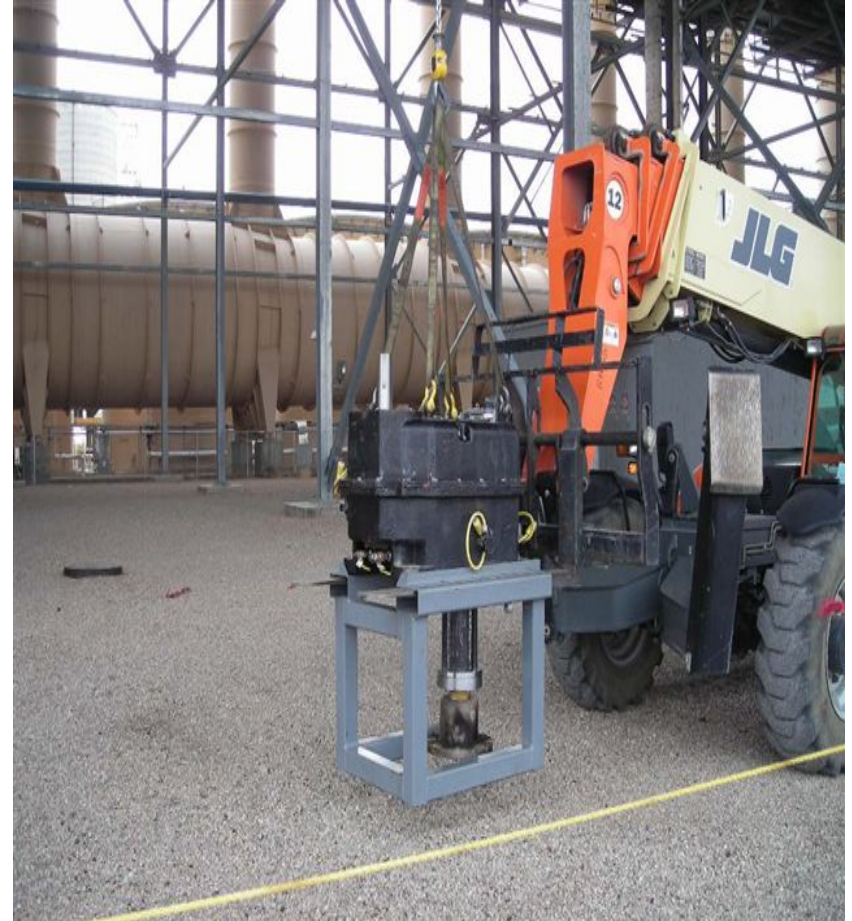
***Gear Box Staged for Installation***

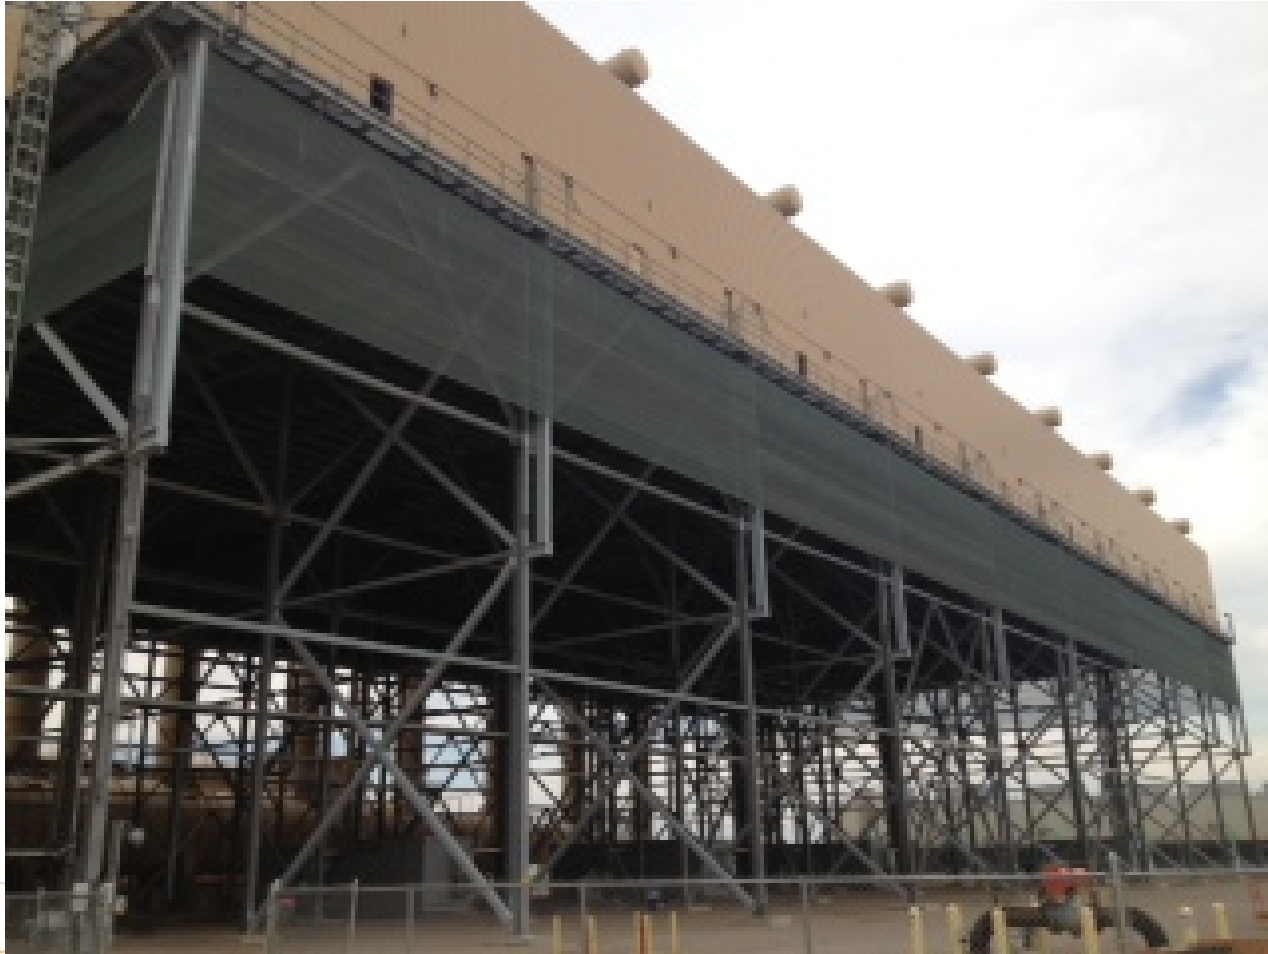
- **Goal was to Minimize Fan Blade Cracking**
  - **Worley-Parsons Engineering Study Conducted on the ACC Structure**
  - **Results Concluded that Extensive Cross Bracing was needed for any type of Wind Screen Material**
  - **Bracing Installed**
  - **Non-movable Screen Installed**
-

## *ACC Wind Screen Installation*

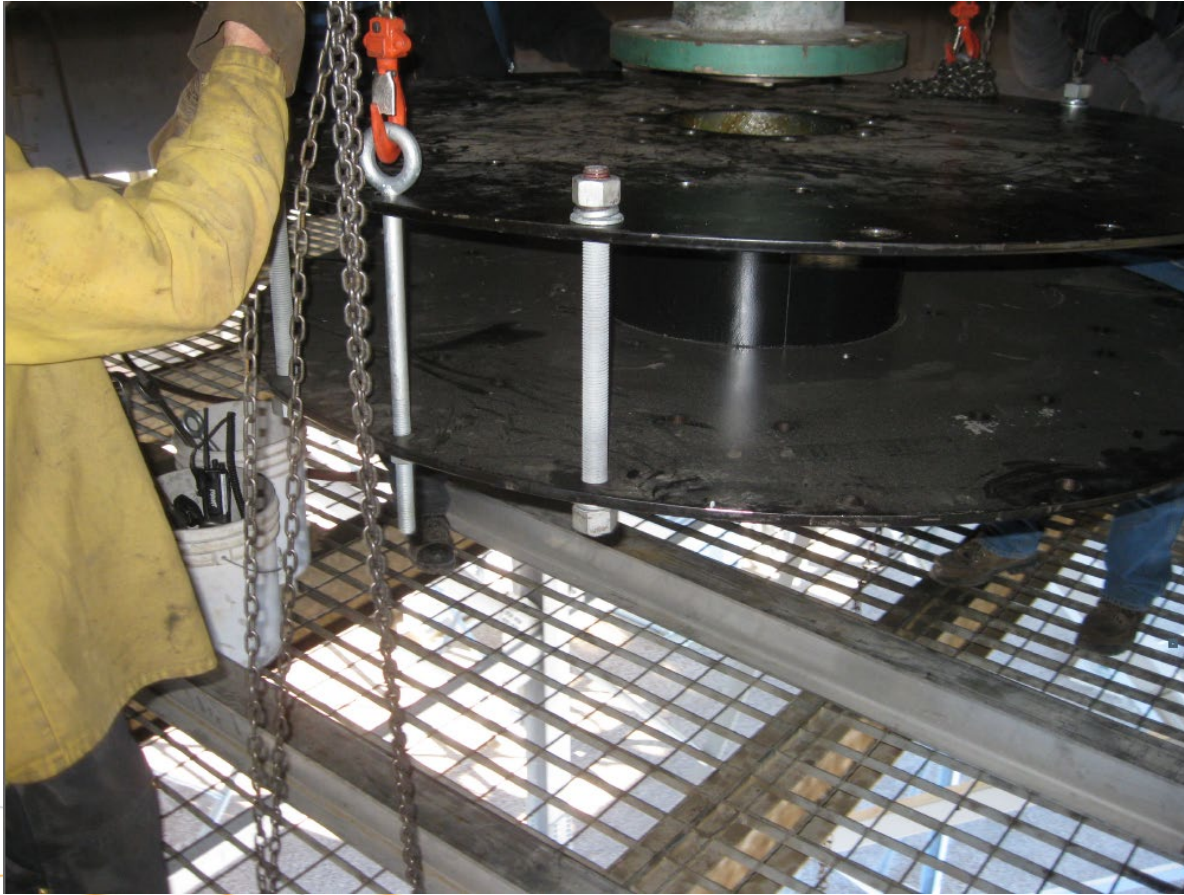
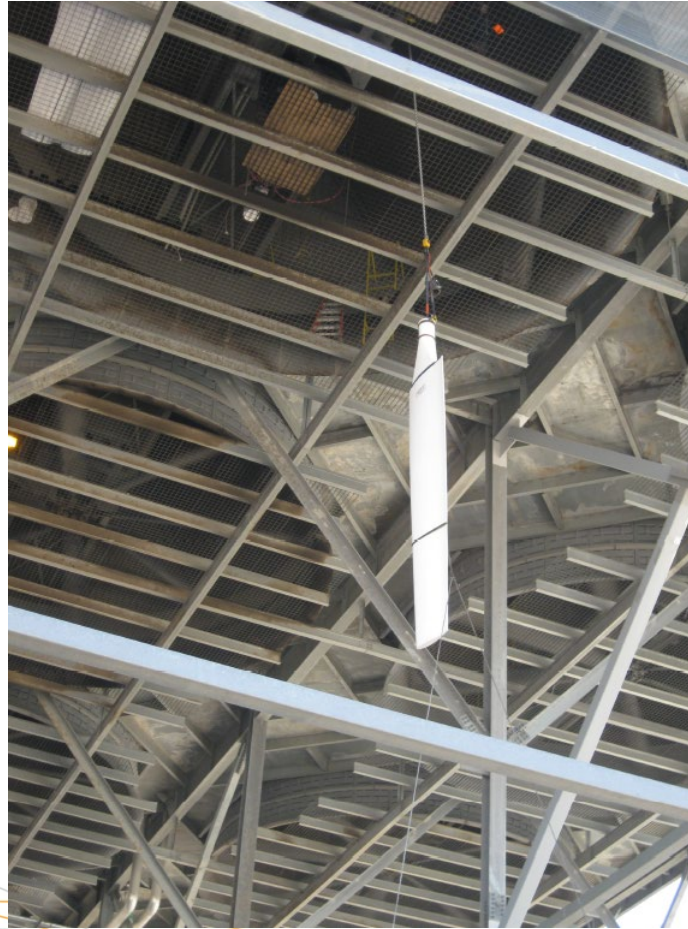
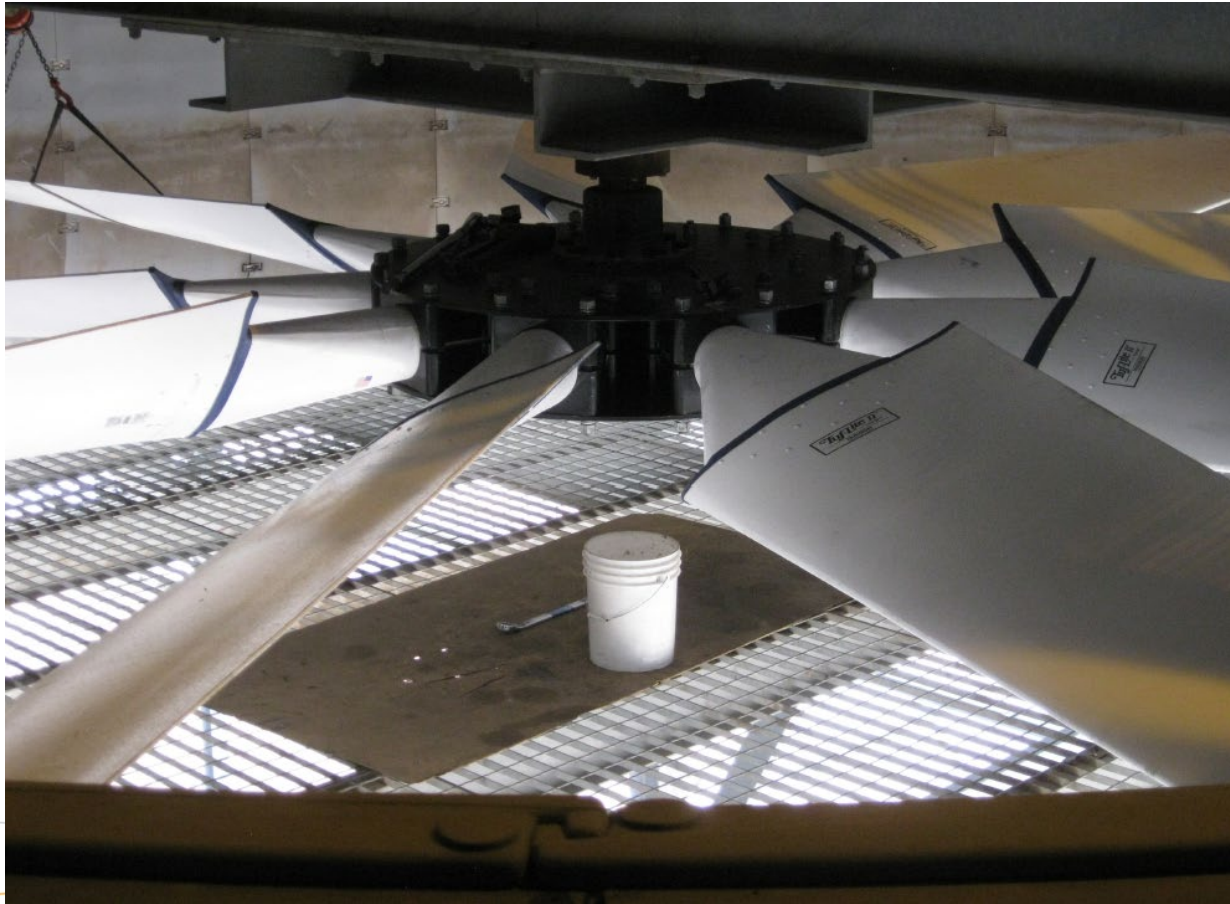
- **Blade cracking continued after wind screen and gear box modifications**
  - **OEM and an outside vendor conducted resonant and tip speed frequency studies**
  - **Results were varied but decision was made to change from an (8) blade to (9) blade with non-OEM blades**
  - **Blade installation will be completed in December of 2014**
-

# New Fan Blade Installation

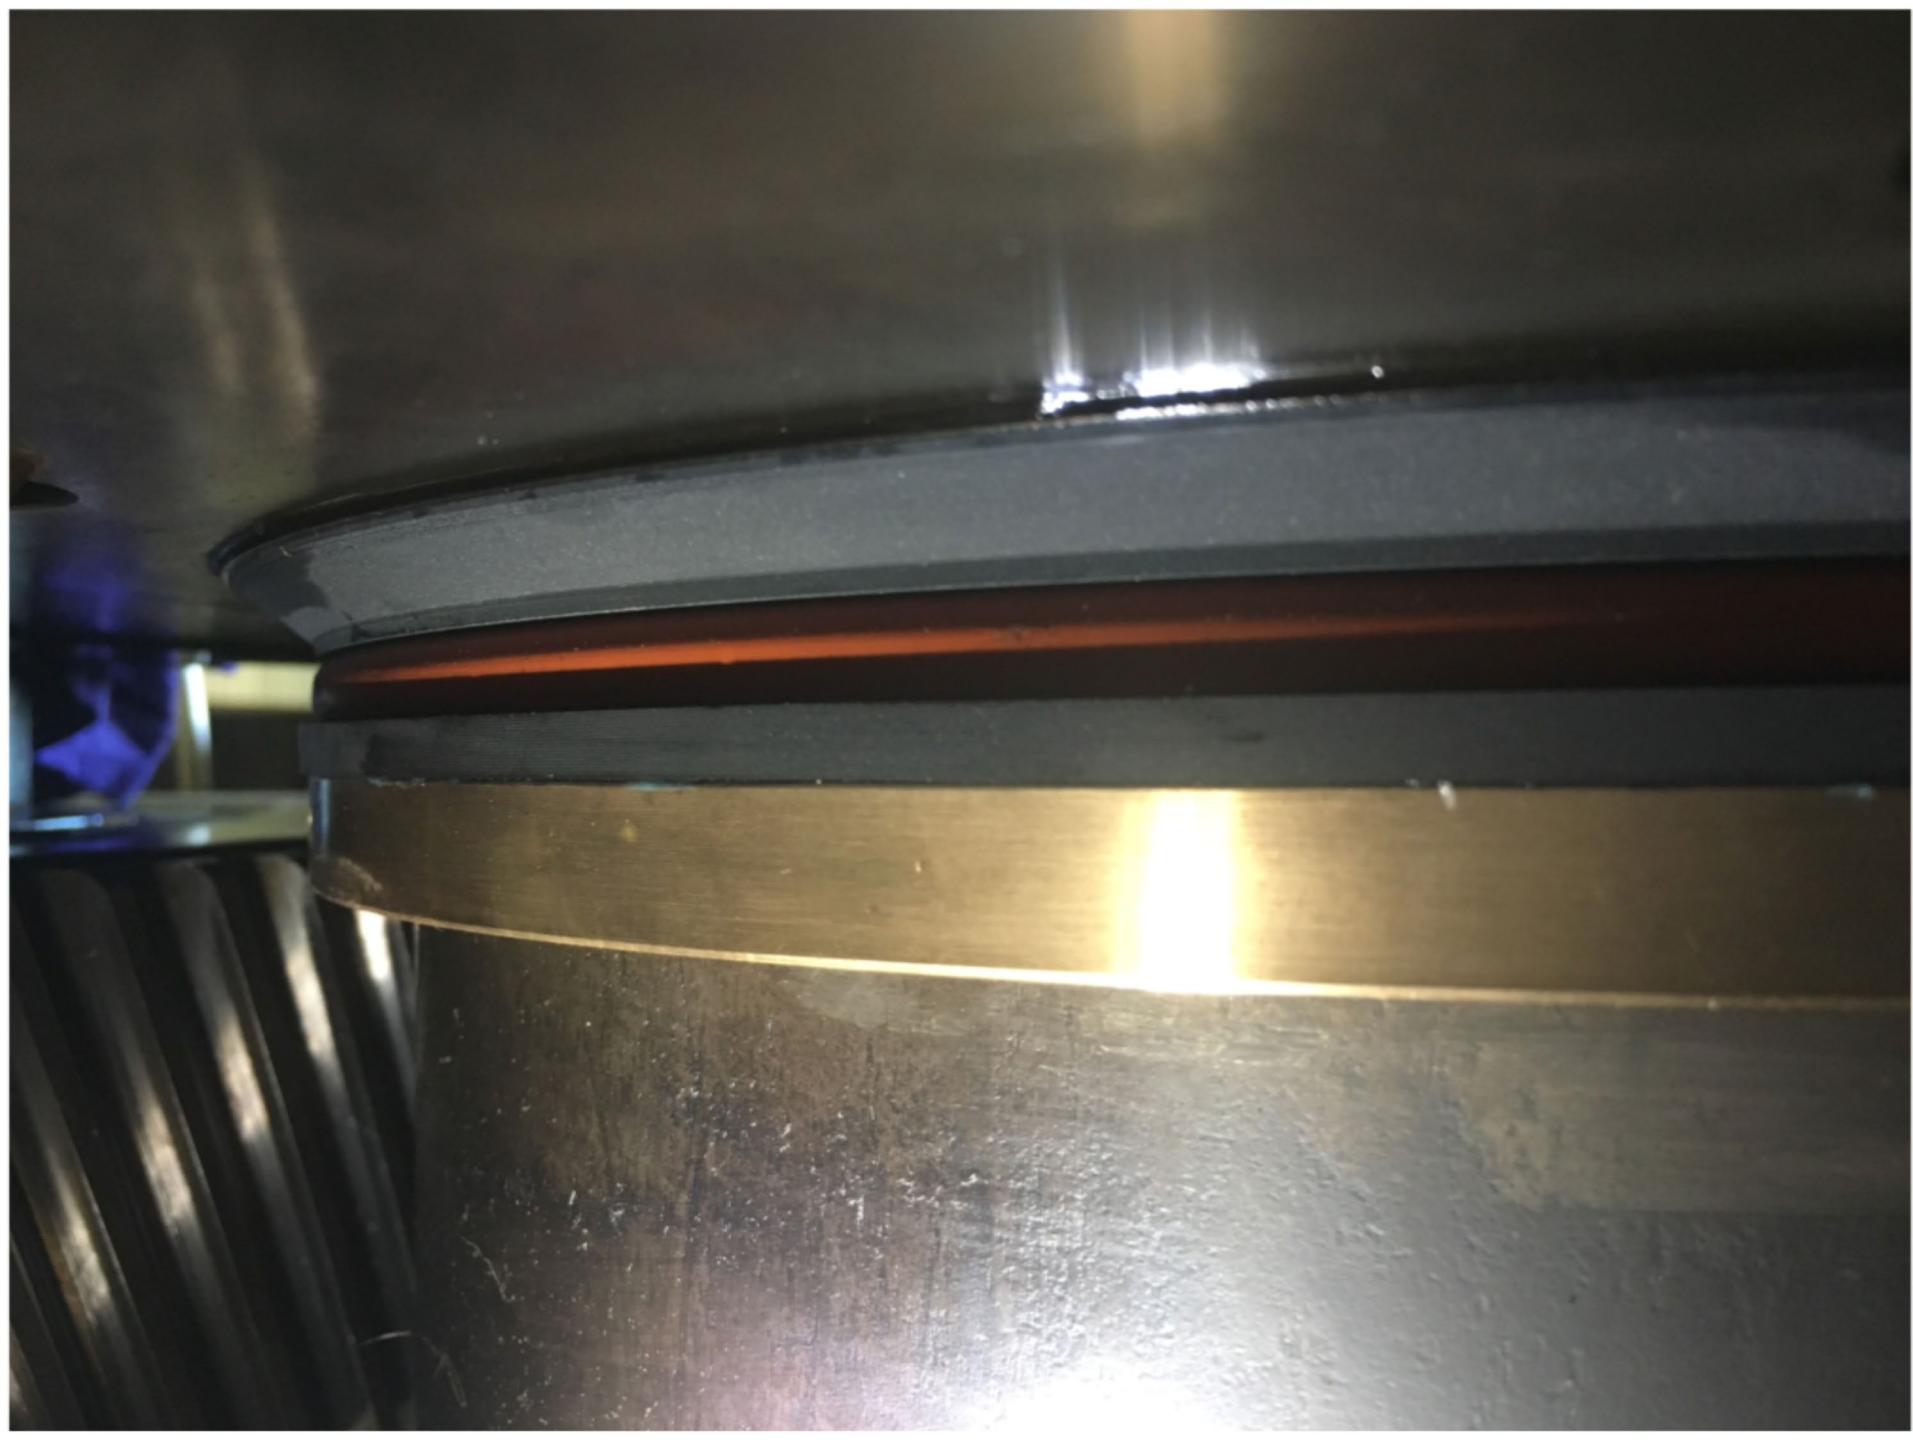
- **Output Seal Leaks**
  - **Fabricated Seal support ring.**
    - **Supports the seal completely.**
    - **Machined to set seal at design load.**

- **Potential Leak Caused by out of spec blade tracking.**
  - **During routine inspection it was discovered that there may be a correlation between excessive blade tracking and output seal leaks.**

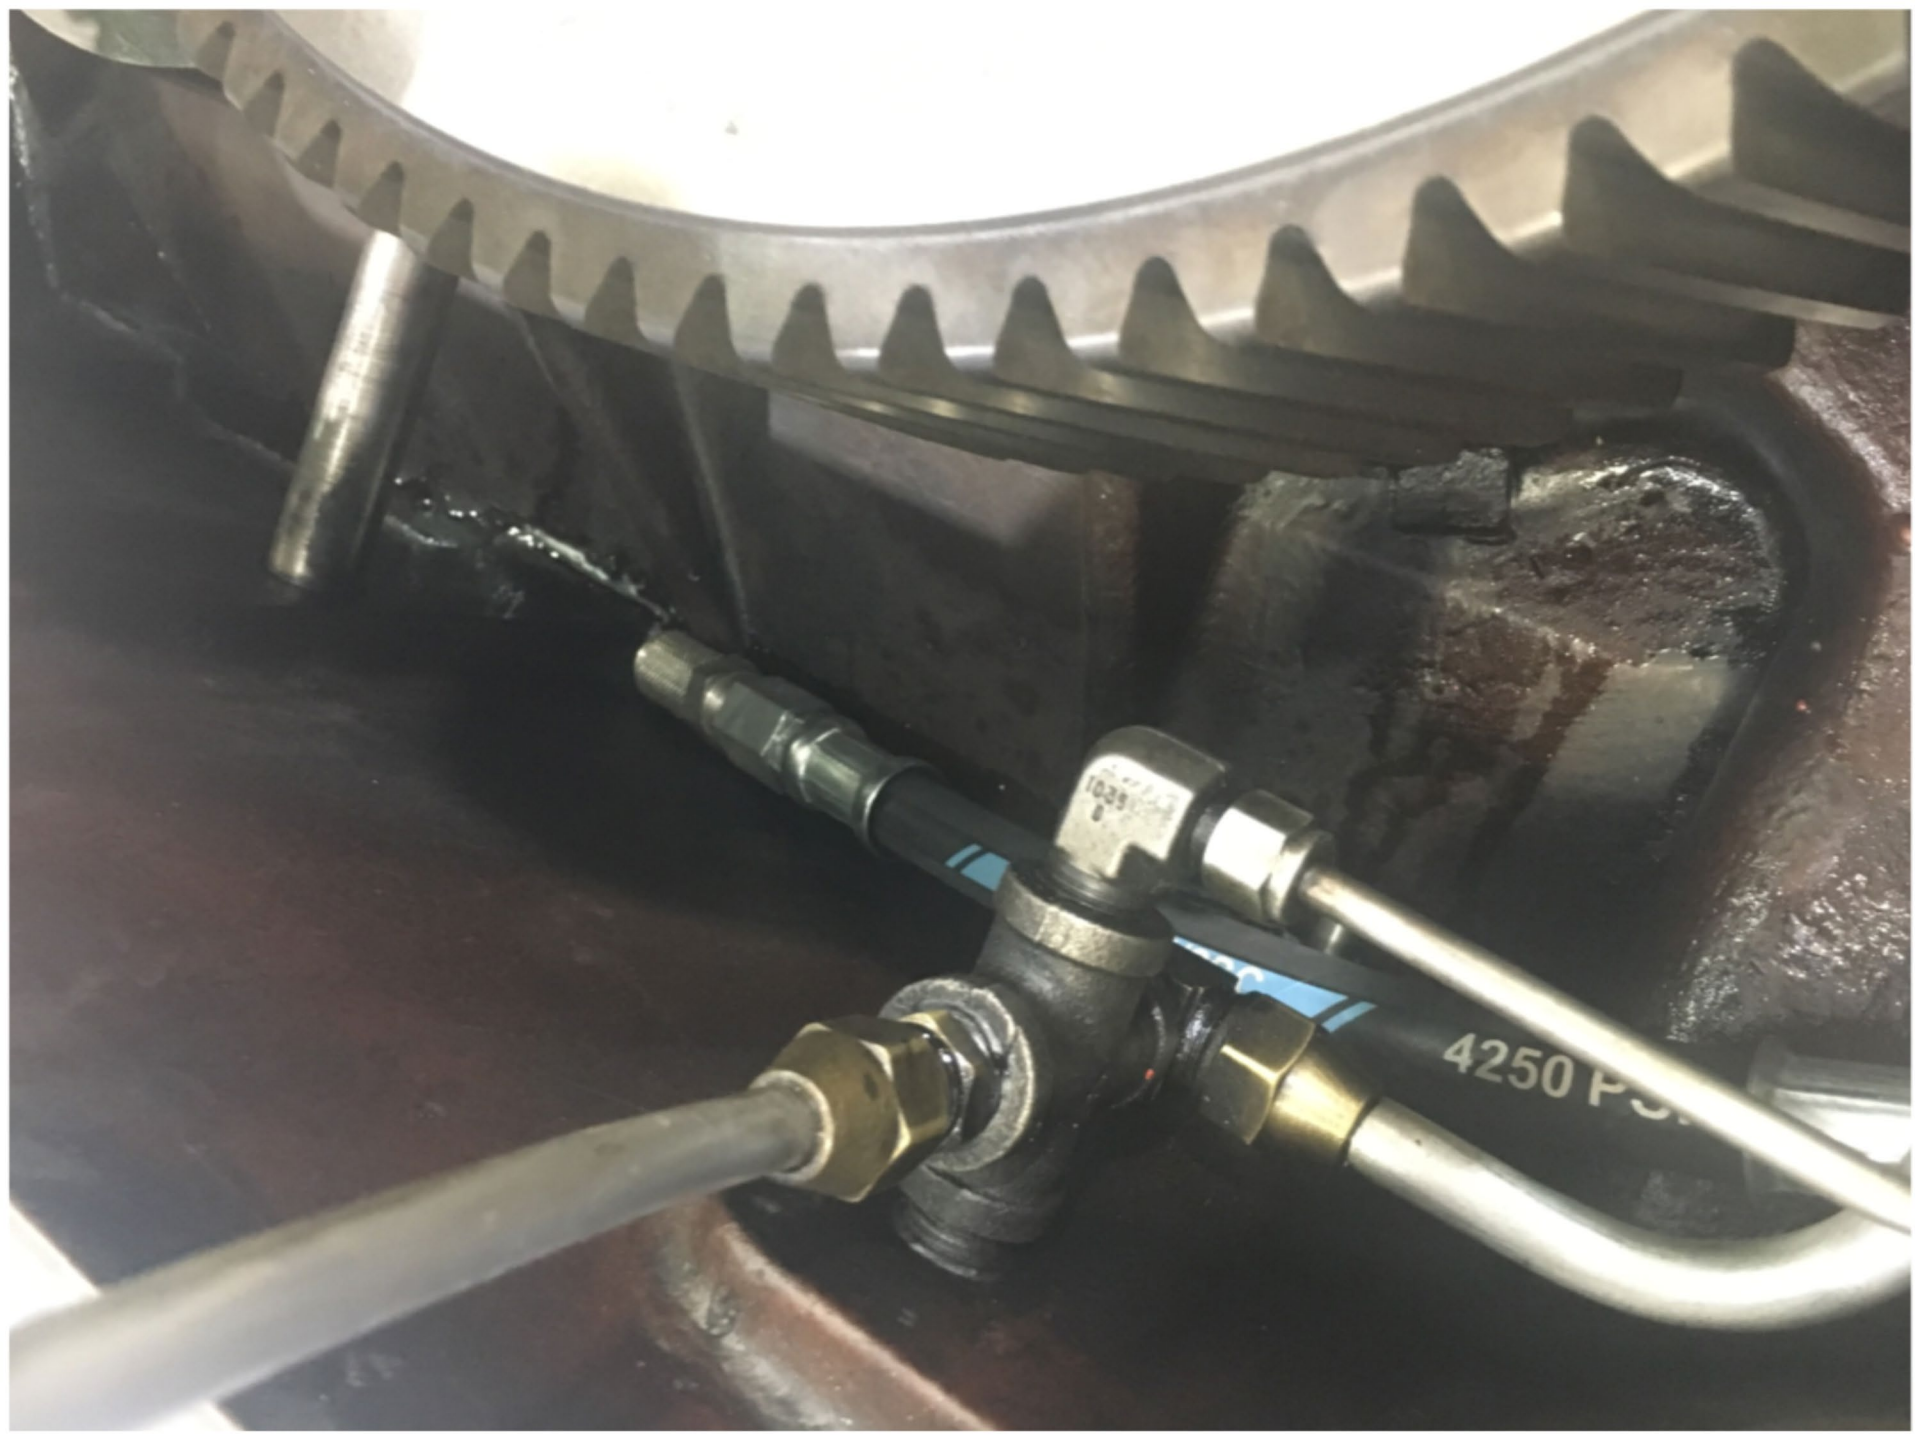
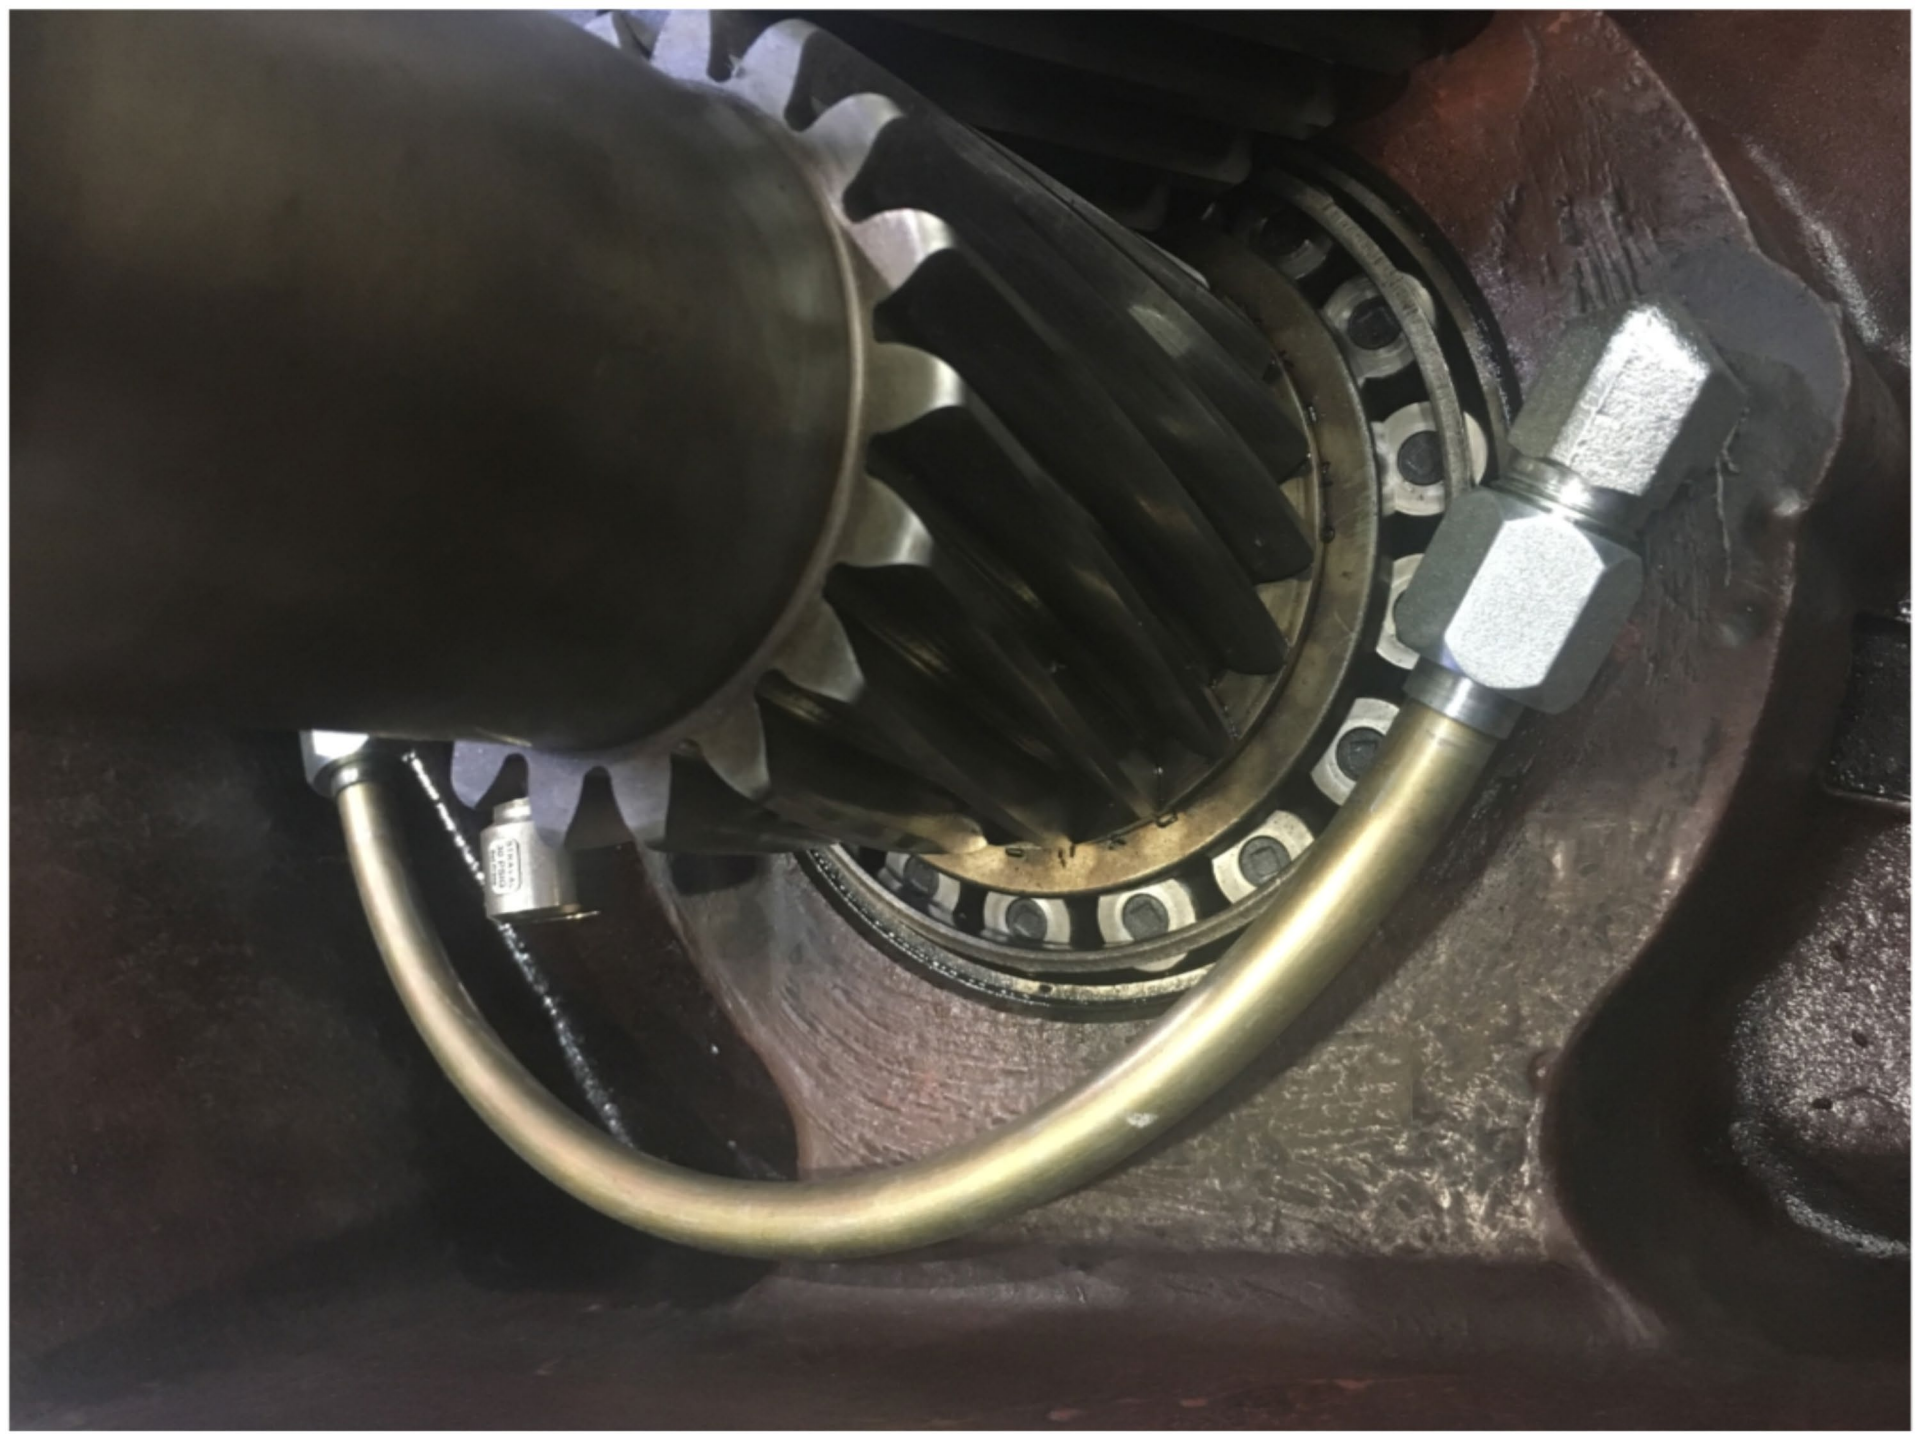
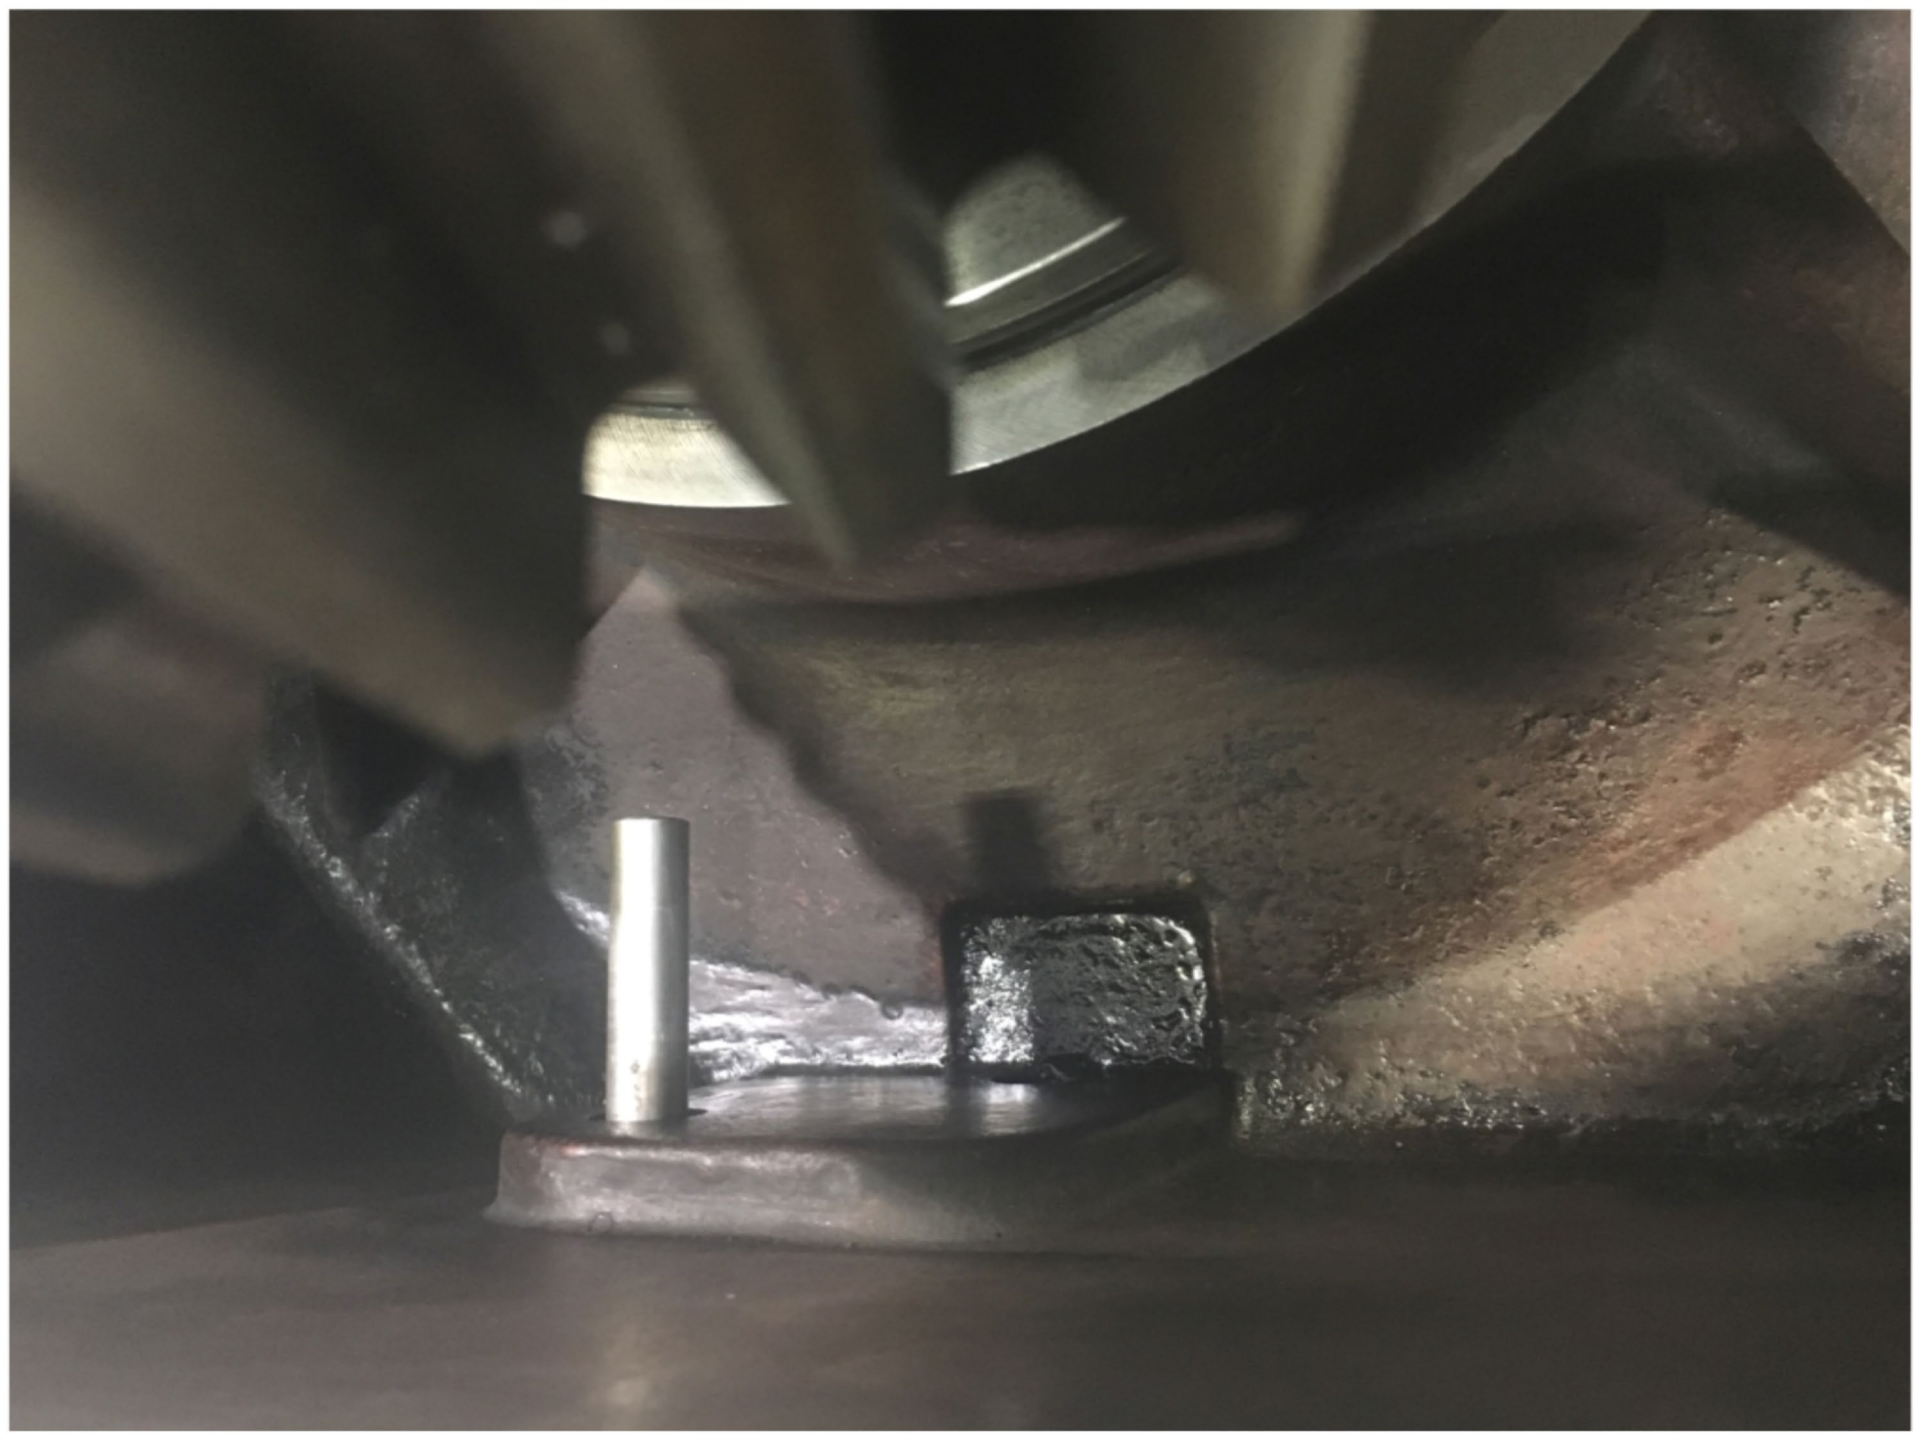
- **Oil Contamination caused by oil heaters.**
  - **Fabricated extended thermal couple.**
  - **Added screen to oil pick up.**
  - **Moved oil pick up to side of gear box with access window.**
  - **Used a hose for oil pick up so that it can be removed and cleaned from access cover**

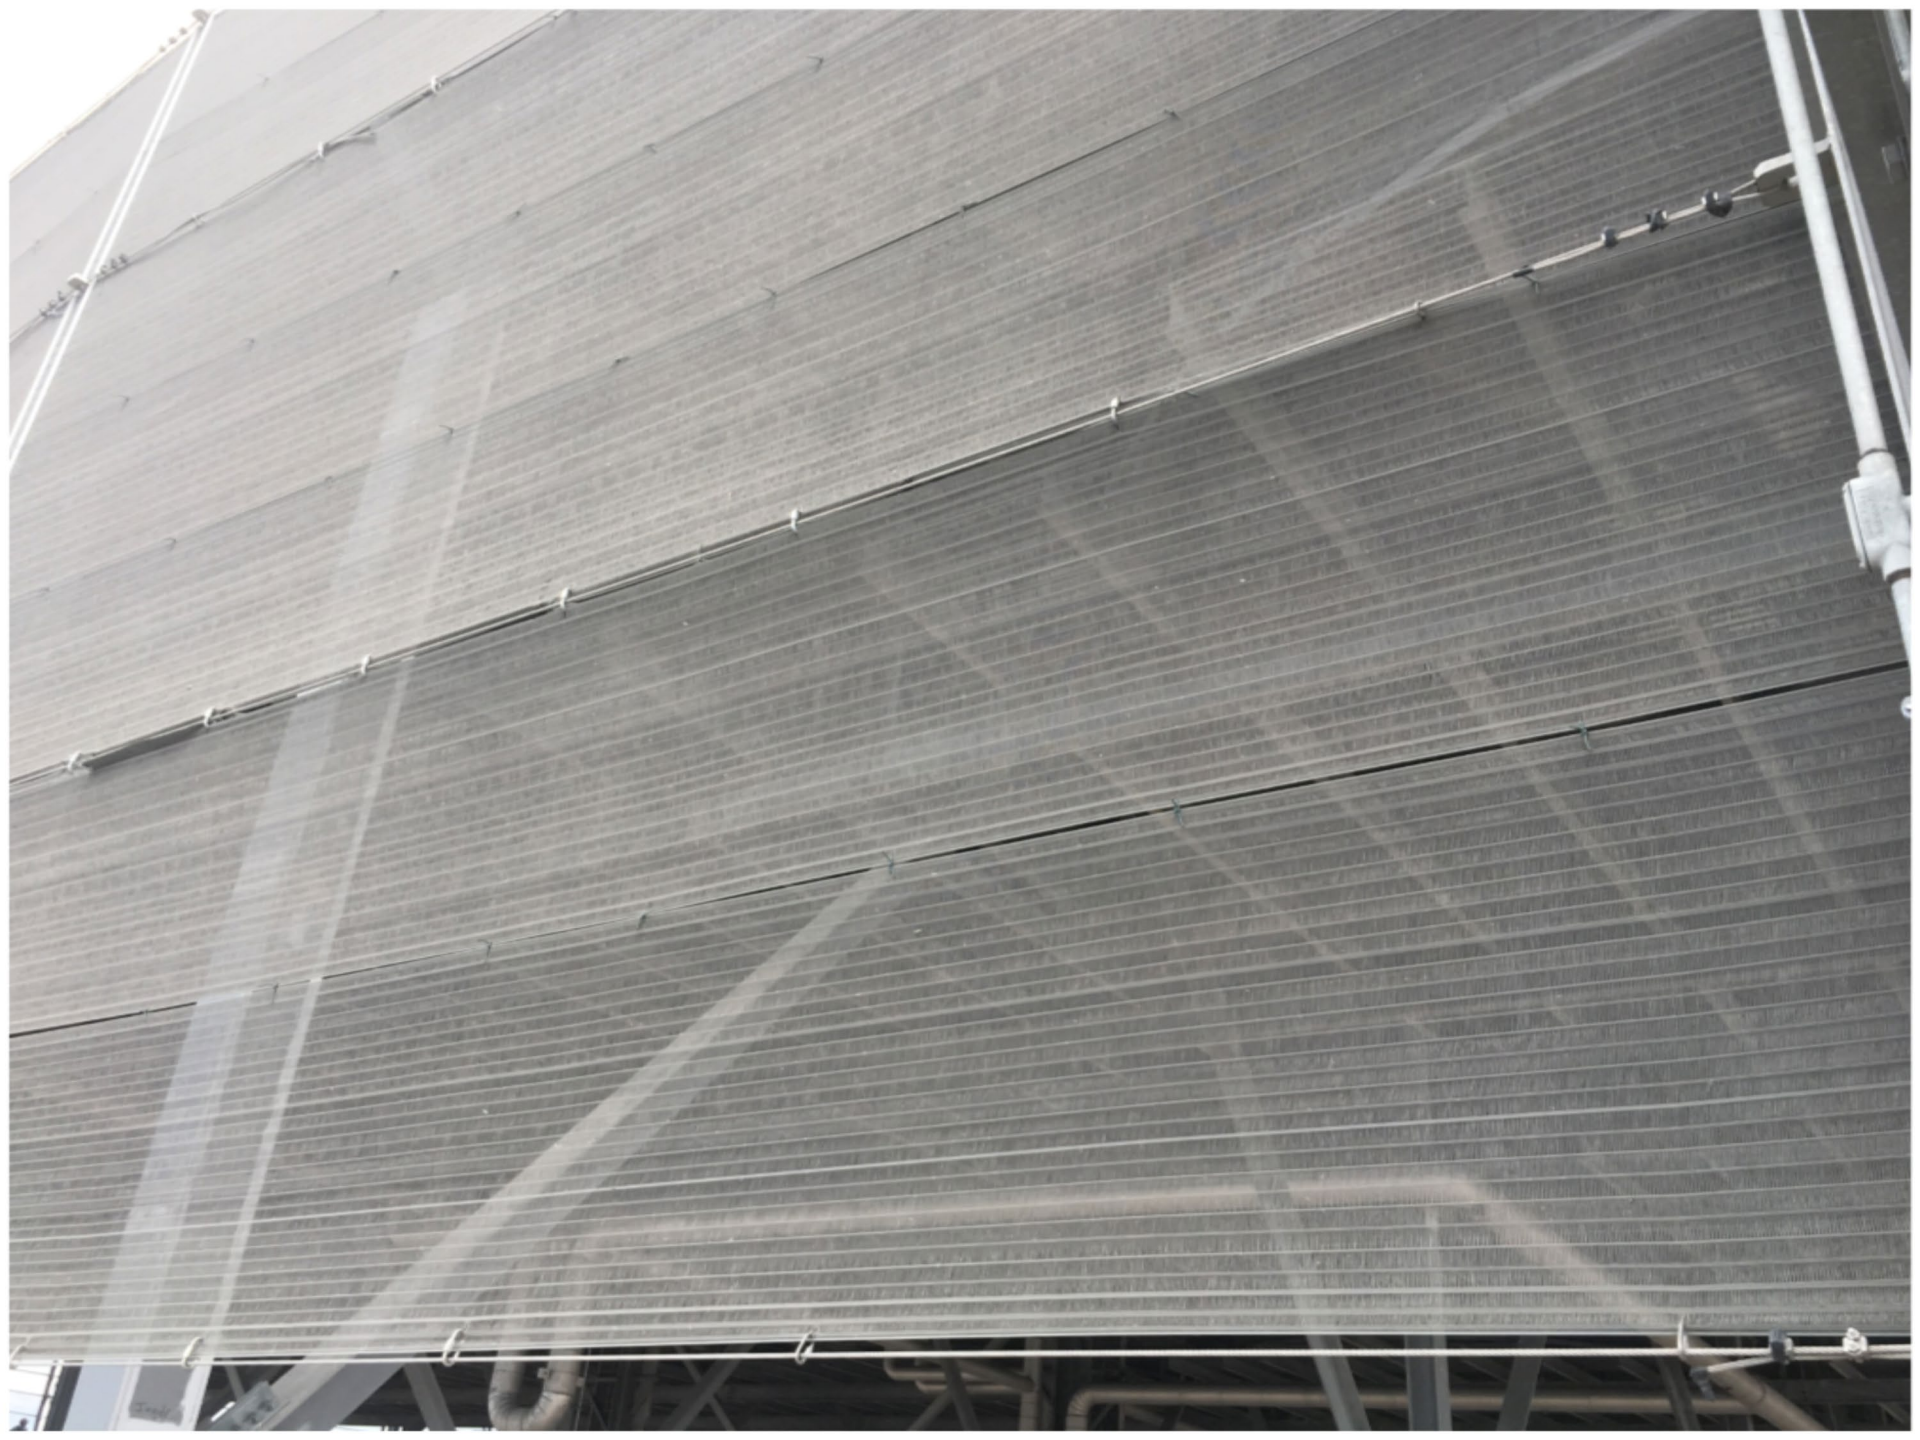
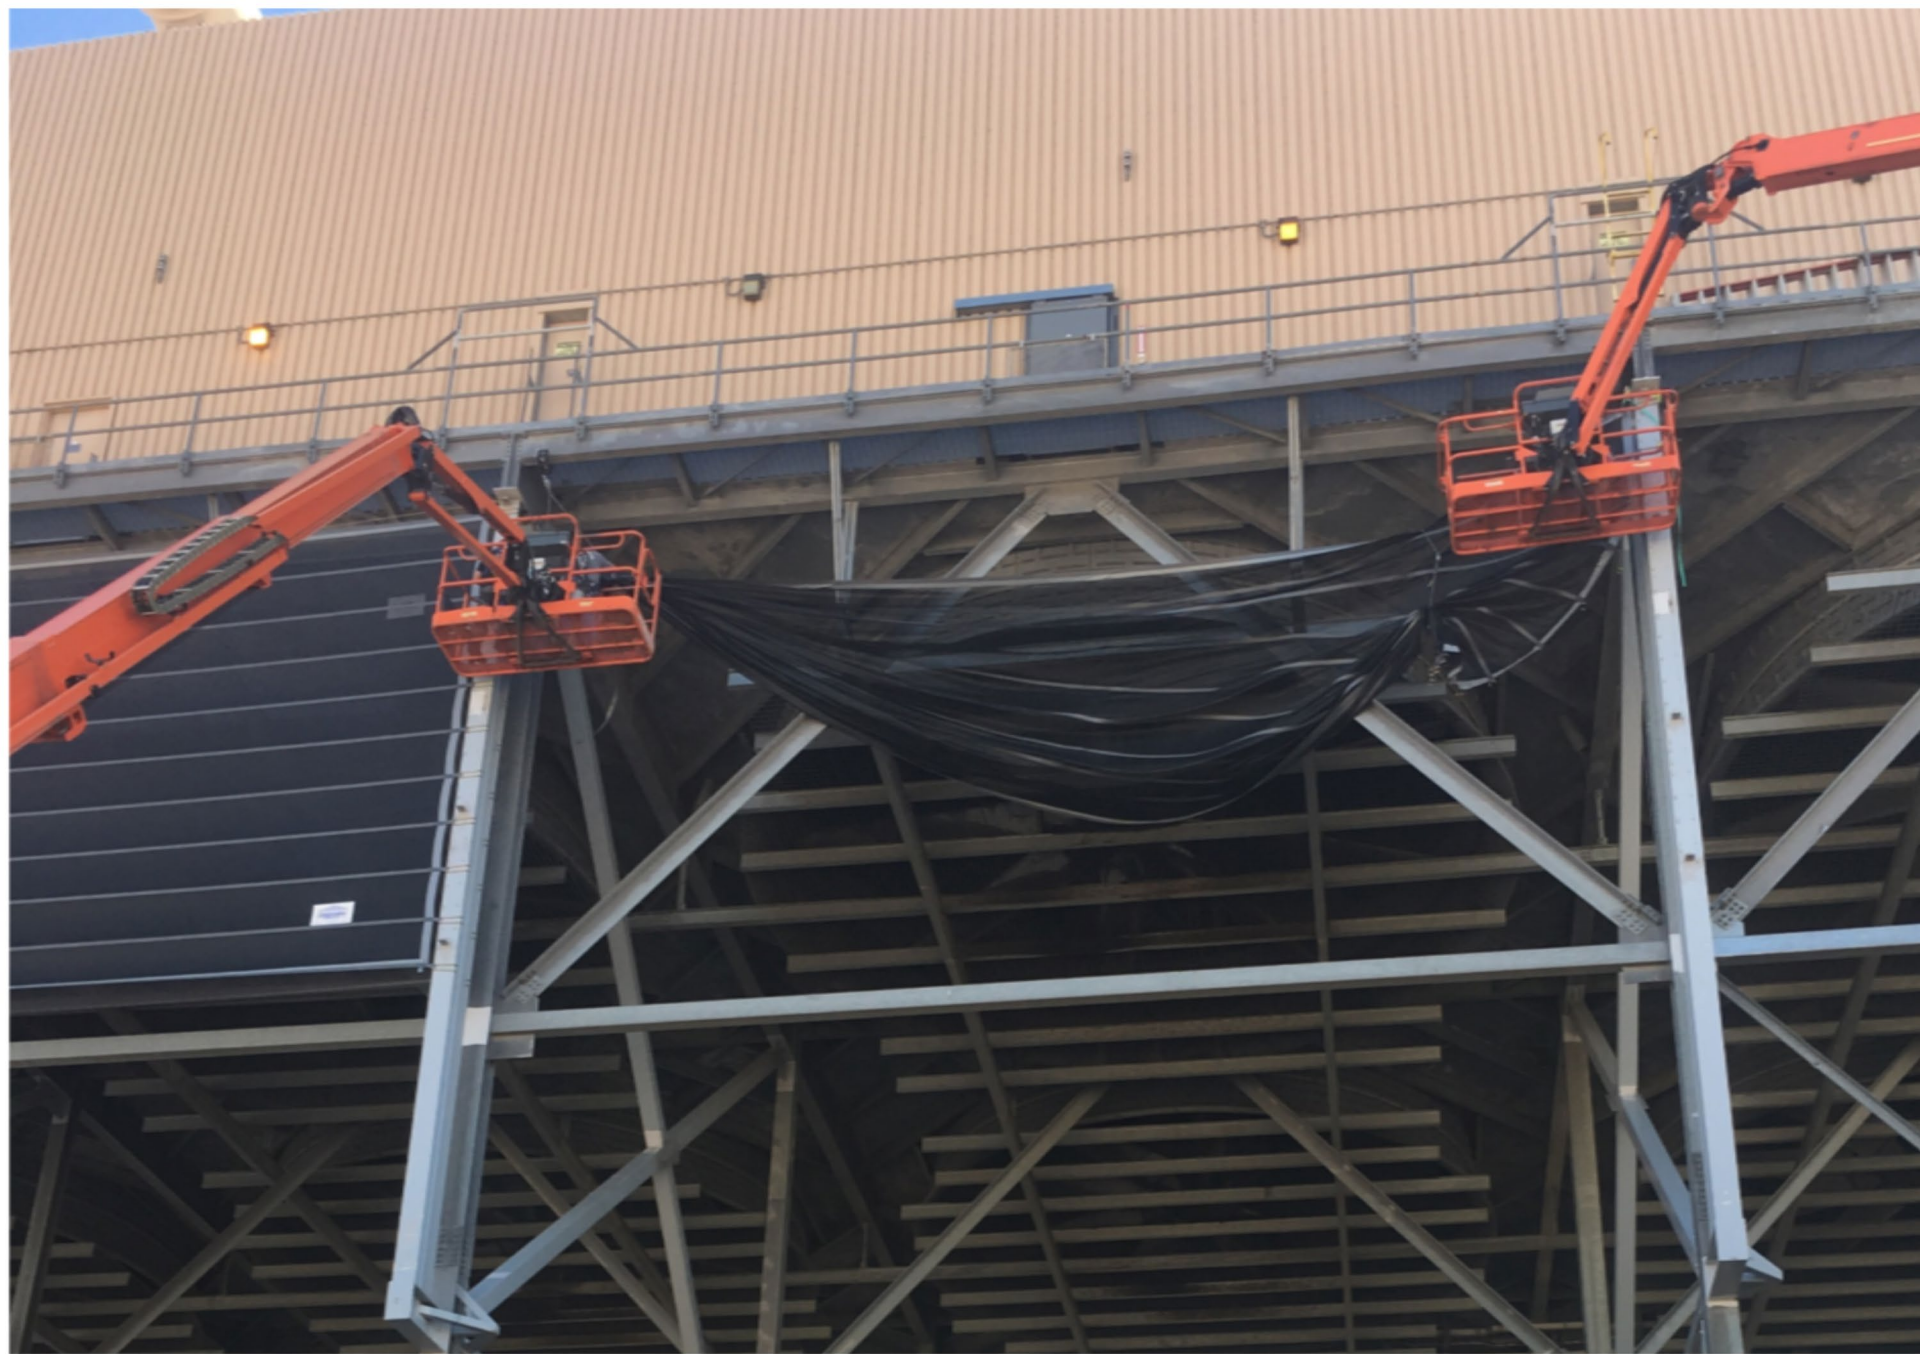
- **Old wind fence material was weak and would tear easily.**
- **Tested Galebreaker fence on one cell for four years.**
  - **Decided to completely replace fence with Galebreaker fence after evaluation should the material to be virtually maintenance free.**
