# Drone Inspections of Air Cooled Condensers

ACC Users Group 2026

Keith Paul  
Principal Technical Leader EPRI Program 223 Heat Rate  
and Flexibility

# Drone Inspection Methodology for ACC Inspections

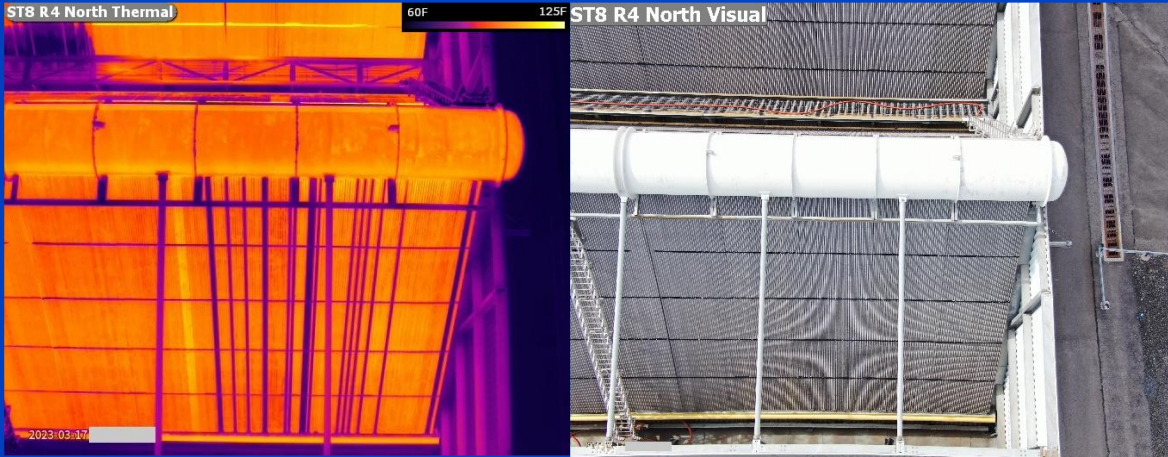
Street 8  
Row 4 North

- The North side clearly has tubes that are cold, which means they are likely not full of condensing steam. Therefore, they are either air blanketed or are plugged as denoted by the white arrows in the image on the right. This reduces the capacity of the air-cooled condenser, and will increase condenser backpressure, decreasing steam turbine performance. Plugged tubes and the specific locations were confirmed on an internal inspection and the numbers of the plugs aligned with this image.

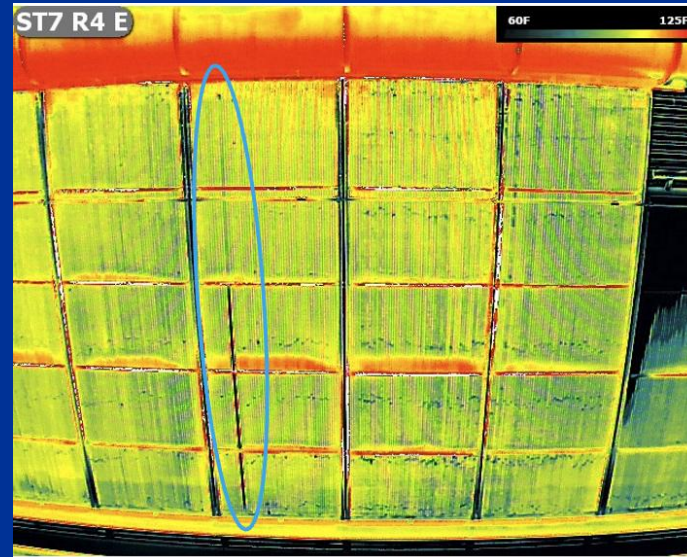
# Cold Tube

Tube was cold in person, further investigation will be required to see if tube is plugged or what the problem is.

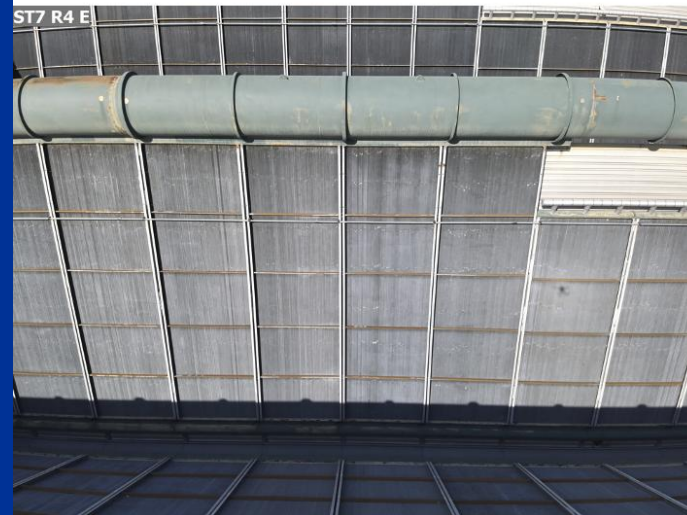
The photograph image looks normal

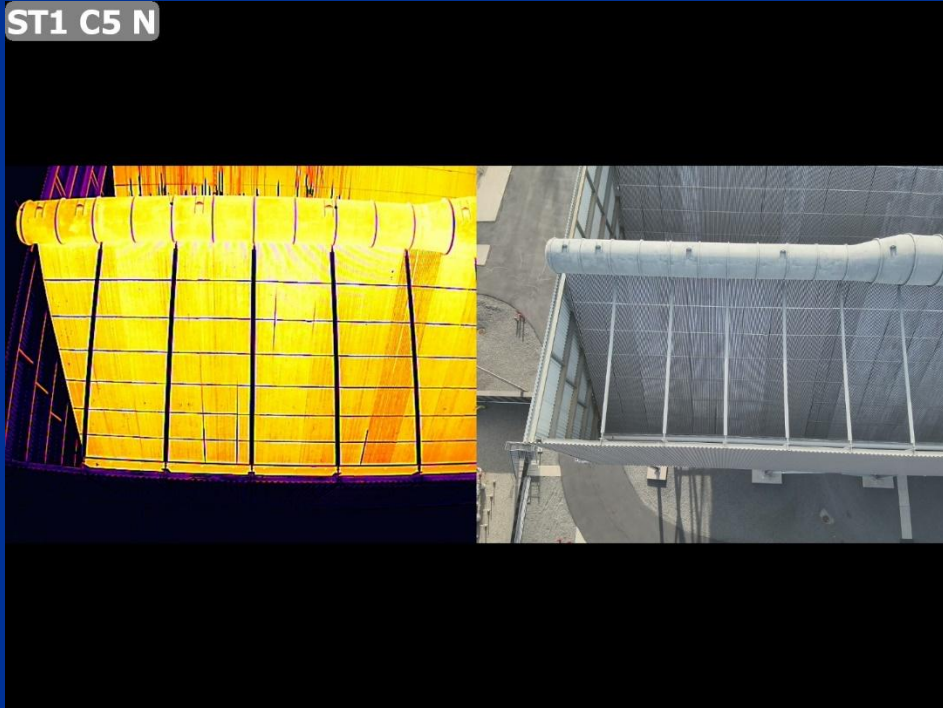
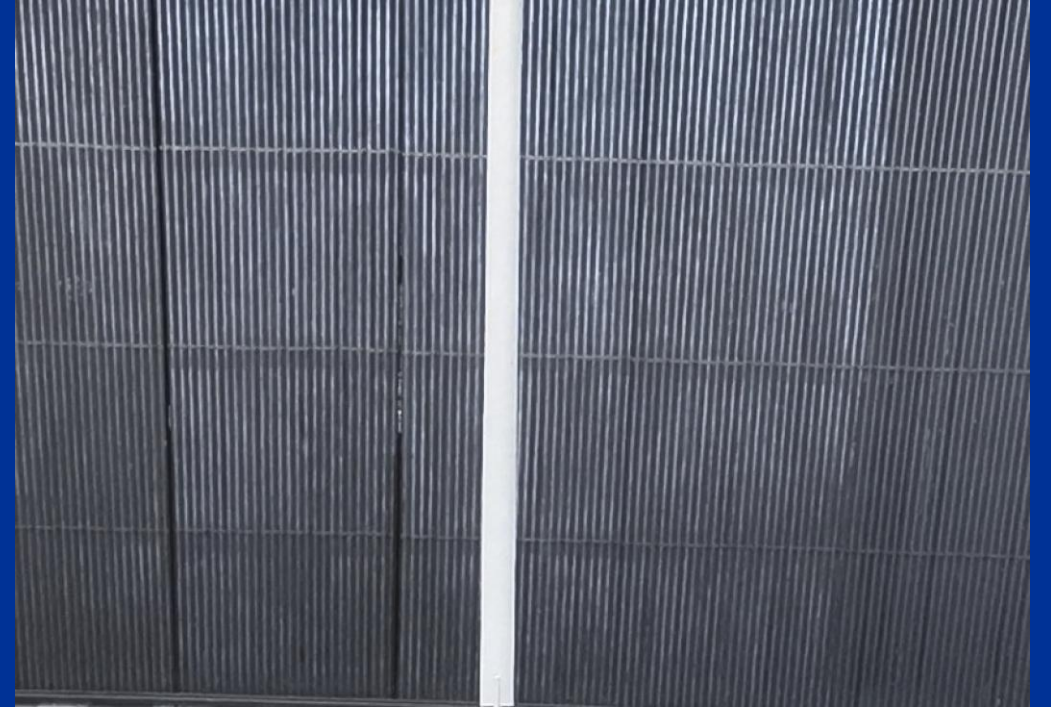
ST1 C5 N

# Freezing Damage

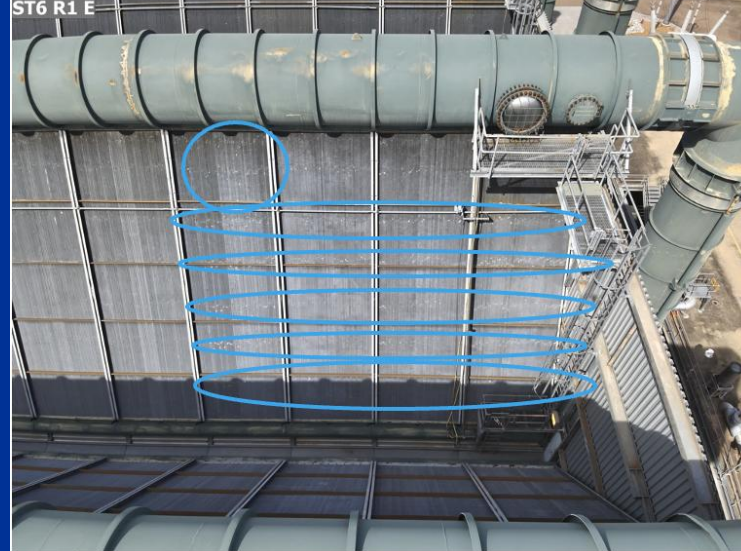
Some of the debris/corrosion can be seen in the photograph:

# Cleaning Recommended

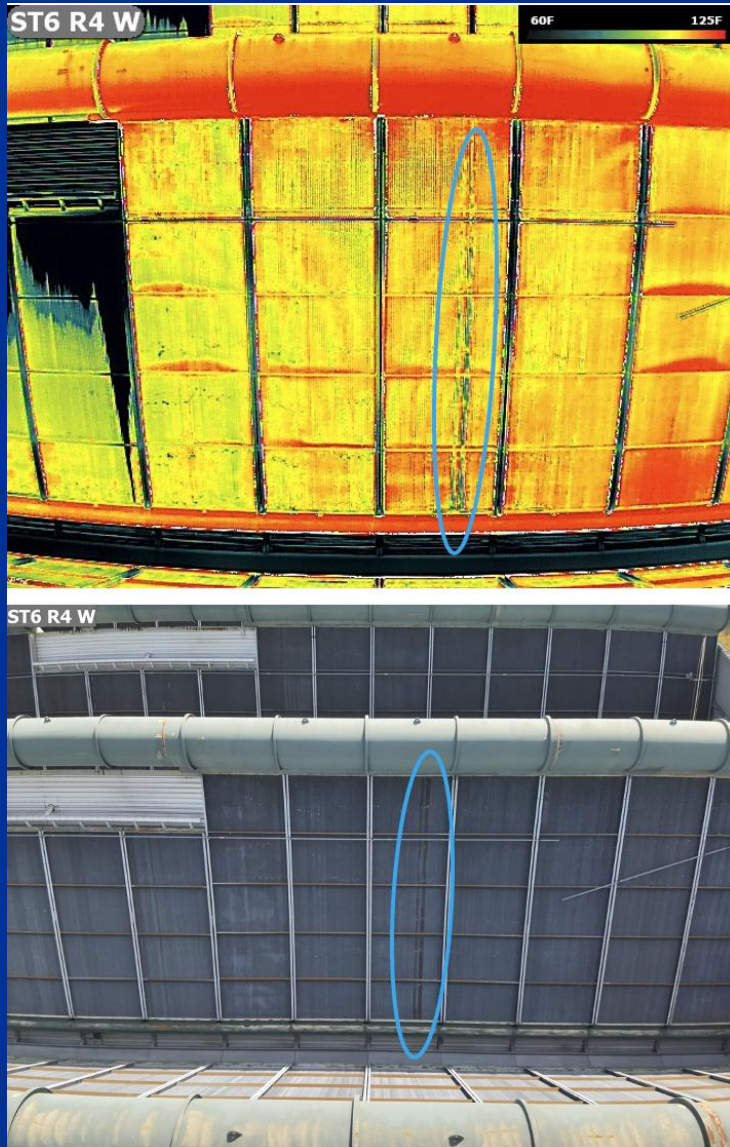
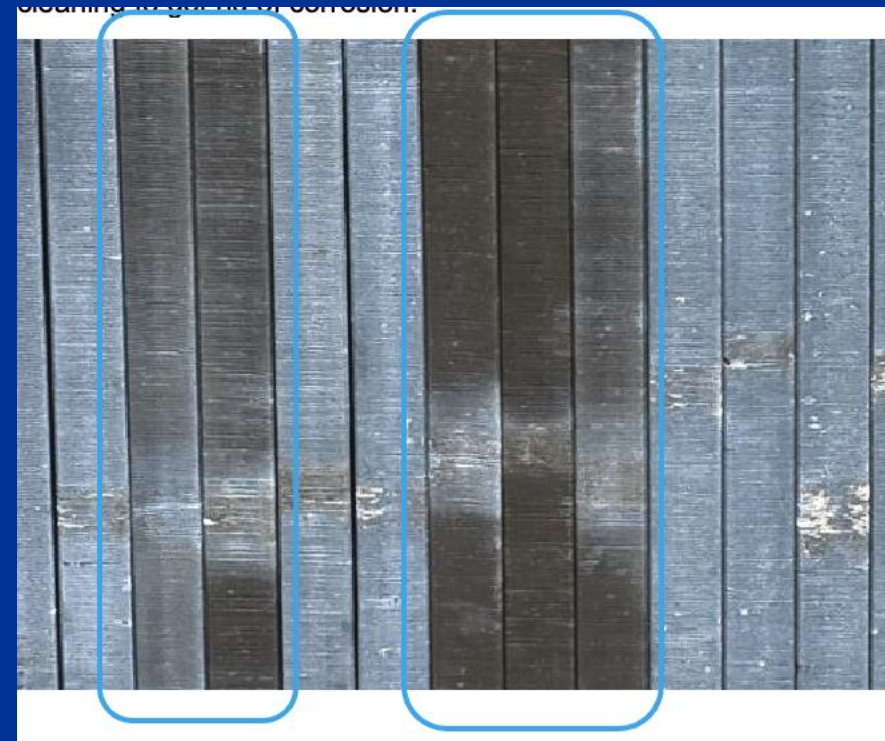
Cleaning recommended to get rid of corrosion, tubes were not cold in person.

# Cleaning Needed

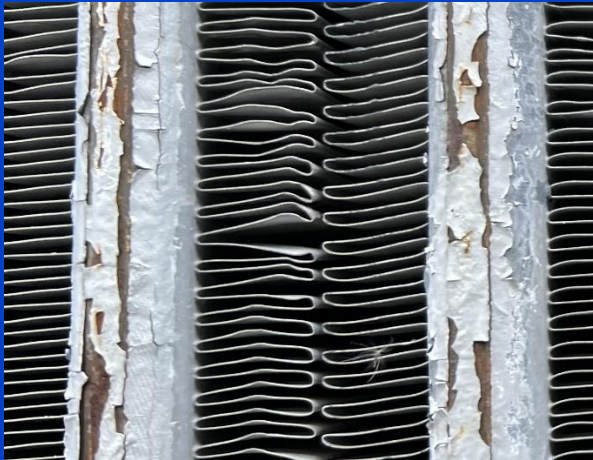
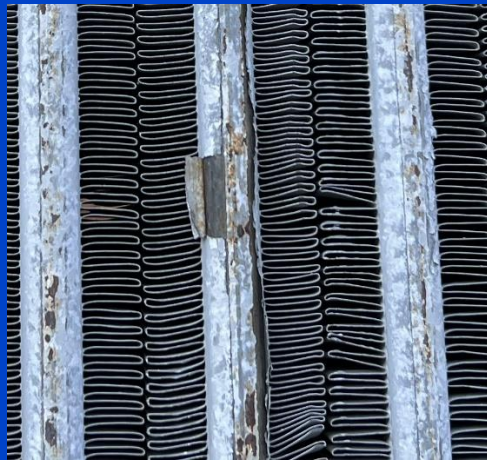
# Tube Coating Failure

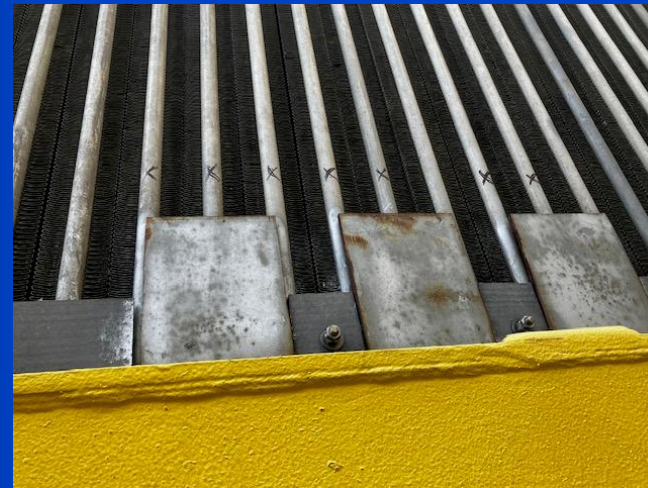
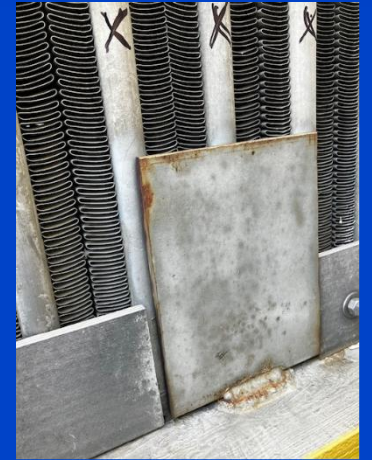
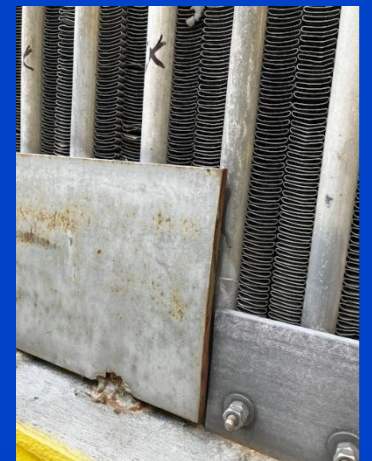
- Multiple tubes identified as cold in where we saw them with the drone, confirming drone IR inspection results. The drone results allowed the plant to focus on this section.
- Some may be plugged. Inspection, verification, and possibly repair may occur in the upcoming outage.
