# Induced Draft ACC Overview

# Input Bearing Assembly Rebuild on B3NV-10 Gearboxes

# MAINTENANCE TECHNOLOGIES INTERNATIONAL (MTI)

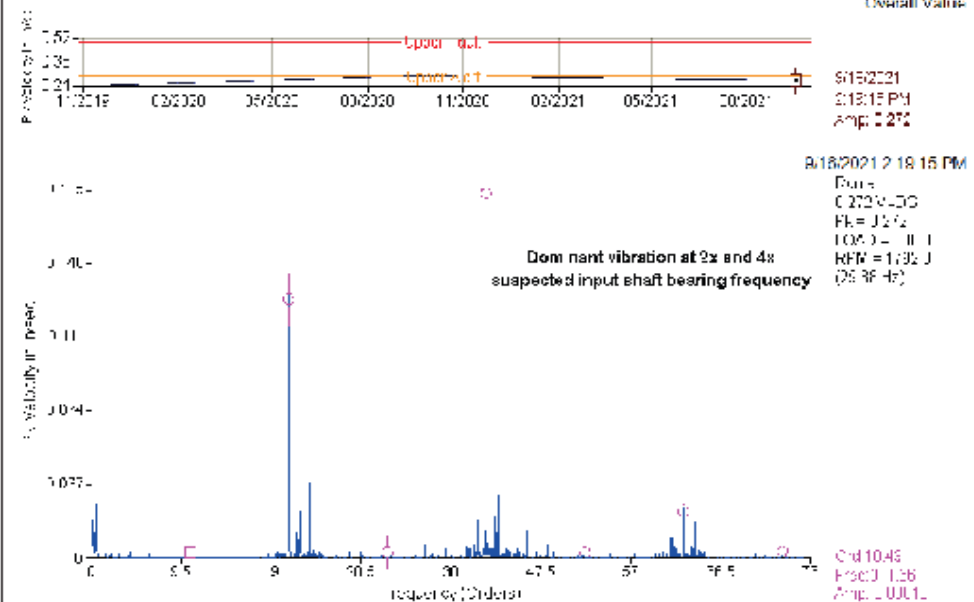
Valley Energy Center Unit 1 / ACC / ACC FAN 102 / CA - ISO INPUT AXIAL

**Explanation:** 9/16/21: Vibration analysis on this gearbox shows suspected inner and outer bearing defects on the gearbox input shaft bearings. Previous gear inspections have not shown any suspected issues. MTI recommends replacing the input shaft bearings and remonitoring.

Bearing vibration dominant

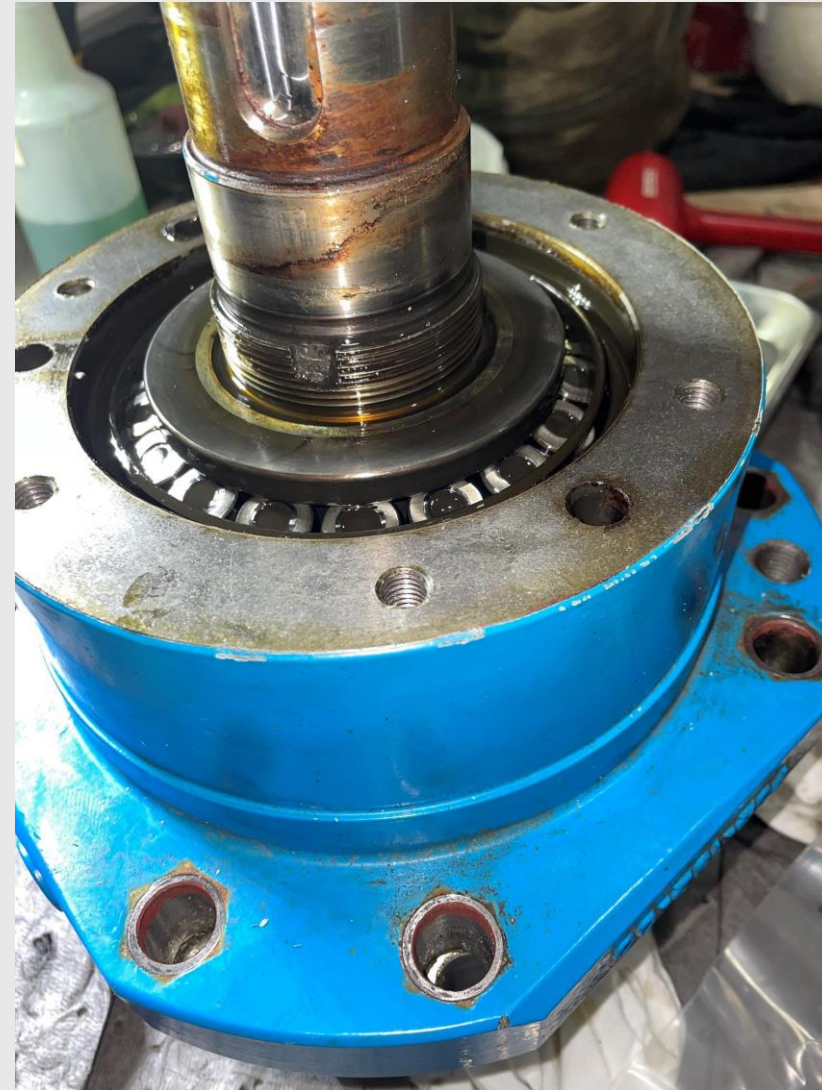
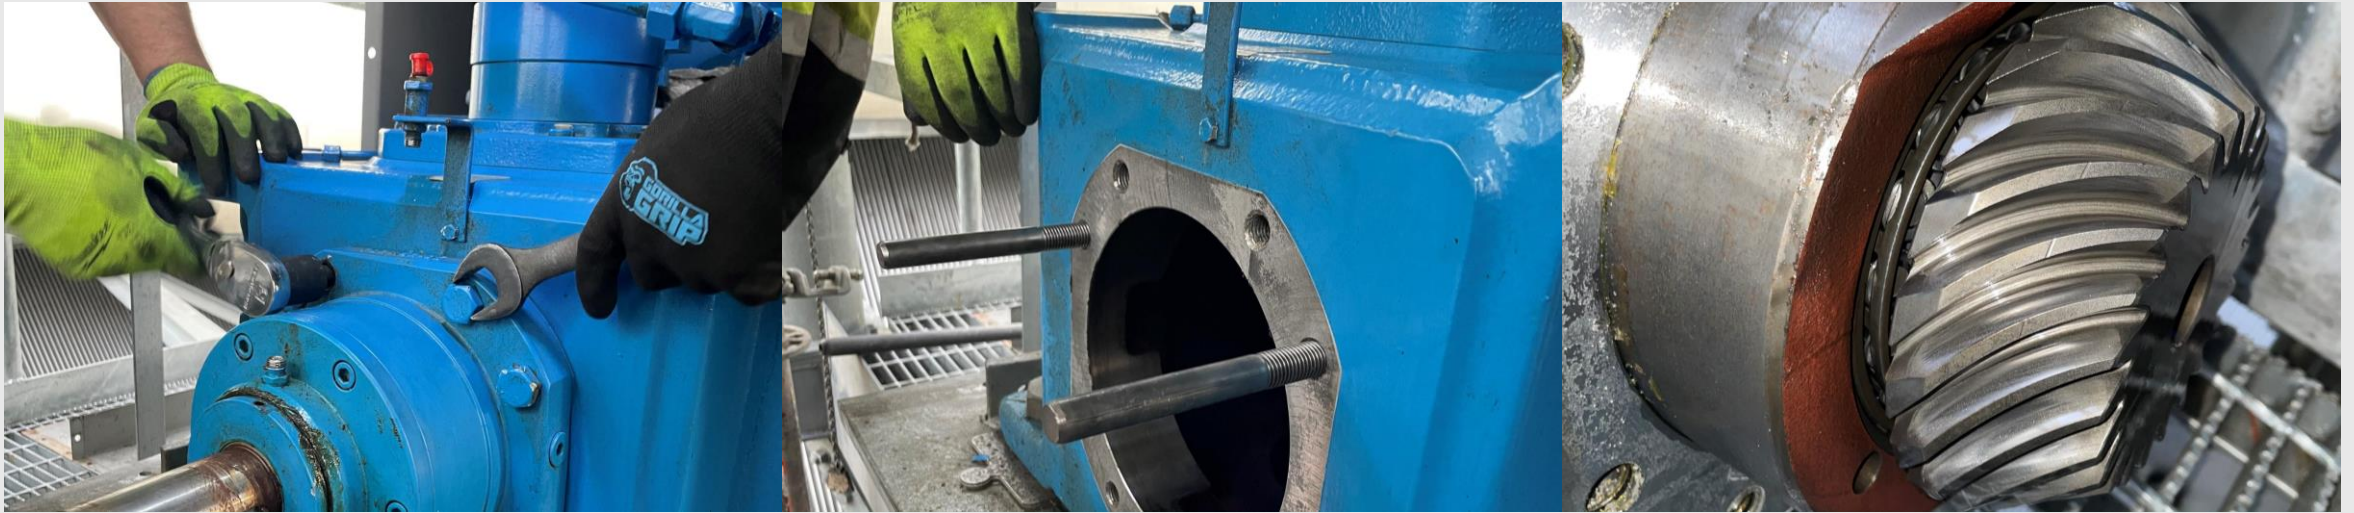
- Upon disassemble of the inboard housing it was noted that there is normal wear on the drive gear. The helical cut gear is annealed for hardening purposes and will naturally wear off when in normal operating service.
