KOGAN CREEK UPDATE

4TH ANNUAL ACC USERS GROUP
MEETING – 25 – 26 SEPT 2012

August 2011 Outage (3 ½ Years since commissioning)

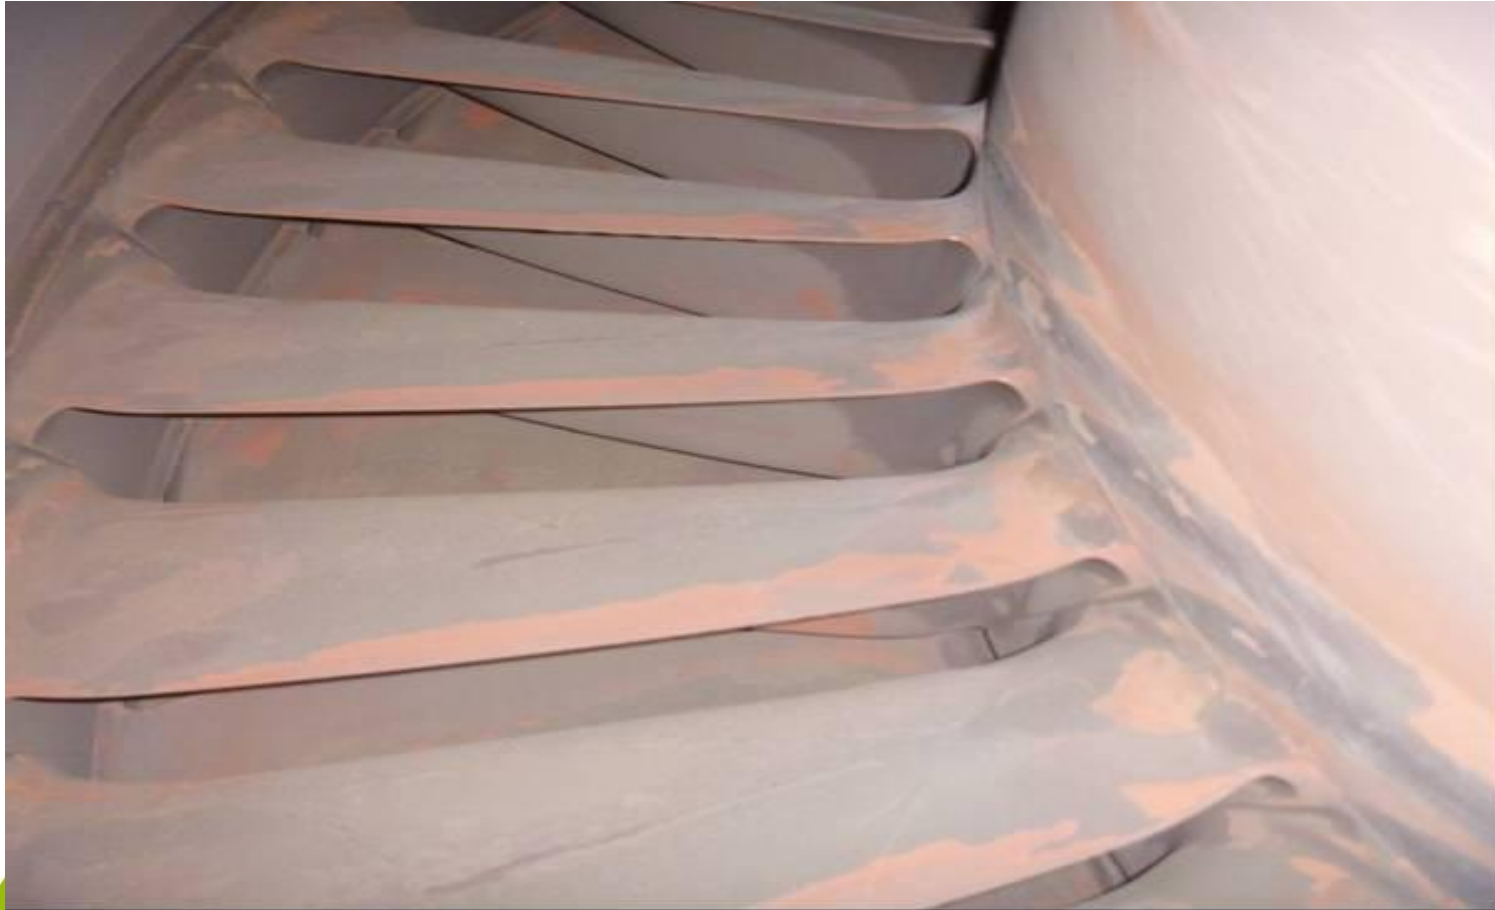
HP Exhaust - 2011

- Significant boiler tube iron deposition identified during the plant's 8000hr outage (October 2008)
- Boiler chemical clean conducted to remove deposits (August 2009)
- Deposits of Iron confirmed on last and final 3 stages of the HP turbine (August 2011) – significance? – contribution to MW loss? – significance and source of Al, Cu and Cr.
- Minor Iron deposits found at IP and LP turbine inlets or exhausts (August 2011).
- Further heat rate tests and investigations to be conducted
- Further inspections at mini overhaul 2013
- Planning for first HP cover lift – complex – costly ?

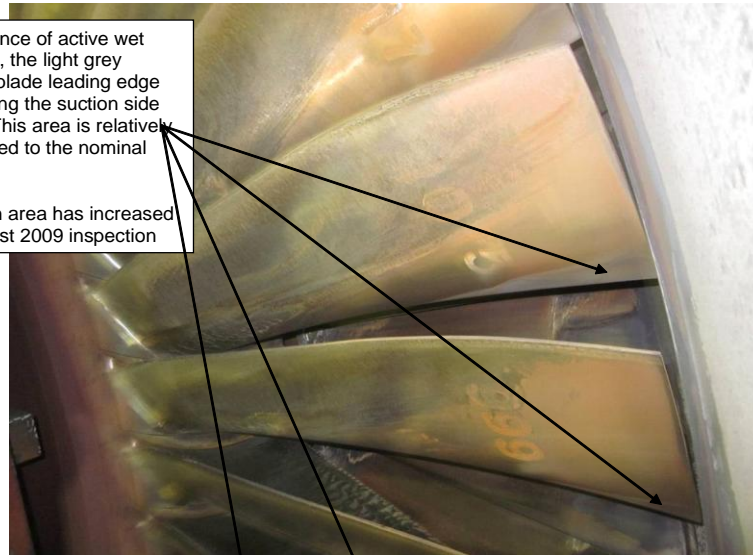
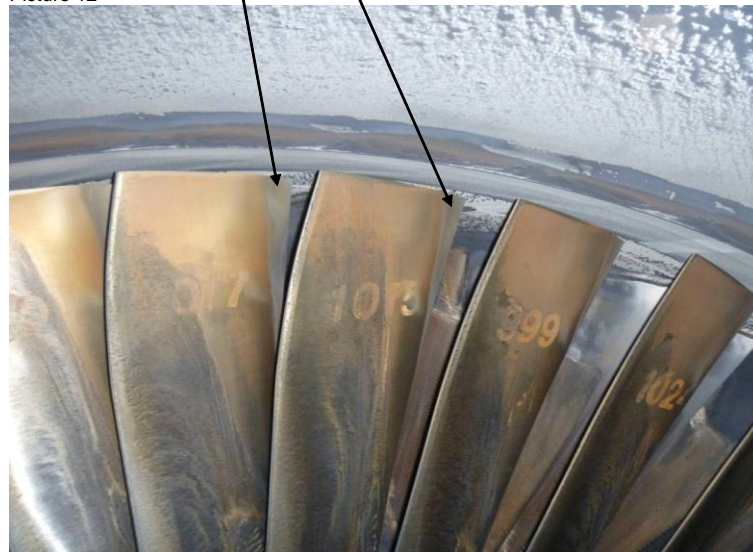
LP Turbine Exhaust Region – 2011 inspection

There is evidence of active wet steam erosion, the light grey colour on the blade leading edge continuing along the suction side of the blade. This area is relatively rough compared to the nominal blade surface.

This is erosion area has increased from the August 2009 inspection

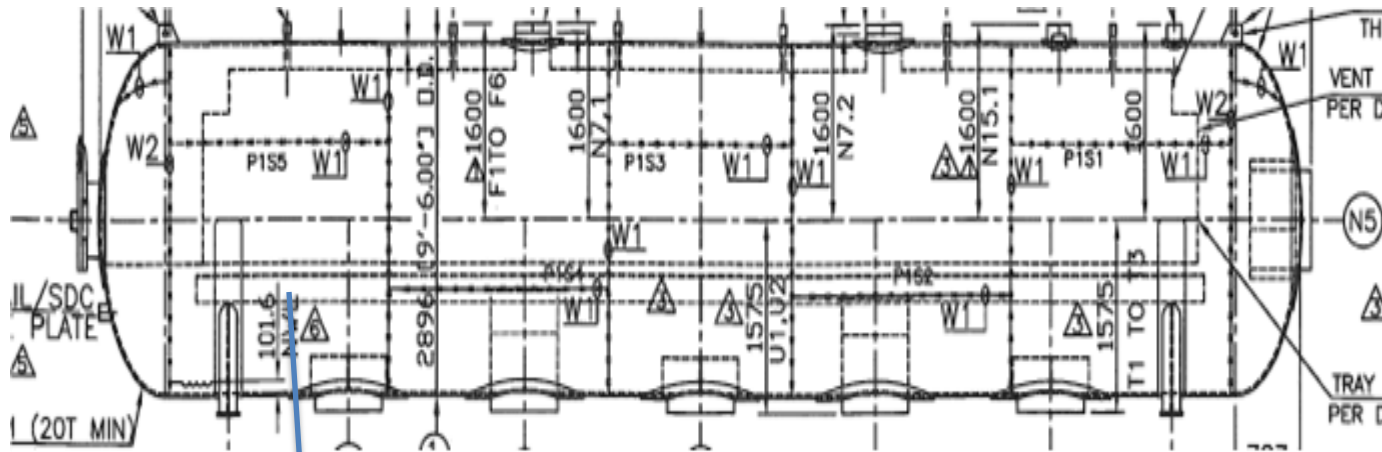
Kogan Deaerator Deposit

Deposit location

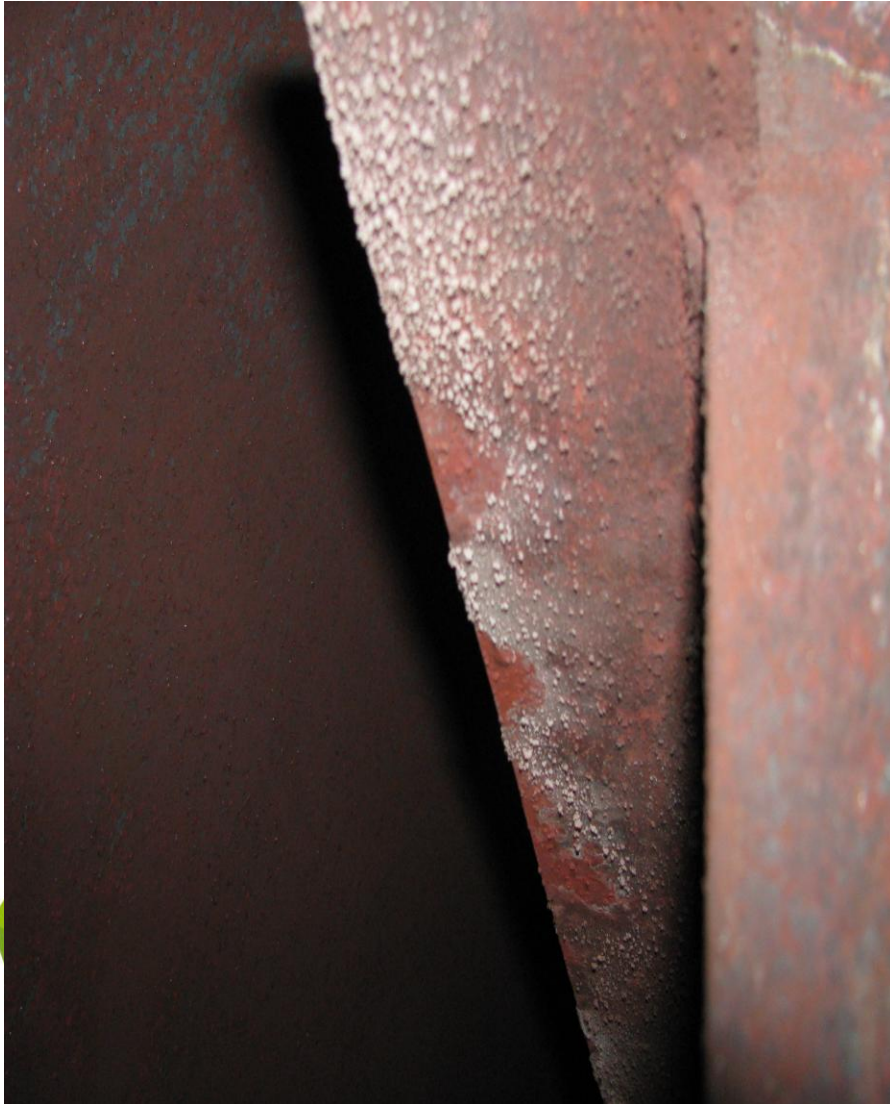
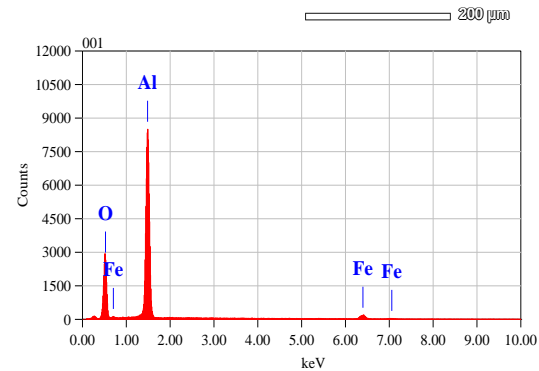
Kogan De-aerator Al Deposit

Element	(keV)	Mass%	Error%	Mol%	Compound	Mass%	Cation	K
O *		44.87						
Al K*	1.486	46.06	0.31	91.31	Al2O3	87.02	14.61	82.3426
Fe K*	6.398	9.08	1.60	8.69	Fe2O3	12.98	1.39	17.6574
Total		100.00		100.00		100.00	16.00
