# ACC Corrosion

## Chemistry Options To Address FAC (like) Corrosion

# Sister Units

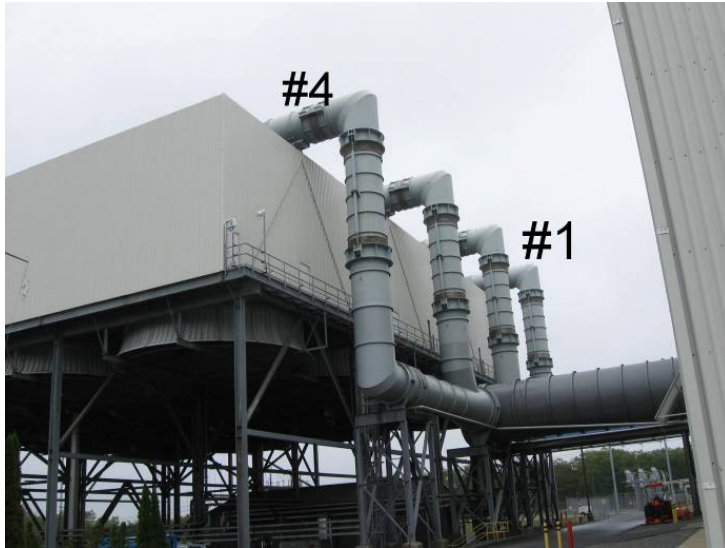
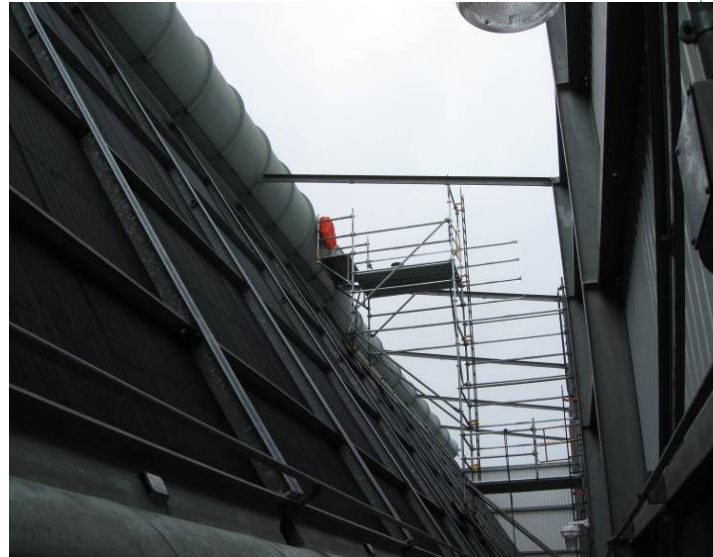
Due to the cost to erect scaffolding the ACC were not inspected. When inspected FAC like corrosion was noted in the upper ducts And transition ducting from the steam turbine.

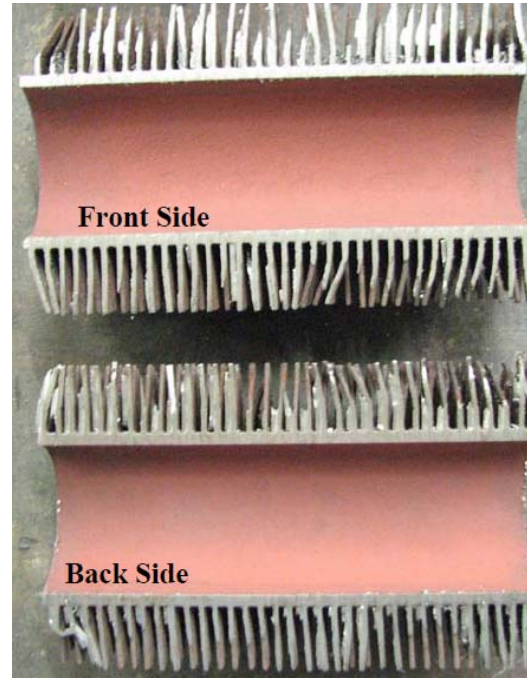
- ▶ Tube specimen removed from HP evaporator
- ▶ The tube hot side accumulated internal deposits was 9 mg/cm<sup>2</sup> (8.7 g/ft<sup>2</sup>).
- ▶ There was no evidence of under-deposit corrosion seen in any of the areas examined.
- ▶ Minor pitting with a maximum pit depth of 0.005" on the ID surface of the tube.

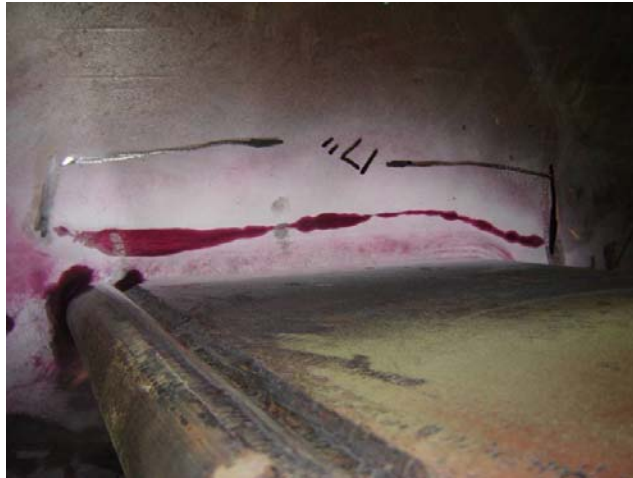
A through wall 17 inch crack was found below the bearing area at the exhaust of the LP steam turbine last stage into the steam turbine exhaust trunk to the ACC

This crack is through wall and should have been an issue with air in-leakage and high condensate pump discharge dissolved oxygen hence the recommendation of proper cycle chemistry monitoring instruments.

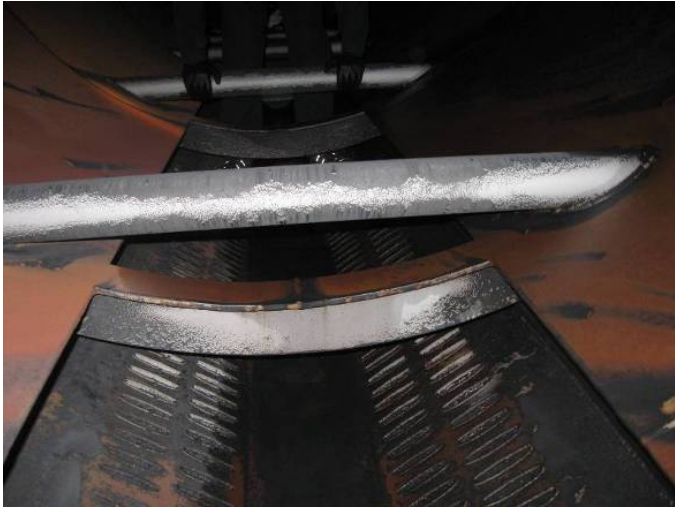
As found 2011 inspection

Turbine exhaust duct where the ACC transition  
branches into two ducts to 1-2 & 3-4

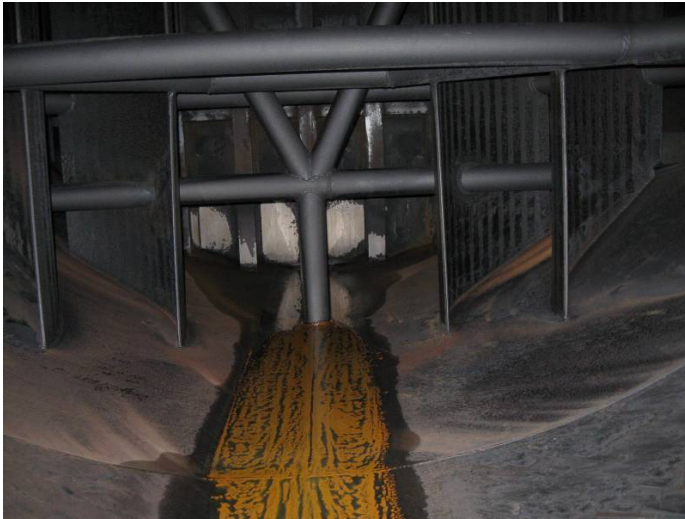
As found 2011 inspection

Turbine exhaust duct, steam turbine condensate duct drain down going towards the ACC duct transition branches

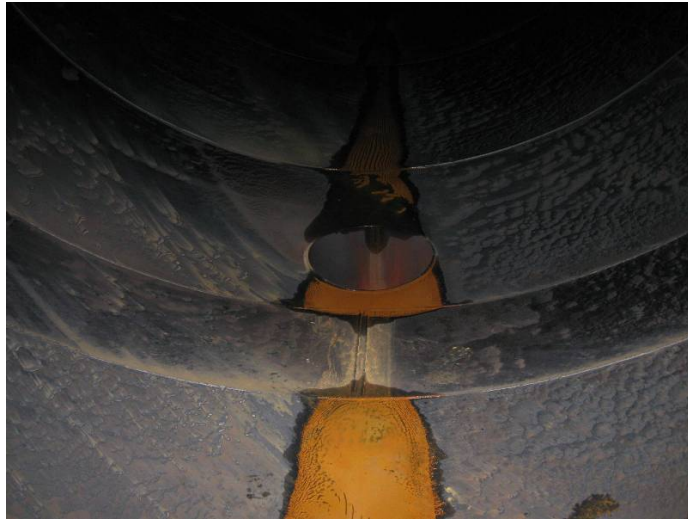
As found 2011 inspection

Inlet vanes into the #1 upper duct with previous areas with FAC that has been passivated

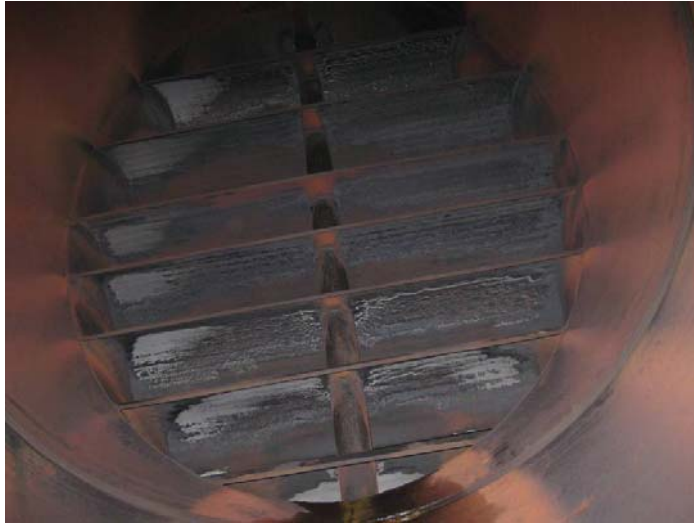
As found 2011 inspection

## Isolation valve to ACC duct #4 just below the entry into duct #3

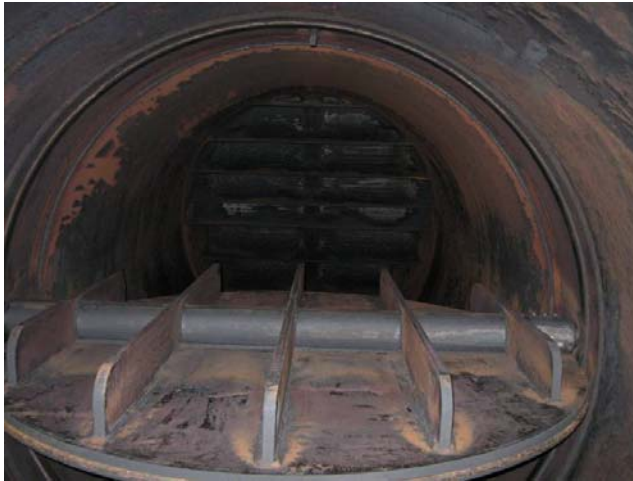
As found 2011 inspection

The #1 duct inspection showing water beading from the Anodamine treatment and passivation of tube inlet and lower duct metal surface

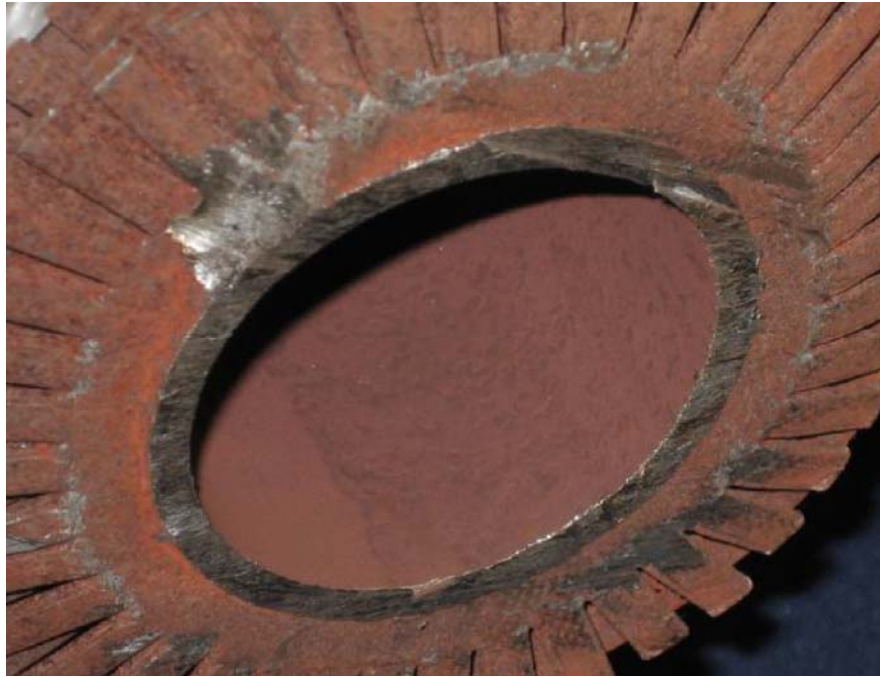
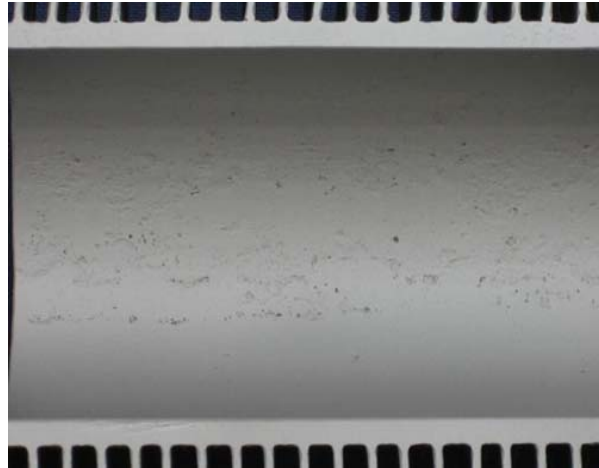
Tube after bead blast cleaning

- ▶ Tube specimen removed from HP evaporator
- ▶ The tube hot side accumulated internal deposits was 8.9 g/ft<sup>2</sup> cold side 8.5 g/ft<sup>2</sup>
- ▶ Areas with pitting were passivated.
- ▶ Minor pitting with a maximum pit depth of 0.005" on the ID surface of the tube.

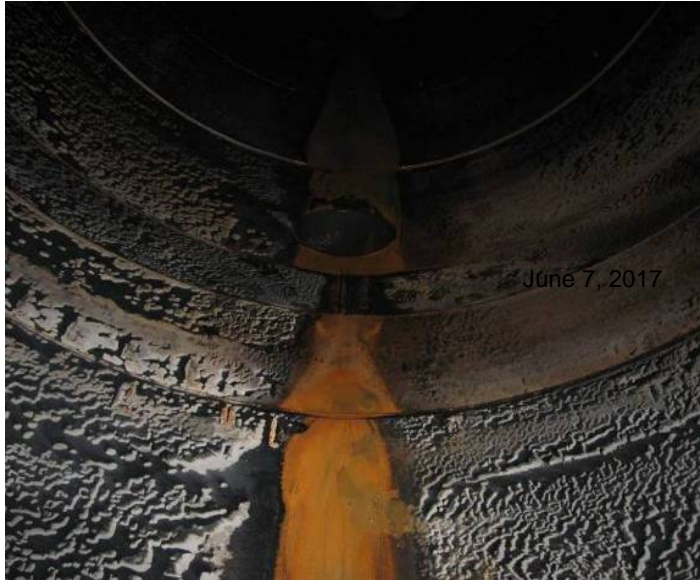
As found 2011 inspection

Turbine exhaust duct, steam turbine condensate duct drain  
down going towards the ACC duct transition branches

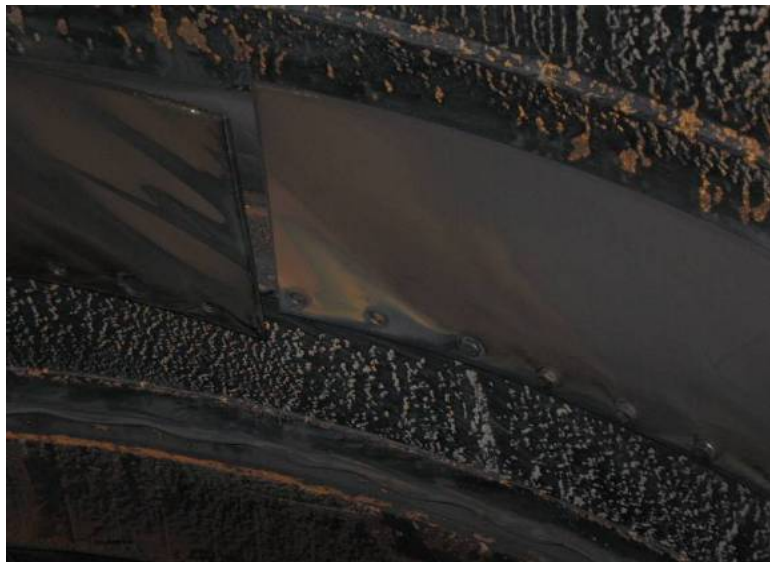
As found 2011 inspection

# Steam turbine expansion joint protective shroud
