ACC Steamside Finned Tube Corrosion Downstream of Tube Entries

2023 Air-Cooled Condenser Users Group Meeting
Richmond, Virginia

Andrew Howell
Electric Power Research Institute

June 20, 2023

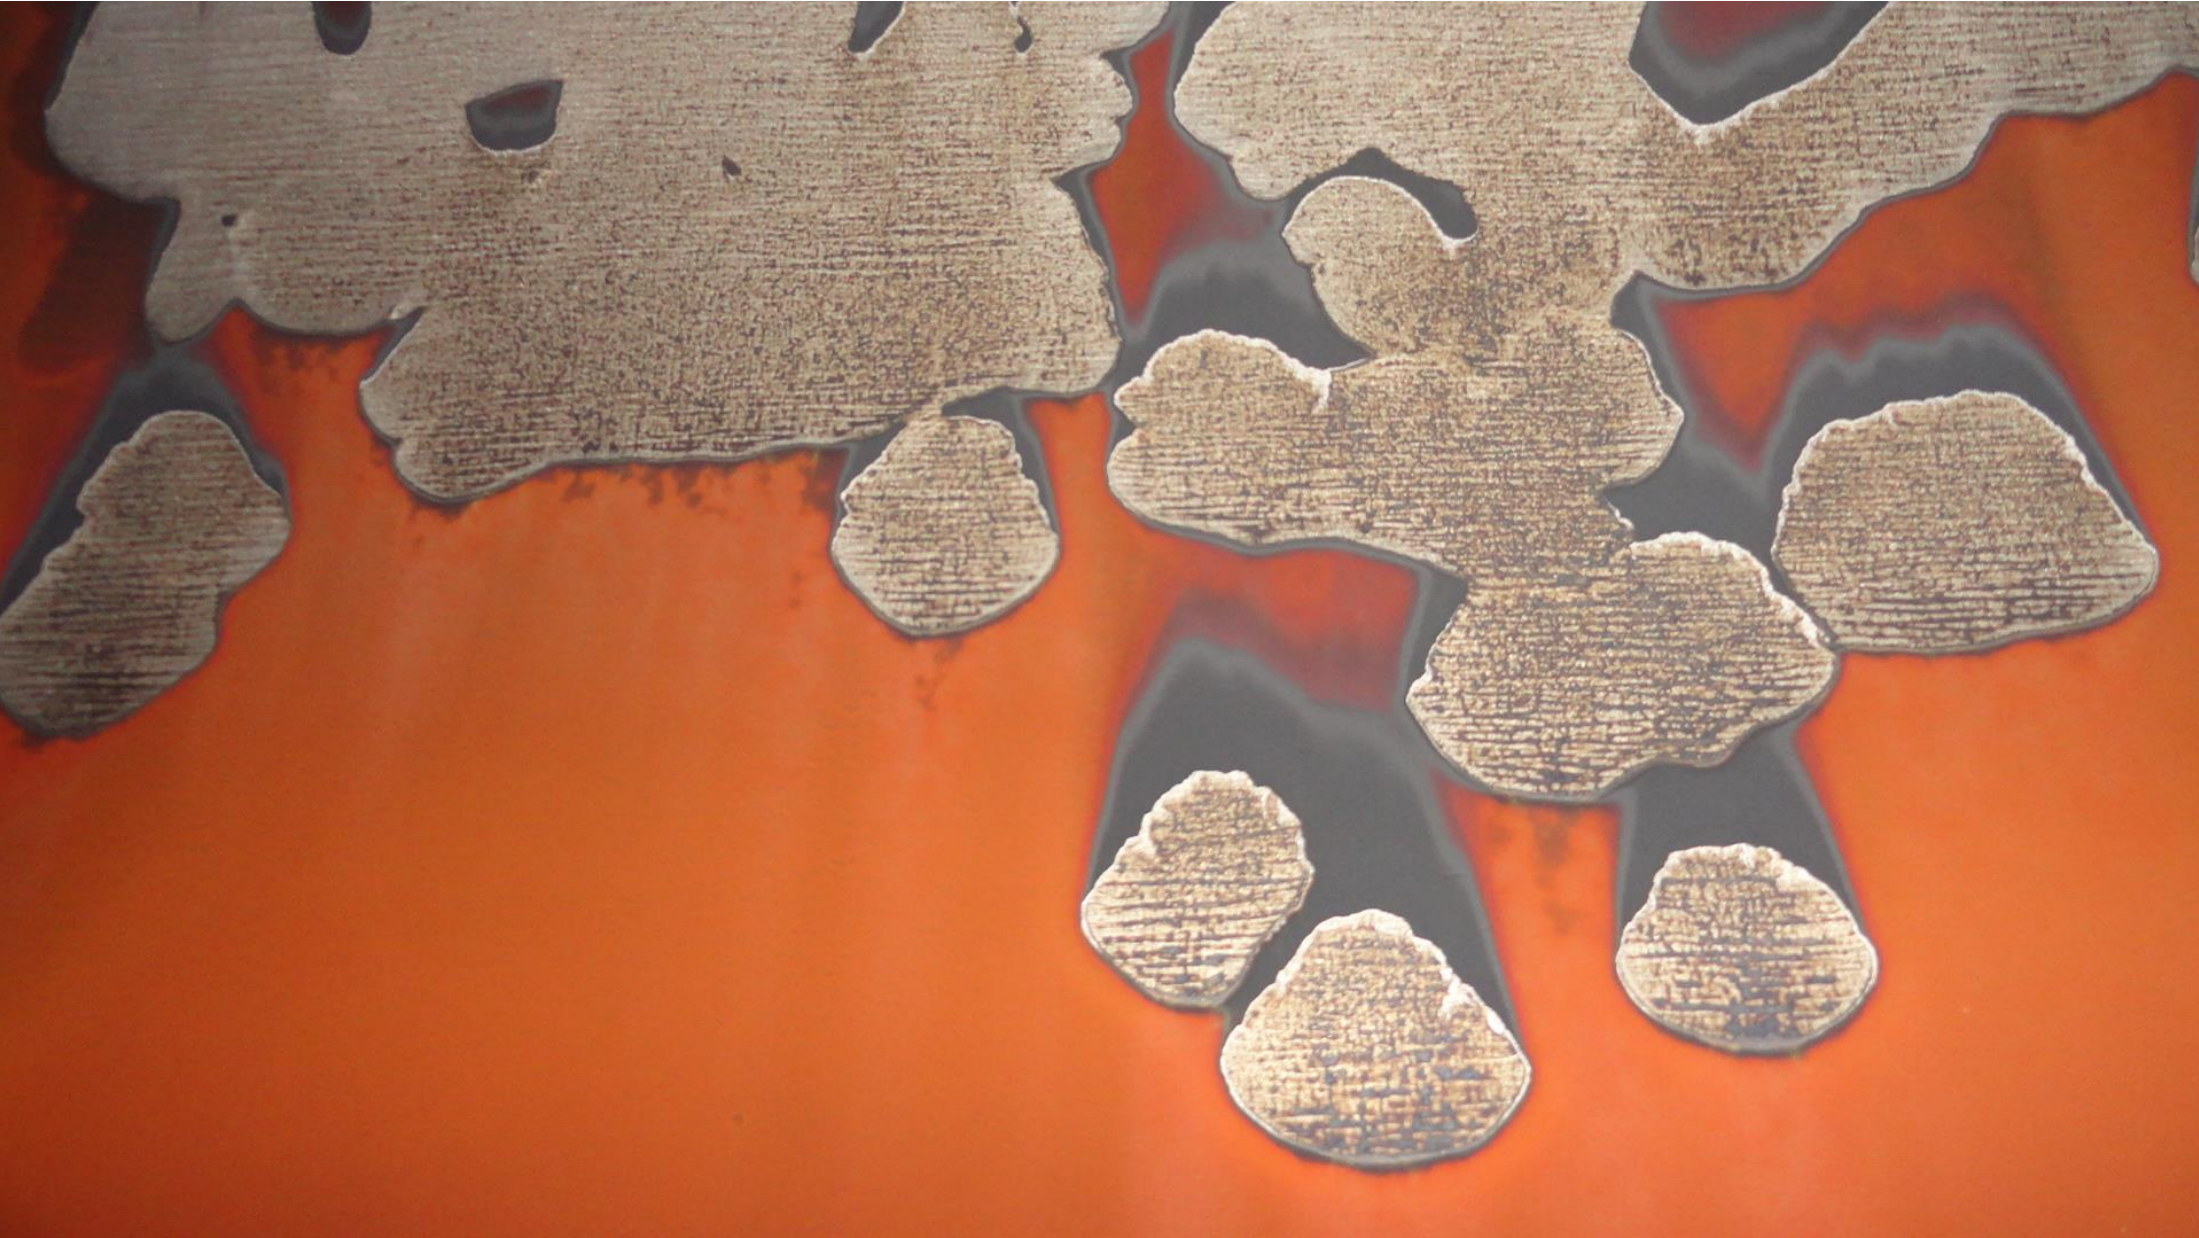
Metal loss on duct walls from LP turbine steam exhaust

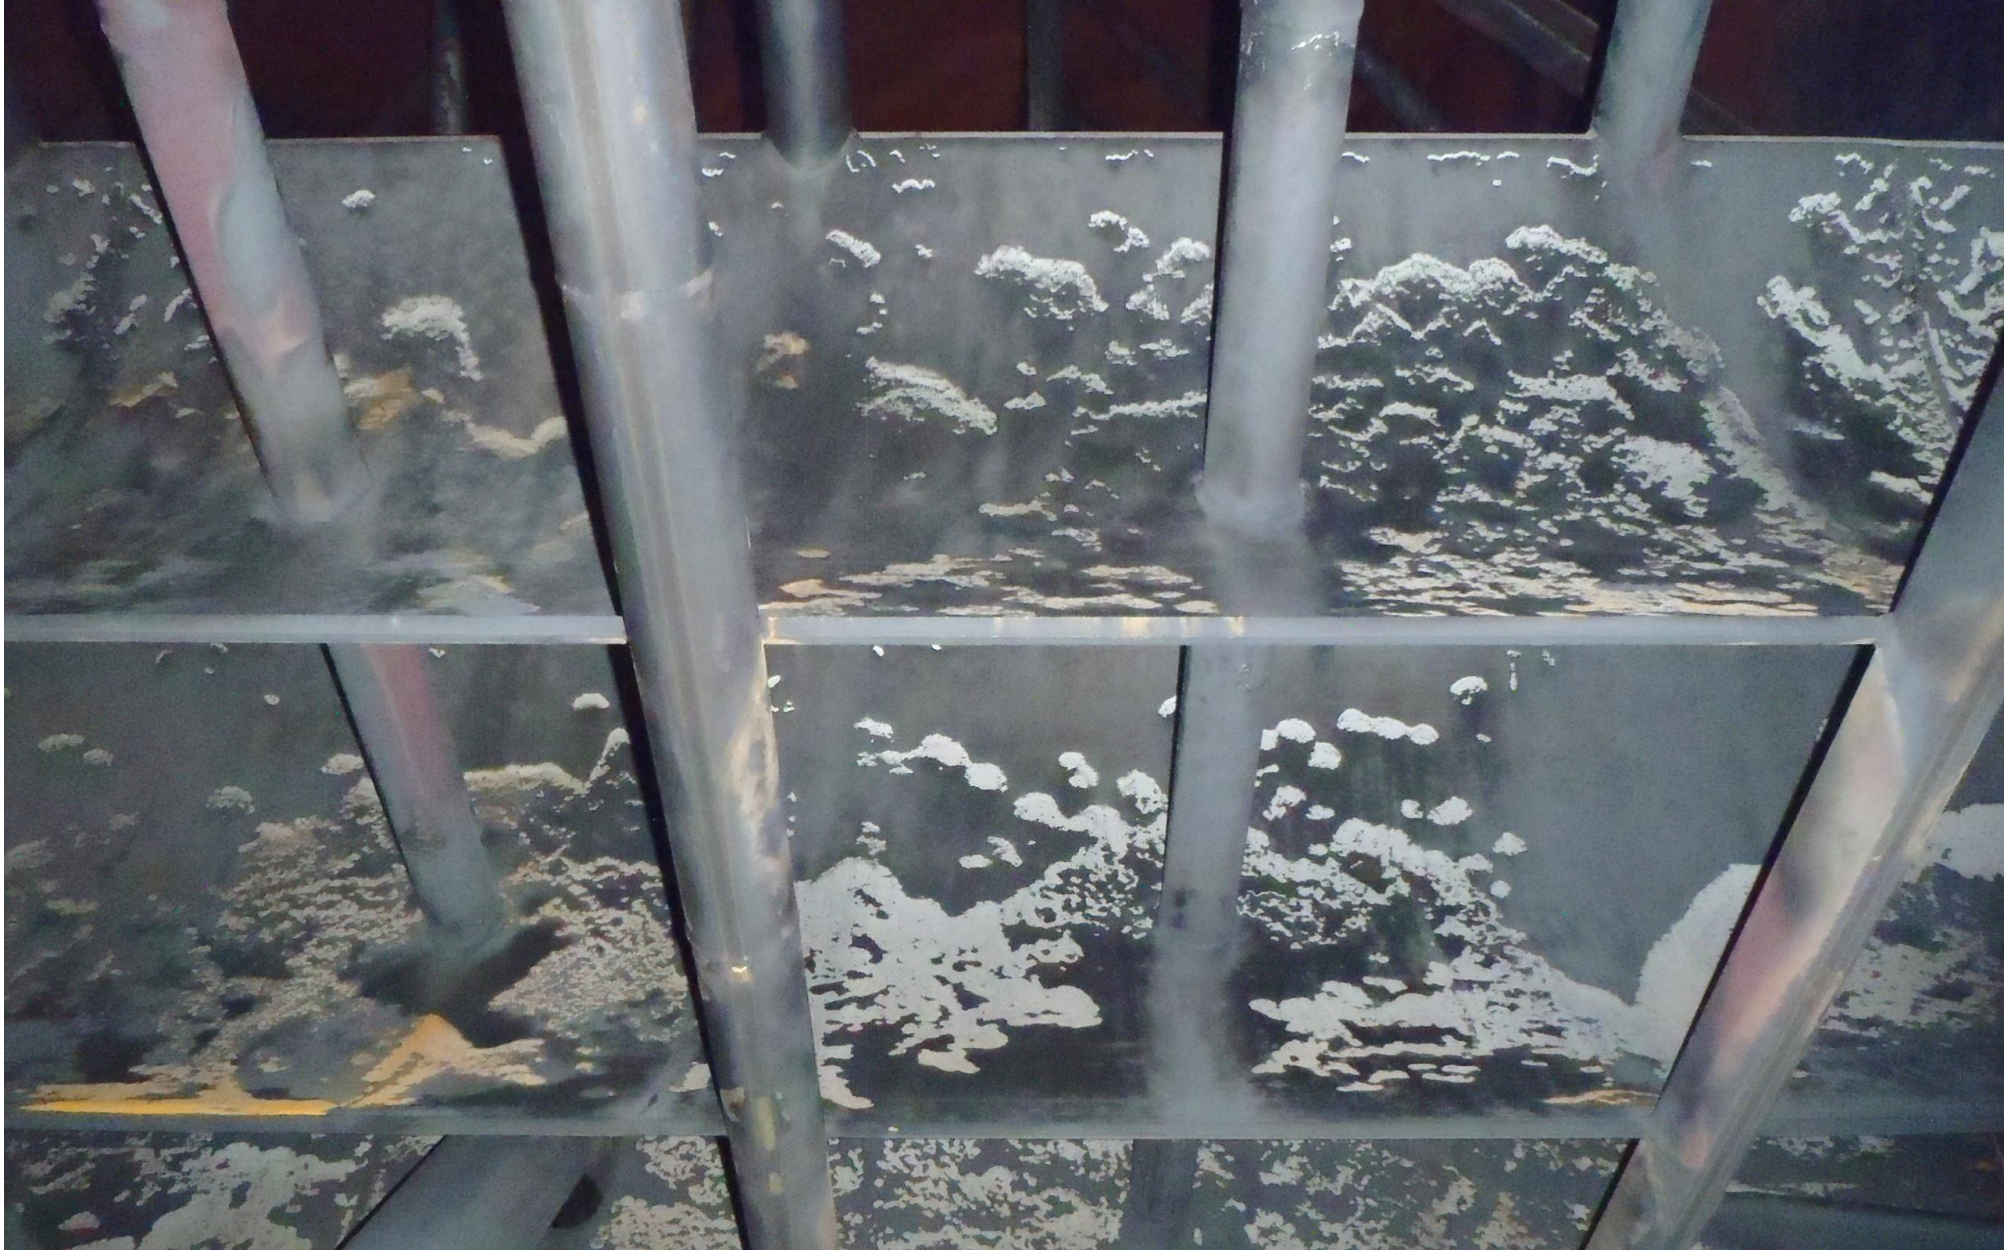
Metal loss in the LP turbine exhaust steam turning vanes

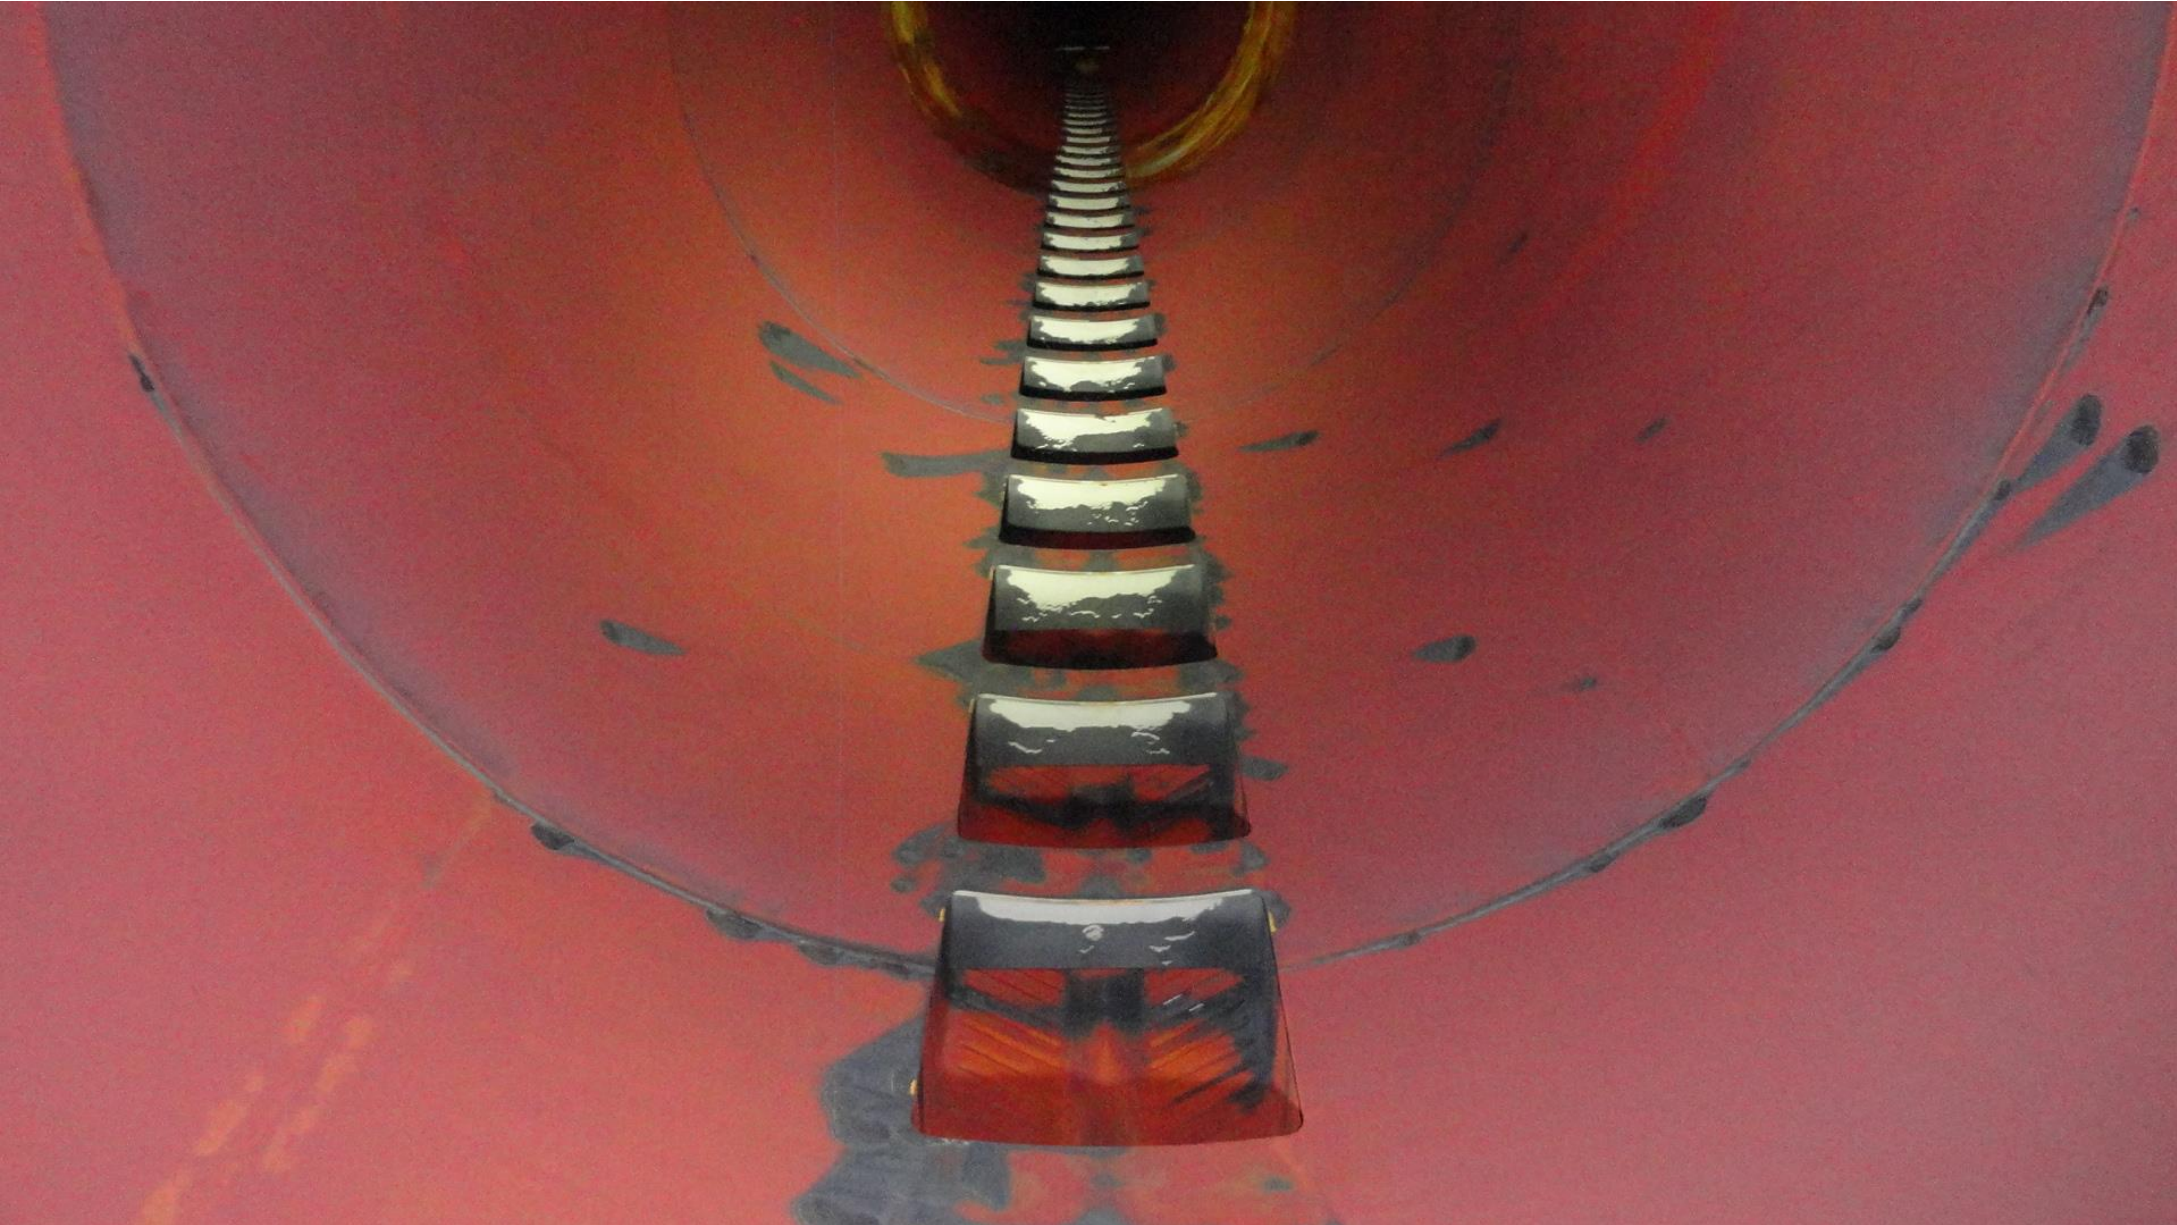
Metal loss in the ACC Steam Distribution Upper Duct

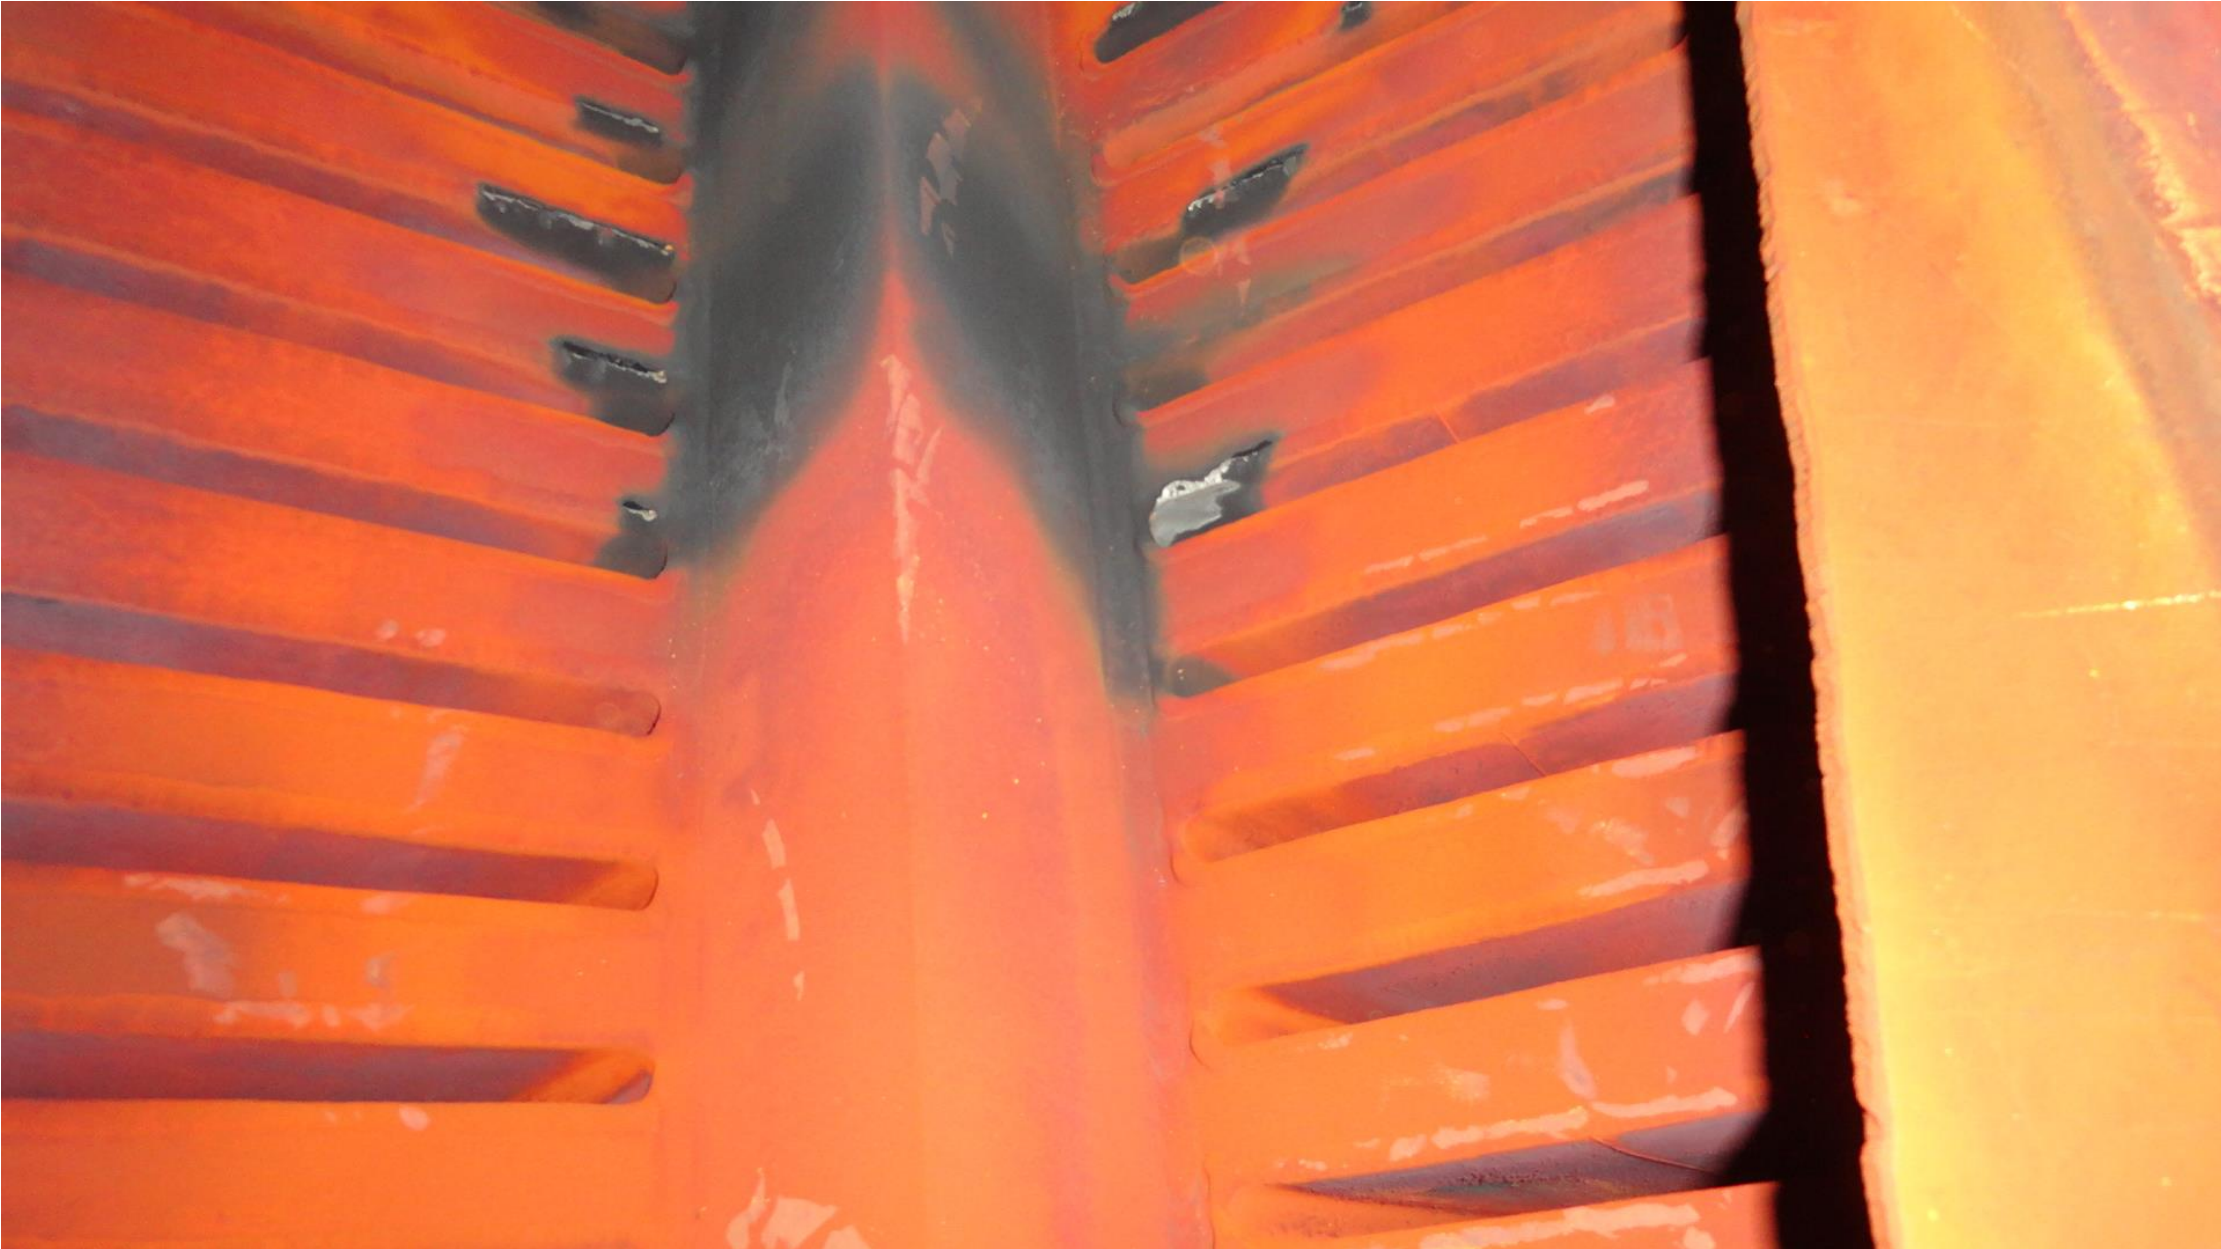
Metal loss at HX tube entries in the steam distribution upper duct

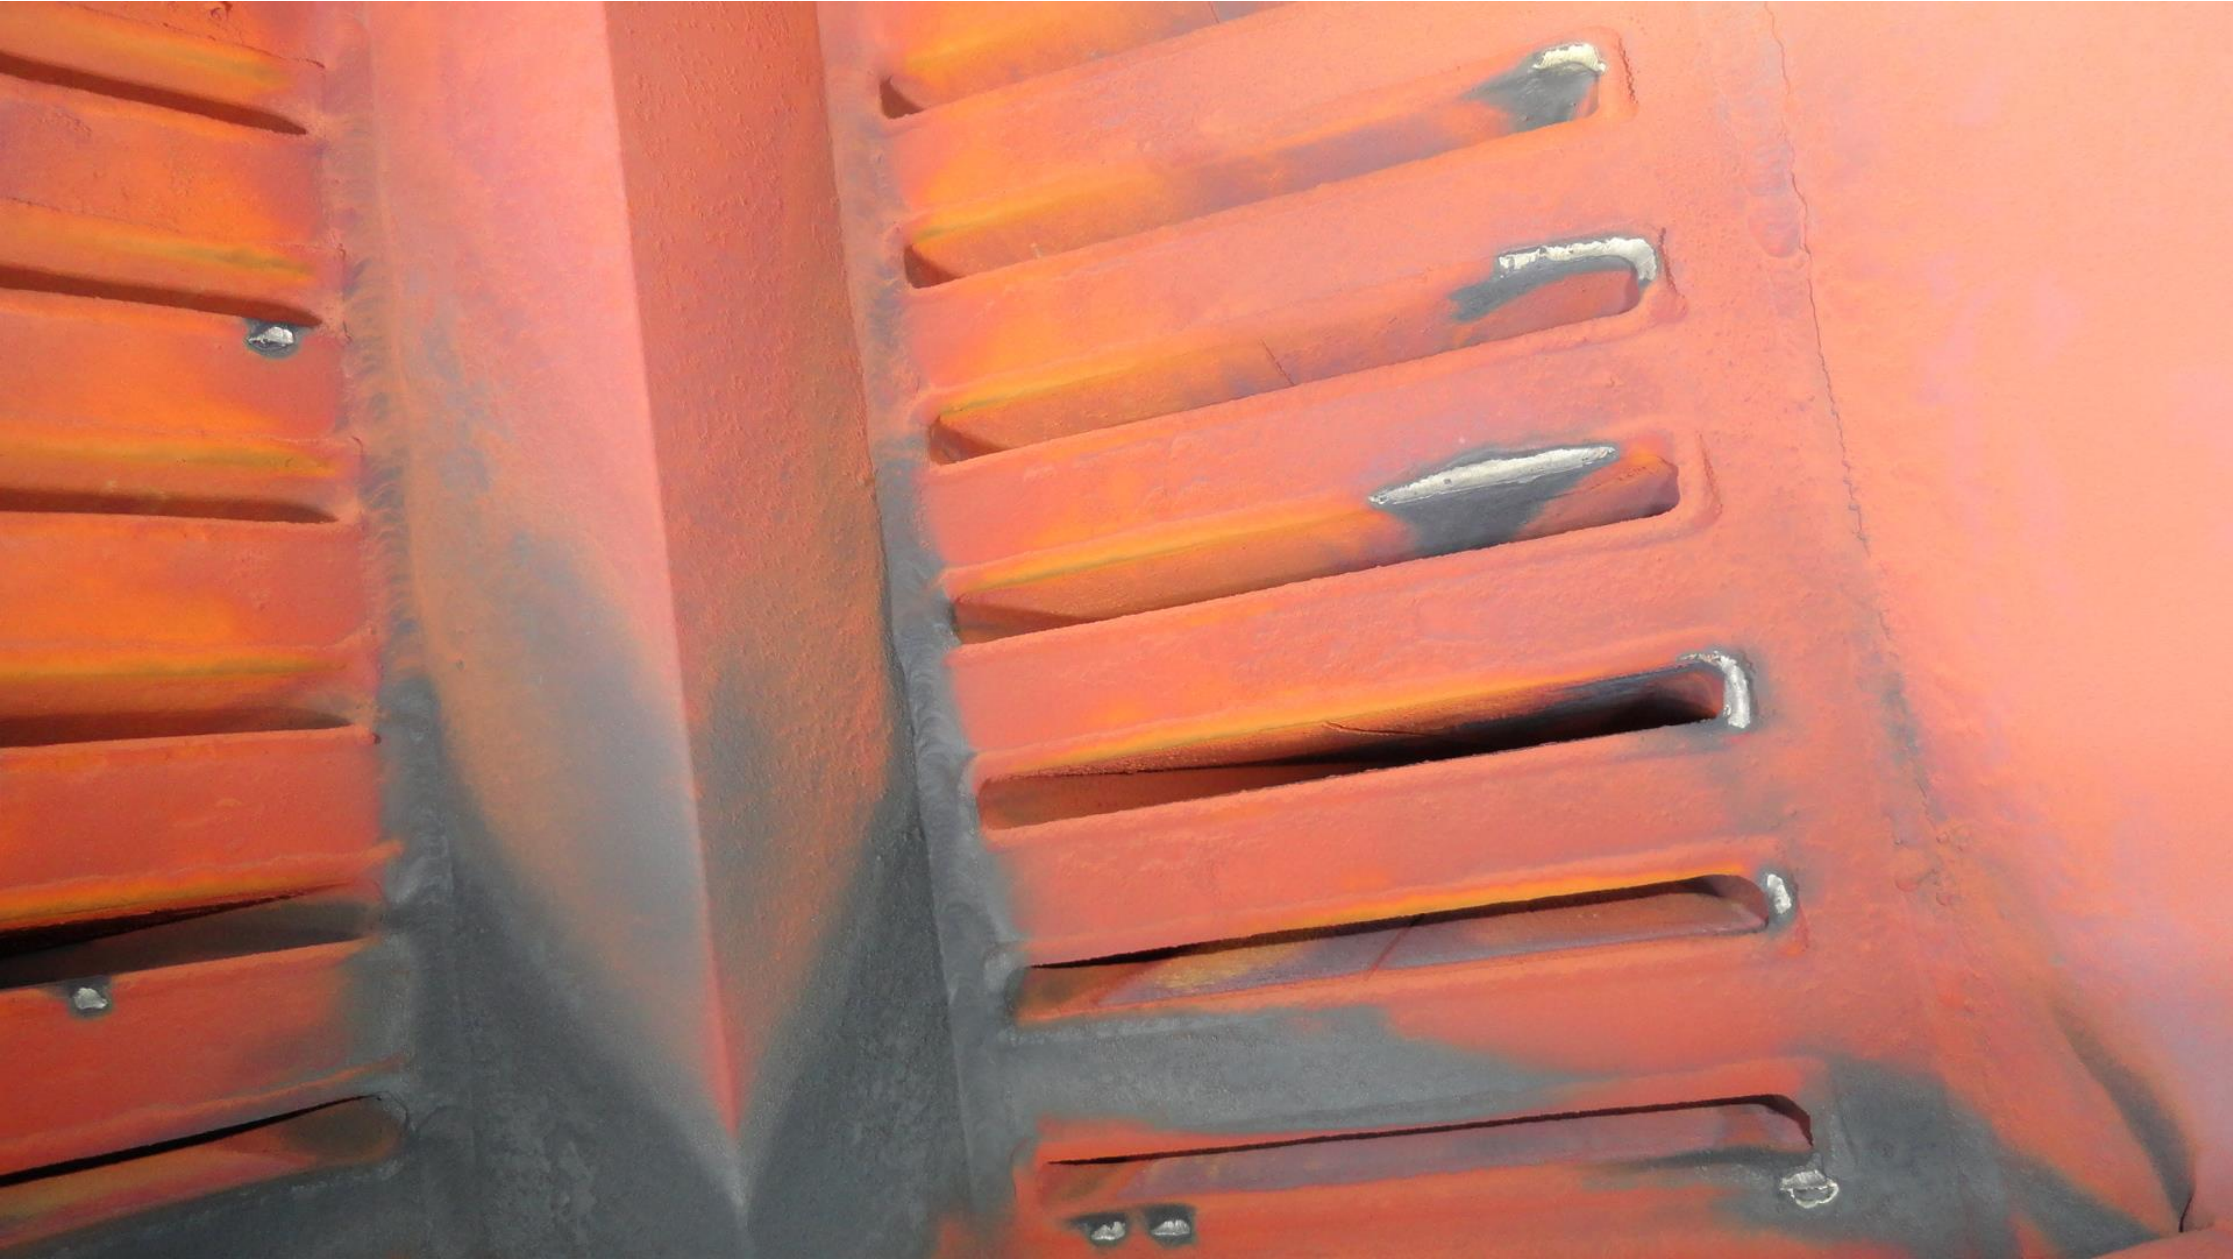
Metal loss at HX tube inlet

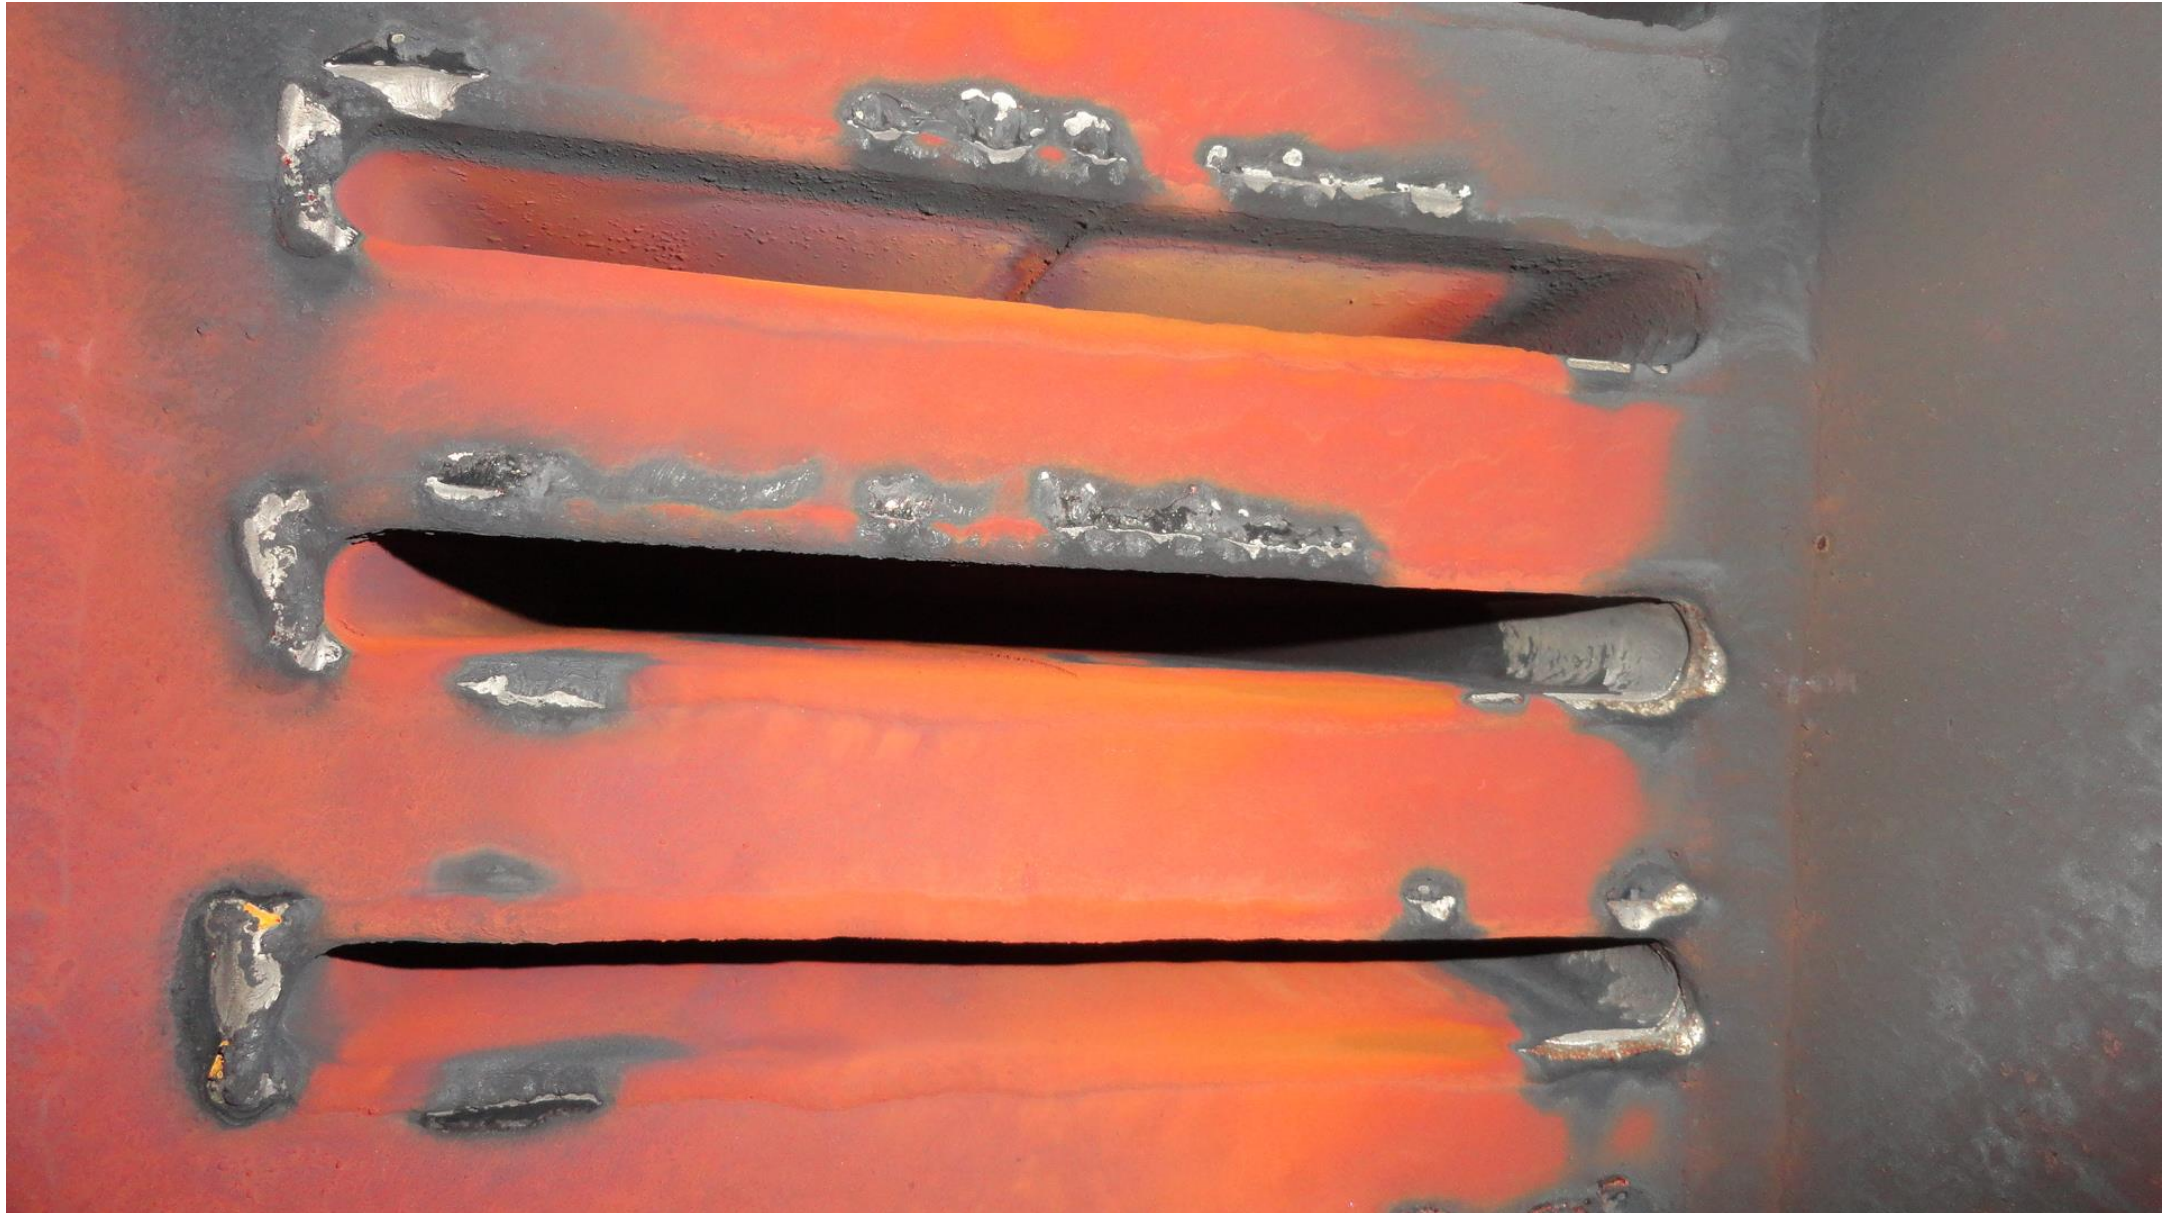
Metal loss at HX tube inlet

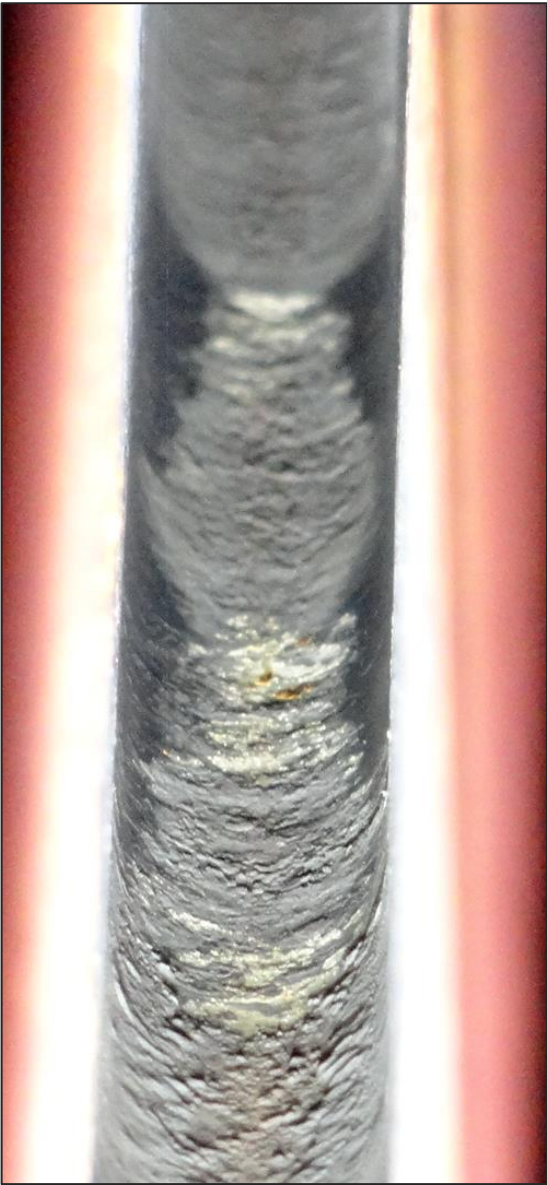
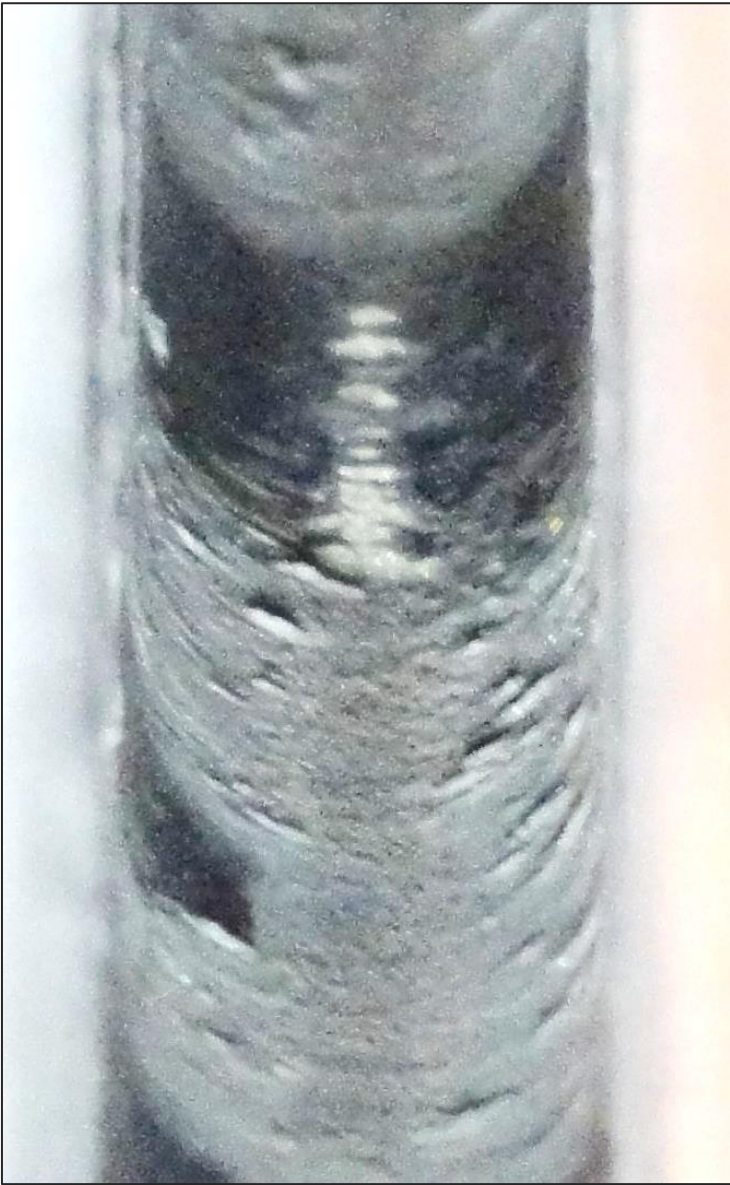
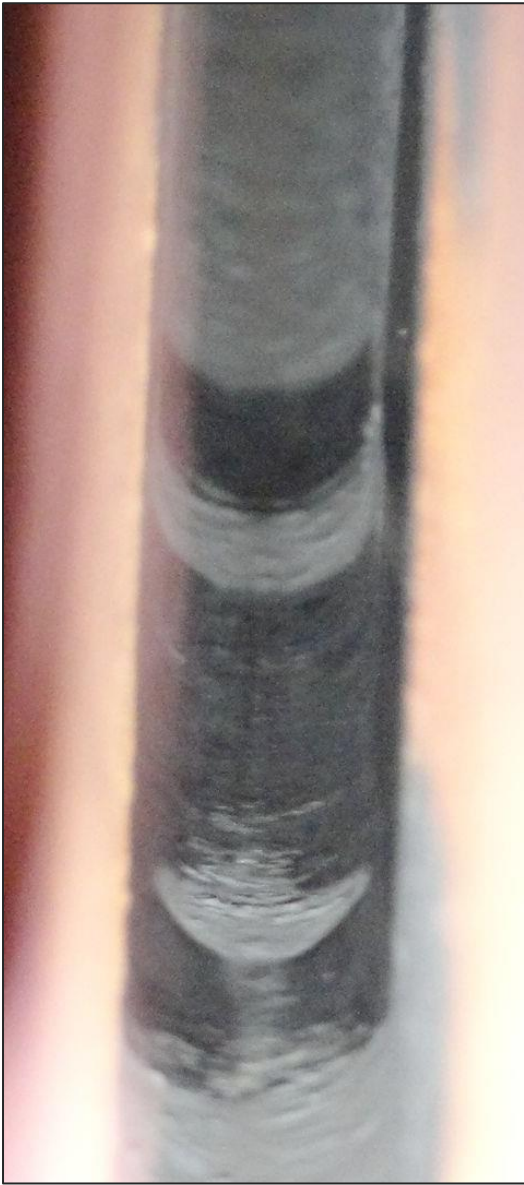
Metal loss downstream of HX tube inlet (about 3-6 ft, 1-2 m)

Current need – to determine the extent of this issue by making downtube observations during upper duct steamside inspections (consider borescoping)

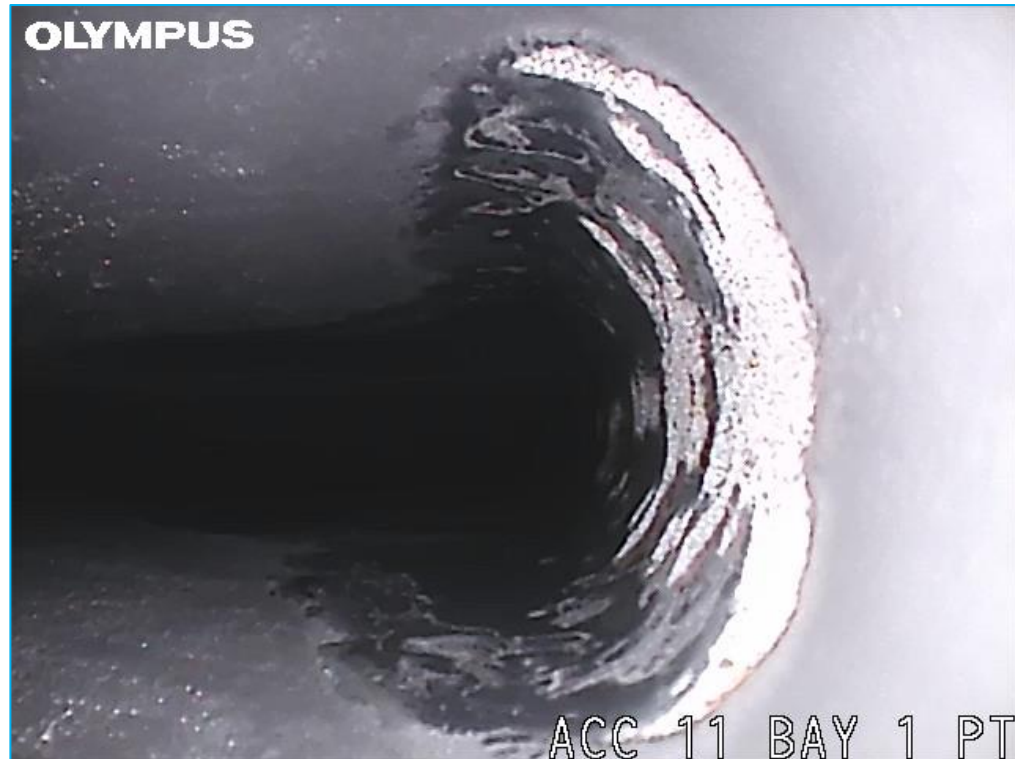
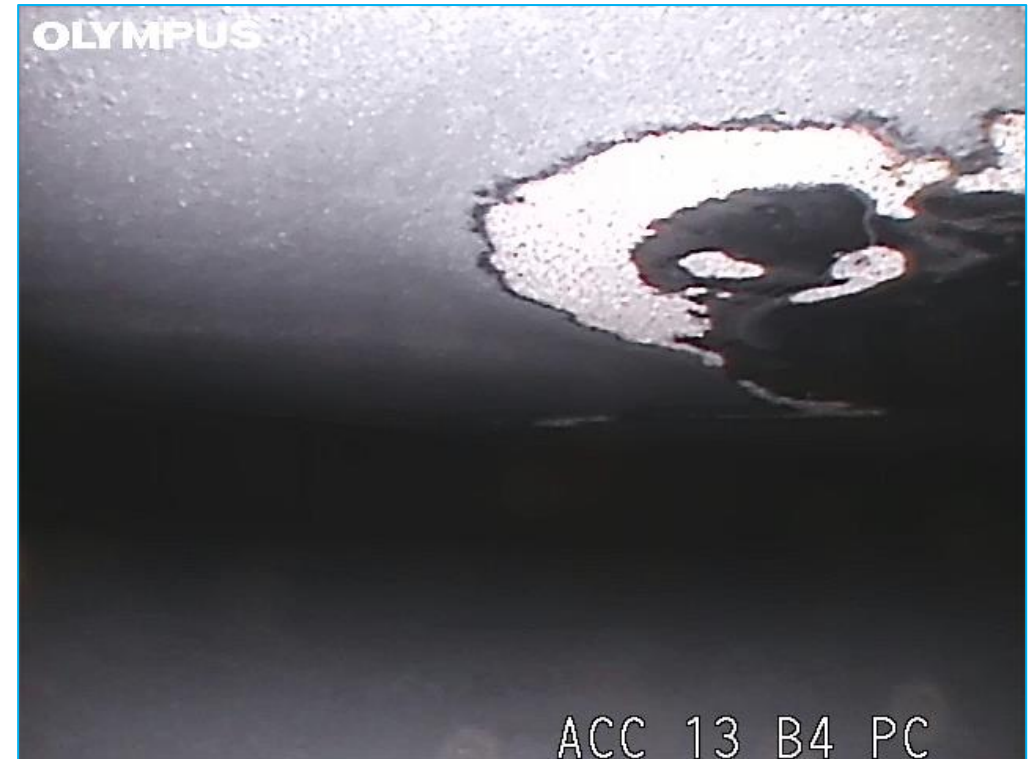
The plant started up in 2007 and had reported routinely observing this feature in ACC inspections beginning in 2010.

Confirmed by borescopic record in 8 different upper ducts during the same outage:

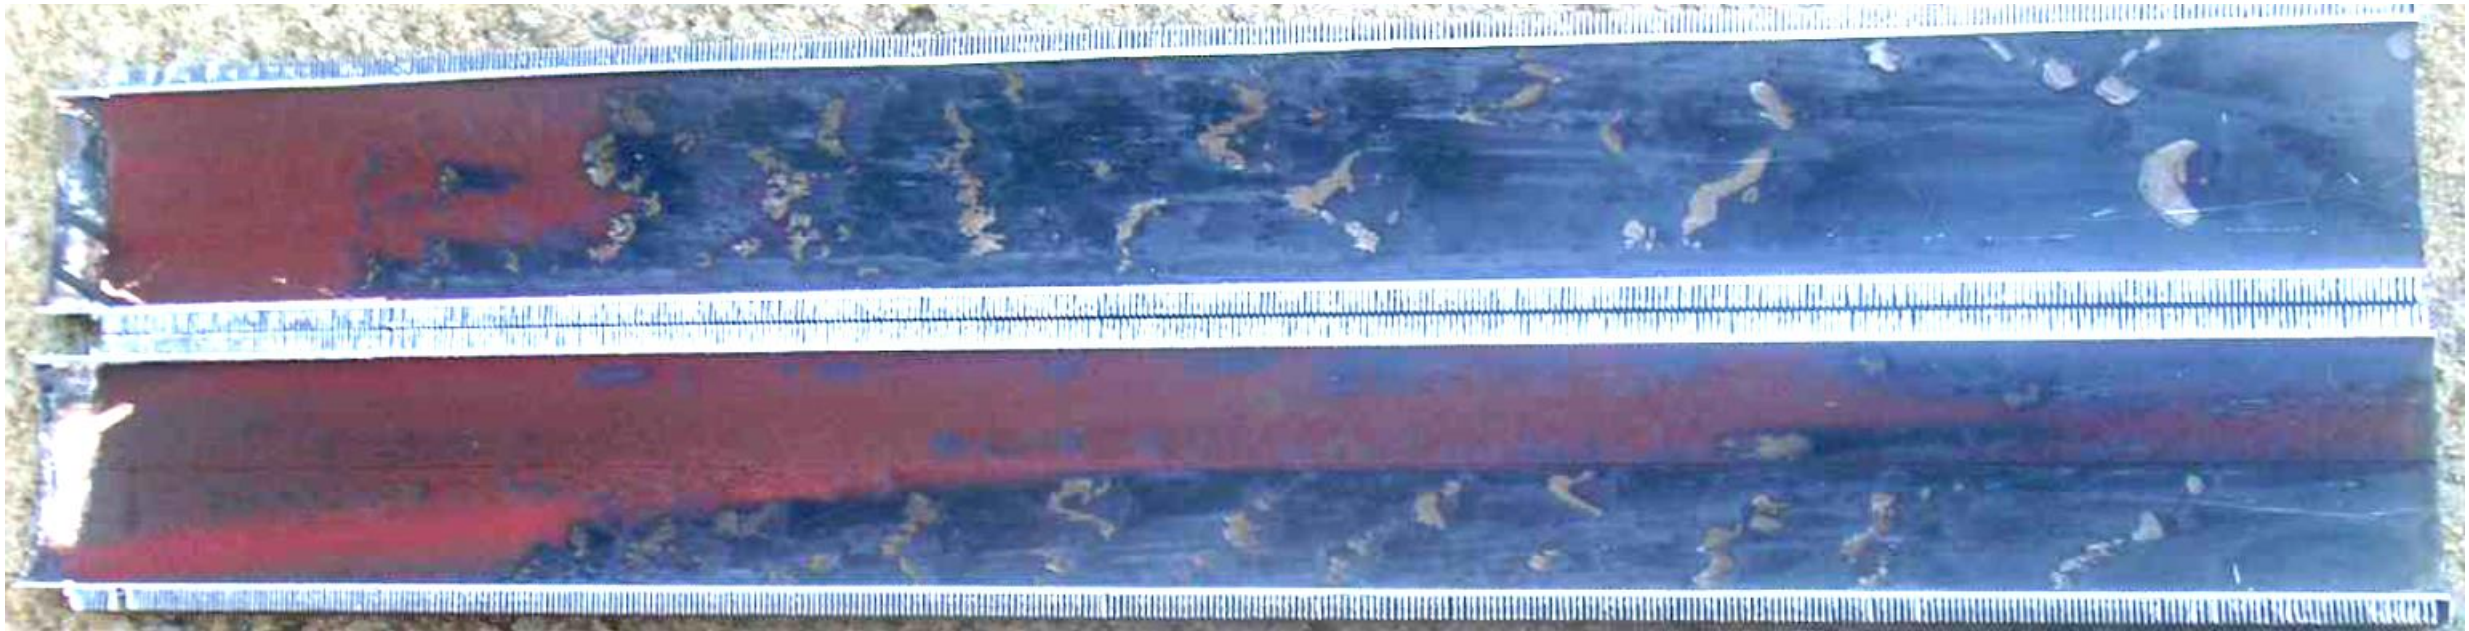
A similar situation was subsequently identified at a different ACC plant, although details were limited (distance down the tube, frequency of occurrence etc.).
