ACC fan dynamics

Jacques Muiyser

Development Engineer Howden Netherlands

Power Generation Engineering - Dominion Energy

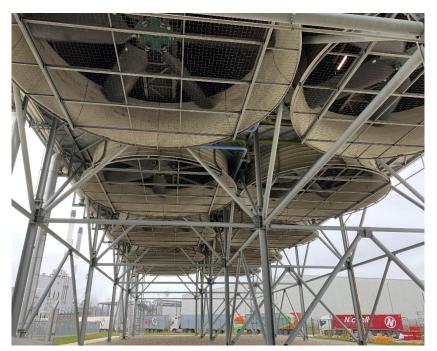
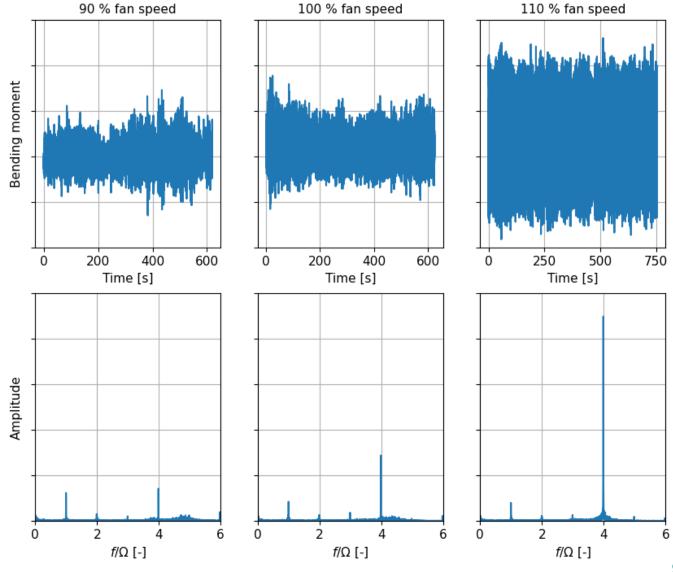
Case 1

Isolated U-bolt failures on site.

Strain gauge measurements showed resonance at 4x fan speed.

Performance measurement showed the blade angle could be increased while reducing the fan speed to avoid the issue while maintaining performance.

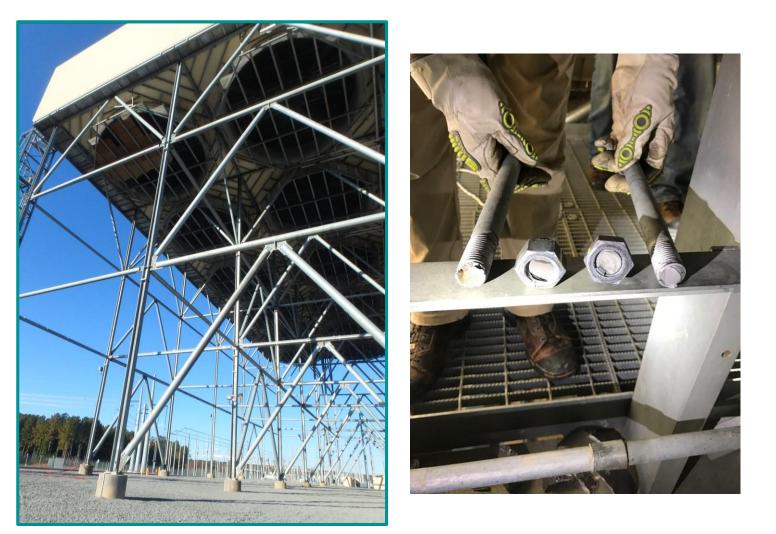
Dominion Energy, Brunswick County VA

Two recurring issues on site at Dominion Energy, Brunswick County:

- Blade separation at leading edge
- Blade clamping bolt failures
 (straight bolts)

Strain gauge measurements were performed on the fan blades to determine the loads during operation.

The measurements showed an amplification of dynamic loads with higher fan speeds while still remaining within the design limits.

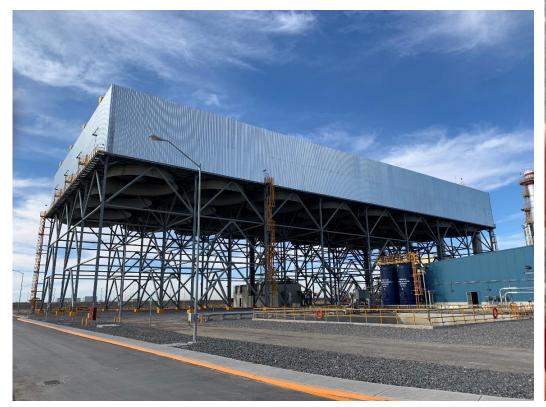
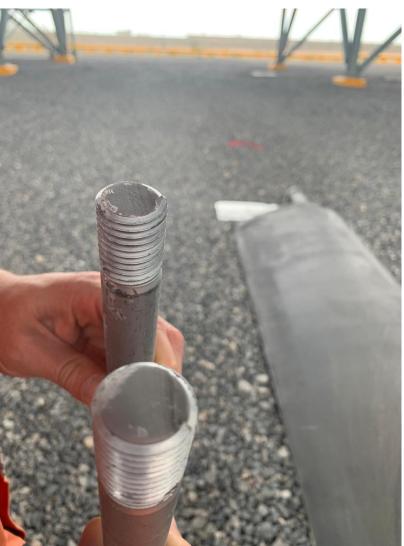
Straight bolt failures shortly after installation, showing signs of fatigue failure at edge fans primarily.

Howden Netherlands performed on-site measurements to determine root cause of the failures.

Measurements showed high dynamic loads due to winds and resonance at 3x fan speed.

Hub-ring solution introduced to change blade natural frequency due to the increased stiffness of the blade fixation.

Also had the effect of reducing equivalent dynamic bolt loads.
