Baseline FAC Inspection Hunterstown Generating Station

2025 ACC Users Group

Hunterstown Generating Station

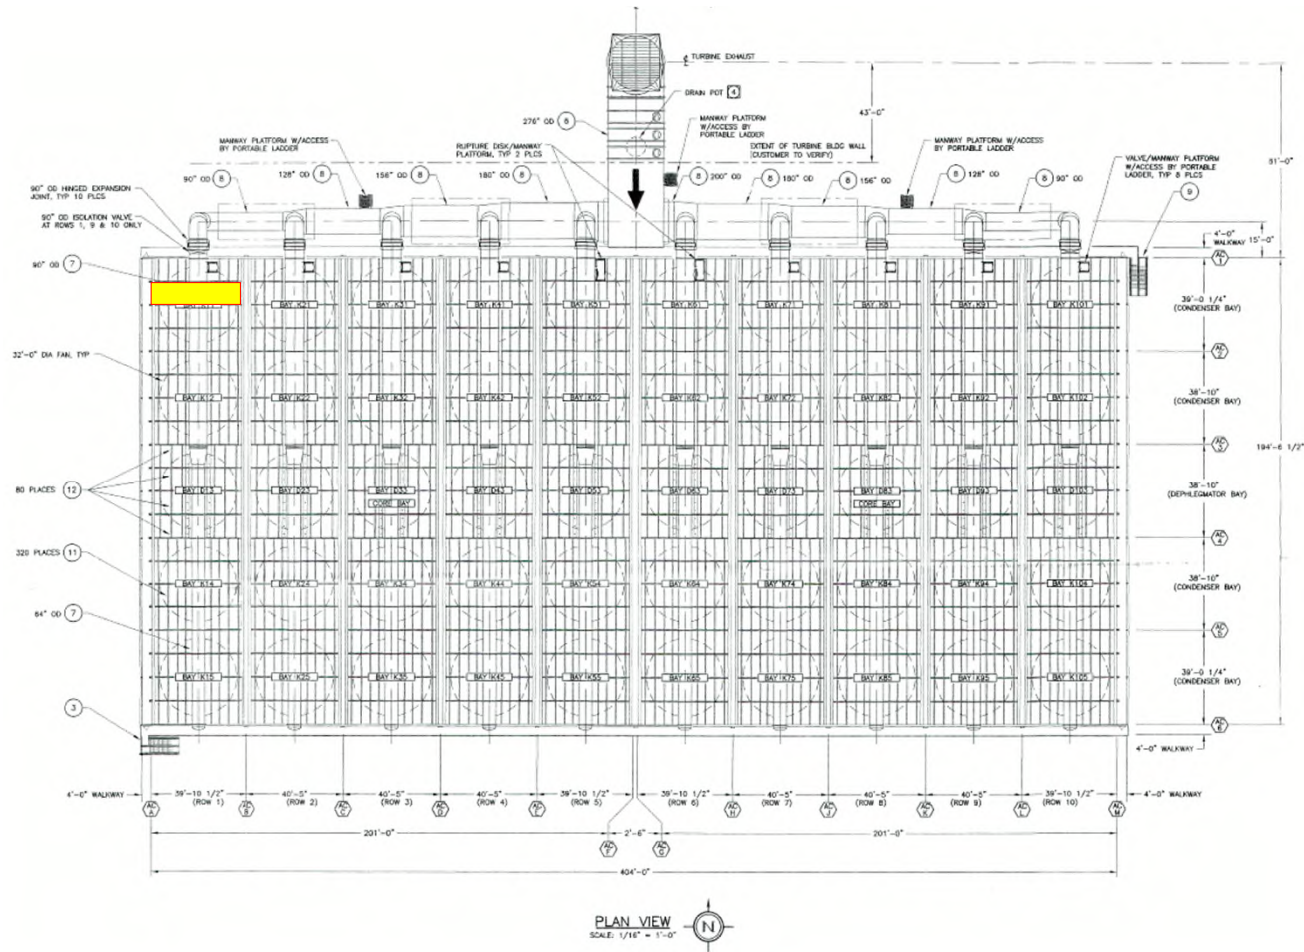
Street 1, Bay K11, Bundle 1

Tubes blanked
March 2018

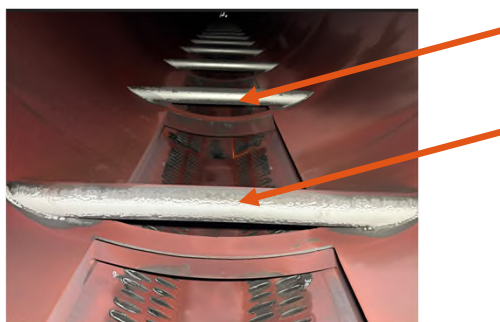
Street 9, Bay K91, Bundle 1
Looking South

Notes: Bare metal exposure consistent on all SDM round cross members. Very little iron oxide accumulation at the South end of the SDM (K95).

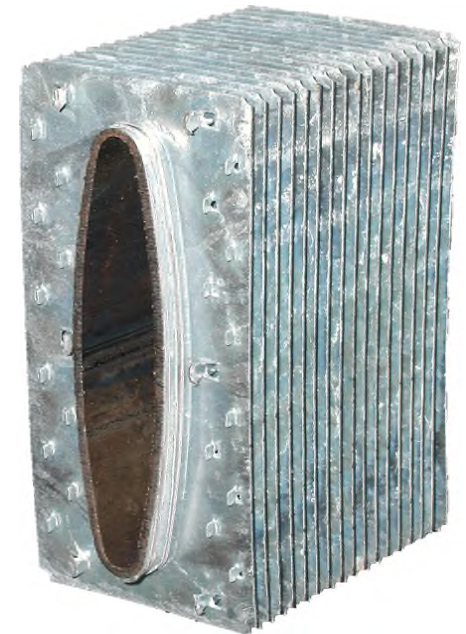
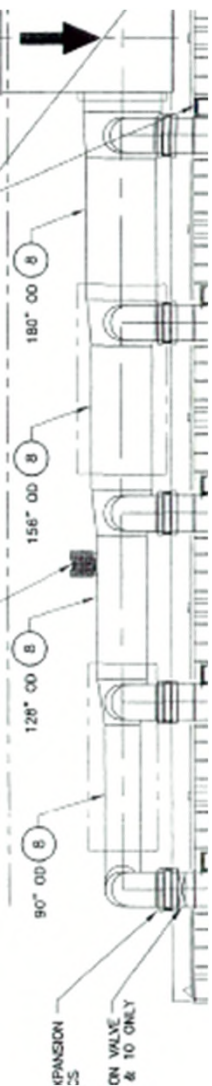
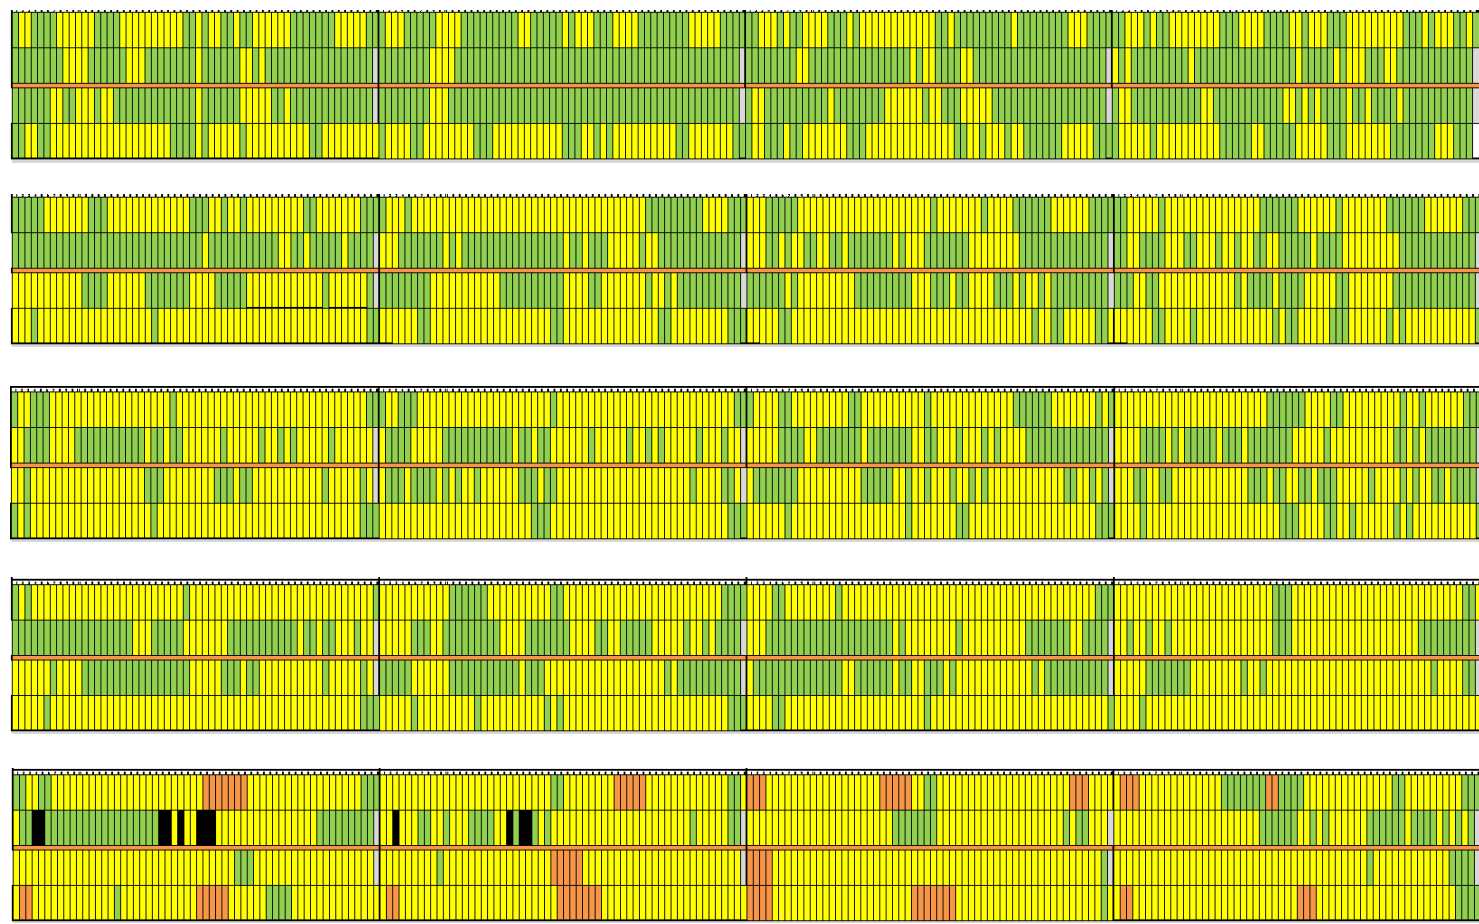
Ultrasonic Testing for Thickness Results

- UT measurements taken on targeted tubes with DHACI = 4
- No tubes found $<0.058''$ wall thickness (1.47 mm)
- UT values help correlate DHACI scale with true wall condition
- Some weld repairs performed following findings
- Root cause discussion: localized flow disturbance? Design edge?
