Corrosion in Air Cooled Condensers - Understanding and Mitigating the Mechanisms

Setsweke Phala, Denis Aspden, Dr Francois du Preez, Hein Goldschagg and Keith Northcott Eskom Johannesburg, South Africa

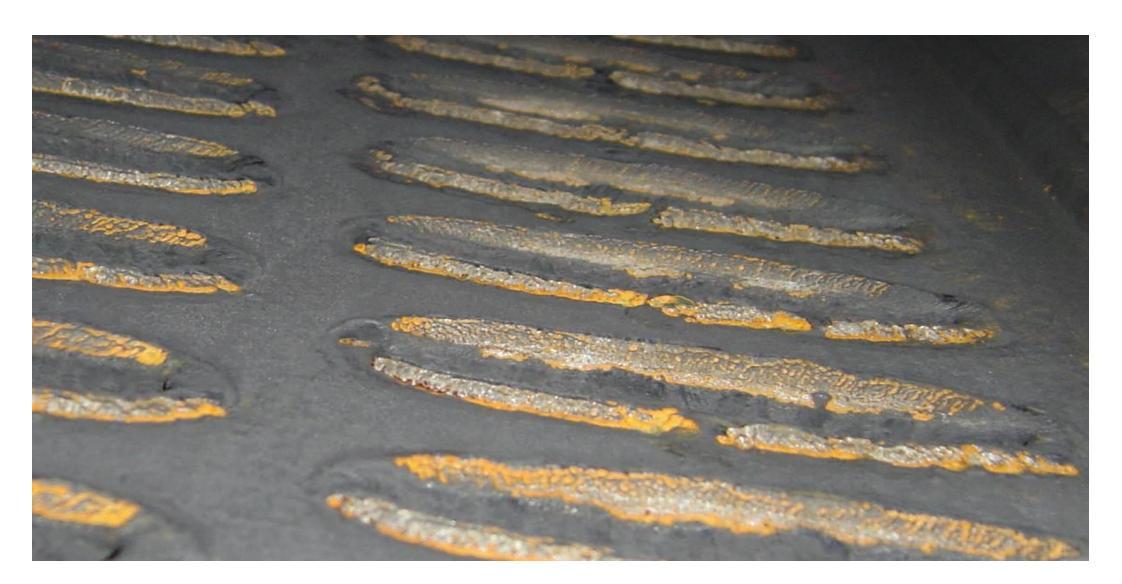
The first is a corrosion/erosion mechanism active on any surface exposed to the high velocity steam in the top distribution duct. Since the steam is wet (i.e. 5% moisture) the small water droplets entrained in the steam will erode/corrode the surface as shown in figure 4 below. The steam velocities in the Matimba ACC ducts vary between 35 m/s and 116 m/s at the minimum and maximum ambient design temperature and 80 m/s at the design point. This mechanism was found to be generic to Majuba ACC as well.

Figure 4. Unit 3 inlet seal weld erosion

Corrosion mechanisms 1 and 3 were corrected by application of epoxy wear coat paint on to the inlet seal welds and upper 100 mm of the fin tubes during outages. Painting of the weld seams started in 1995 and continued as per outage program for the six units. It was only done on the first 10 to 20 meters downstream of the dephlegmator and in the first 8 or ten tubes. Although the paint appeared to be effective in protecting the welds from erosion it is however very difficult to apply as it has a very high viscosity and dries quickly once mixed. We also could not do any surface preparation as the debris could not be recovered from the system except by cutting open the bottom headers. Nevertheless the paint seemed to adhere successfully at the surface even without surface preparation.

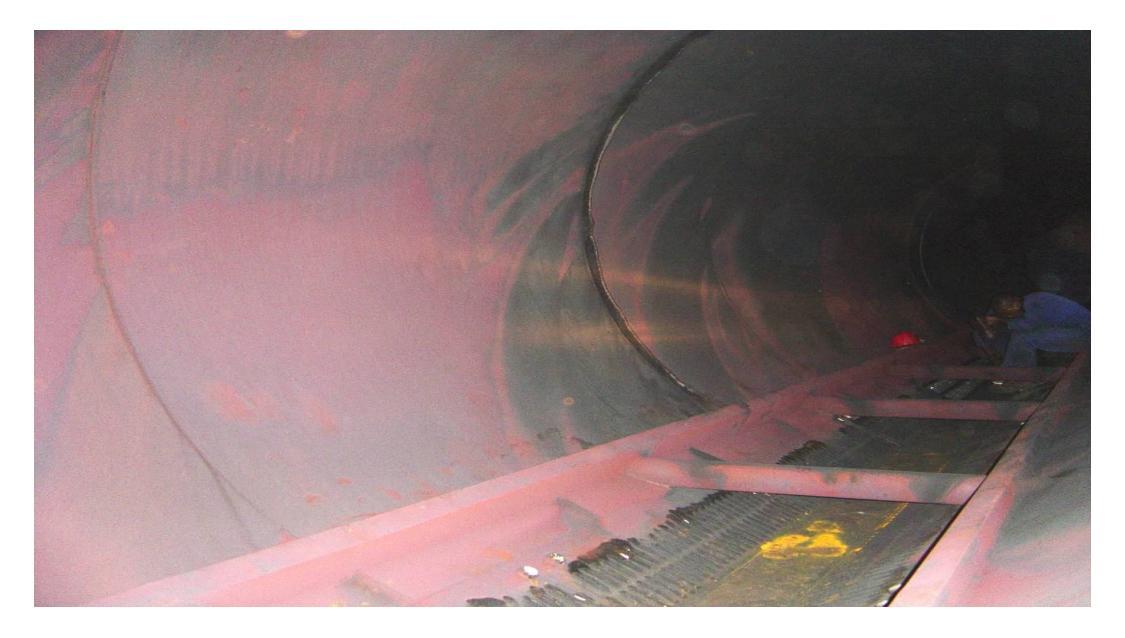
The second mechanism was found to be active in areas exposed to high volumes of the liquid phase of the exhaust steam. The LP turbine exhaust steam contains 5.4% liquid (moisture) which is separated from the steam by centrifugal forces in areas where the steam direction changes, e.g. around bends. One such a position is where the steam direction changes through 90 degrees at the point where it enters the horizontal distribution duct at the top of the fin tubes. The liquid is thrown against the top surface of the circular duct from where it gravitates along the duct wall towards the bottom of the duct in the direction of the steam flow. This flow pattern is clearly indicated in Figure 5 below.

Figure 5: Unit 3 steam distribution header.

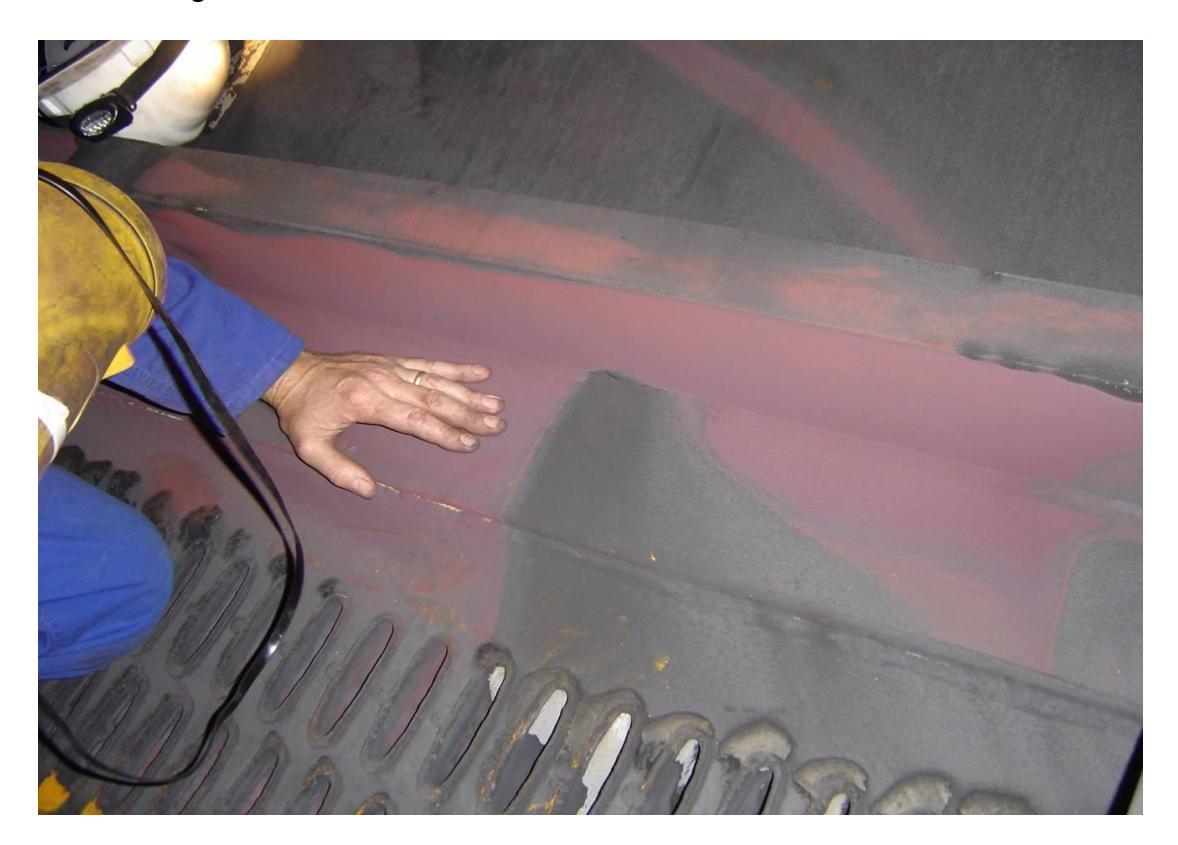
This liquid collects in a trough which is formed between the duct wall and a structural angle profile welded onto the duct wall immediately above the top of the tubes. This condensate is drained from the trough through a series of small openings from where the liquid will find its way into the finned tubes as shown in figure 6 below.

Figure 6, Unit 3 drain flow marks with associated corroded areas at the tube inlets.

Almost without exception it was in areas like these where the second mechanism was active preventing any passive corrosion layer to develop on the steel surface. This is well illustrated in figure 6 by the grey patches visible in the 4 tube ends below the opening in the trough. Based on a visual inspection these grey patches are bare metal surfaces without any protective corrosion layer. A tube was removed from unit 3 for analysis. The results of the analysis are documented in a separate report but in summary confirmed that the grey patches were corroded areas with no oxide deposits. The corroded areas were found over a distance of about 2 meters down the tube measured from the inlet end of the tube. The average wall loss associated with the corroded areas is very small, in the order of 0.1 mm. The only exception to this was a small area immediately below the inlet seal weld where a through- wall pit was visible as shown in figure 7.

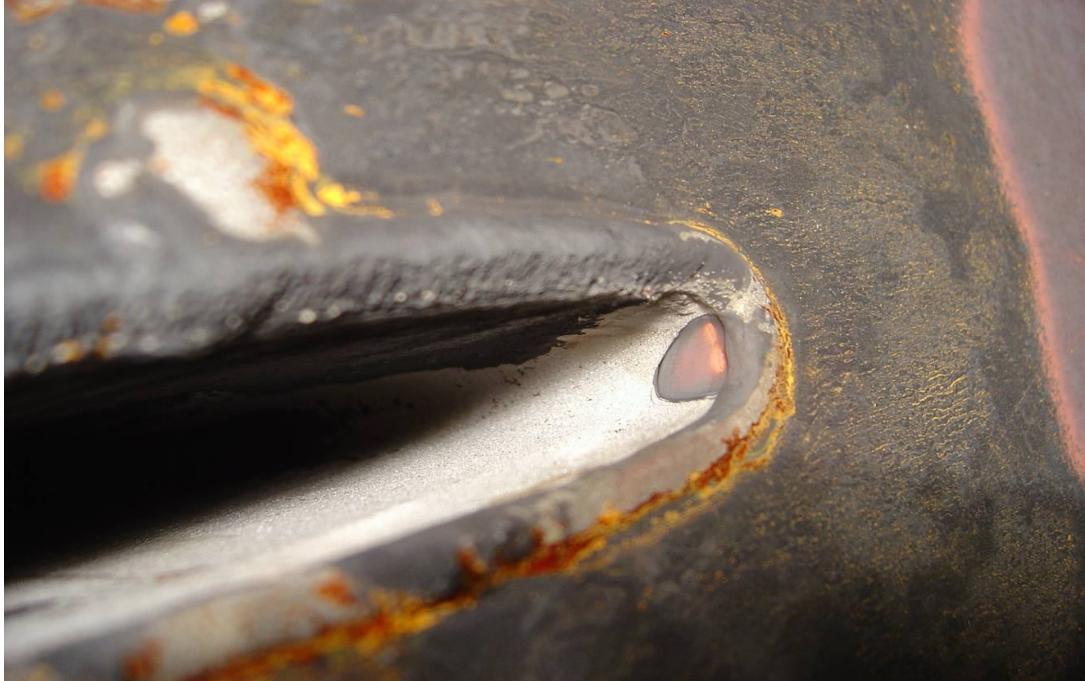
Figure 7, Through -wall pit observed on unit 3.

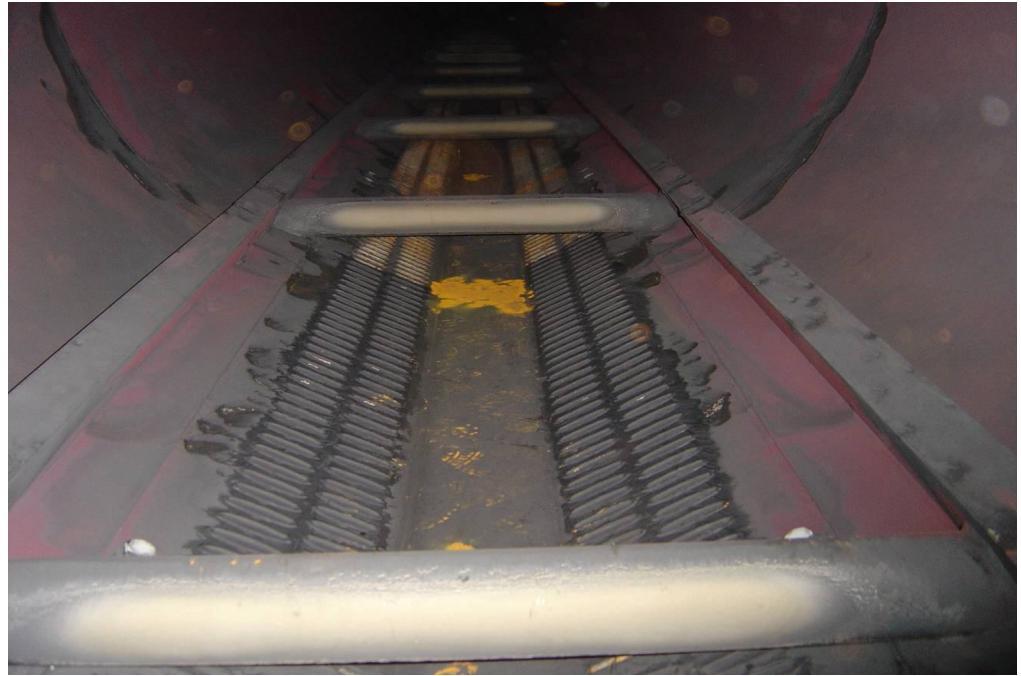
The third and perhaps less important mechanism was found on bodies directly exposed to the steam flow like the stiffeners shown in figure 5. Although the appearance of the third mechanism is similar to that of the second, it differed in the sense that in this case the eroded surface is directly exposed to the approaching steam and not subject to a high liquid flow.

Figure 8. Eroded areas on stiffeners.

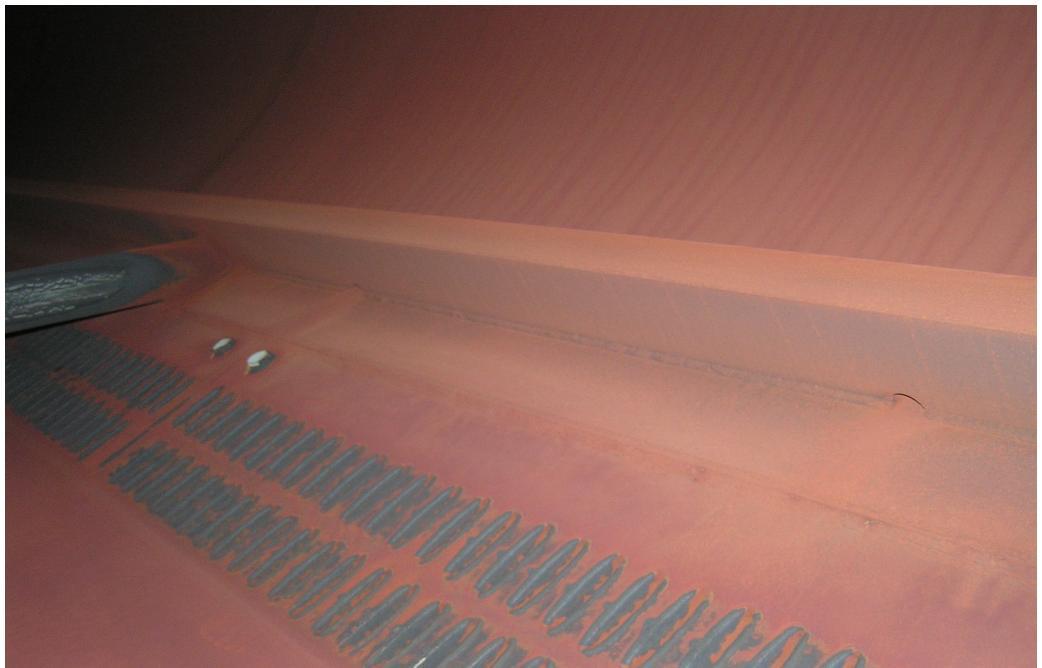
The confusing part was the obvious difference between the observation made on this corrosion mechanism as observed at Matimba and Majuba. A photograph below was taken on Majuba unit 1 ACC. In this case no internal tube erosion was found and the entire internal ACC surface, apart from the tube inlets, was found covered with a healthy red iron oxide layer of Heamatite. Majuba unit one is one of the Majuba units which was not two shifting due to limited starts on the generator and should therefore be comparable to Matimba.

Figure 9. Majuba unit 1 Acc duct condition

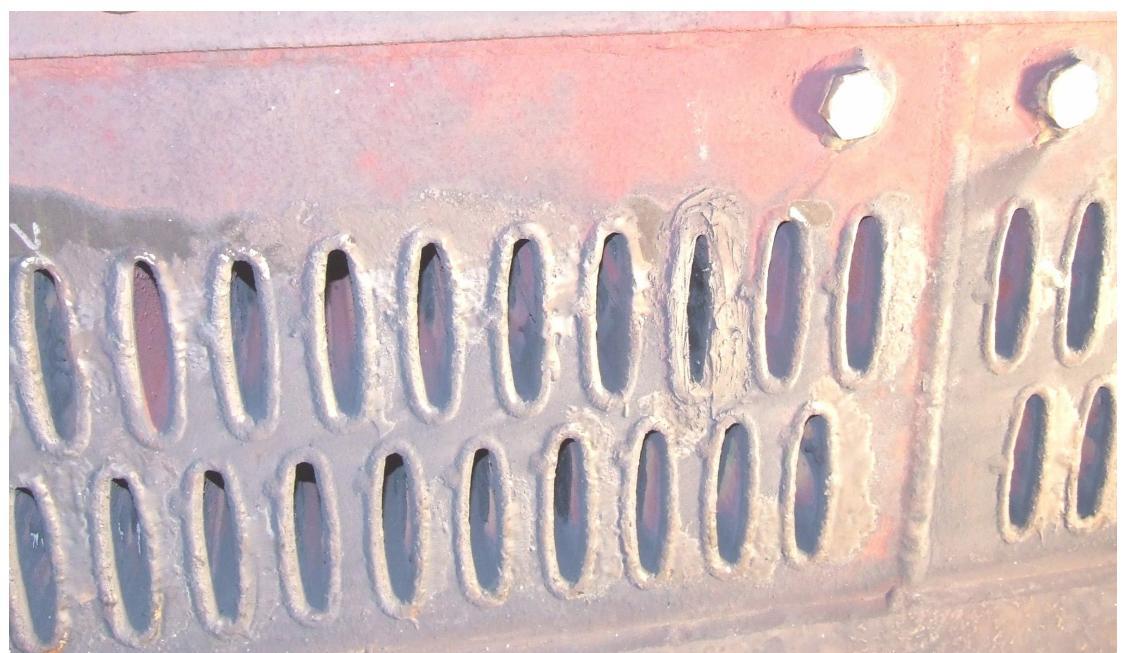
This treatment was done as per inspection in areas of concern. The experience with the epoxy wear coat was found to be favourable and very little deterioration of the coating and the painted areas was observed between outages.

Figure 10: Matimba ACC Tube welds after painted with epoxy paint.

By applying the epoxy wear coat paint on the inlet seal welds, any additional metal loss during operation was found to have been prevented as observed during the subsequent plant outages in the areas that were previously painted.

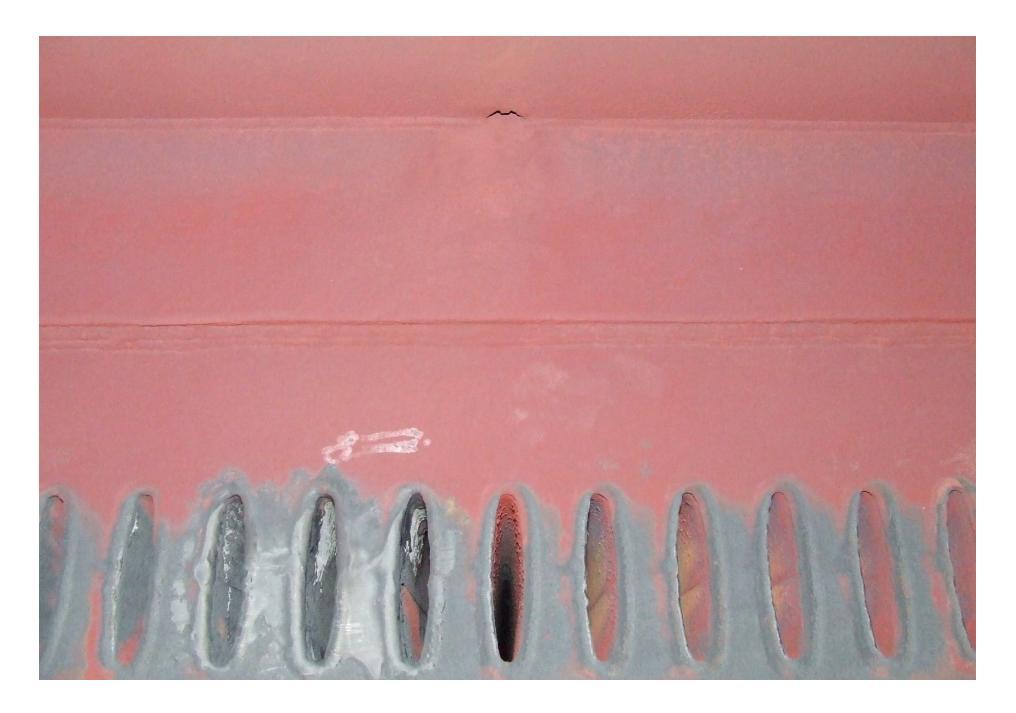
Unit 1 was inspected during Nov 2007 and results shown in figure 9 below. This photo was taken on unit 1 in a similar location as that in figure 3.

Figure 14. No corrosive products from drain hole. Some bare metal patches still remain in tube inlet.
