NORTH BATTLEFORD ENERGY CENTRE

Air Cooled Condenser Maintenance and Vibration Issues and Solutions

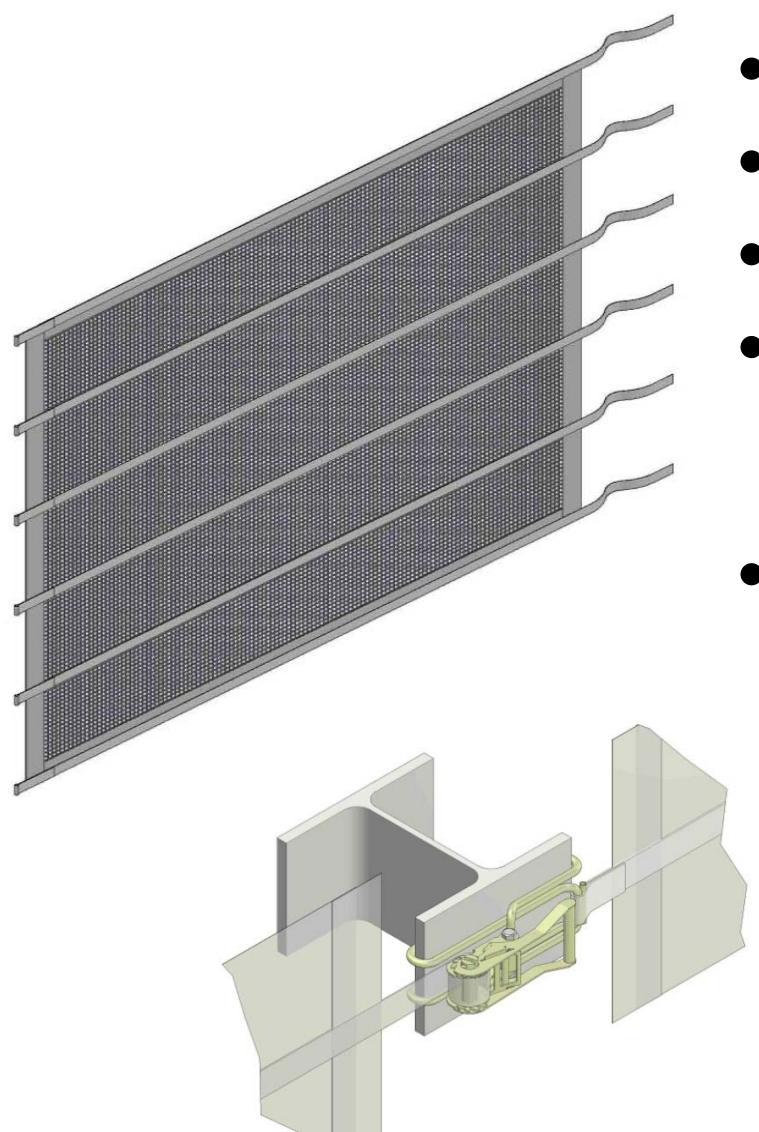
Galebreaker Wind Shield Specification

- •40% Permeable Mesh Wind Shield
- •Able to withstand 90mph winds
- Hooking on to current ACC structure
- •To be located on North, East and West elevations (not fitted to South which is sheltered by turbine hall building)
- •Wind shield design to extend down 6.5m from bottom of Wind Wall (~50% of Fan Deck height)

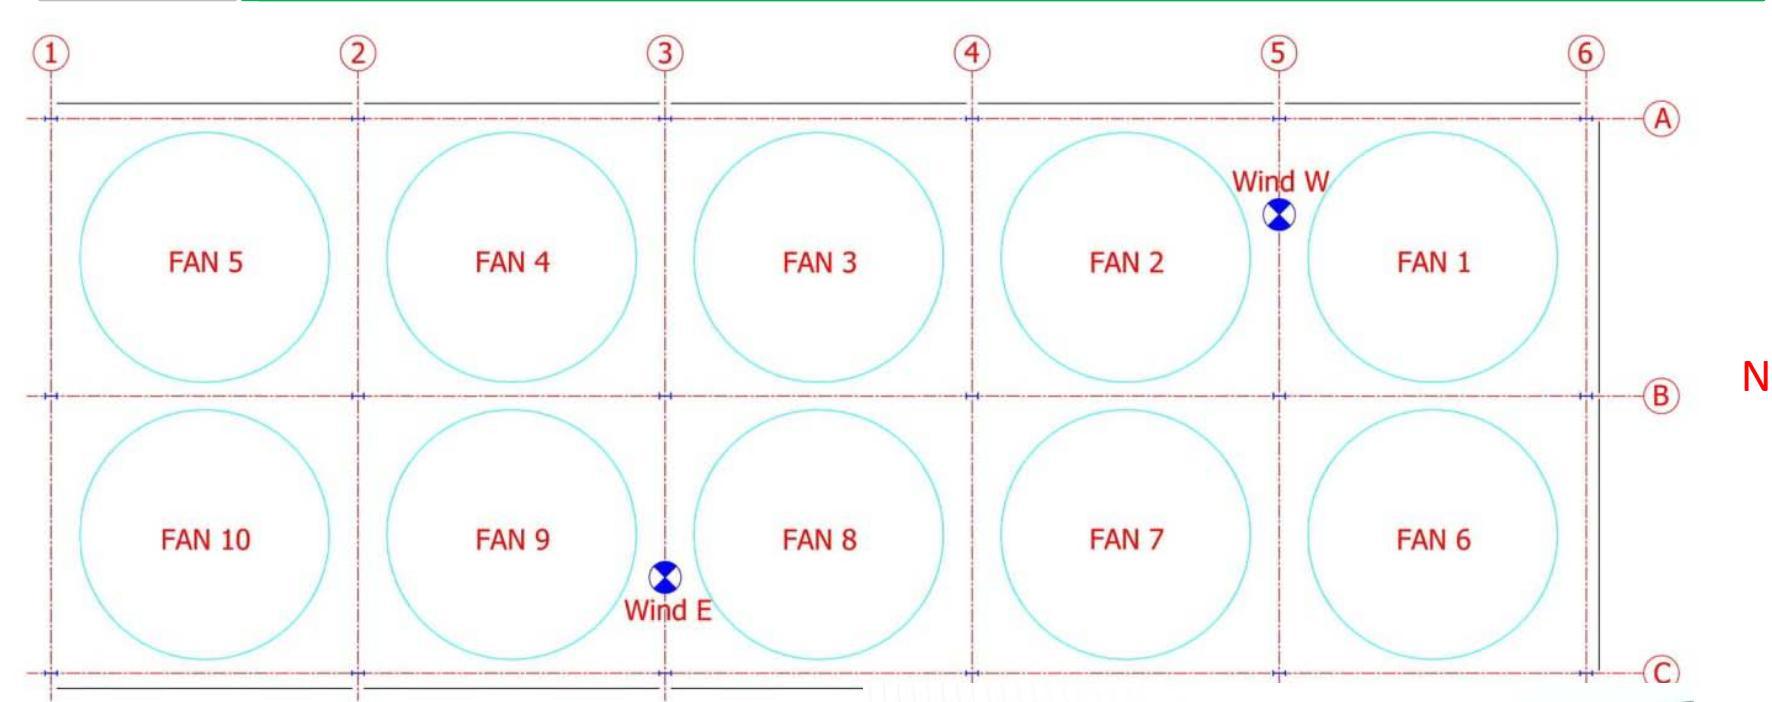
NBEC Ultrasonic Wind Sensor Locations

- Additional Sensor Installed at Perimeter Fence line
- Sensors are Vaisala Heated Ultrasonic

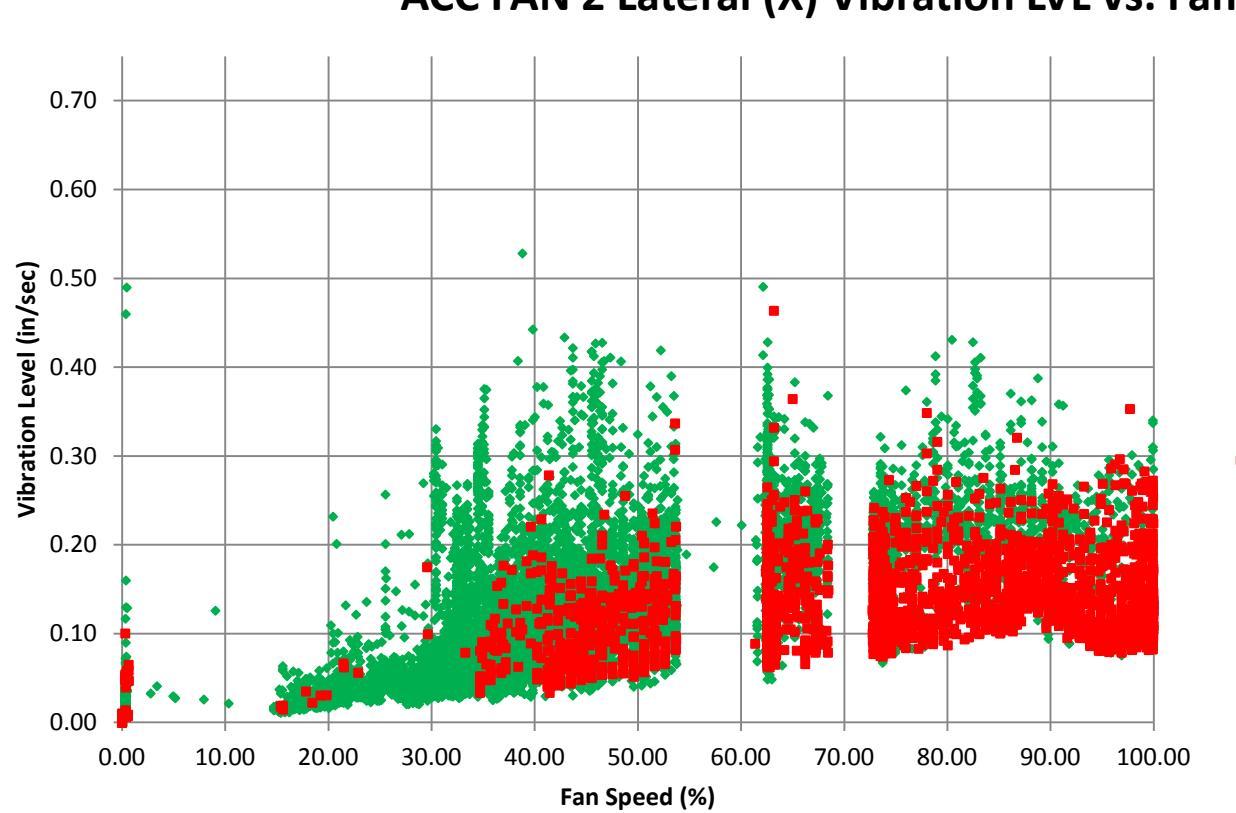
ACC FAN 2 Lateral (X) Vibration LVL vs. Fan Speed

- Fan 2 Vibration Level Prior to Screen Instllation
- Fan 2 Vibration Level After Screens

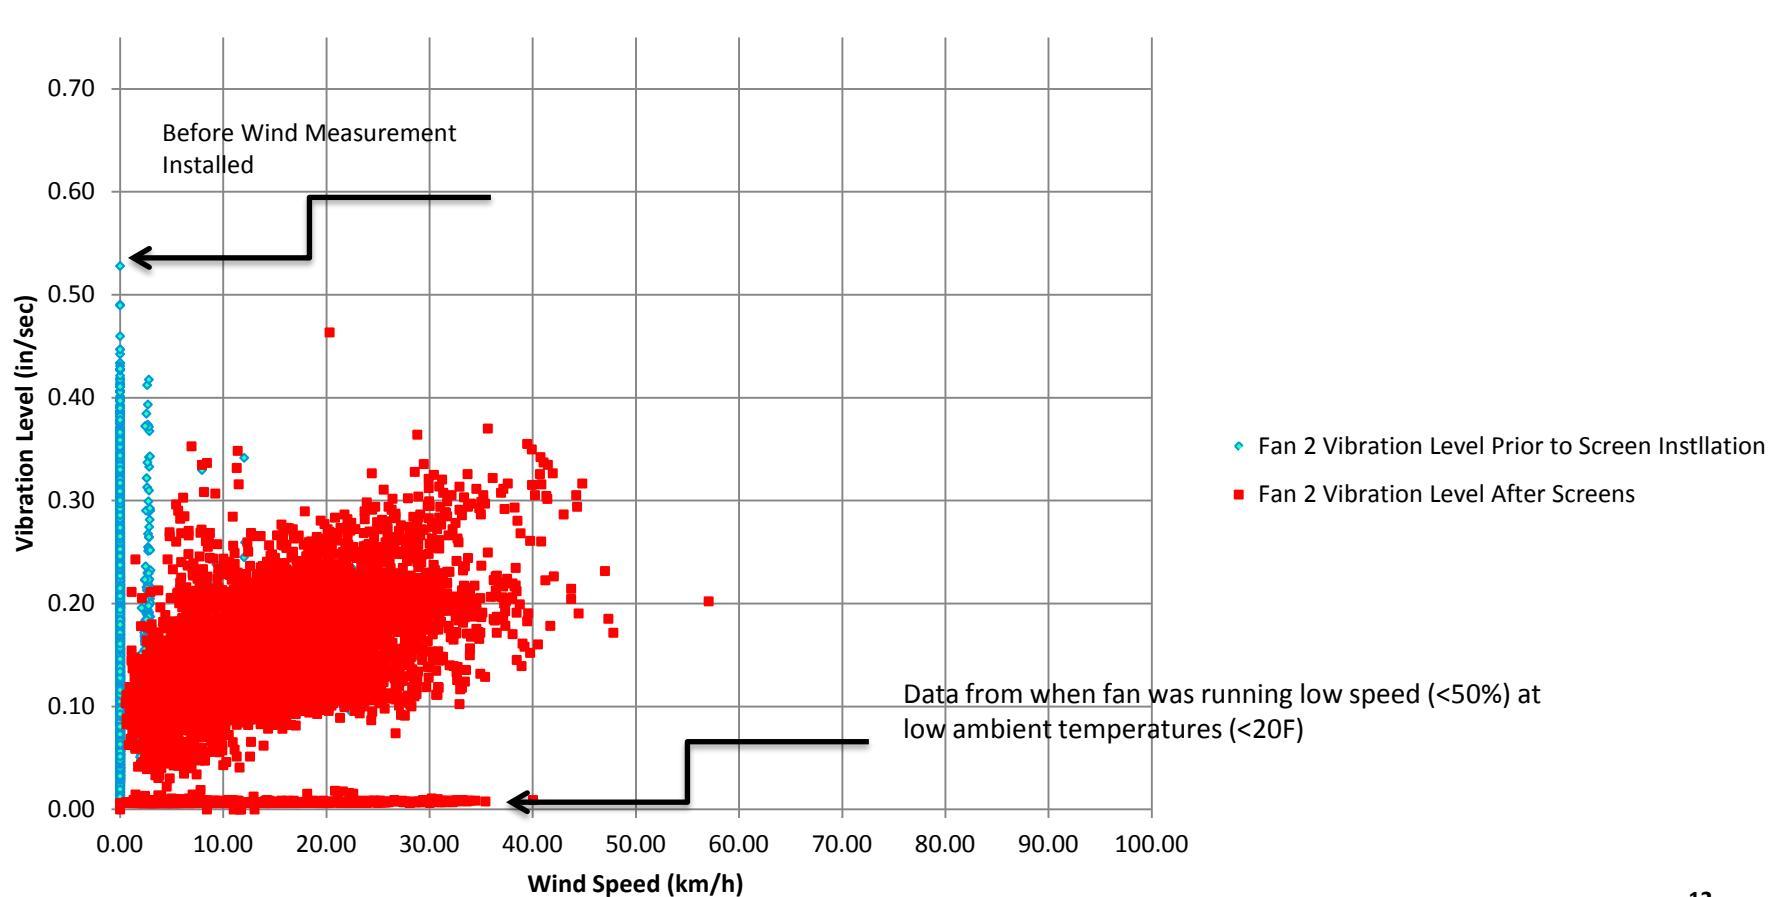
Fan 2: Mean Lateral (X) Vibration vs Wind Speed

- **ZERO** fan trips since installing wind screen
- Horizontal vibration levels have been reduced approximately 25% and spikes reduced dramatically
- Axial vibration levels have increased slightly on average, likely due to changes in axial loading
- Axial vibration is now closely correlated to fan loading
- Negligible thermal performance impact observed
