Walter M Higgins Generating Station

ACC GEARBOX SEAL CHANGE

NEW APPROACH TO REPAIRING LEAKING
INPUT SEALS ON FLENDER GEARBOXES

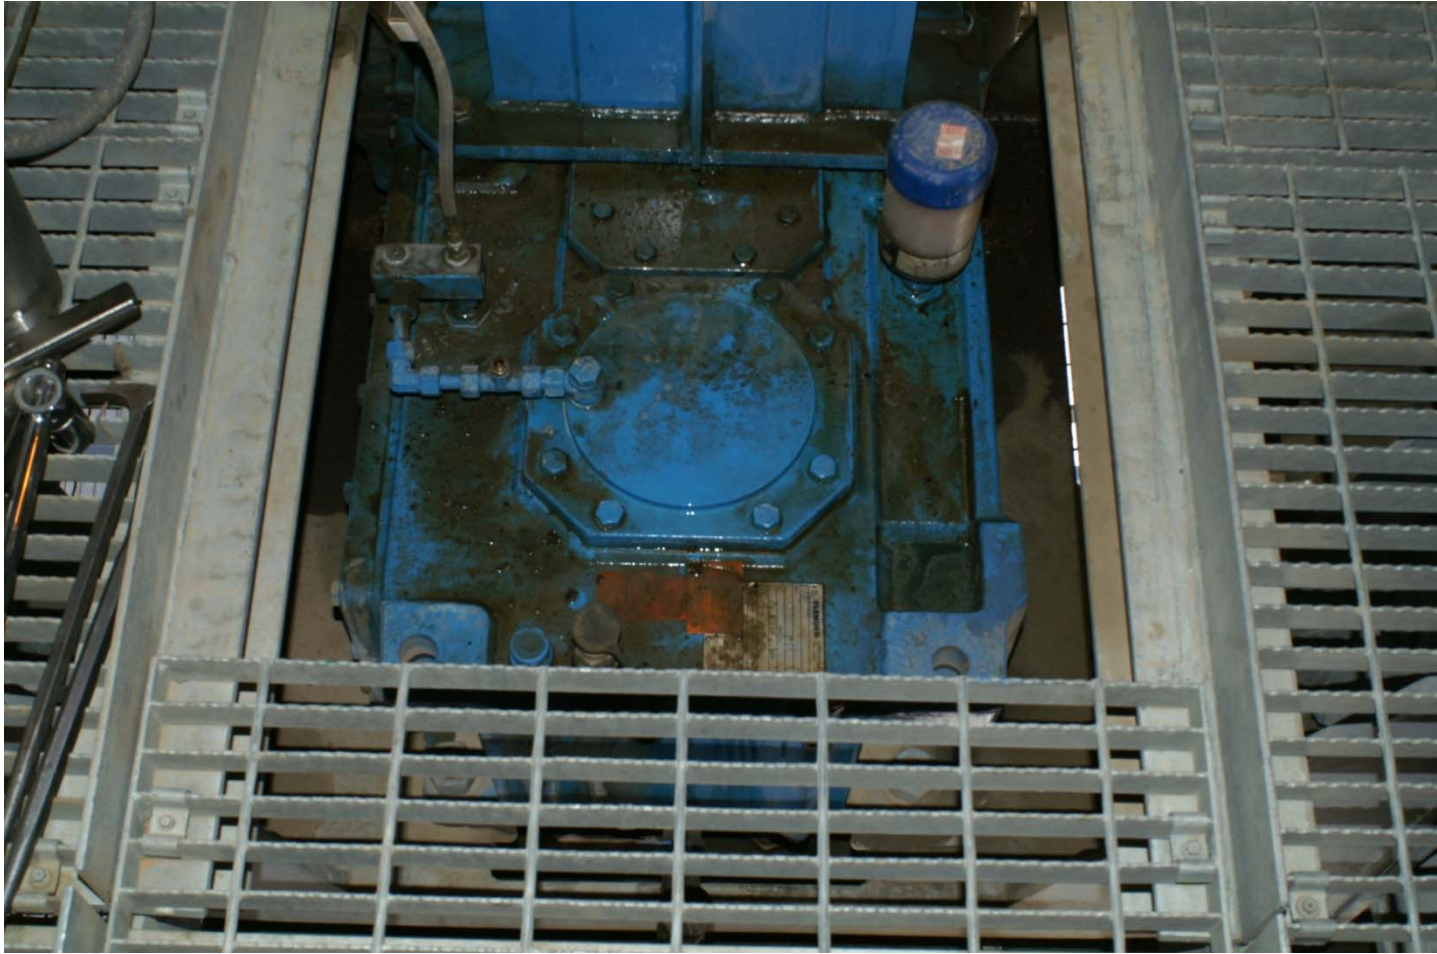
INPUT SEAL DEVELOPS LEAK

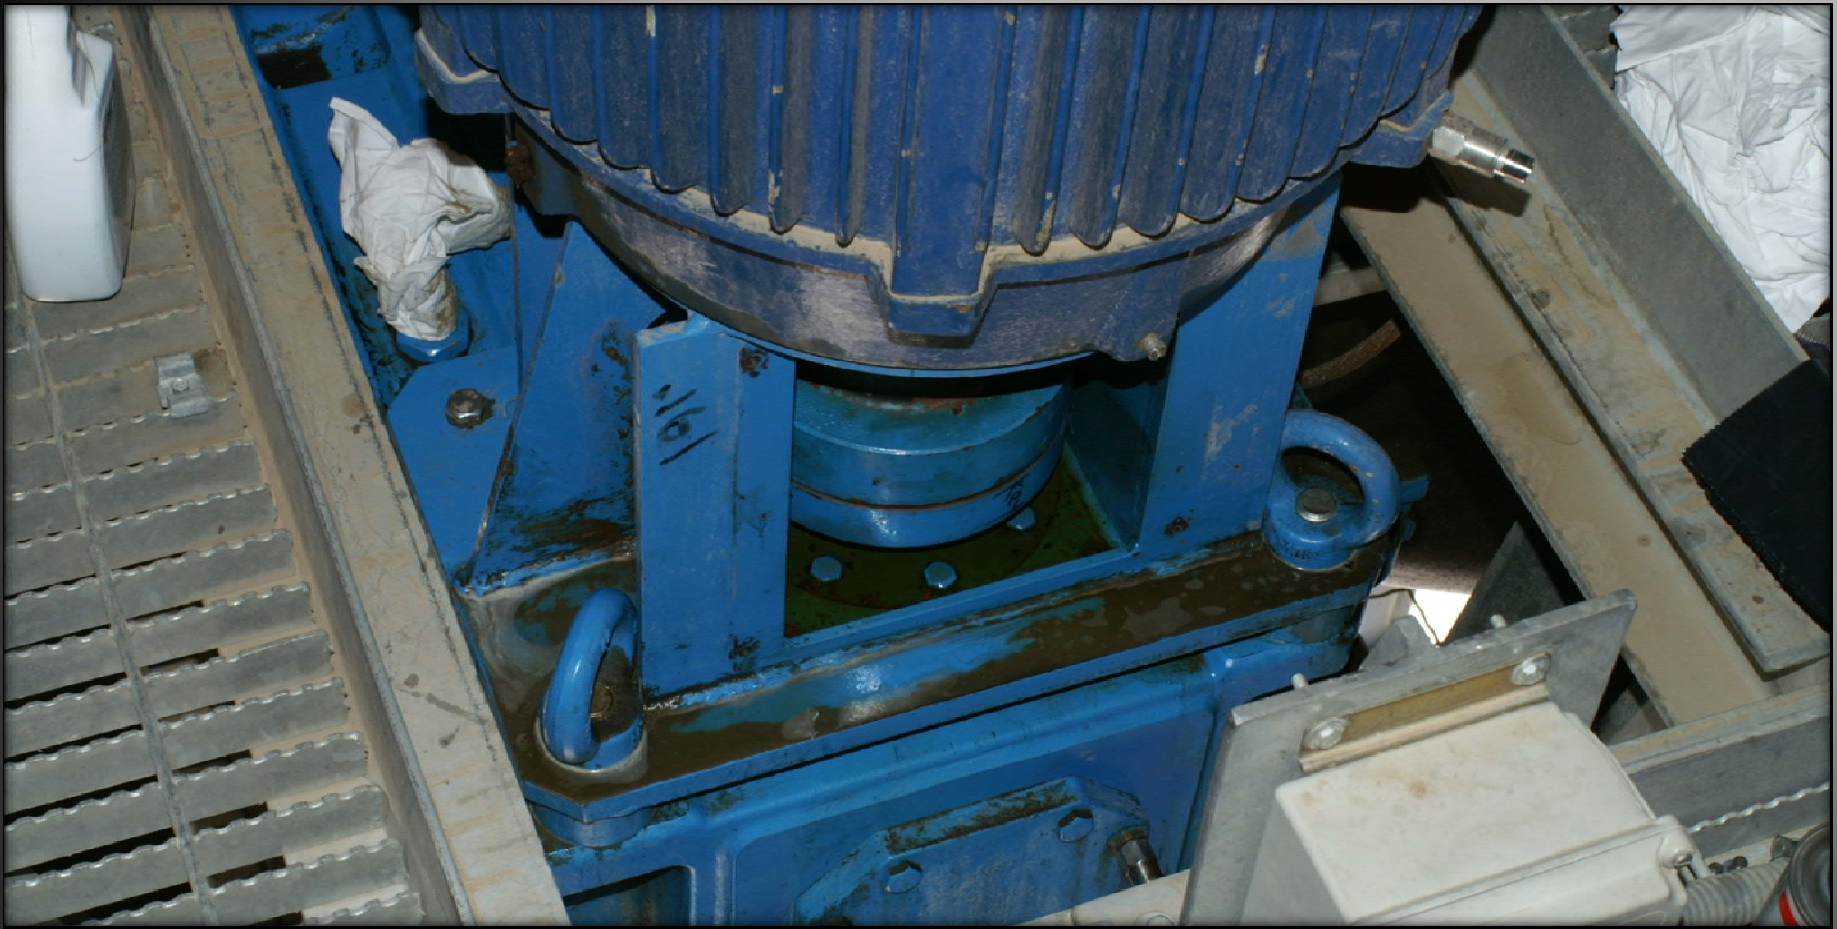
INPUT SEAL LEAKING OIL >>

AT THE START OF THE JOB WE WIPE DOWN THE PARTS OF THE GEARBOX WE CAN GET TO FIRST, IN ORDER TO REDUCE THE POSSIBILITY OF CONTAMINATION. THE SEAL IS ON THE TOP OF THE GEARBOX BUT BELOW THE WALKWAY GRATING. NOTE: lack of room at coupling.

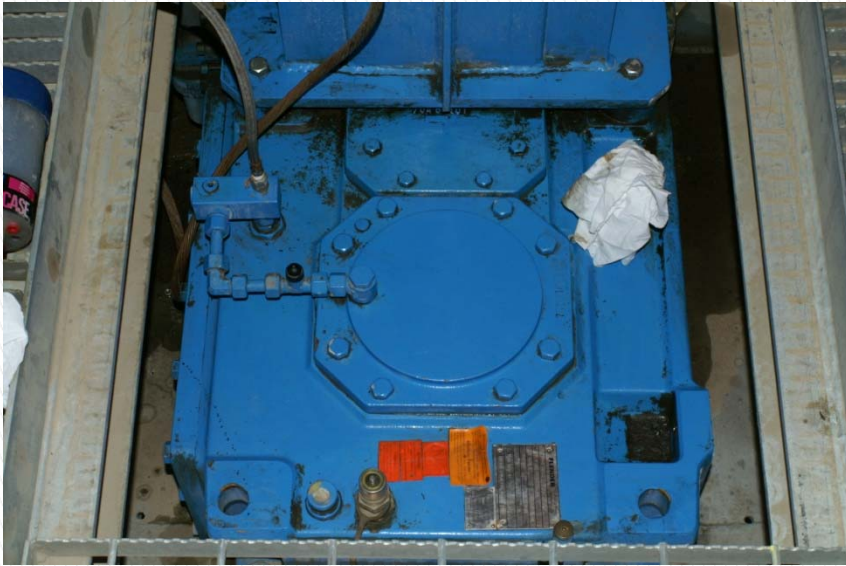
Wiped down before motor removal.

Pre-clean gearbox before removing parts.

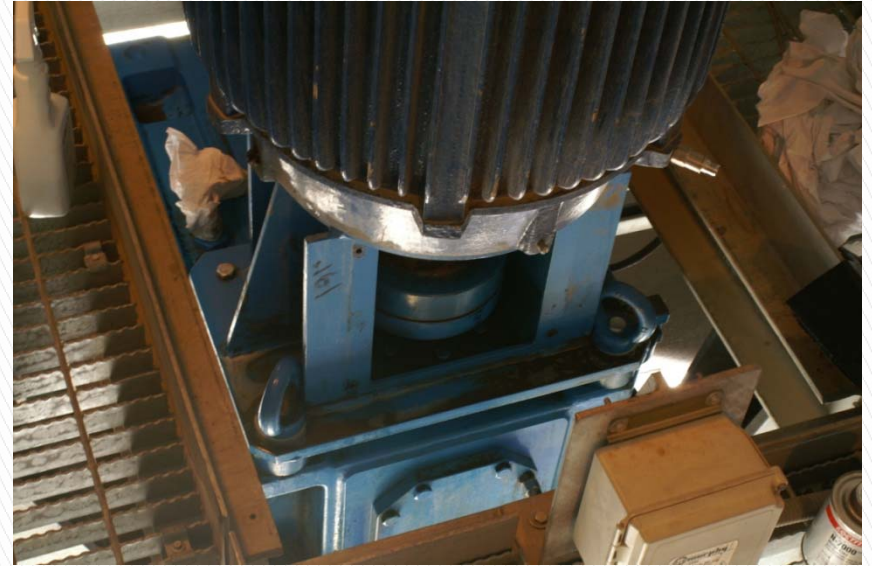
Base wiped down prior to motor removal.

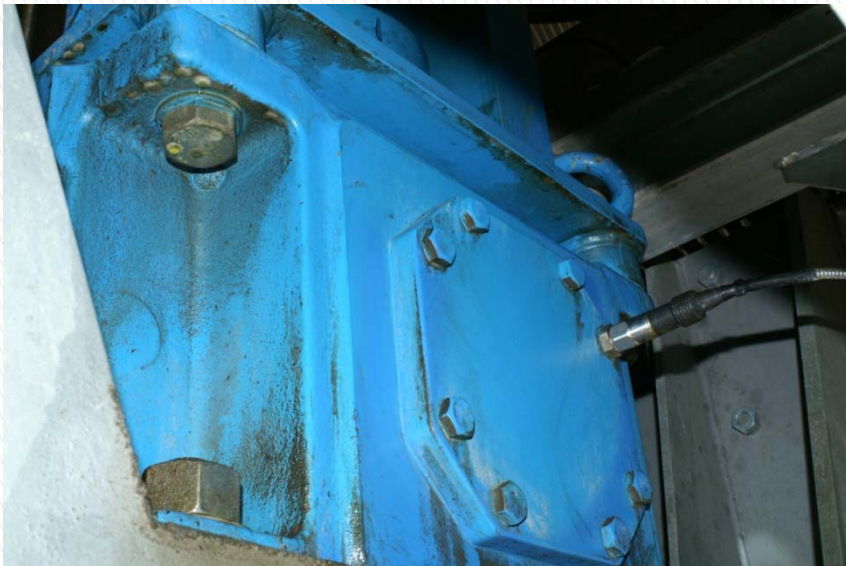
Lower motor mount bolts and accelerometer.

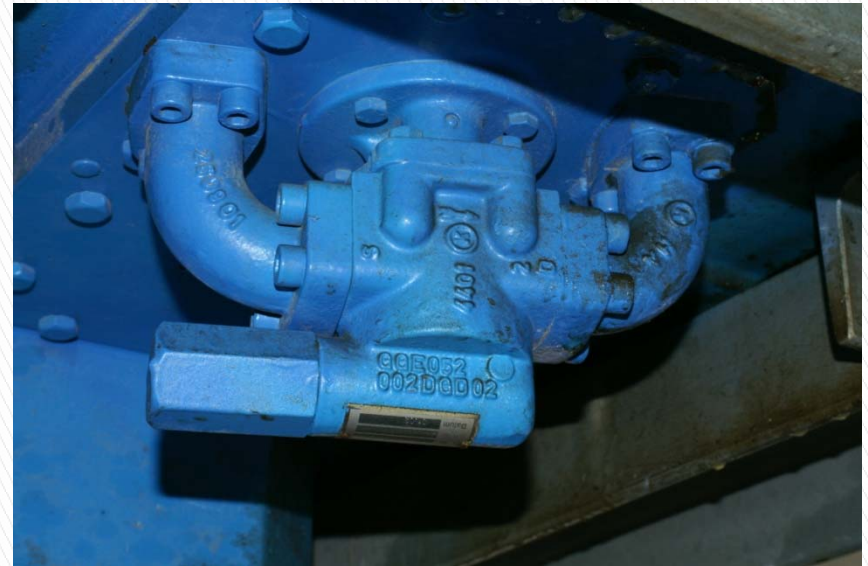
Oil pump and regulator (Hex cap covering adjustment nut).

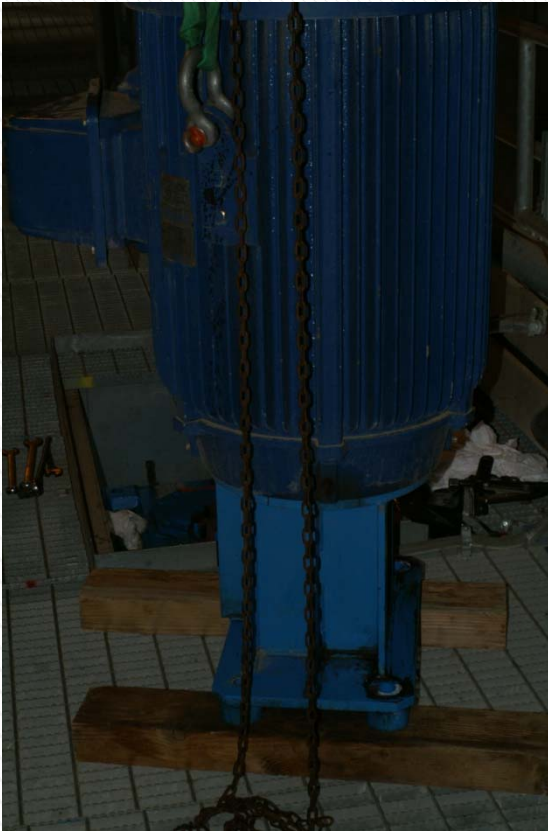
Motor sitting on crib block, hoist still attached and slightly lifting.

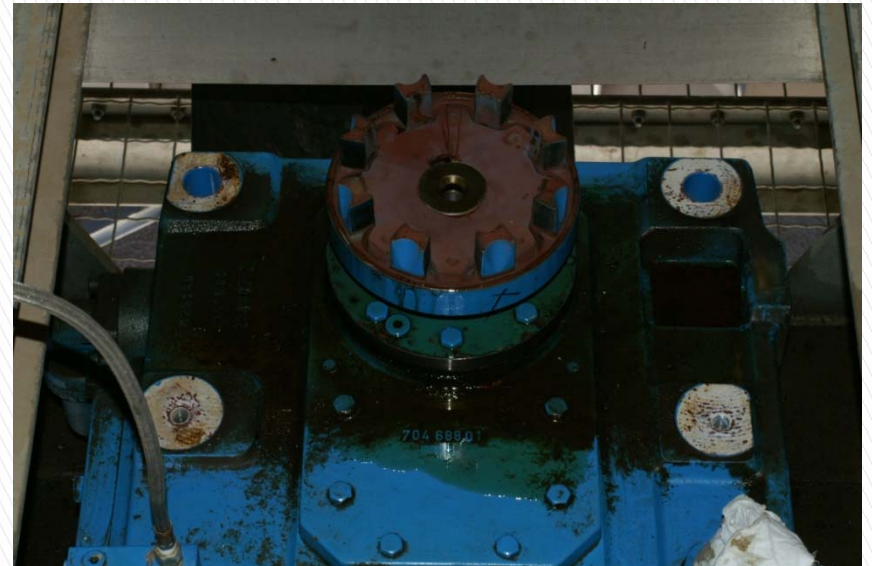
Oil and dirt that needs to be cleaned up before proceeding. Not accessible prior to motor removal.

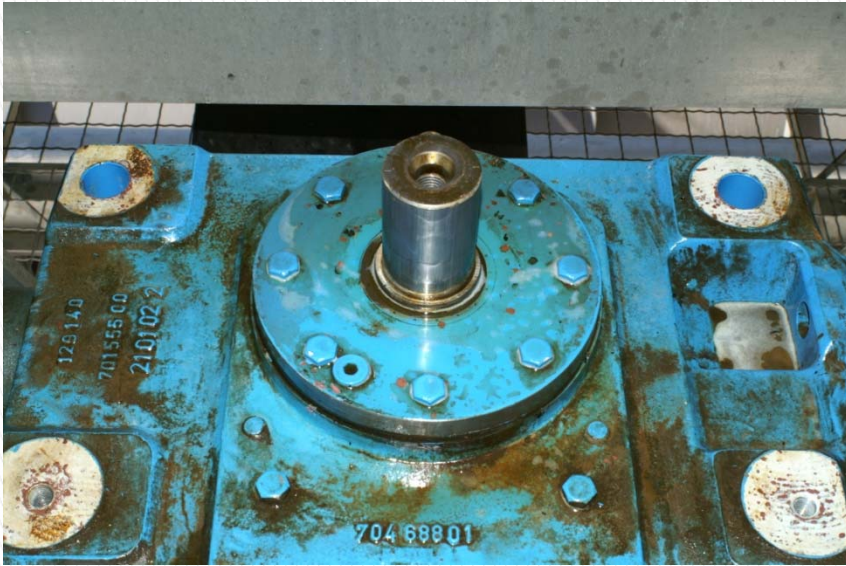
Just oil wiped off with loose dirt.

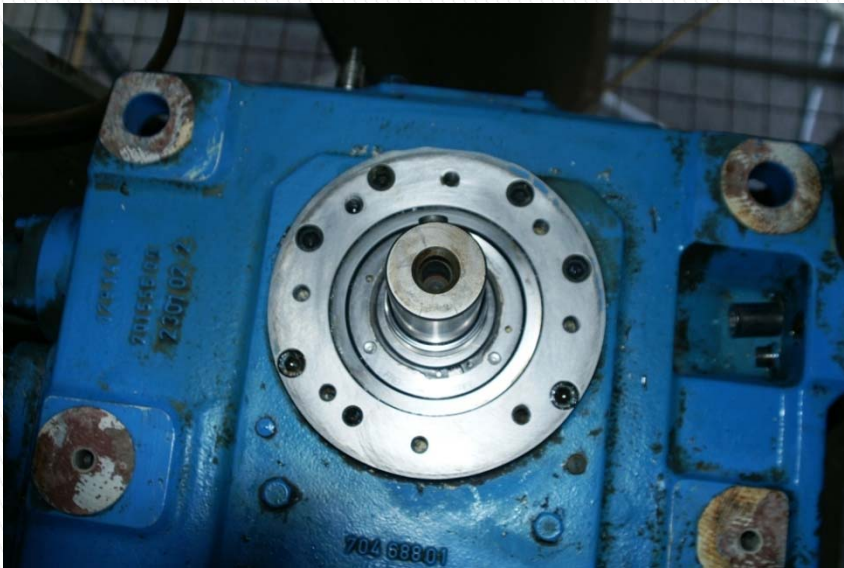
Large area exposed to air. Eight bolts removed. Oil pathway opened. Plate tapped for push bolts.

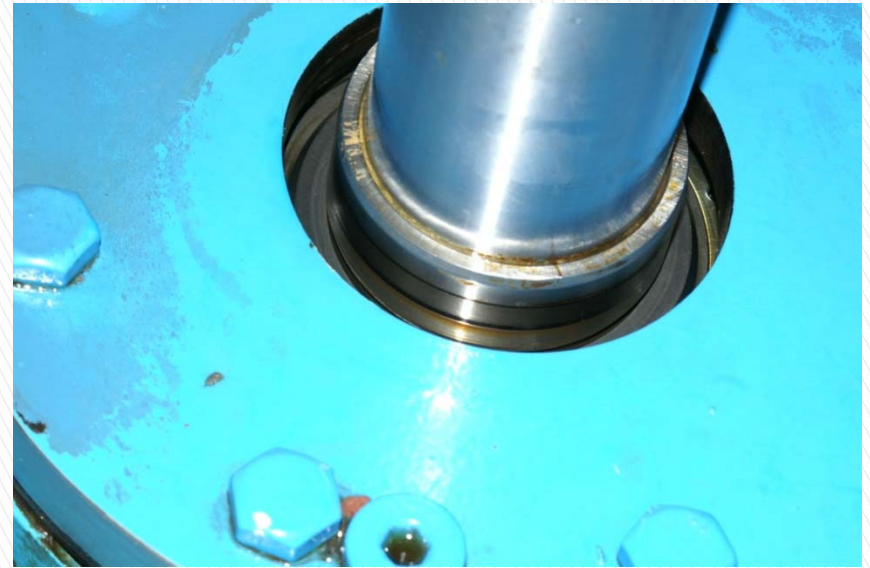
Very small area exposed. No bolts removed, no oil pathways exposed.

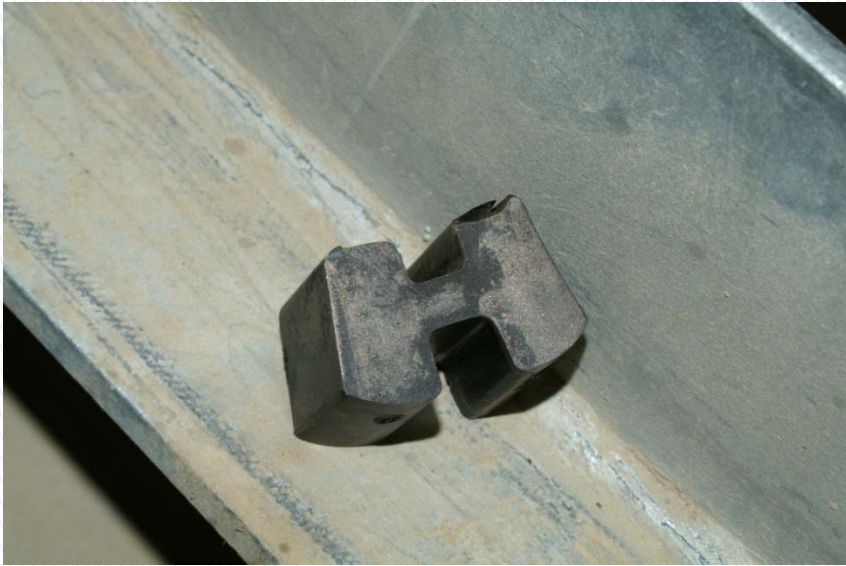
Old worn insert beginning to fail.

Change out coupling inserts during job.

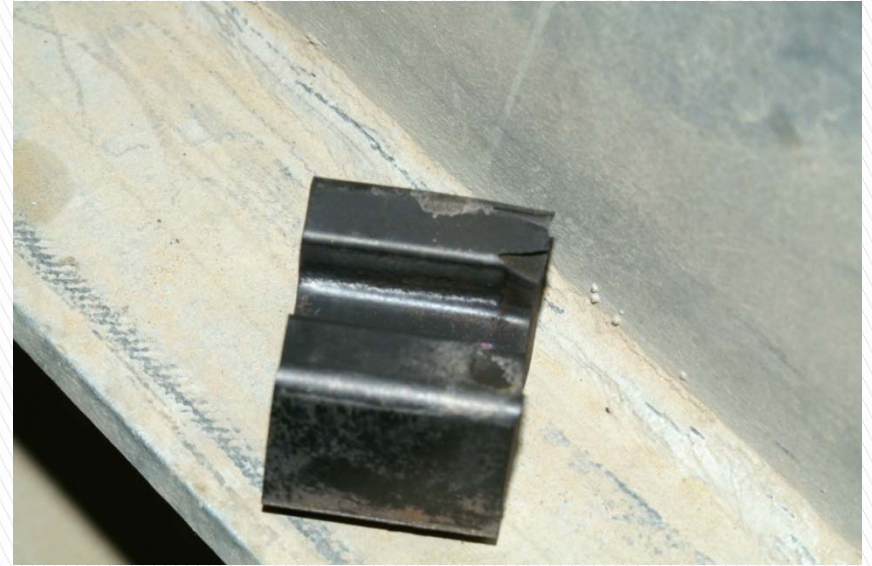
Second view of same insert. Note cracking and indentation.
