Improved ACC performance

How to enhance the performance
with an acceptable price level

A client in The Netherland needed an ACC replacement

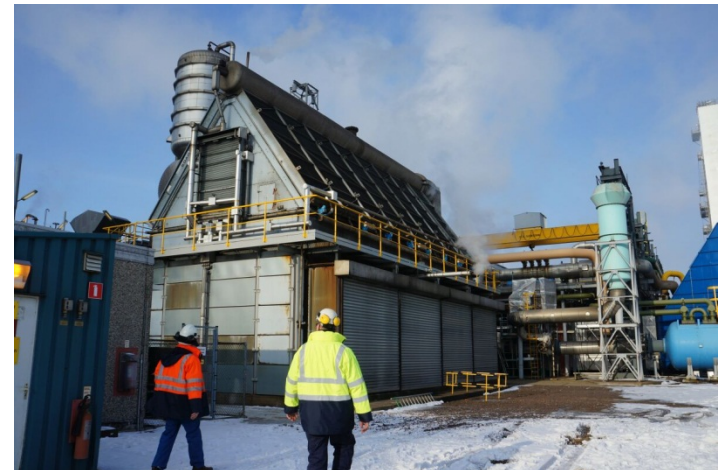
The location for the new ACC was behind the existing ACC. The steam duct had to be routed around the old ACC.

During winter the air inlet of the ACC was almost completely closed to reduce the air flow as now fan control was present.

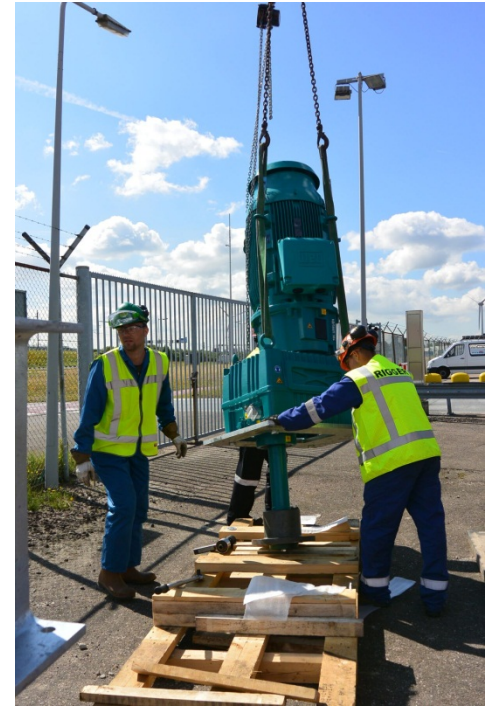
Design of fan motor and gear box was based on the specified capacity.

For an amount of \$3500.- per cell the gearboxes and motors were upgraded from 45 kW to 95 kW

The fan was installed in a way that with 50 Hz

The specified performance was guaranteed.

By increasing the frequency to 60 Hz motor power became 90 kW with 61% more air flow.

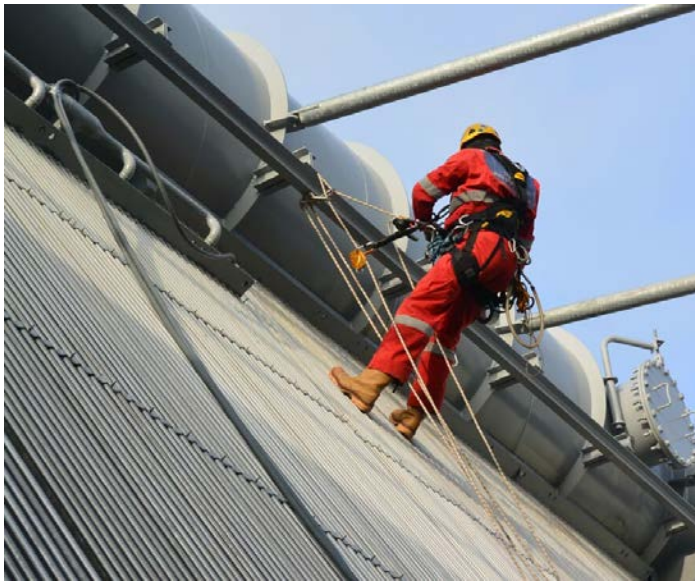
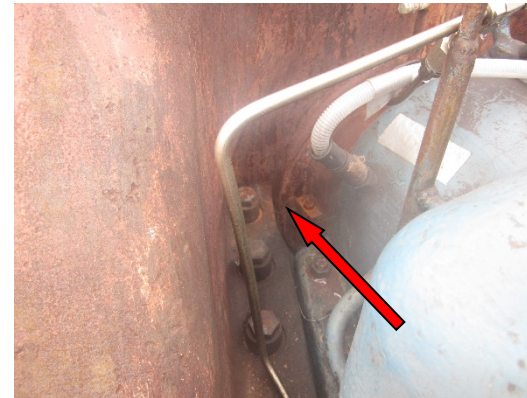
This was cleared by using a helium detection test

All welds on the ducting were tested with helium.

The leaks found were in the turbine casing and gland steam condenser
ACC was completely tight.

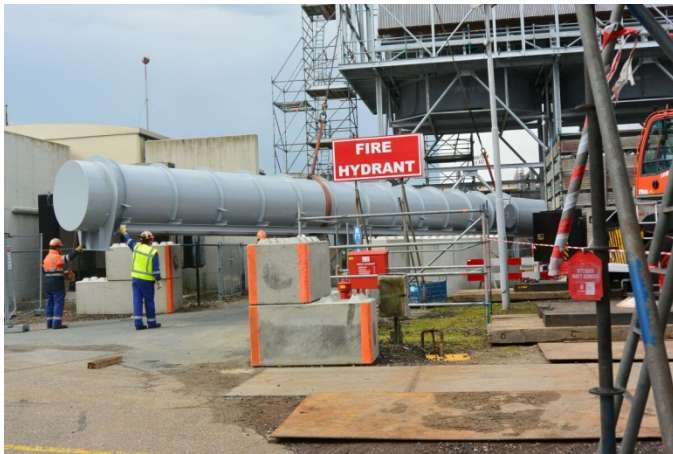
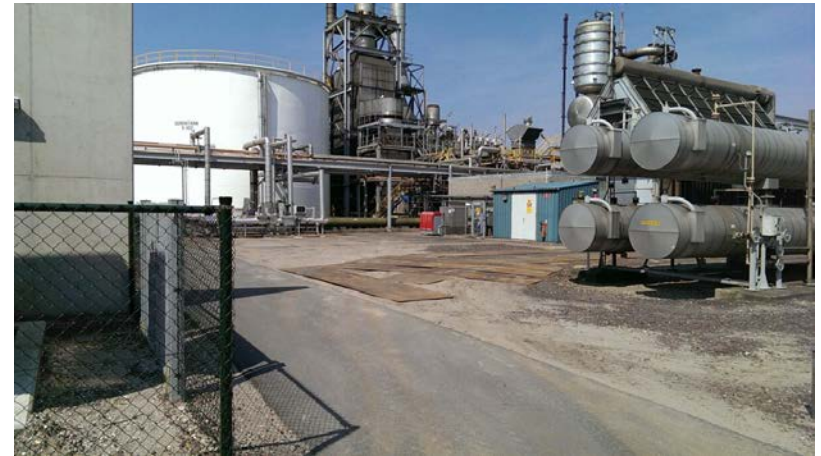
The location was completely surrounded with process equipment.

Many piping and ground cables were found. For this reason the construction of pits was not allowed.

Due to all operational process equipment, 250 bar storage tanks, lifting of steam ducts were a special exercise

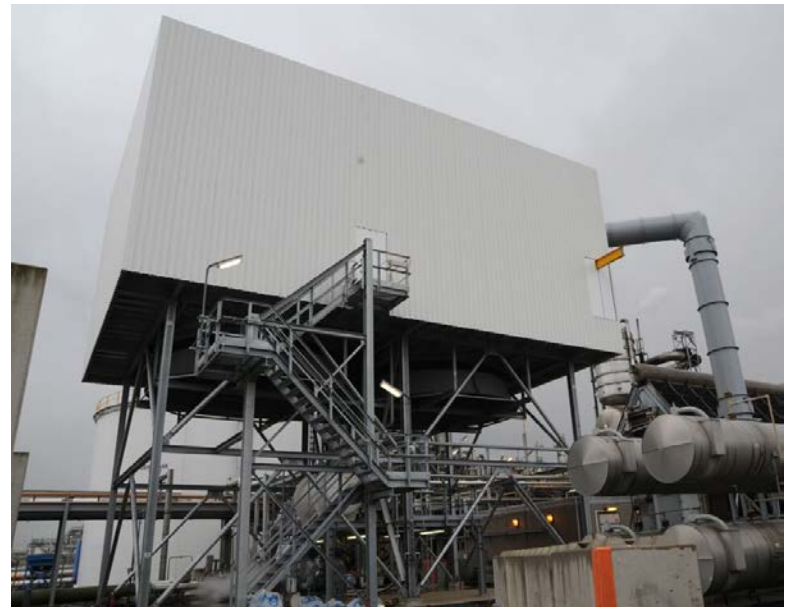
- Lifting the complete ACC 2 meters
- Using the difference in pressure of the condensate tank and ejector surface condenser to suck the condensate

From the surface condensers to the tank while condenser and tank were installed at the same height.

For drain pump a low NPSH (0.17 m) was used,

The result was a simple layout,
maintenance friendly and reliable

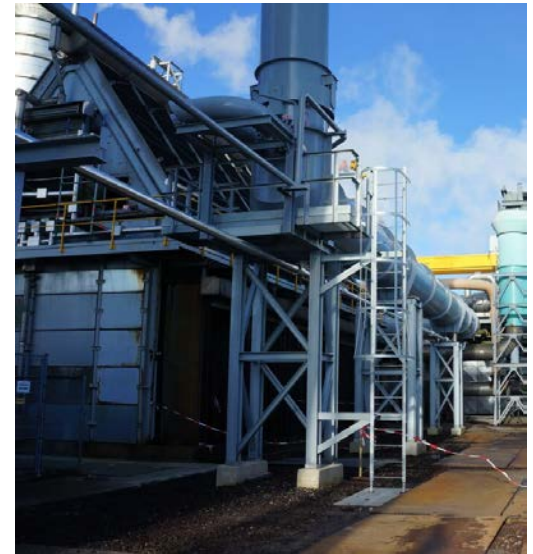
Due to the presence of the old ACC the steam duct was longer than normally installed.

The solution was to increase the diameter of the duct, which meant more plate material.

The increase in diameter was from 48 to 56 inch.

Pressure drop difference 2 mBar

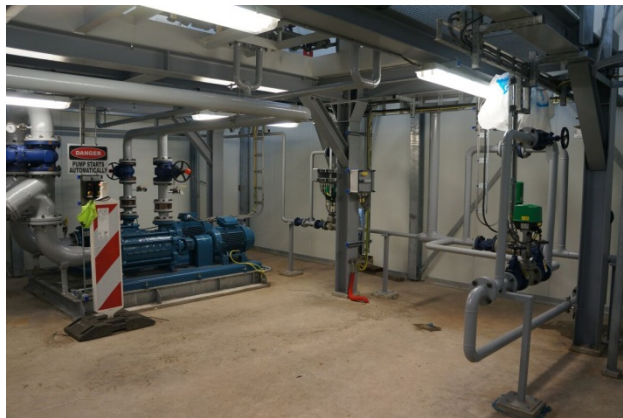
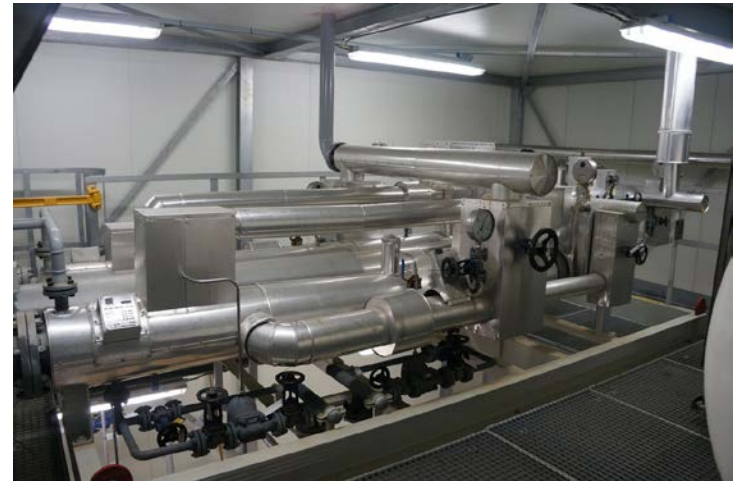
To protect the steam ejectors, pumps and valving against the element and freezing in winter, a room was built around the equipment. Calculations on the air flow to the fans showed that the additional air flow resistance was minimal. All piping to this space was self draining and needed no heat tracing

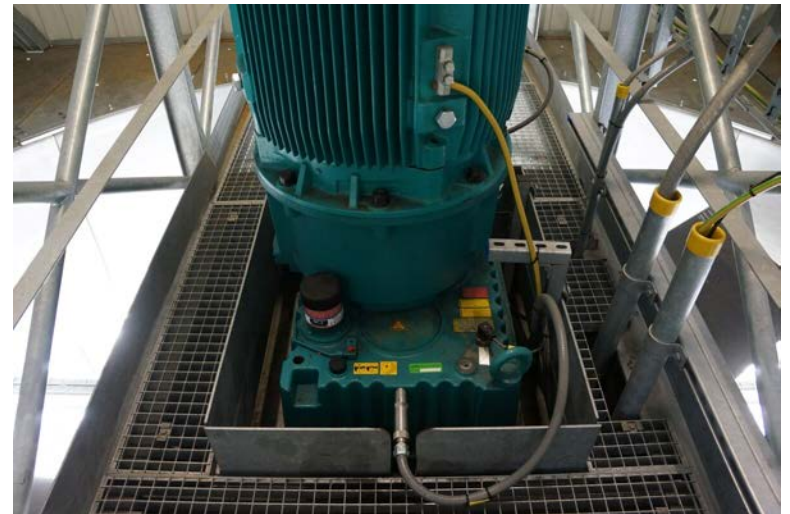
As a special request from the client the vibration switches were replaced by vibration sensors, continuous monitoring vibrations.

The location of the sensor was very critical and was fixed together with the gearbox supplier.

Mounting on the base plate or

Gear-box casing, gave

4 times heavier vibrations

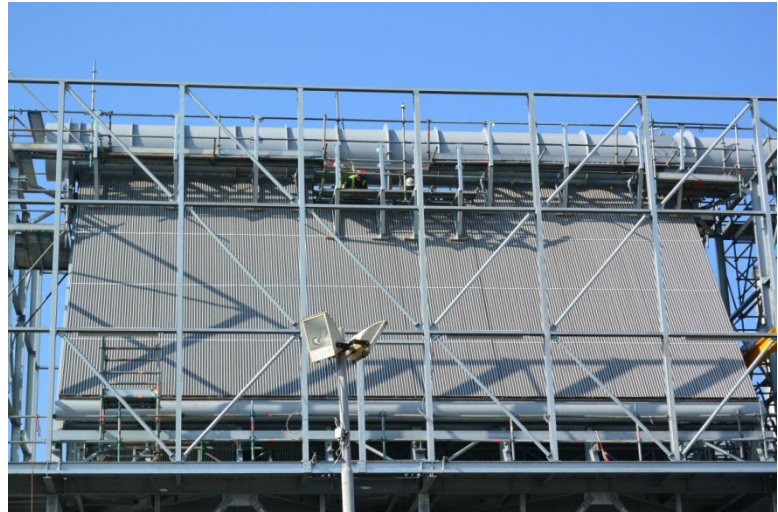
An expensive activity during construction was the welding of the steam duct on top of the bundles.

This was due to safety procedures for working on the inside of the duct. It was decided to weld the steam duct from the outside. Eliminating the safety crew and faster welding.

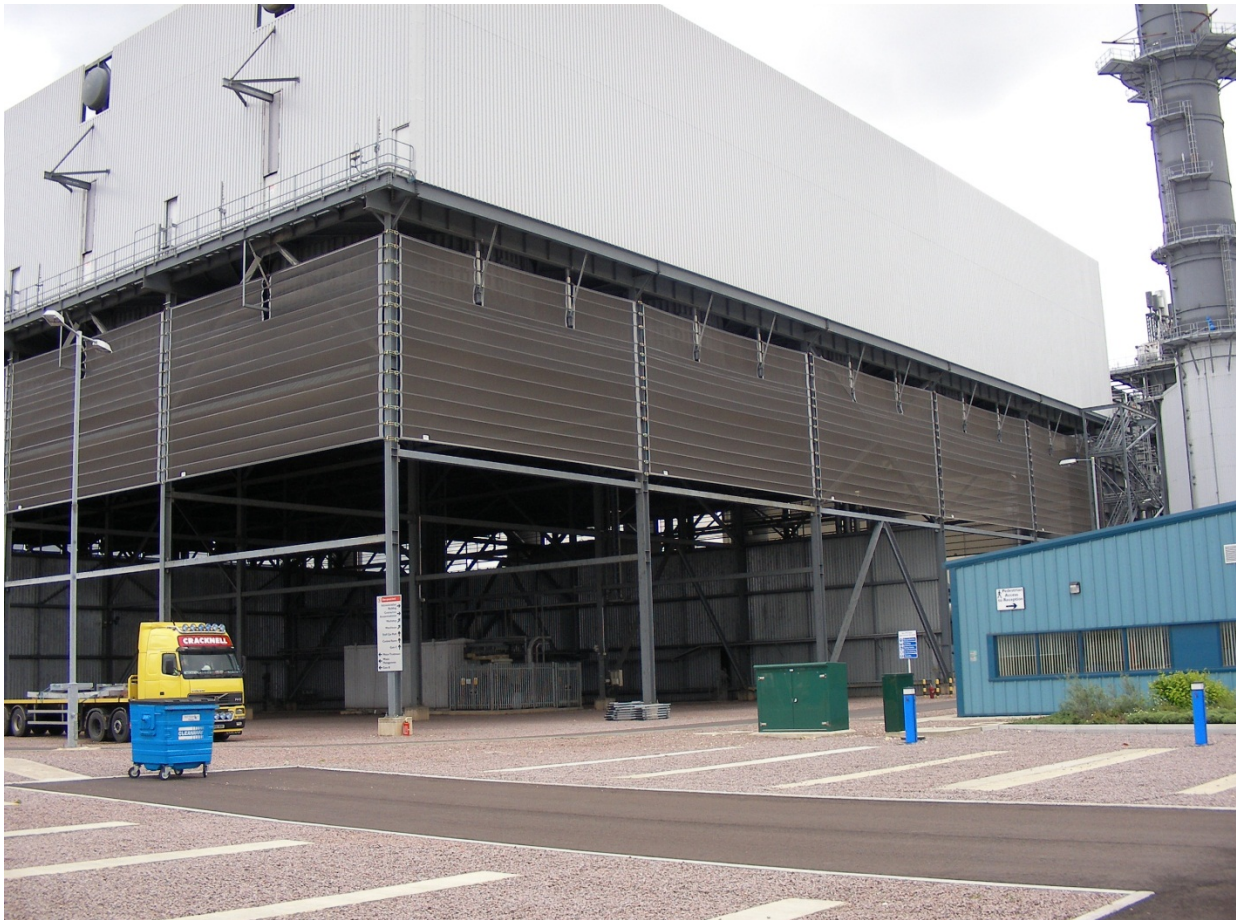
Fitted Windshields

Galebreaker patented design is now becoming a standard item of the base scope in Europe
