# **Medupi Unit 6 ACC hot cleaning: Method and results**

Johannes Pretorius and Pieter Rosslee

China International ACC user's group meeting  
13-16 October 2015

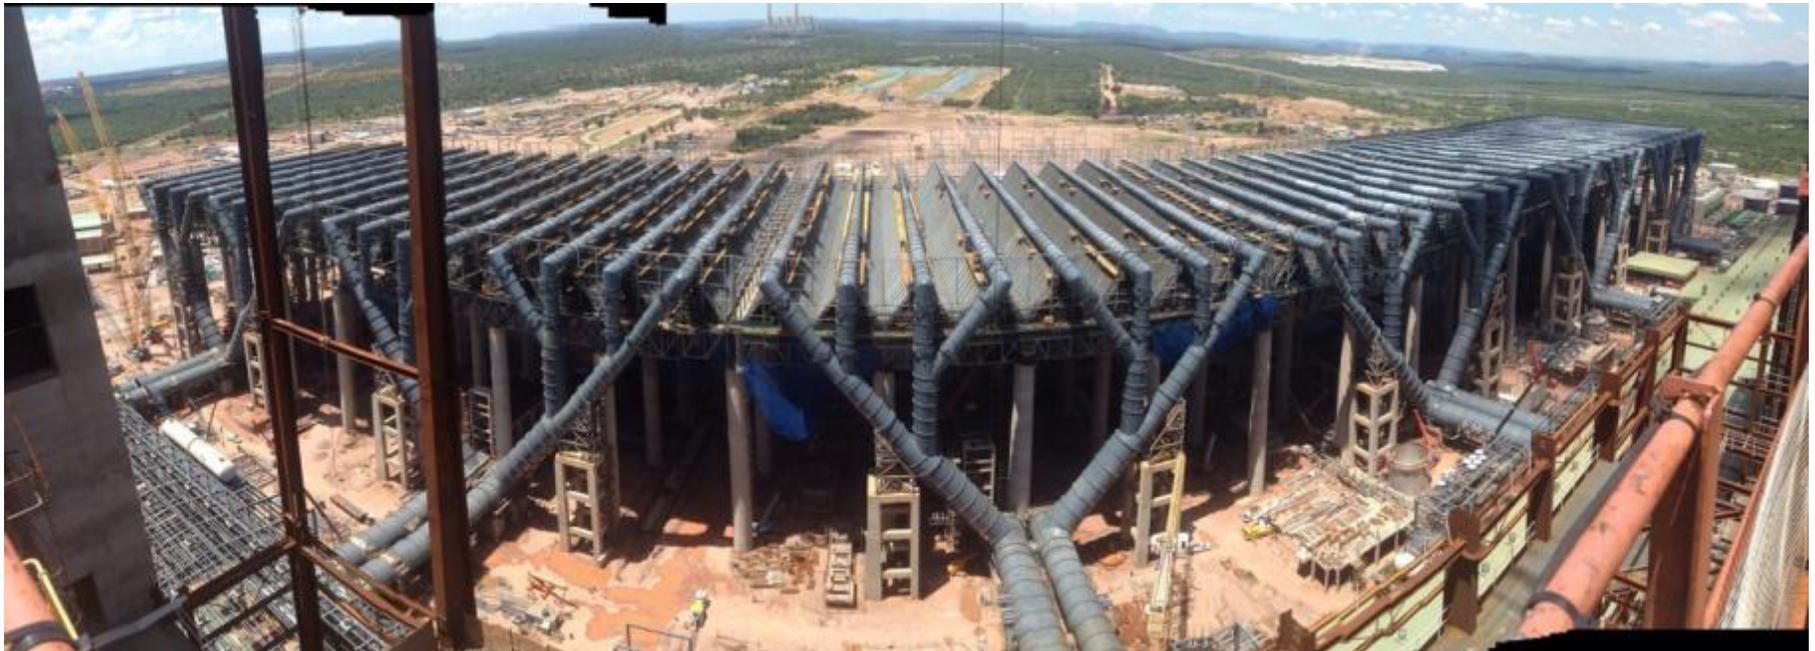
- Medupi Unit 1-6 Air Cooled Condensers (Feb 2015)

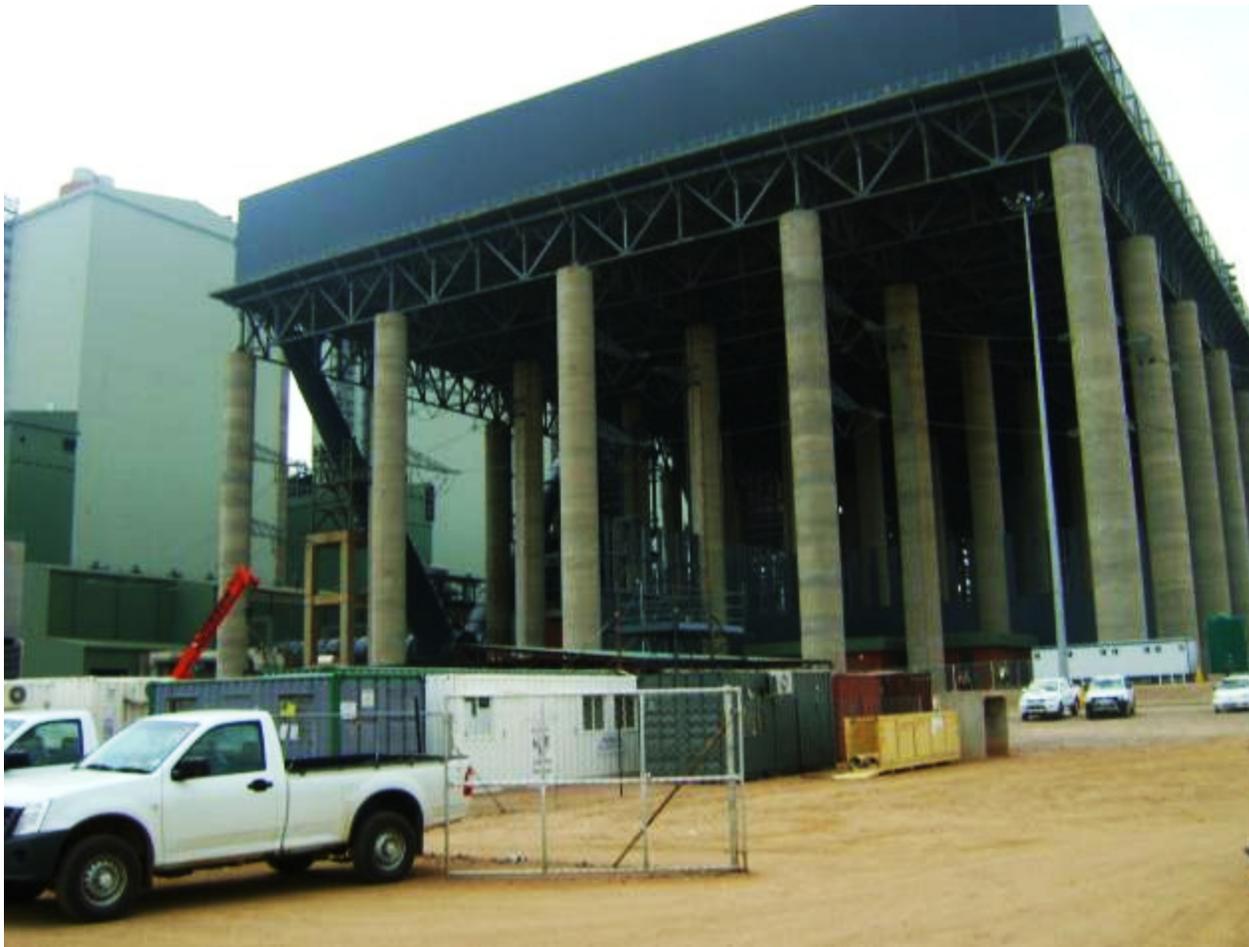
- Medupi Unit 6 Air Cooled Condenser (Feb 2015)

- Lateral exhaust turbines supplied by Alstom
- Medupi's ACC is supplied by GEA
- 8 rows (streets) per Unit
- GEA's 2-row galvanized steel heat exchanger tubes employed
- 64 x 34' Howden ELF8 fans per Unit
- 225 kW Alstom motors & Hansen gearboxes
- 2 x 6m diameter exhaust steam ducts, 50m gap between turbine hall and ACC
- Wind-cross incorporated into design

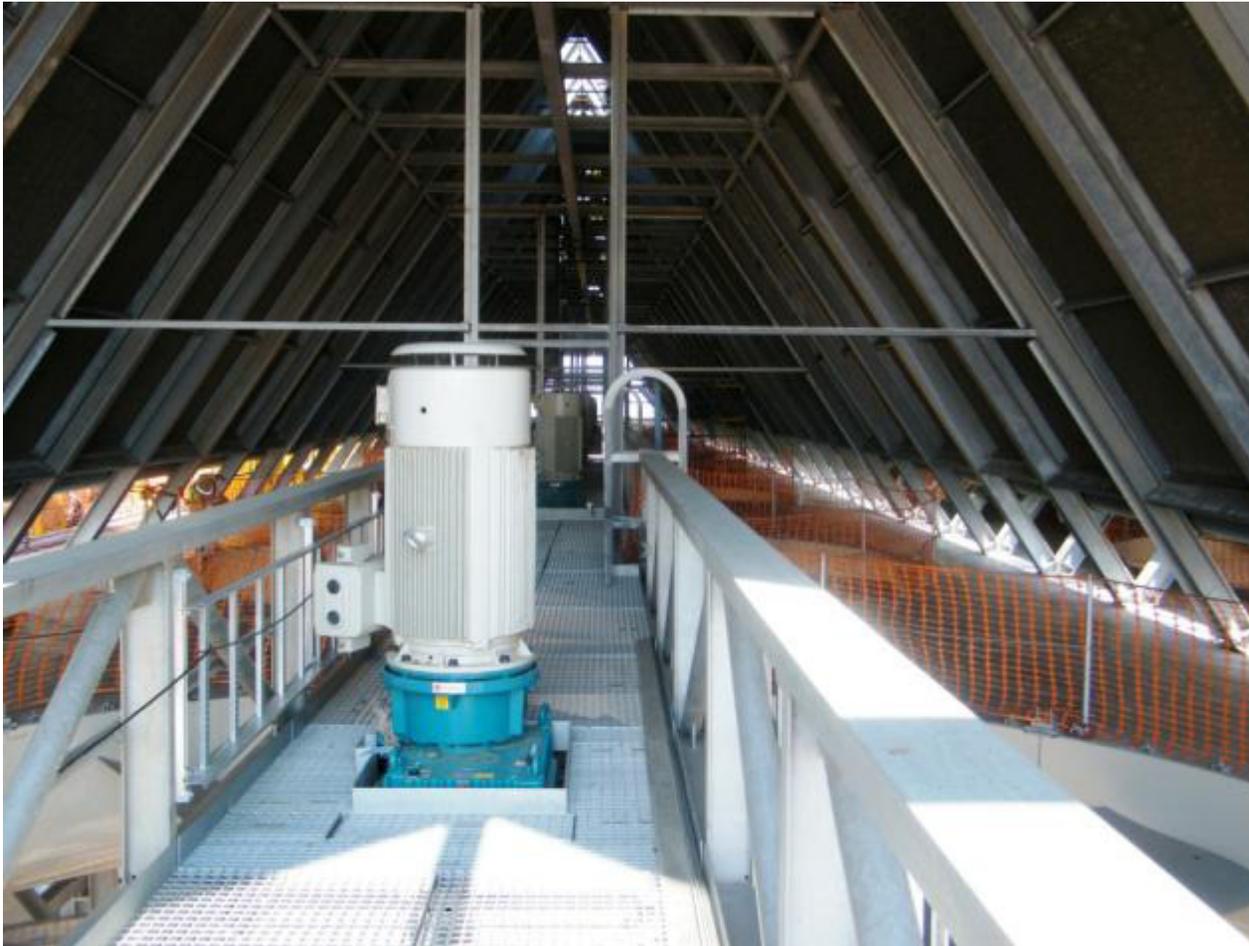
- Medupi ACC fan bridges under construction

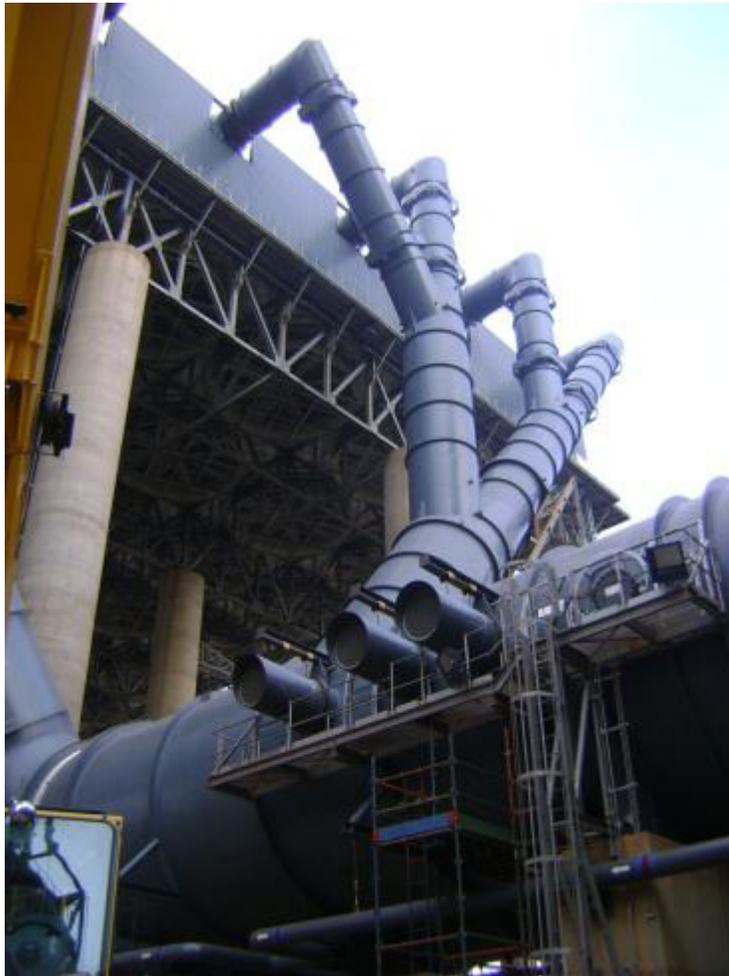
- Medupi exhaust steam ducting and ACC auxiliary building under the ACC

- ACC auxiliary building underneath the ACC, containing the main condensate extraction pumps, ACC condensate tank and steam jet air ejectors (2 x 100% hogging ejectors, 2 x 100% holding ejectors)
- 200 m<sup>3</sup> ACC condensate tank, located within ACC auxiliary building under the ACC
- 100 m<sup>3</sup> Turbine condensate tank (TCT), for collecting miscellaneous turbine and ACC ducting drains, located in the turbine hall
- 1 x 200% (start-up) TCT drain pump
- 2 x 100% (normal operation) TCT drain pump
- (TCT drain pumps return ACC ducting & turbine drains to ACC condensate tank)

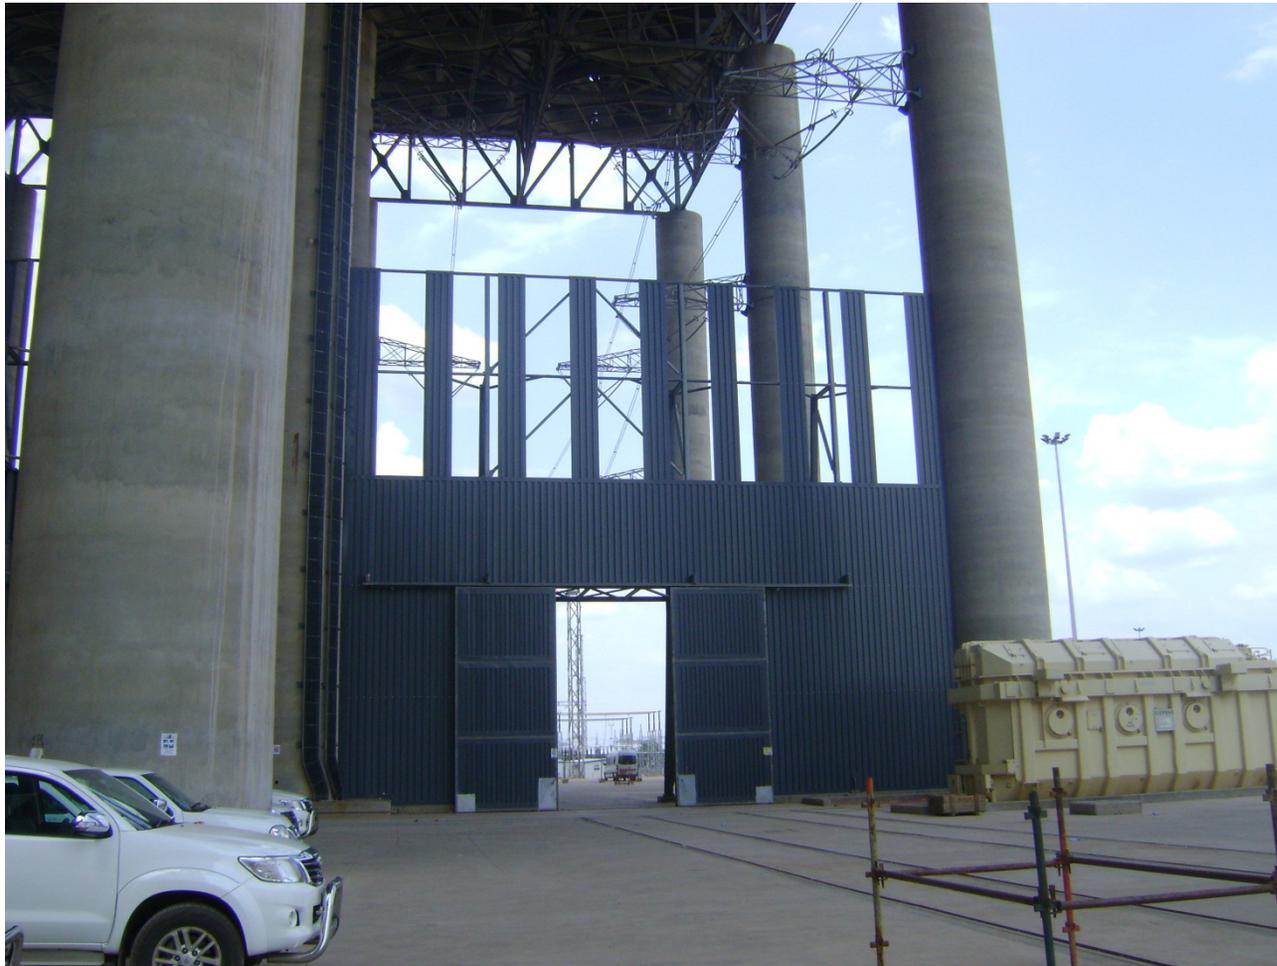
- Medupi ACC wind-cross panel with door

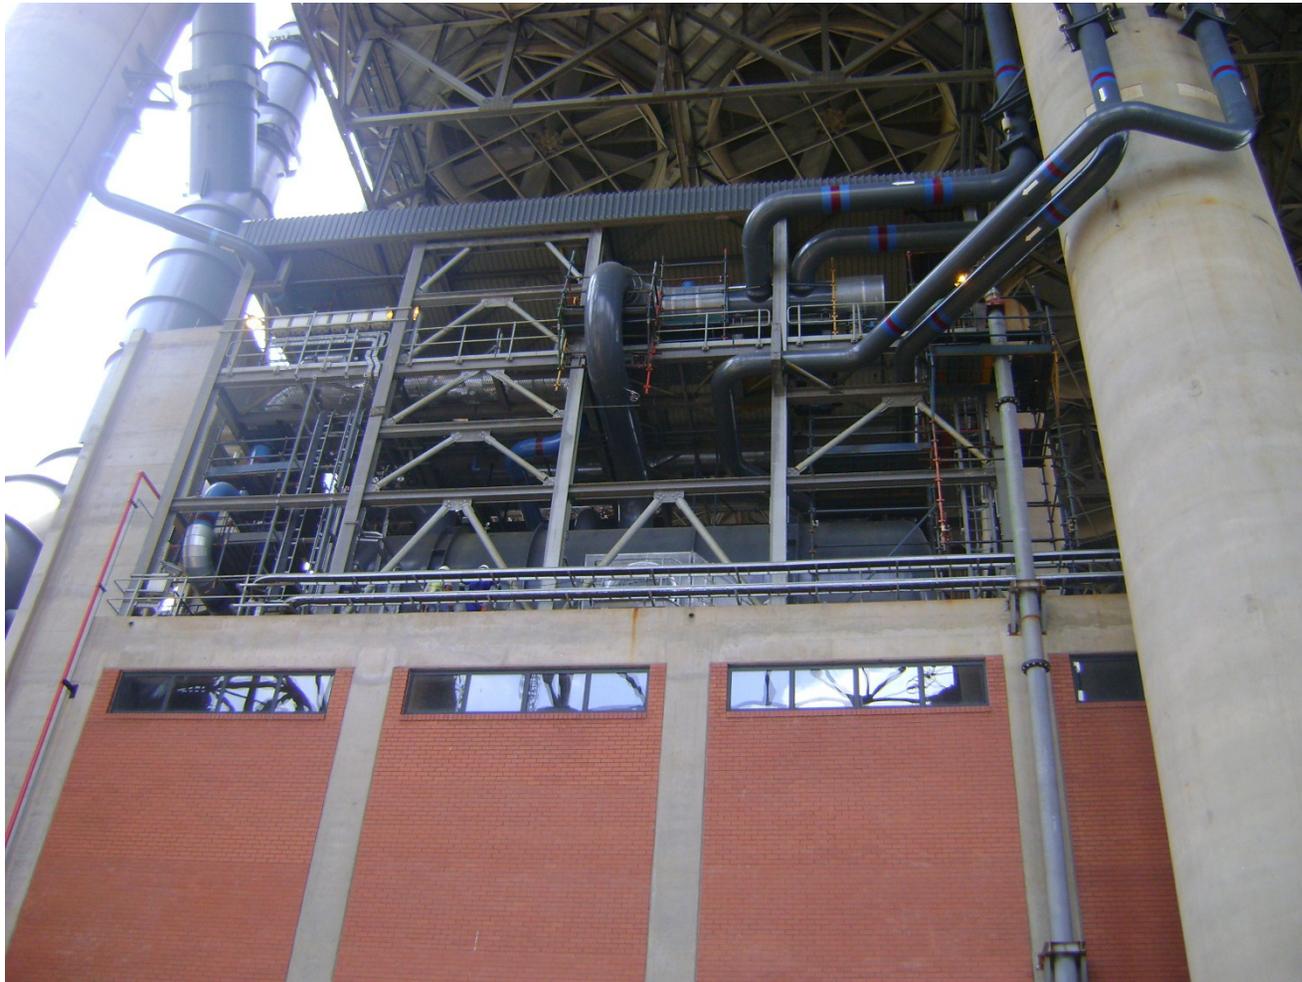
- ACC auxiliary building, with dump line routed to ground level (on the right)

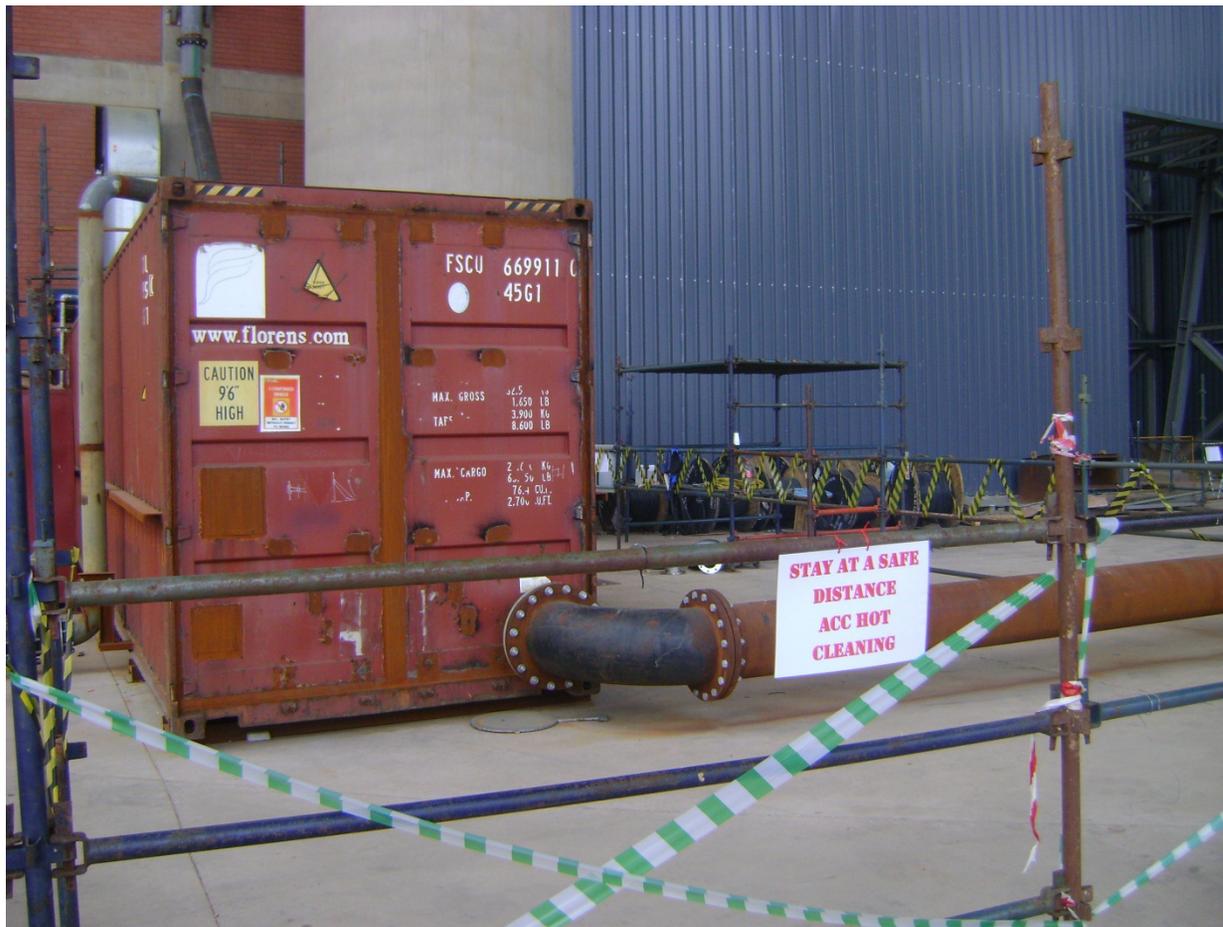
- ACC hot cleaning dump tank (container), with dump line entering the tank, and discharge line routed to station drains

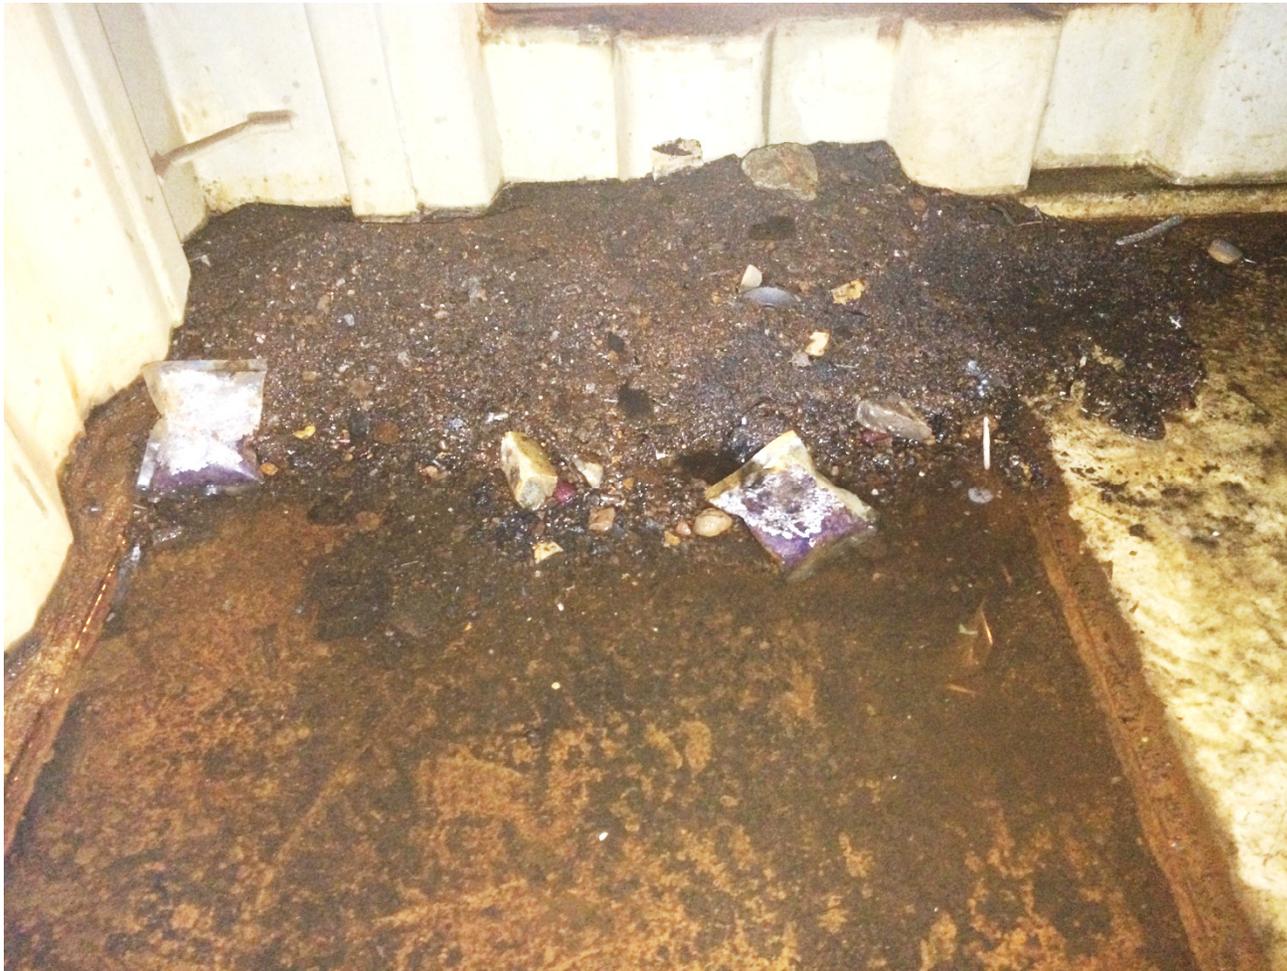
- Debris from the ACC found in the dump tank part-way through the process

- Less debris collected in dump tank than expected. However some large objects found in the dump tank
- Online TSS sensor proved to be inaccurate. Samples taken to lab for analysis instead
- Samples taken for mostly for each row-pair configuration in operation
- Samples of condensate revealed how quickly ACC was being cleaned
- Other delays during ACC hot cleaning not related to ACC:
  - Boiler trips, turbine barring gear motor trips, demin water supply shortage, tank level controls
  - Due to the above, time required in terms of overall schedule to complete the ACC hot cleaning activity was approx. 3 weeks

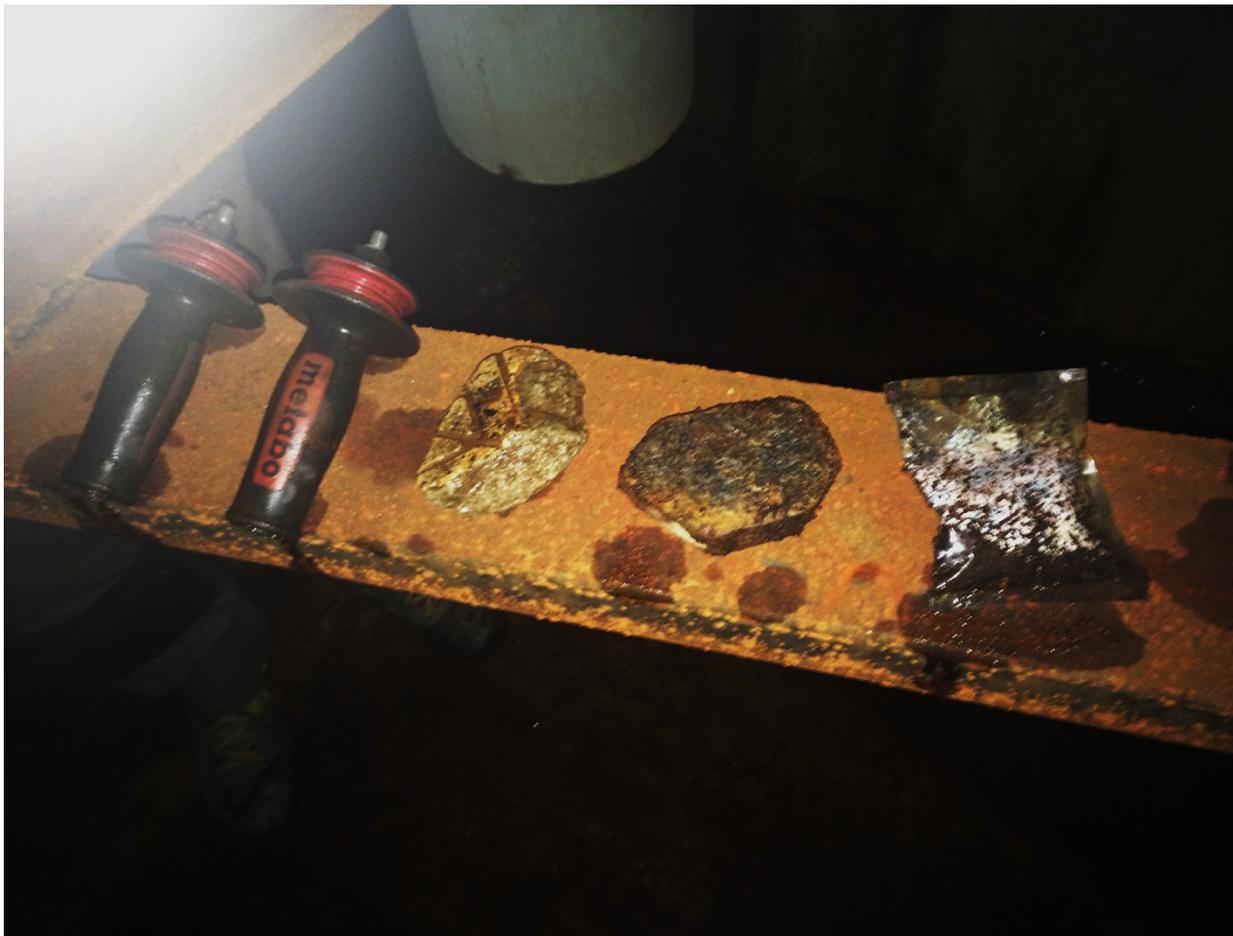
- Some of the larger objects found in the dump tank (grinder handles, rocks and desiccant bags)

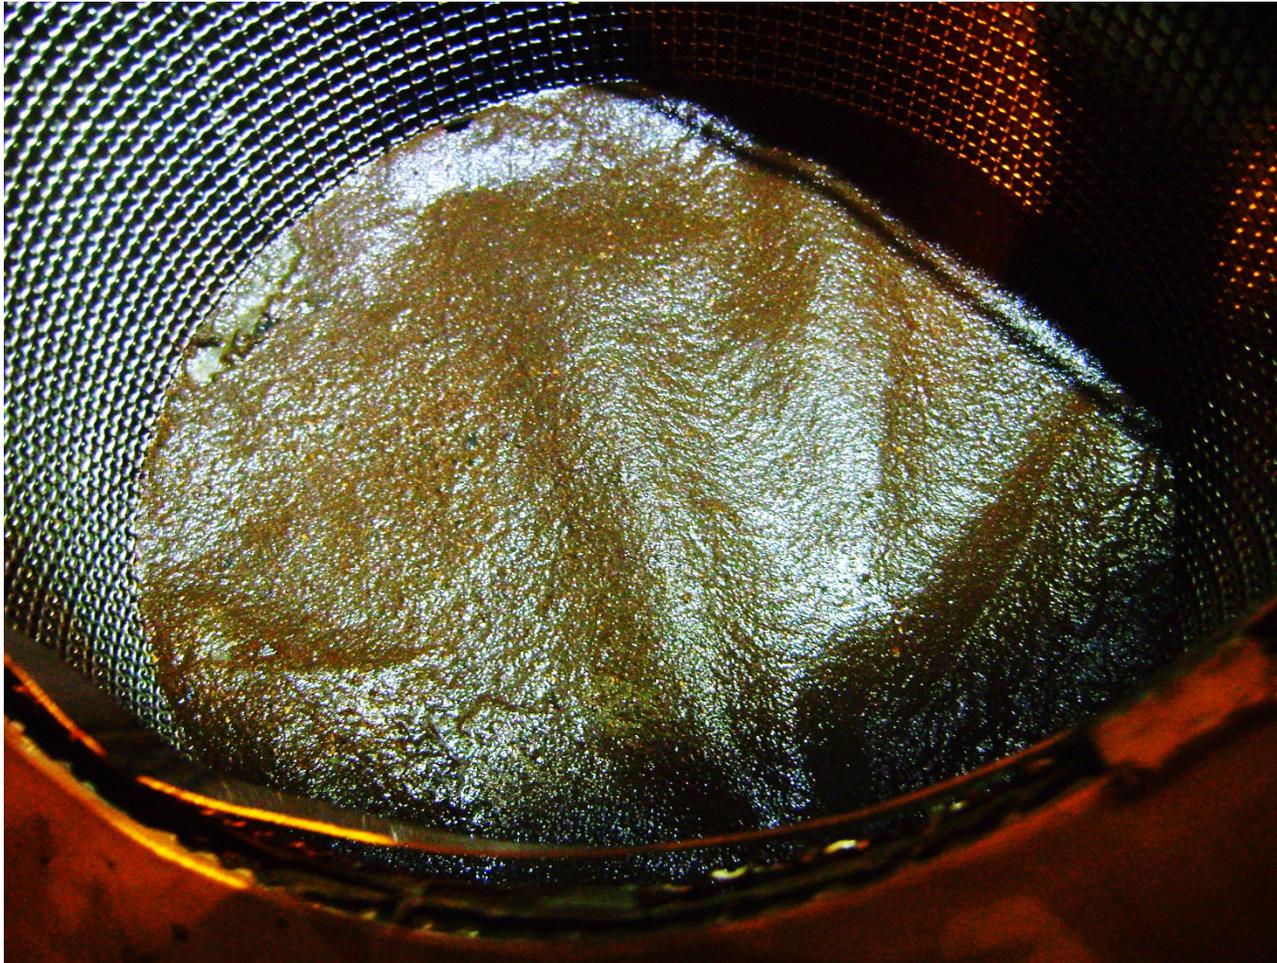
- Blocked TCT drain pump strainer

- Thermal photographs of various components did not reveal any cold spots, blockages or evident problems
- Initially blocking of TCT drain pump strainers a major problem
  - 150 micron strainers of all 3 TCT drain pumps blocked (pressure differential measurement) within 2 minutes of steam admission to ACC
  - Hot cleaning process has to stop (boiler shut down) to avoid filling ACC exhaust ducting with condensate and over-filling TCT
  - Strainers opened, cleaned and replaced after blocking – taking approx. 30 minutes per strainer
  - Source of major delays to ACC hot cleaning process, exacerbated by instability of the Unit at the time.
  - Problem eventually solved by installing a 1mm strainer on one of the TCT drains pumps to avoid constant blocking

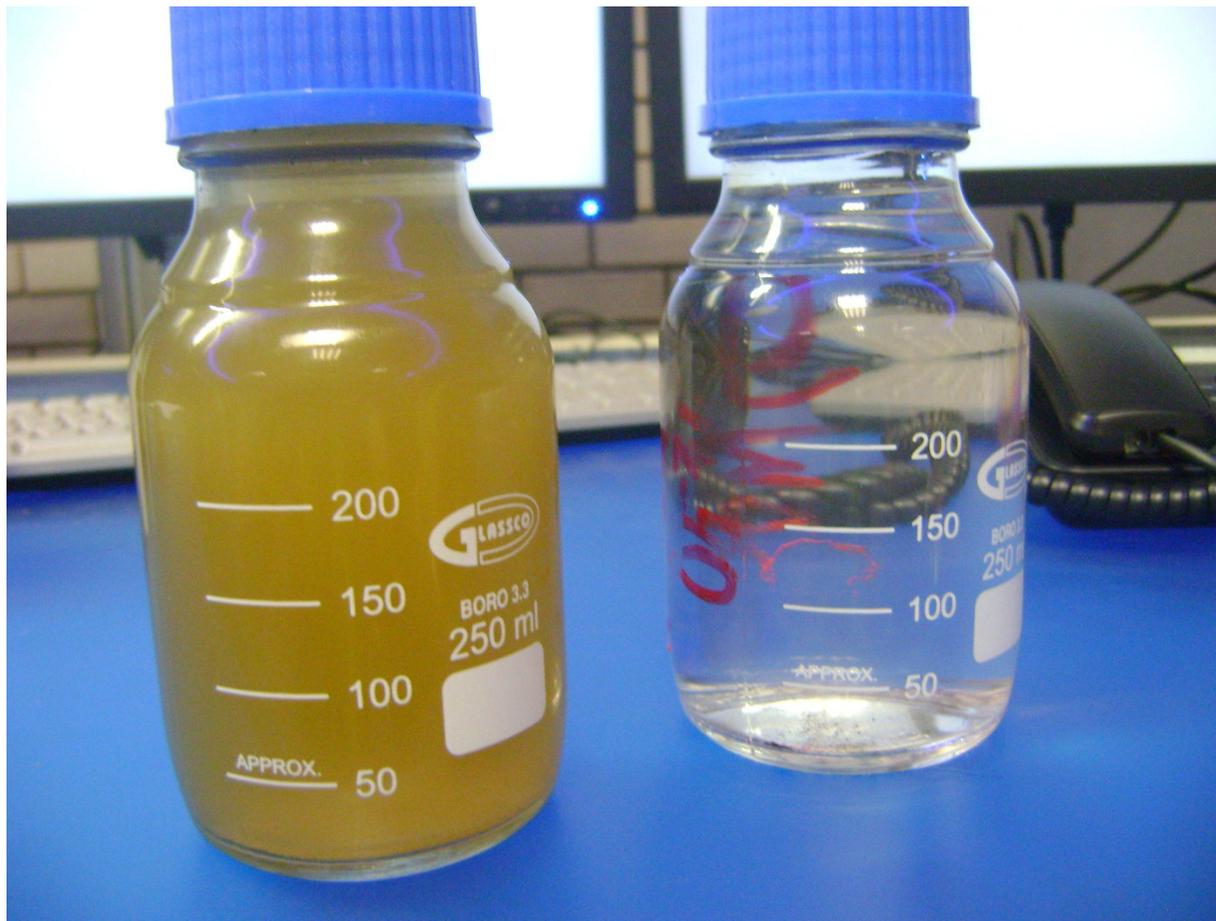
- 1<sup>st</sup> (left) and 2<sup>nd</sup> (right) condensate samples taken from the dump line during ACC hot cleaning (samples taken a couple of hours from each other)
