Walter Higgins Generation Station

By David Rettke
Maintenance Specialist
WALTER M. HIGGINS III
GENERATION STATION
PRIMM NEVADA

WHAT IS THE CONDITION OF YOUR ACC SYSTEM?

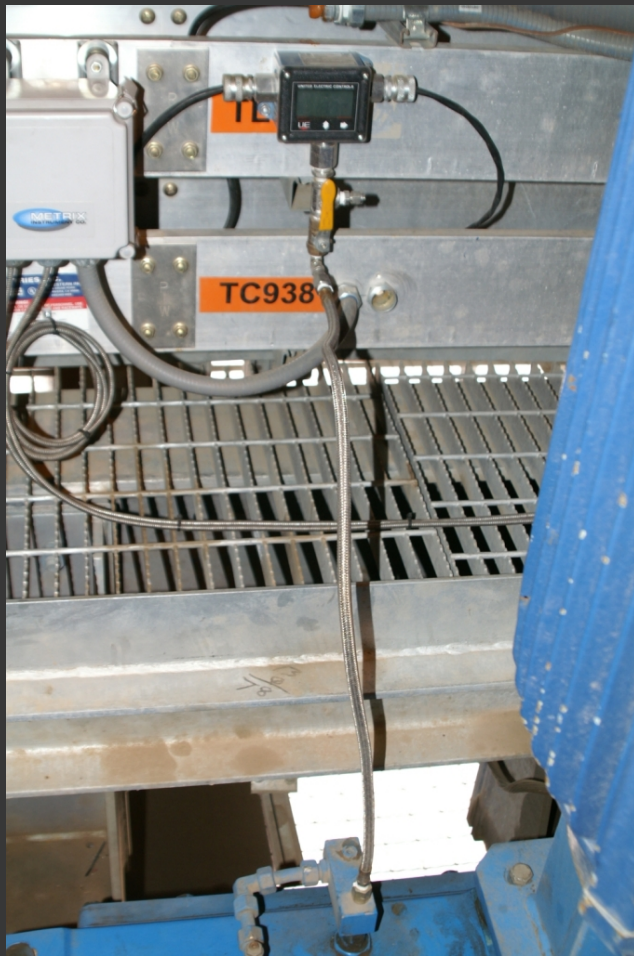
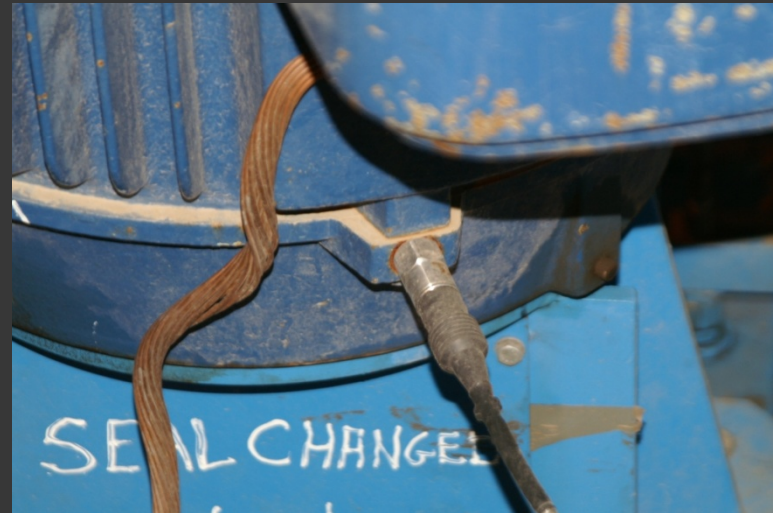
Oil pressure and vibration

- We found a need to monitor vibration and oil pressure remotely.
- It was determined that one accelerometer on the motor and one on the gear-reducer would monitor vibrations sufficiently enough for a warning as well as sending data to PI
- Oil pressure is monitored through a digital pressure gauge that allows data to be sent to PI.
- PI screen for ACC is utilized during weekly walk-down inspections so trends can show a need for closer inspection on equipment.

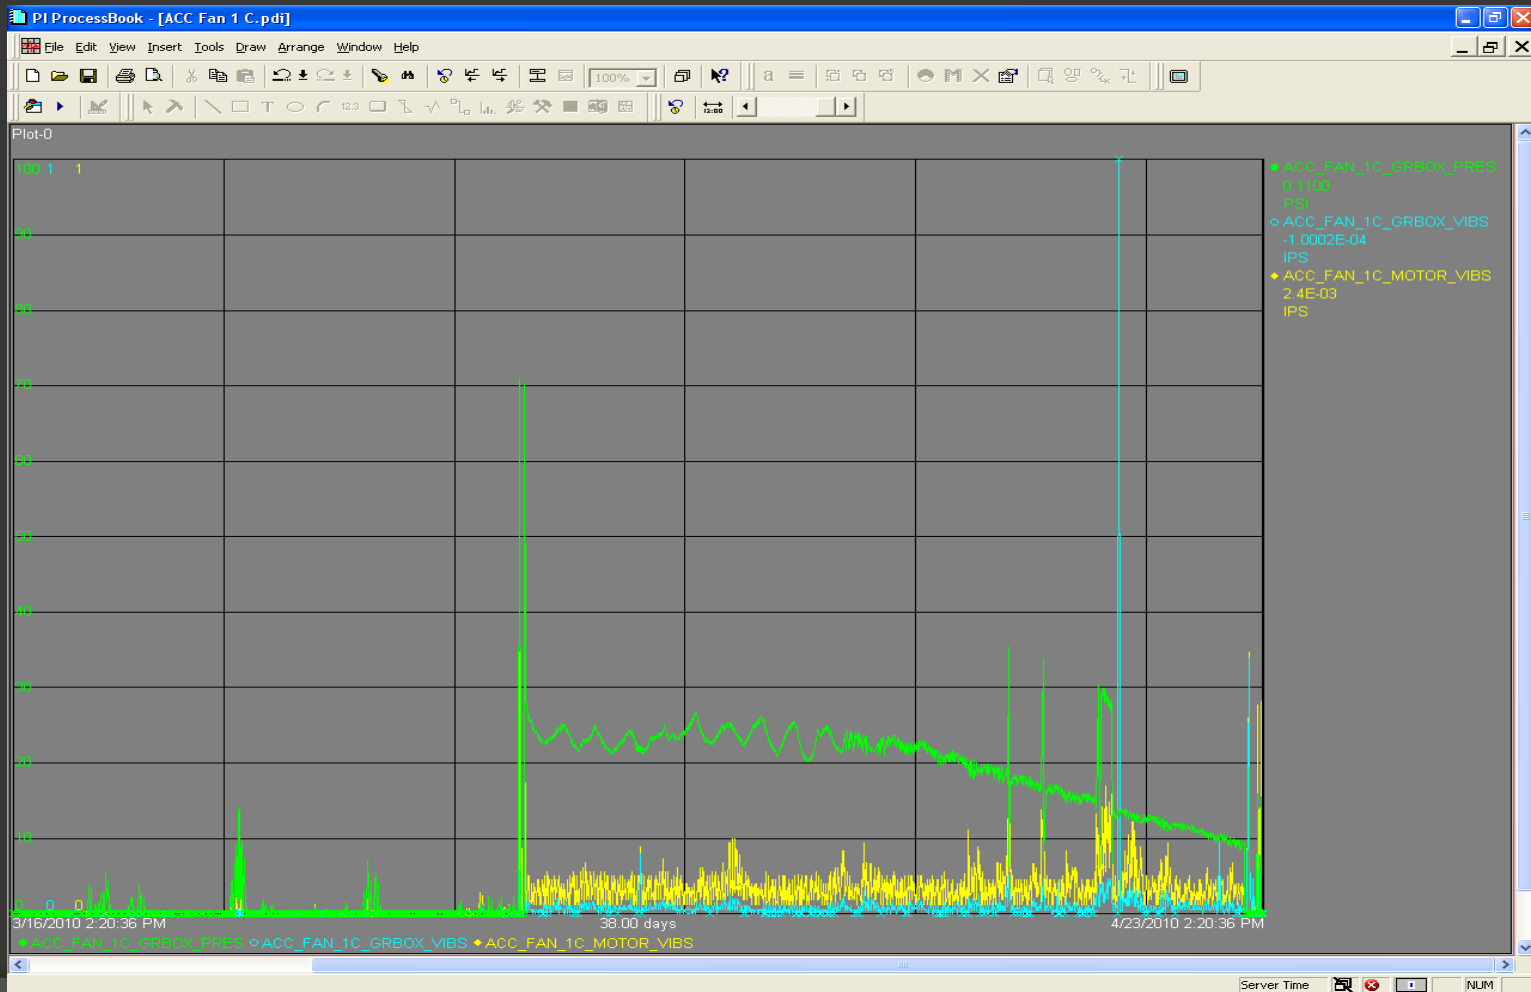
- Right after installation of the oil pressure/vibration units we caught a gear-reducer oil pump failure. It showed up as a sudden and immediate drop in oil pressure.
- We've trended eight gear-reducer filter clean/change's. (as seen in next slide) These are seen as a gradual dropping of oil pressure in operation.

Typical trend showing lube oil pressure drop off due to clogging filter.

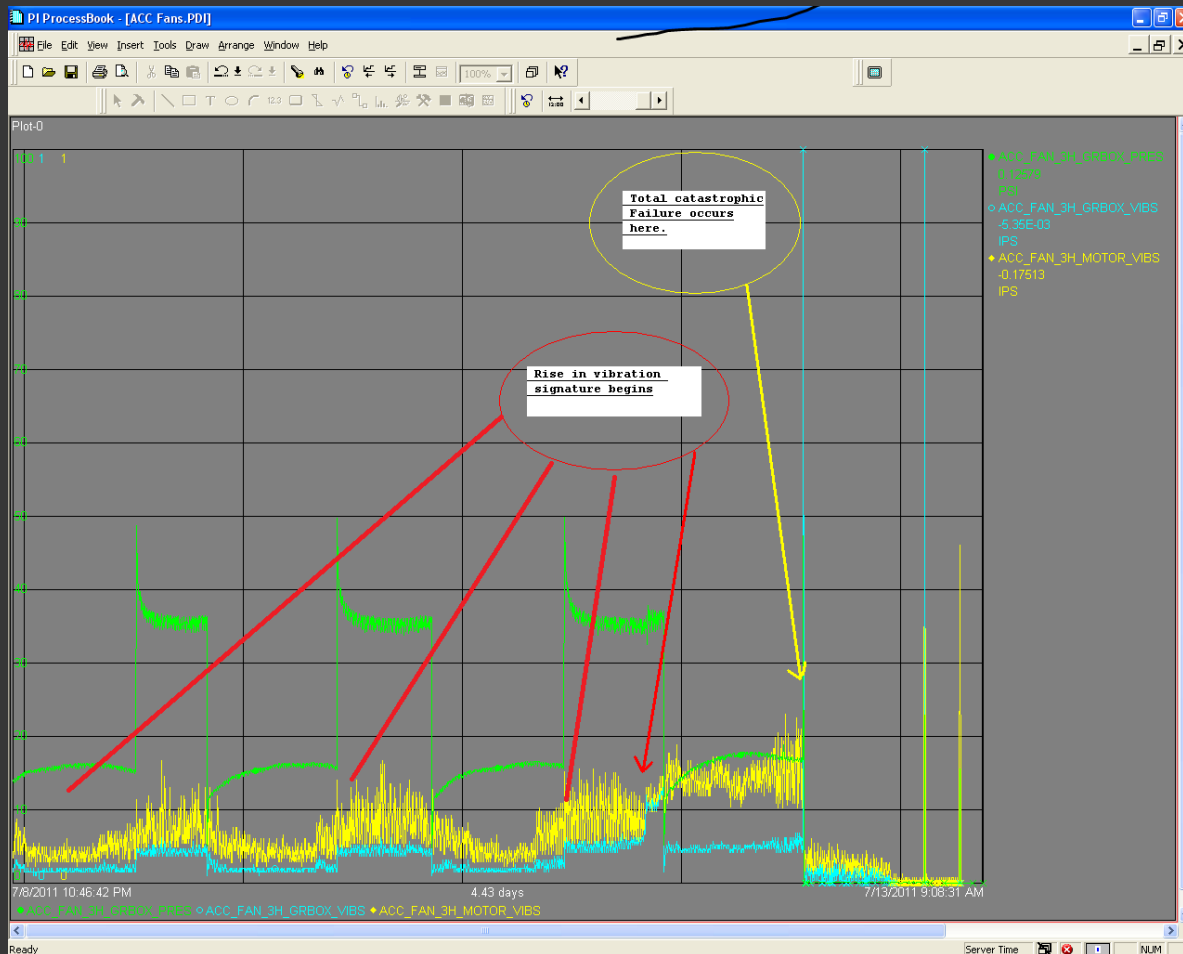
Catastrophic Gear reducer failure

- Because we can monitor our ACC unit's individually, we were able to trend this issue weeks before failure.
- The time gained allowed us to gear up for the change, ensure parts were onsite and set up outside assistance for the job and to schedule unit for down time.
- Gave us a background on vibration and oil pressure signatures for future troubleshooting.

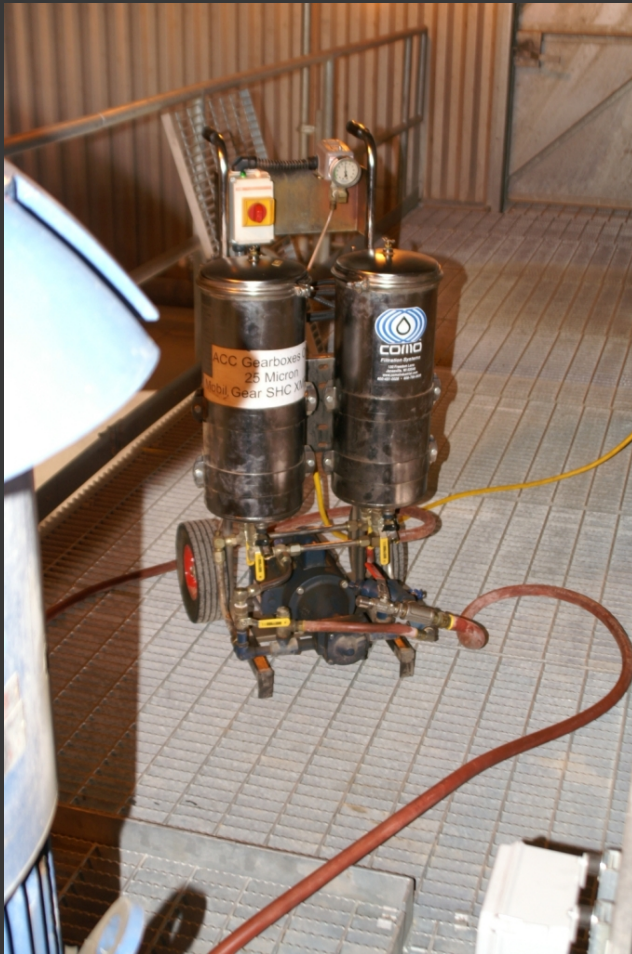
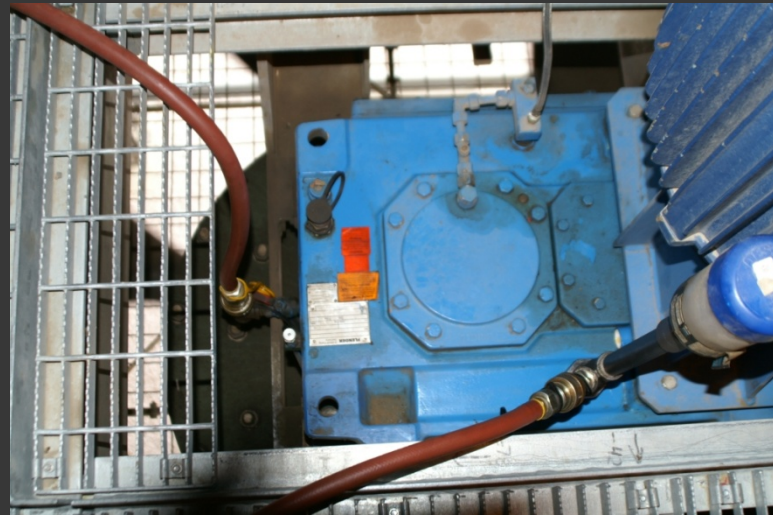
- We now use two filter carts manufactured by Y2K.
- They handle the Mobil gear oil SHC XMP ISO 320 well, though this lube is very 'stiff', (high viscosity) even when warm.
- We filter long enough to allow for a minimum of eight 'changes' of lube.
- We changed the oil out at the five year mark due to physical changes in the chemical makeup of the oil.
- The Y2K cart filters to 7 microns. Both carts have the capability to remove water as well.

Filtering lube oil using COMO filter cart.

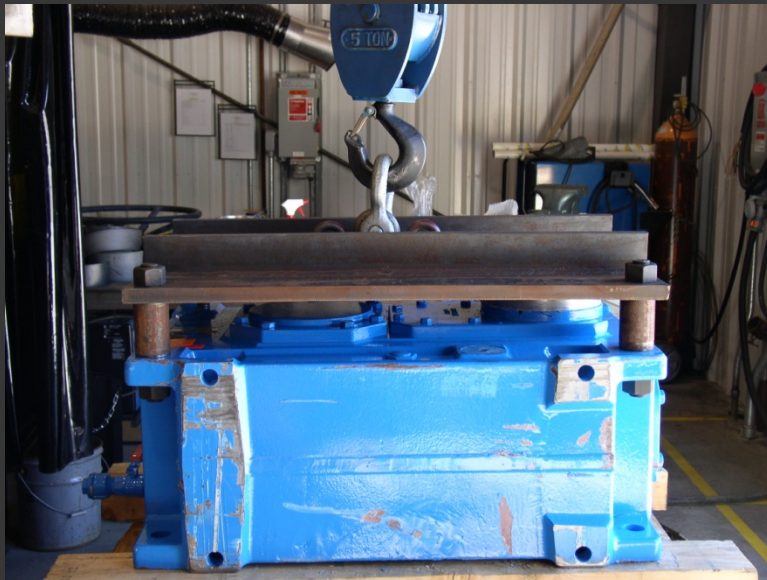
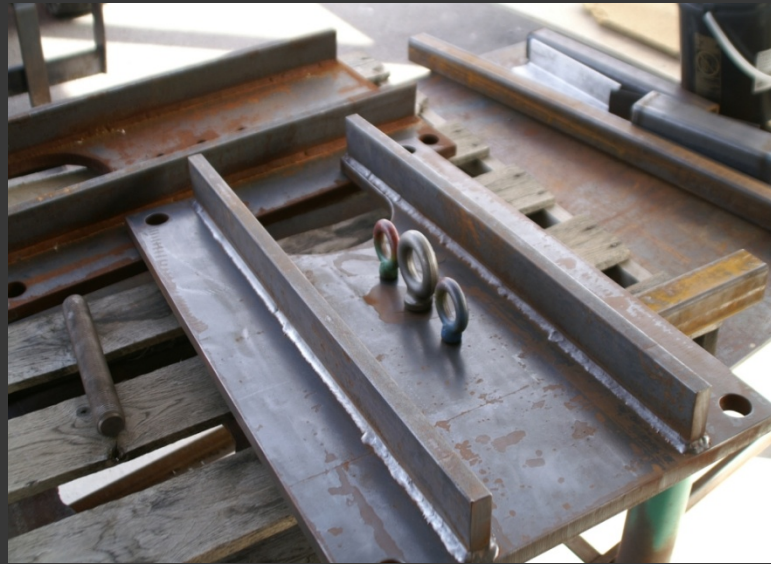
Lifting fixture for gear-reducers

- The fixture lowers rigging height by a substantial amount, allowing gear-reducer to be moved safely without removing doors or headers in each cell.
- 3 individual picking eyes mounted on fixture allows for a positive and safe rigging change from hoist to crane while suspending gear-reducer.

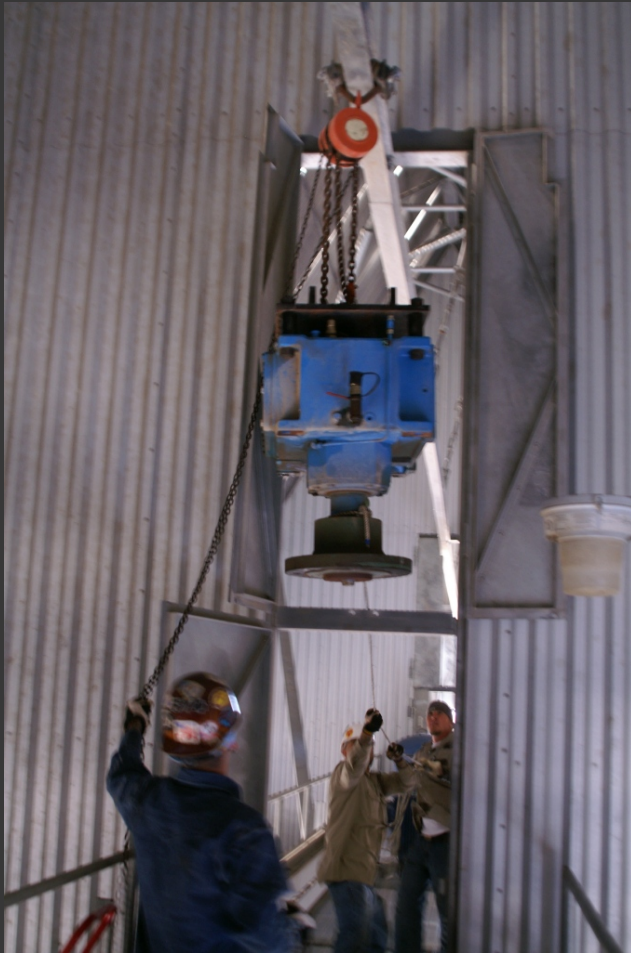
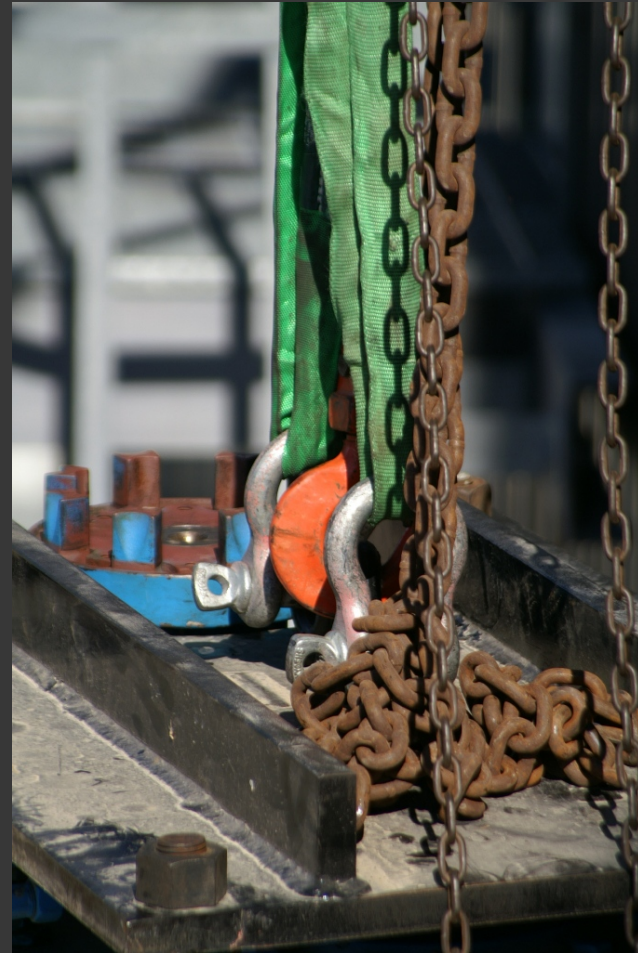
SAFE HANDLING OF REDUCERS

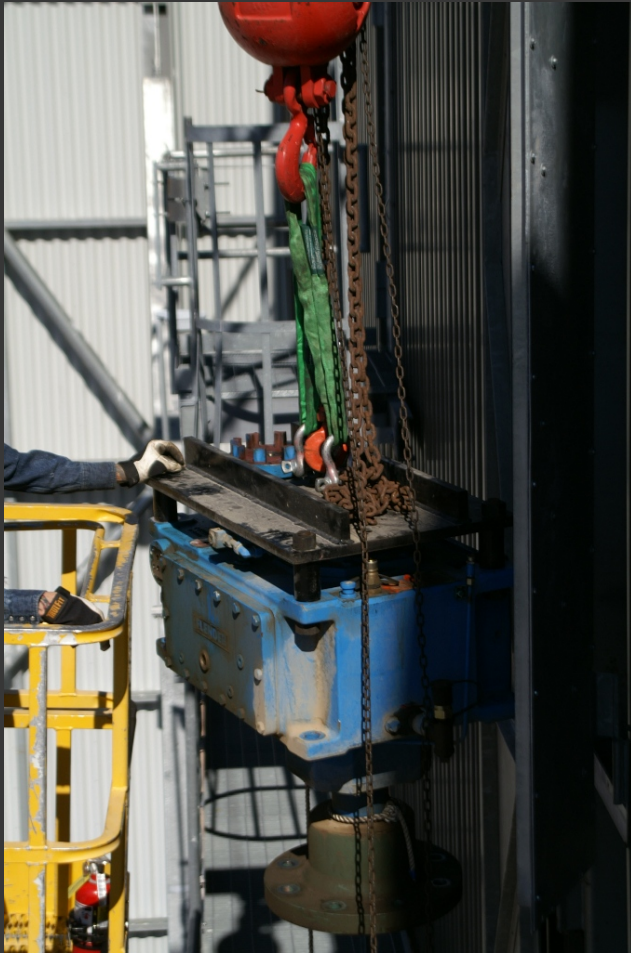
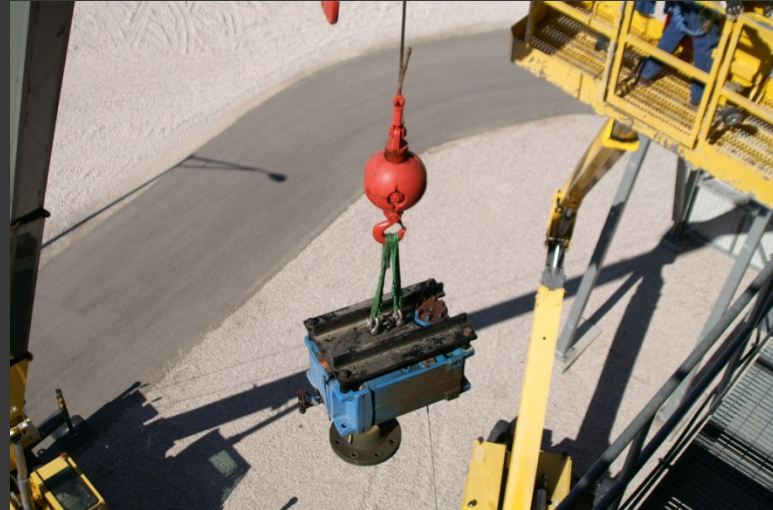
TRANSFERRED TO MOBILE CRANE SAFELY AND EFFICIENTLY

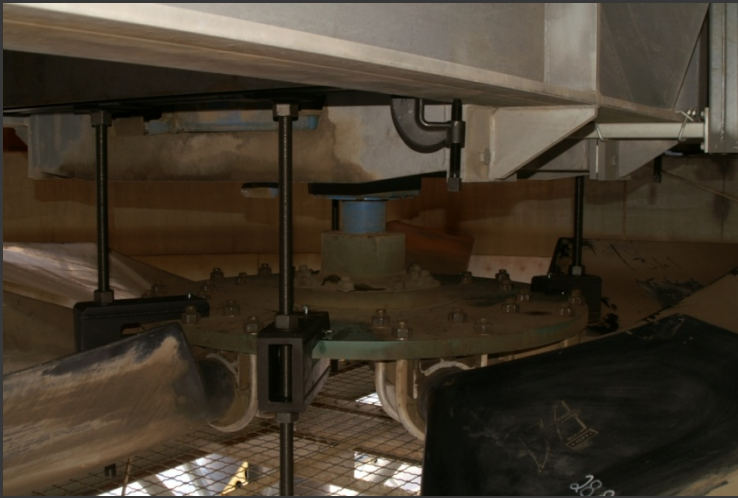
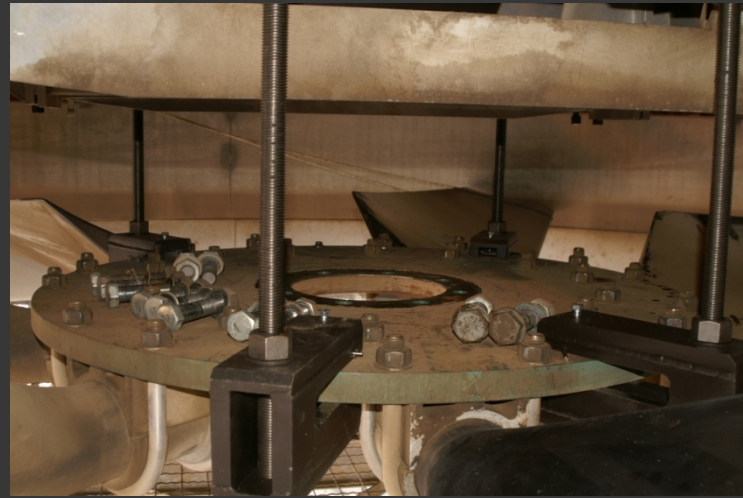
Hub and Blade Fixture

- Fixture bolted to hub assembly
- Reducer removed, hub stays in position

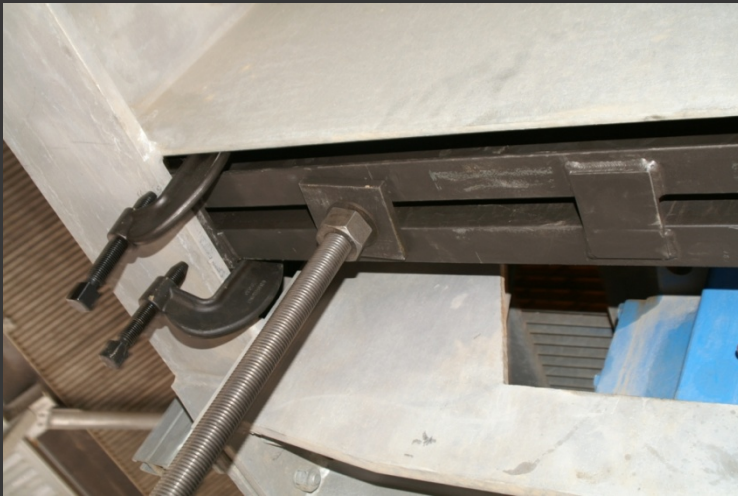
Fixture installed on bridge

- West end of fixture in place

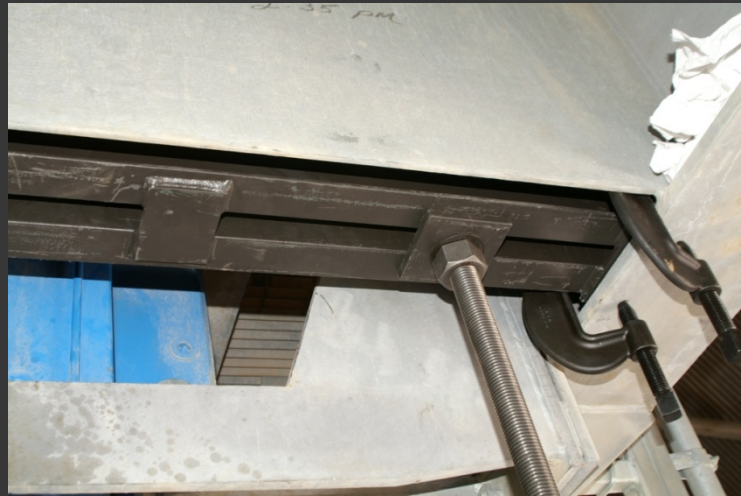
- East end of fixture in place

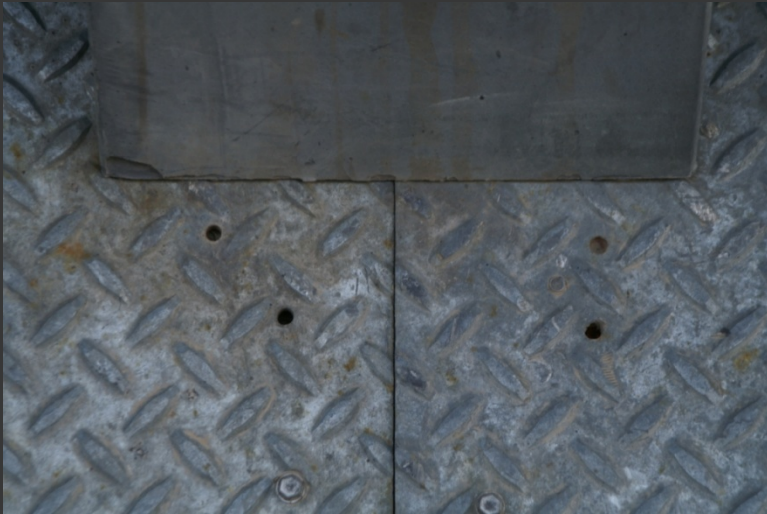
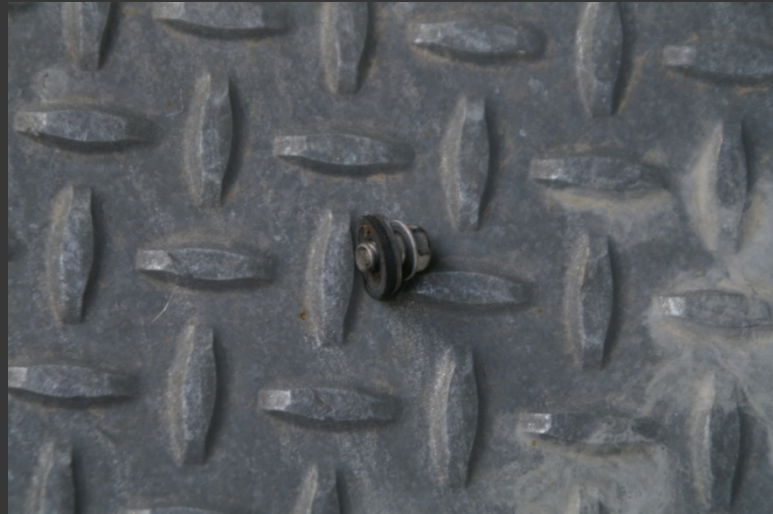
Decking issue caught by walk-downs

- A 3/8" hole drilled in deck plate.
- A 1/4" pan head bolt threaded into deck support beam.
- A 'Fender-washer' used to complete fastening, allows for movement between deck plate and support beam
- Bolt is lock-tite held in position

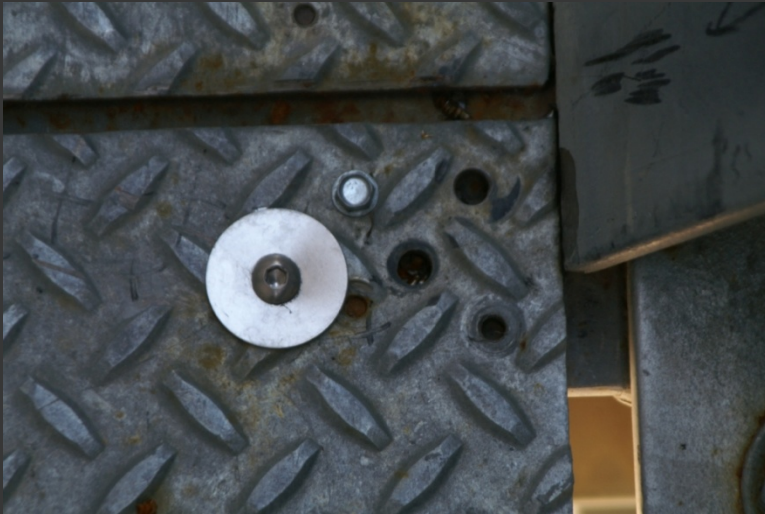
Repair procedure for decking (CBM related fix)

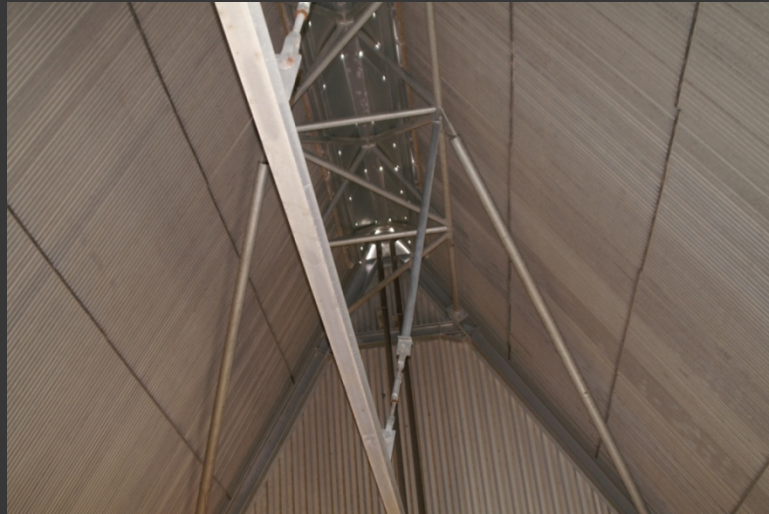
Finding structural issues

- Noted that over time turnbuckles loosen up. Walk-downs catch these and repairs are scheduled to fix.
- Lock nuts on turnbuckles are marked when tightened now for easier visual check.

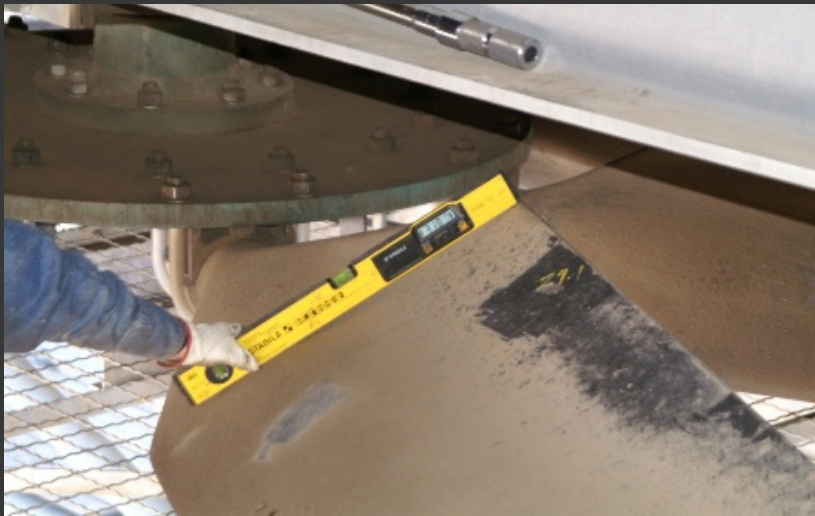
- Hub Angle

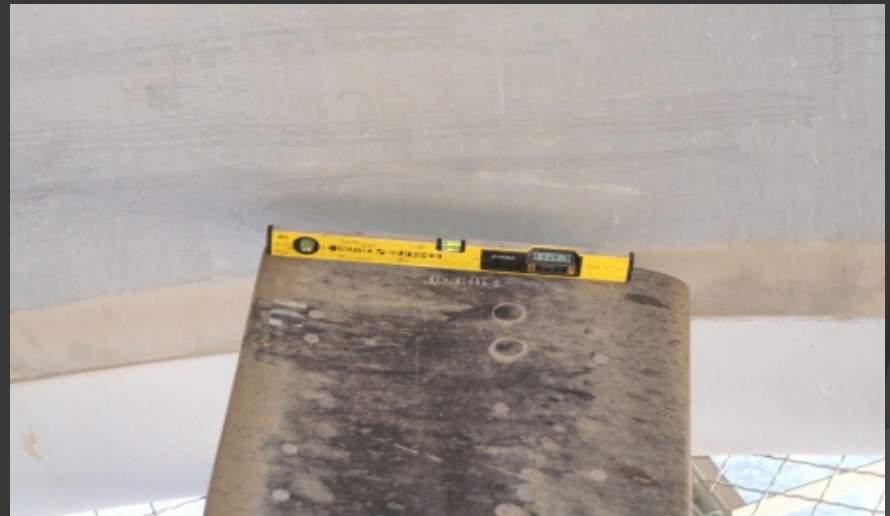
- Tip Angle

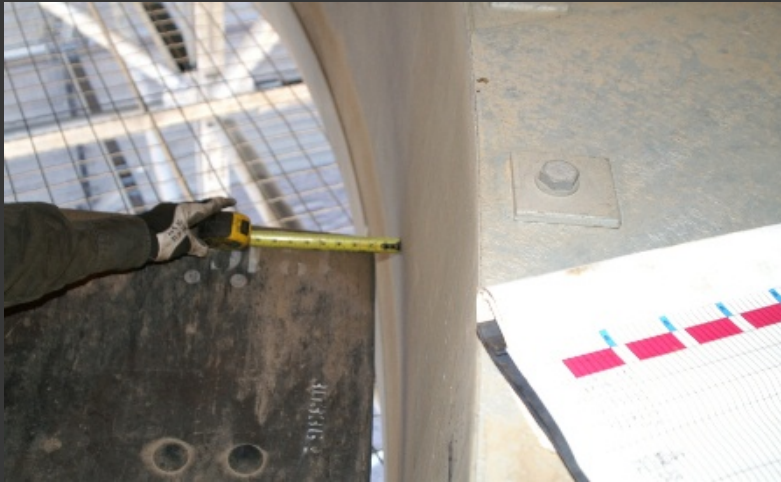
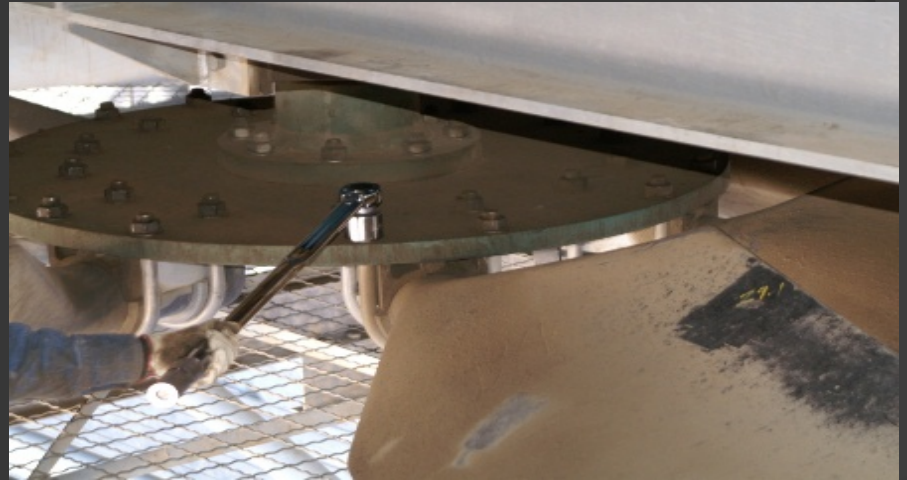
- Blade end clearance
- Fastener Torques

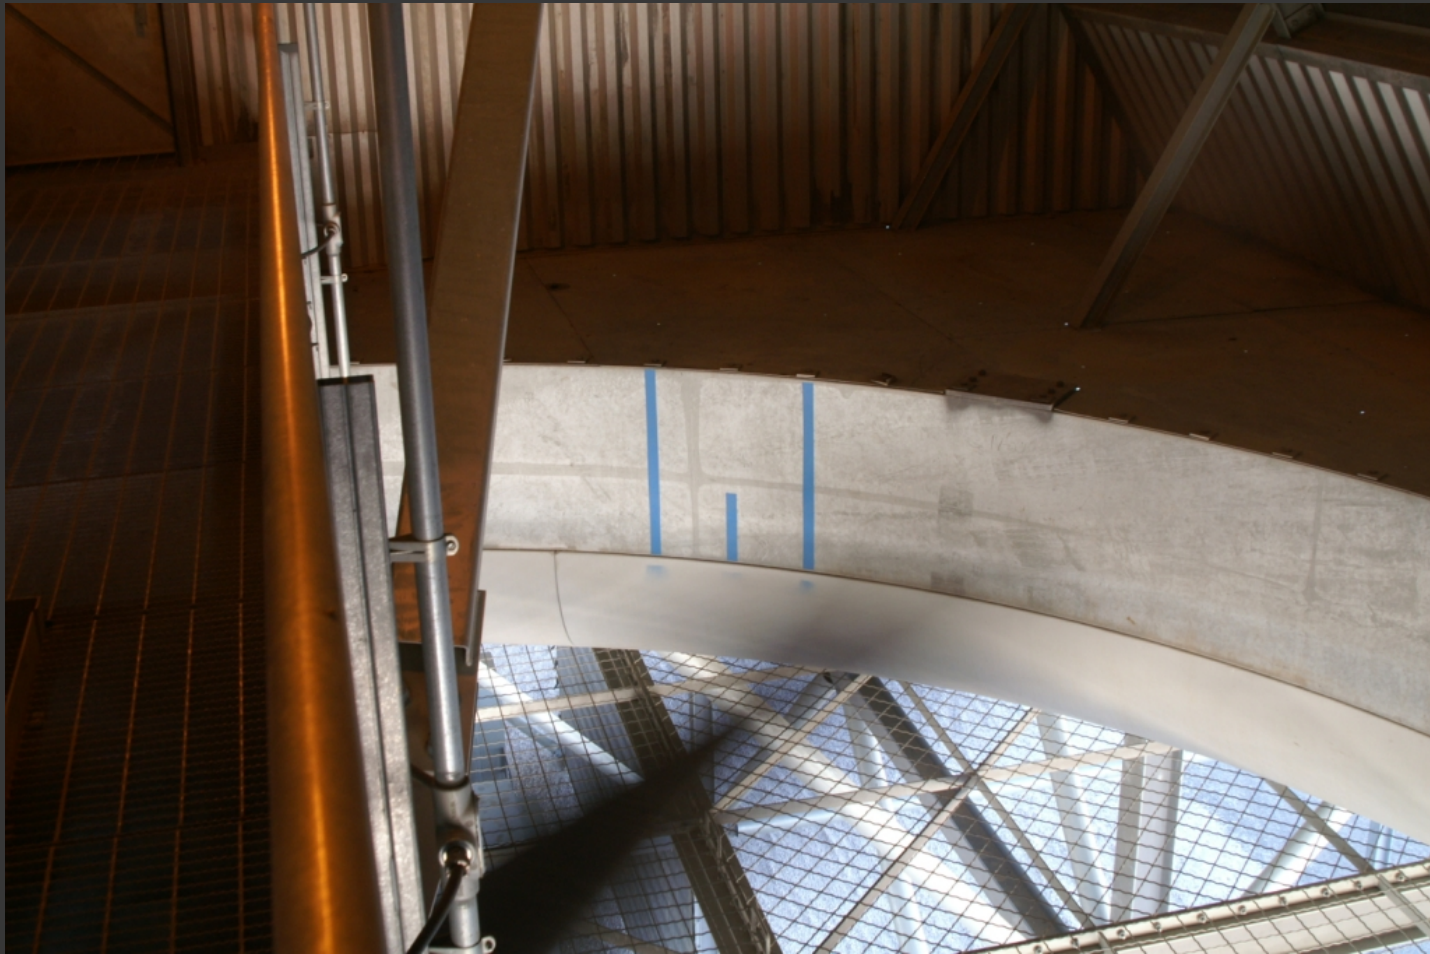
Marked 'Zone' for taking blade measurements

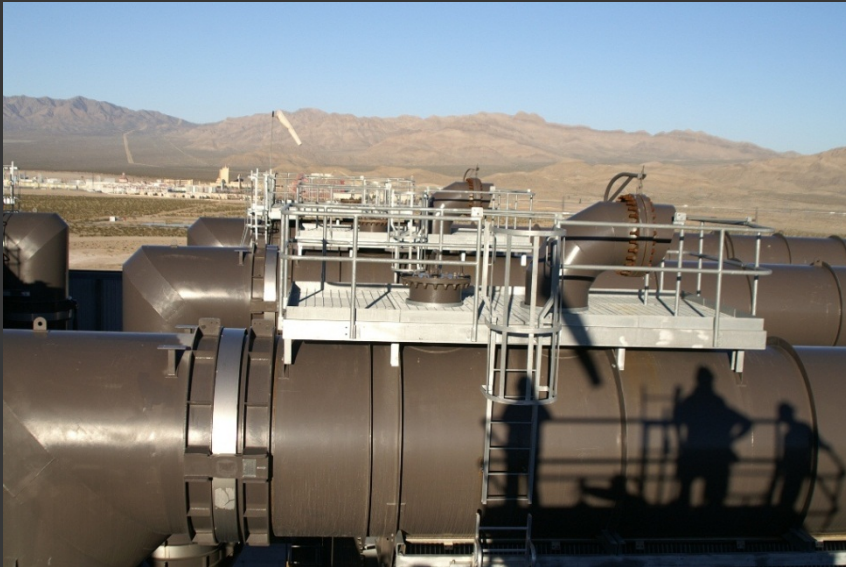
Inspection starts exterior to ducts.

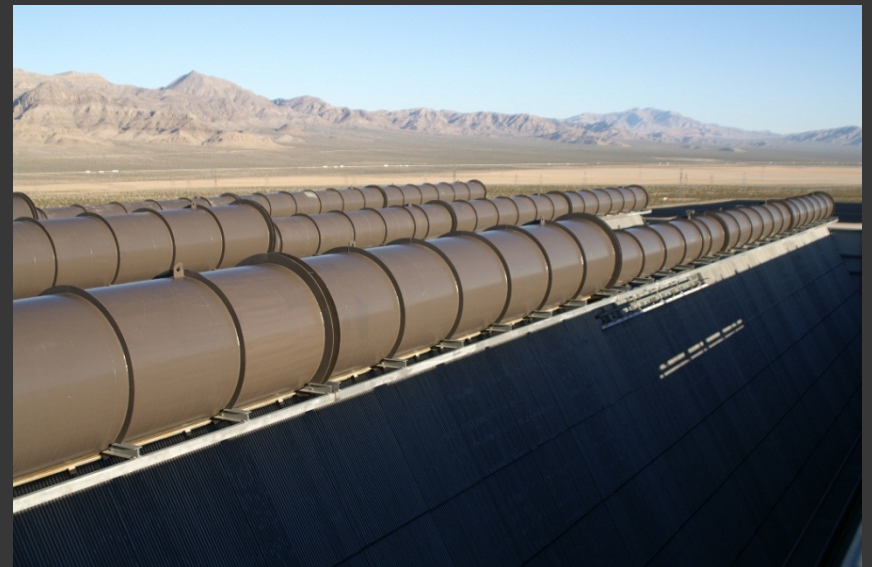
Part of the inspection is rupture disc's and expansion joints (as can be safely reached).

View of other 'streets' from manhole on street 1.

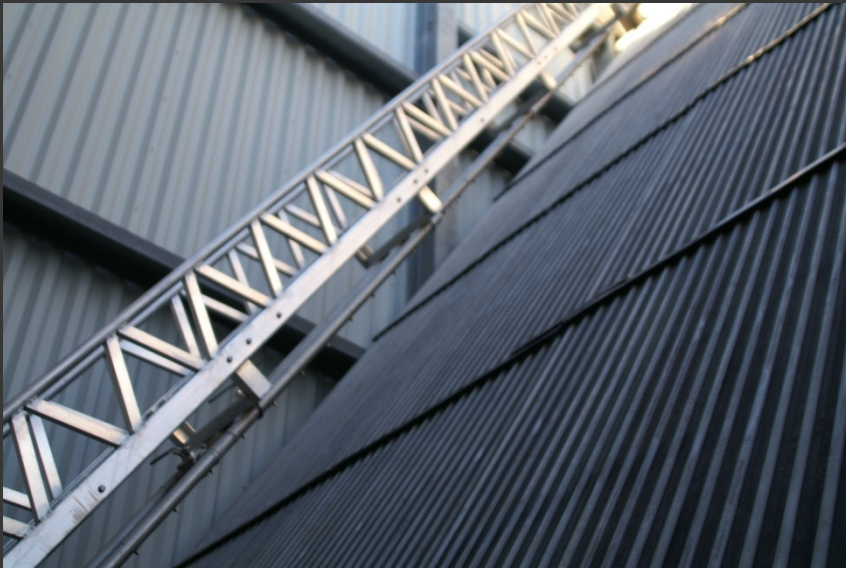
Inspection includes spray clean/ladder

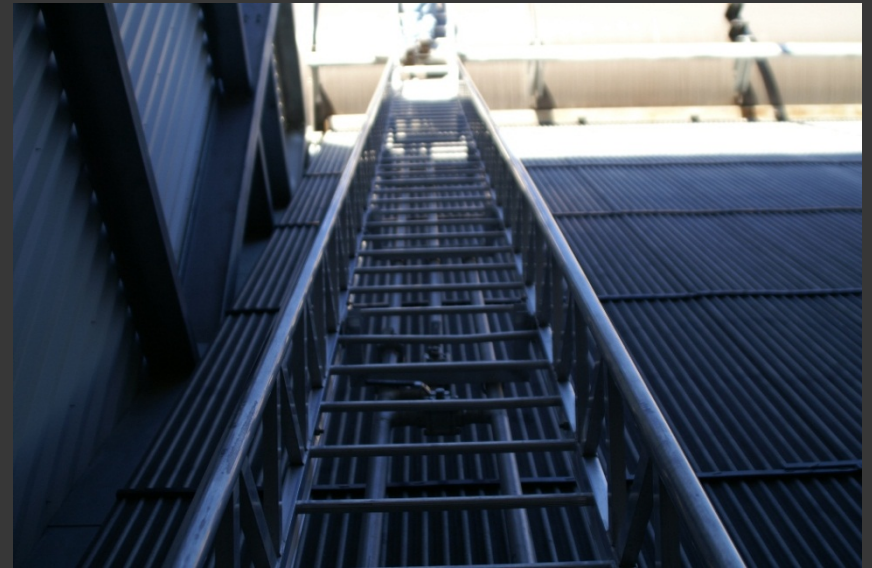
Notice the high pressure spray piping running the length of the ladder.

Valves give choice to which section will be cleaned, upper, mid and lower.

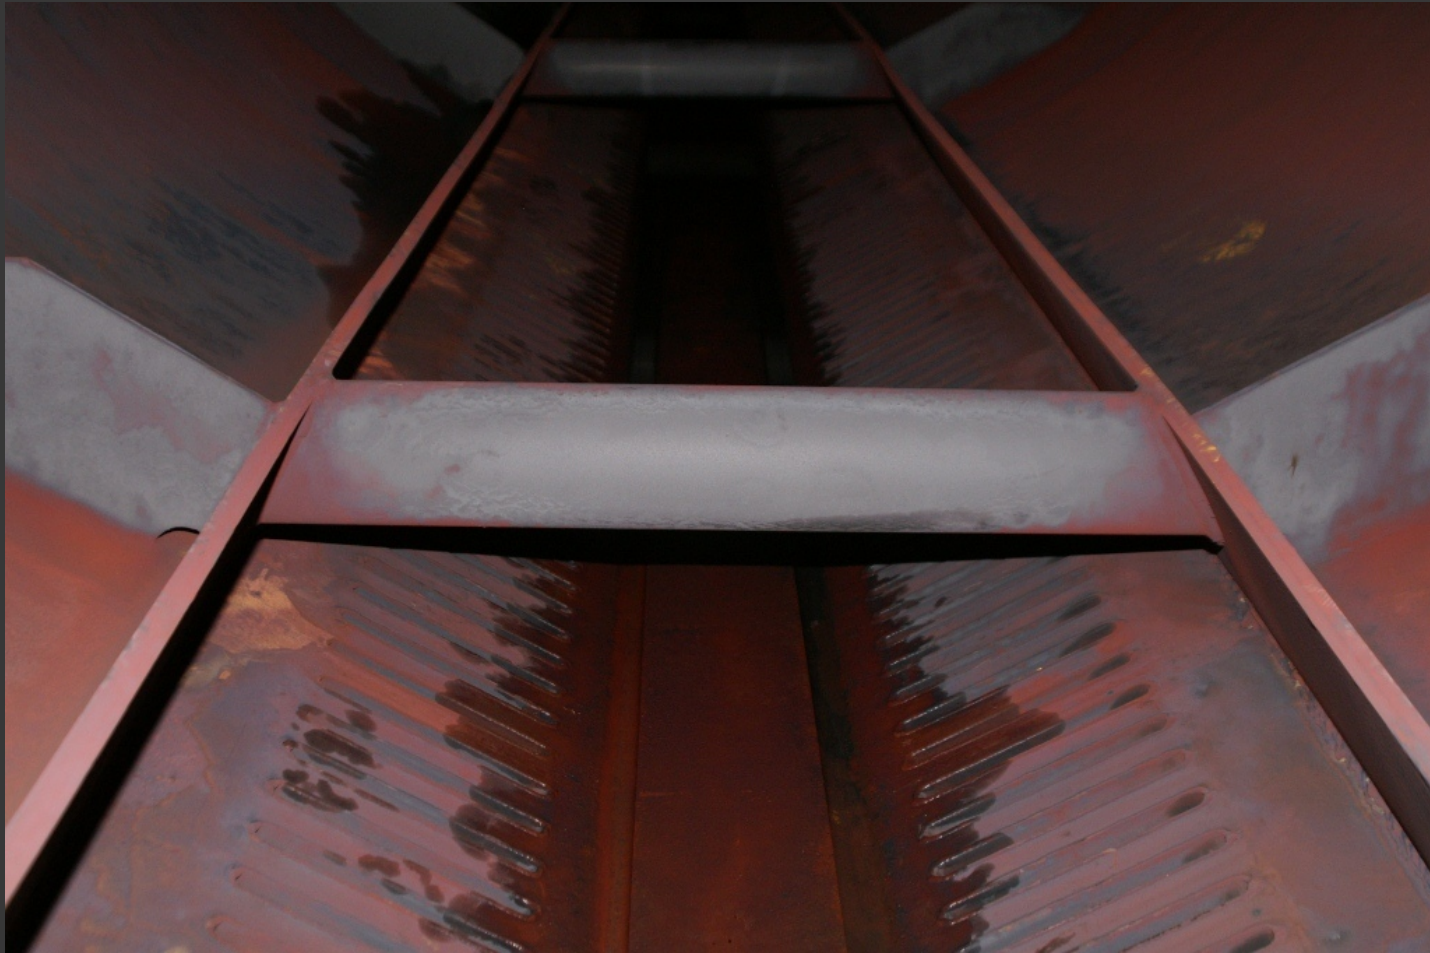
Interior inspection of the top duct

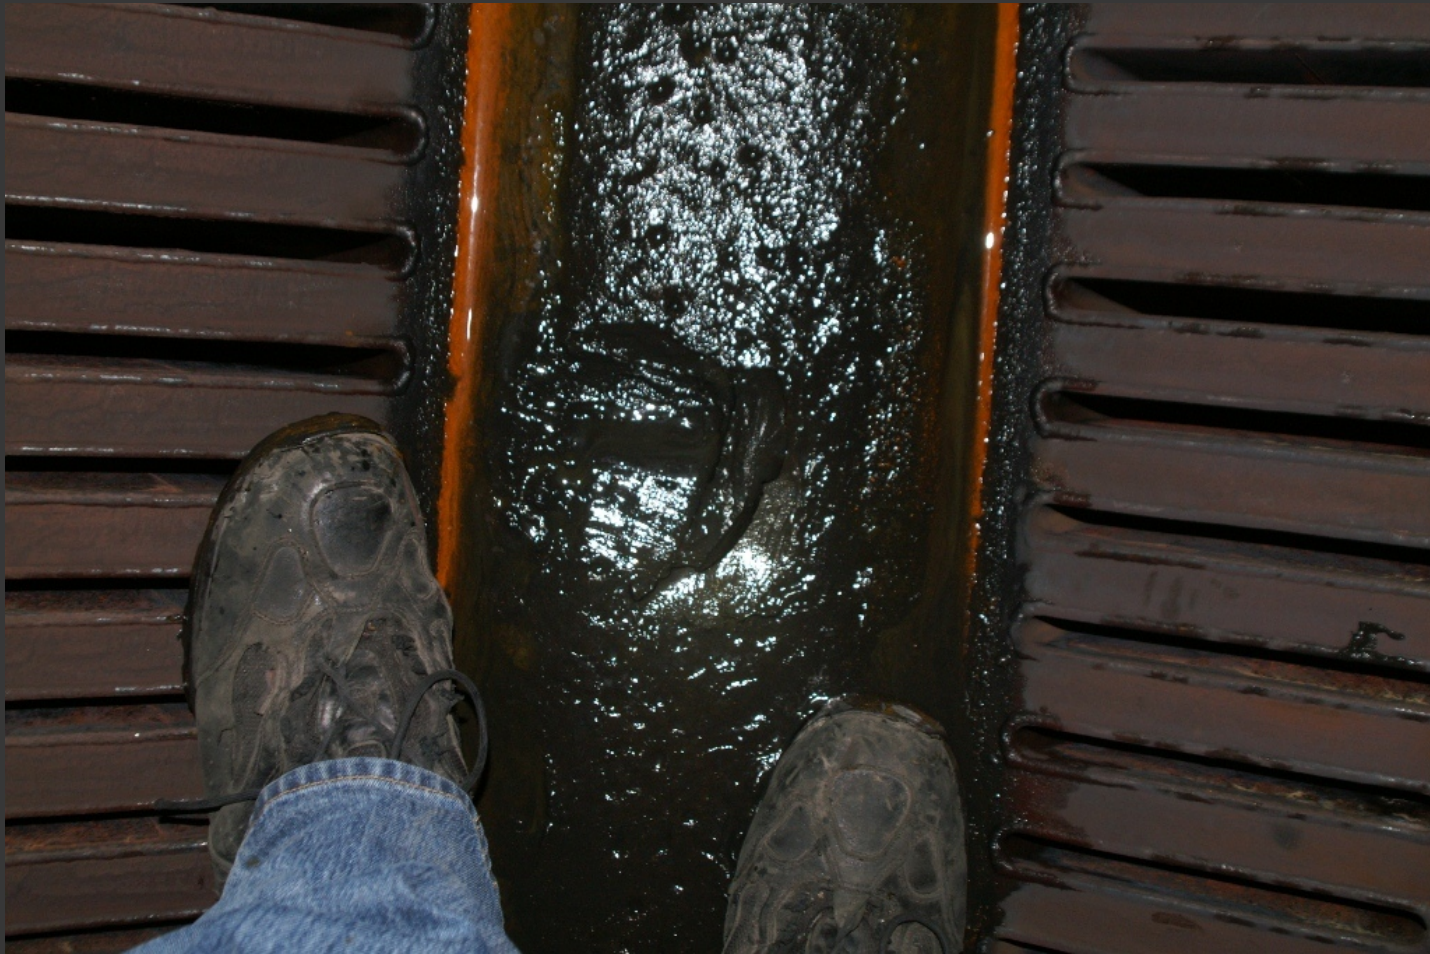
We inspect the tube welds, and clean as needed.

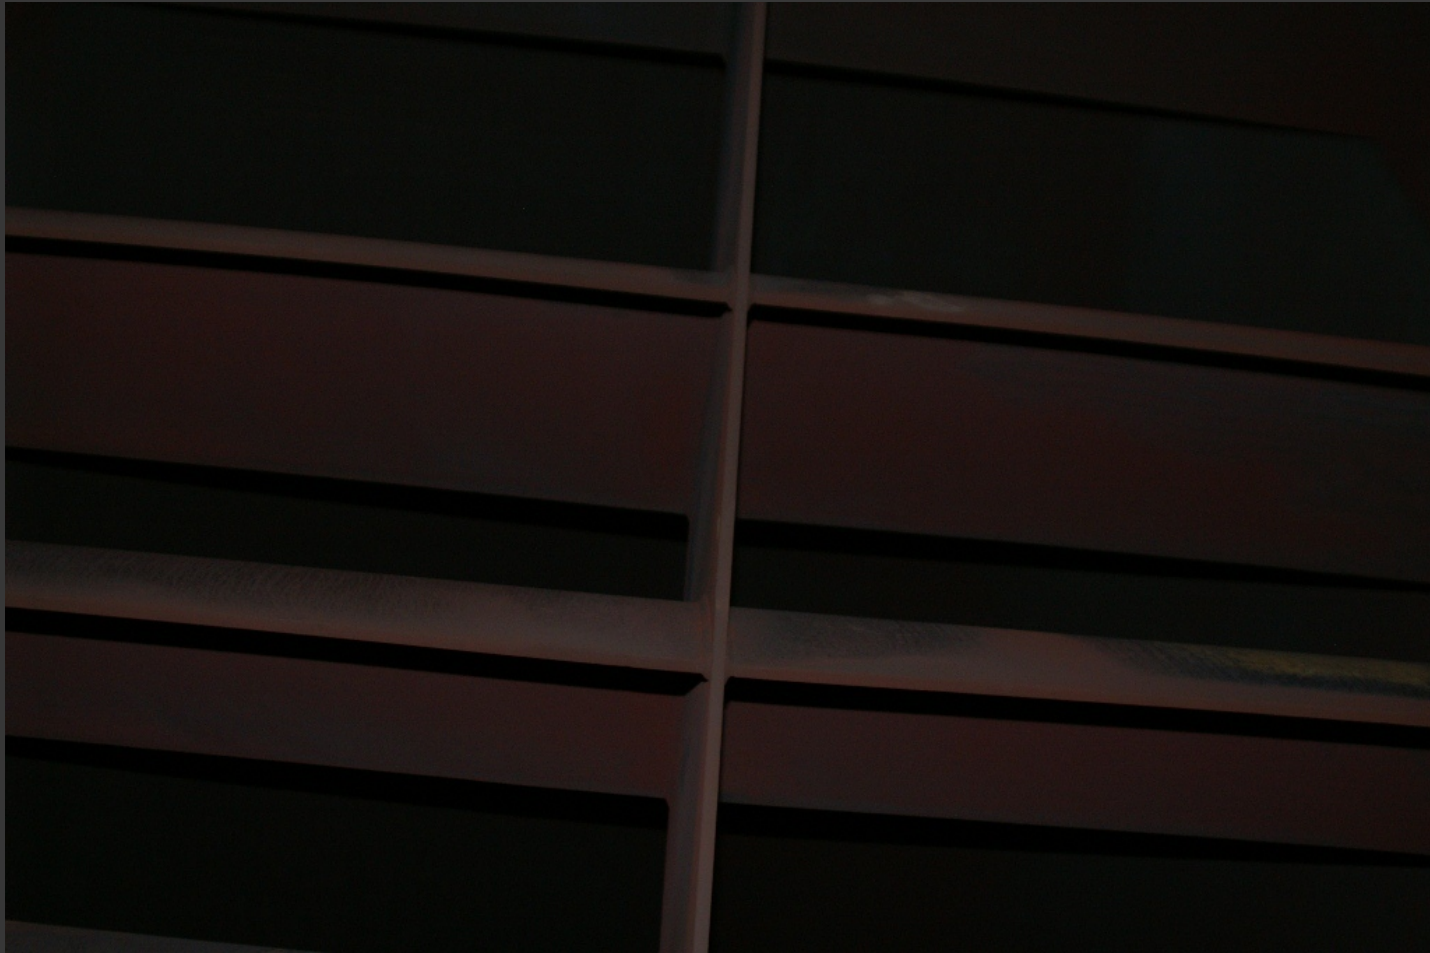
Inspection of flow straighteners on elbows.

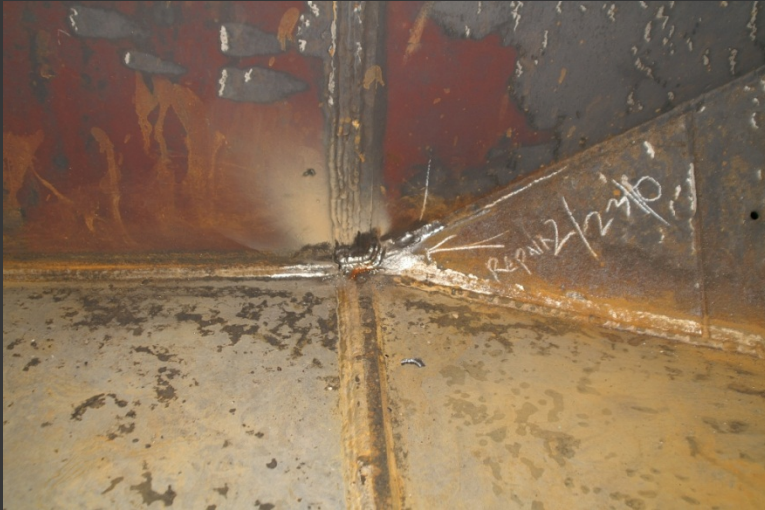
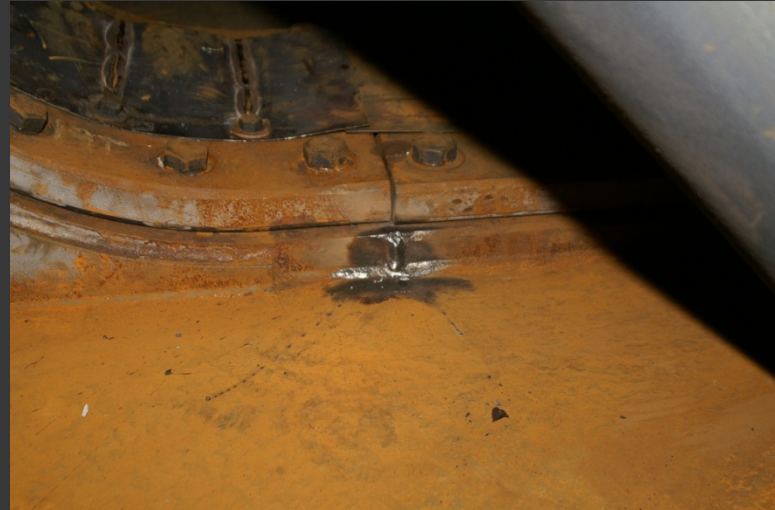
Needed weld repairs can sometimes be hard to spot.

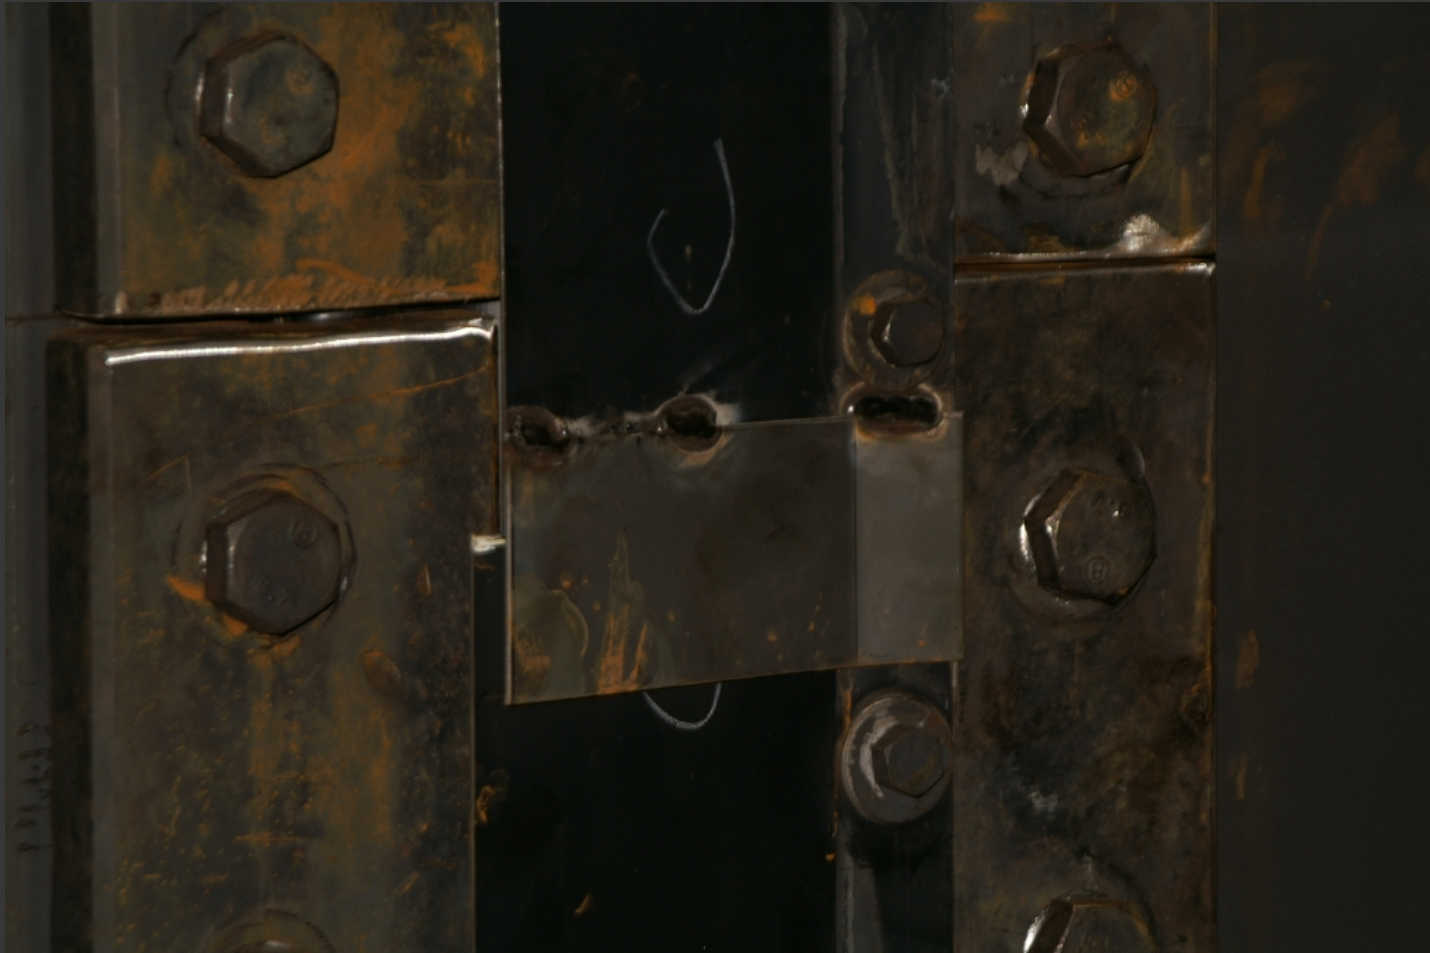
Close inspection of expansion joints from Steam turbine to ACC
