Walter Higgins Generation Station

By David Rettke
Maintenance Specialist
WALTER M. HIGGINS III
GENERATION STATION
PRIMM NEVADA

WHAT IS THE CONDITION OF YOUR ACC SYSTEM?

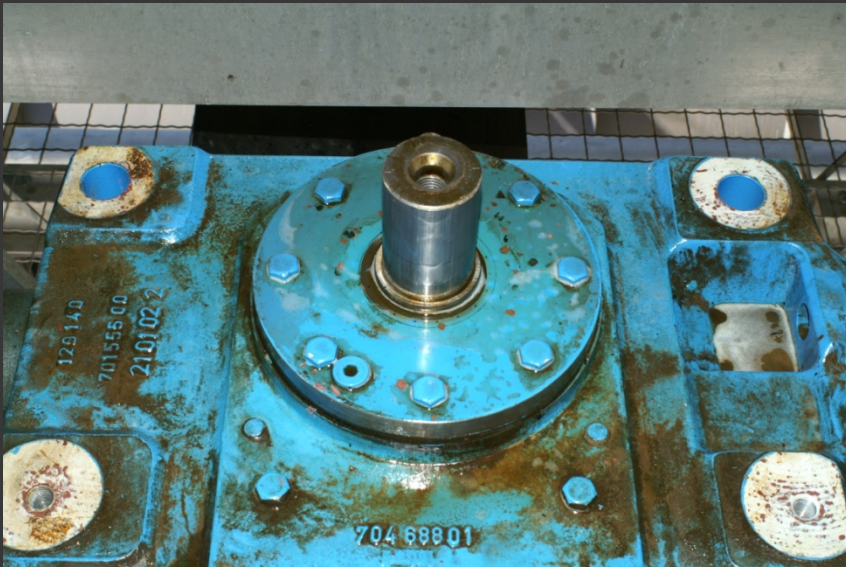
Input Seal Repair Procedure

Wiped up

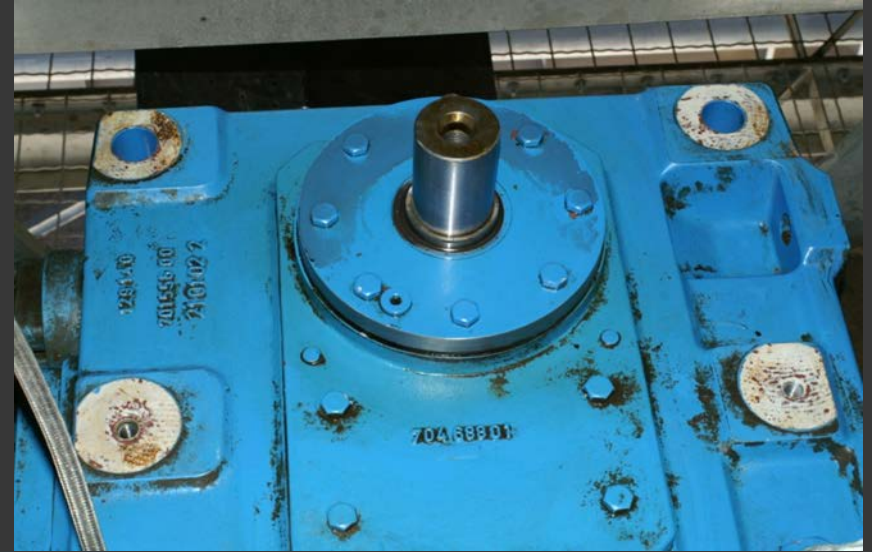
“Cleaned” (Scotch brite pads and spray cleaner)

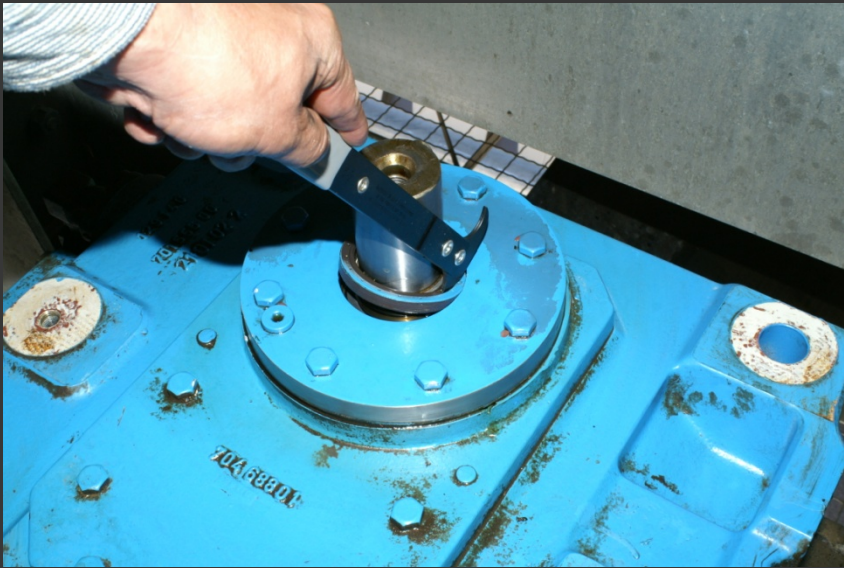
⦿ Seal removal tool

Old seal removed without removing seal plate

Removal of old leaking seal

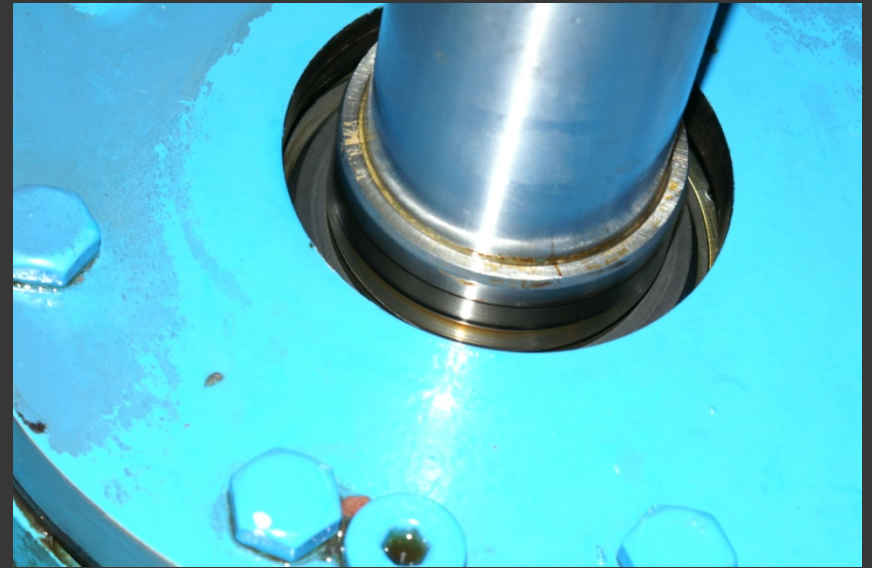
⦿ Seal shaft sleeve

Close up of seal area and seal shaft sleeve.

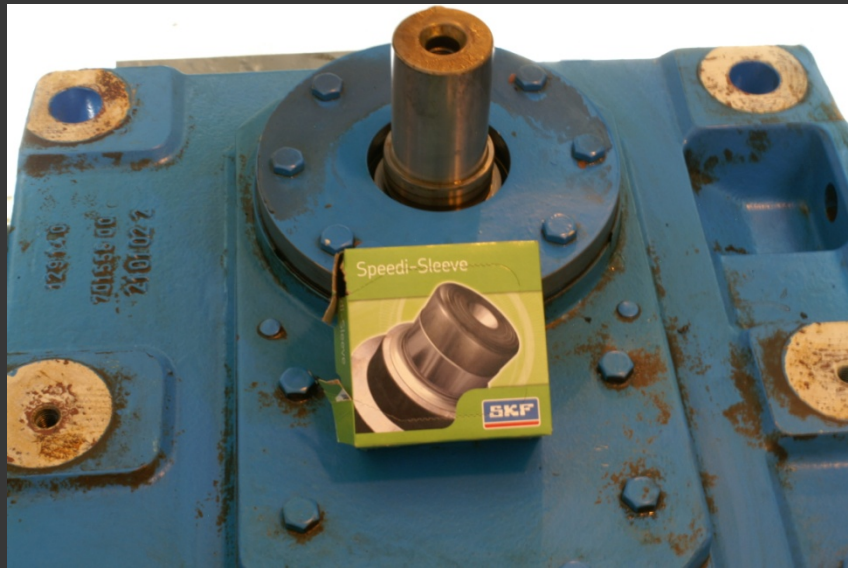
Speedi Sleeve (By SKF)

- Speedi Sleeve in box.
- Actual speedi sleeve ready to install on shaft sleeve.

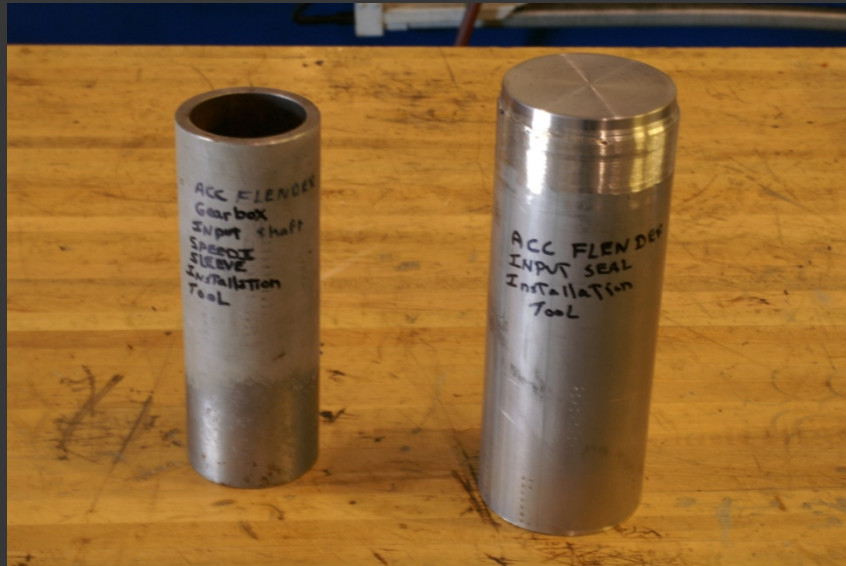
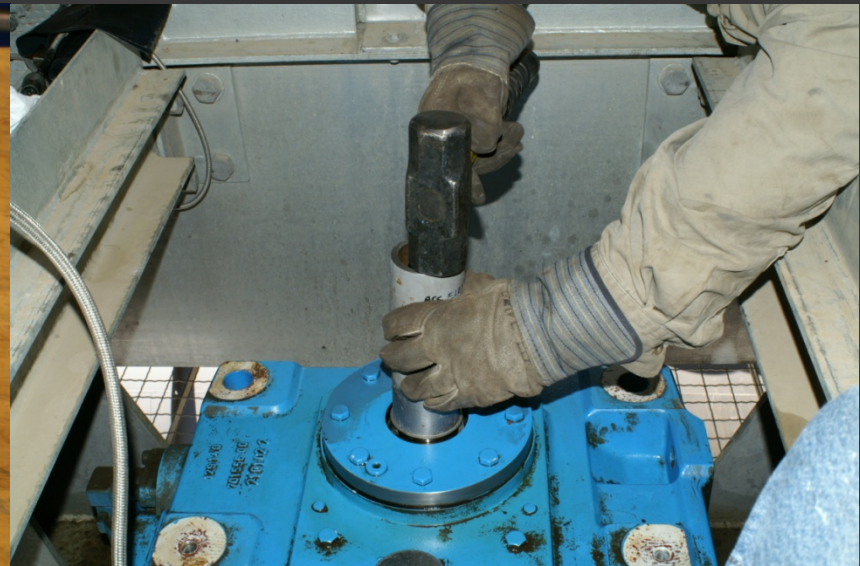
Special tools required

- ▶ The Speedi-sleeve tool and seal tool were designed and fabricated in house at Higgins Station.
- ▶ The Speedi-sleeve comes with an installation tool but that tool will not work on the Flender Gearboxes due to the length of input shaft on the unit.
- ▶ The tools were made to facilitate proper and safe sleeve and seal installations.

- Made in shop proto type tools
- Speedi Sleeve installation tool

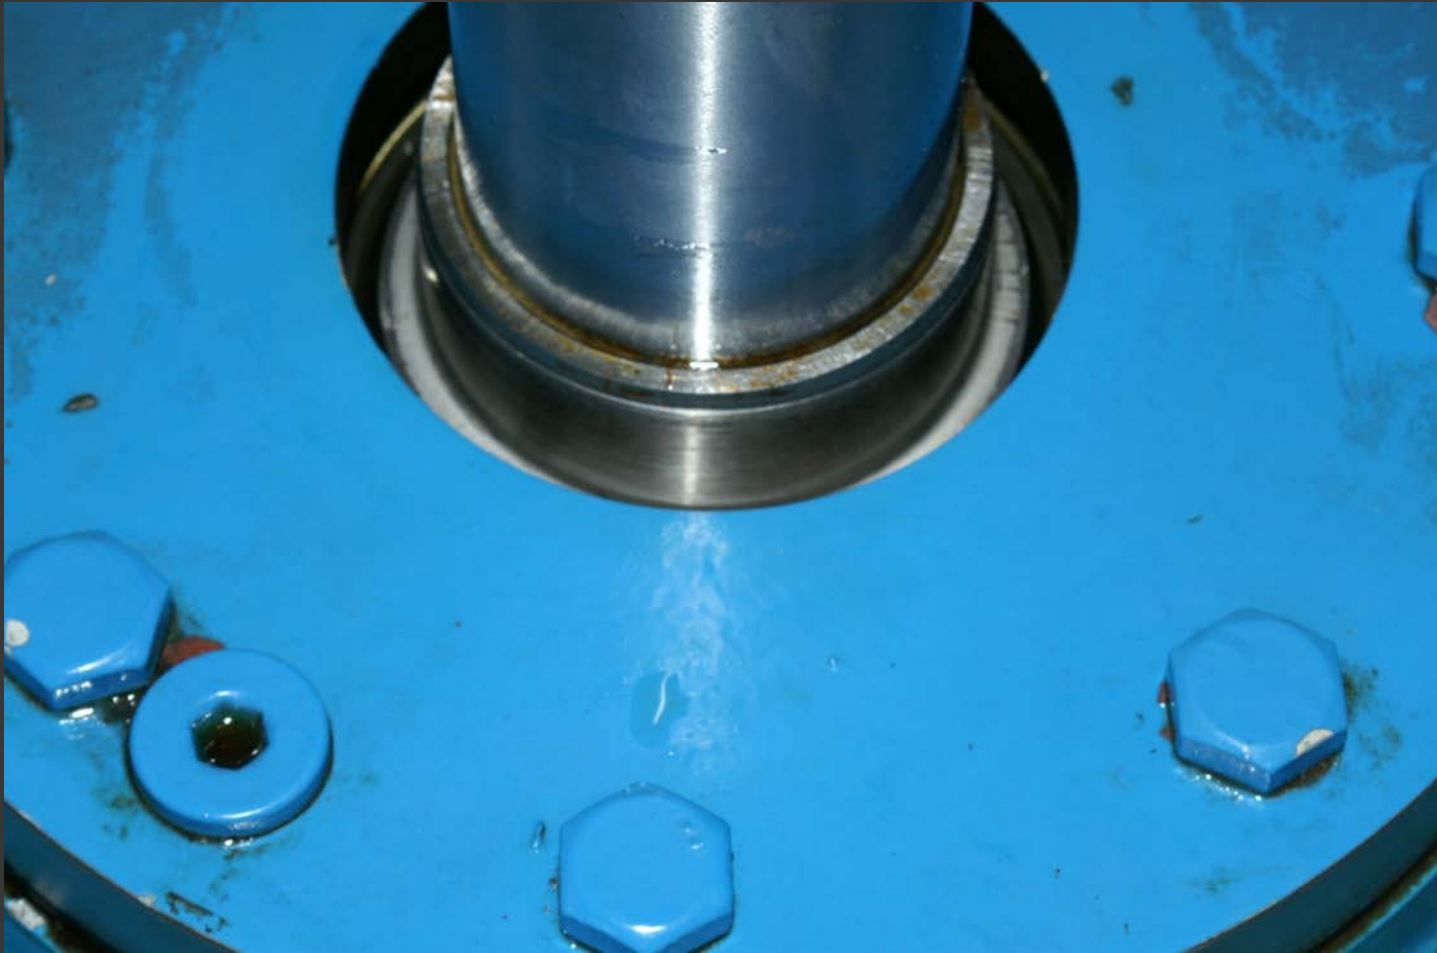
Speedi Sleeve installed

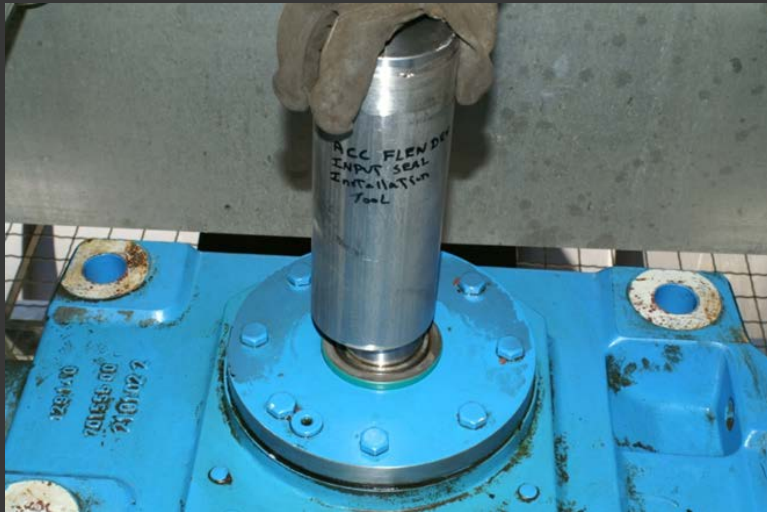
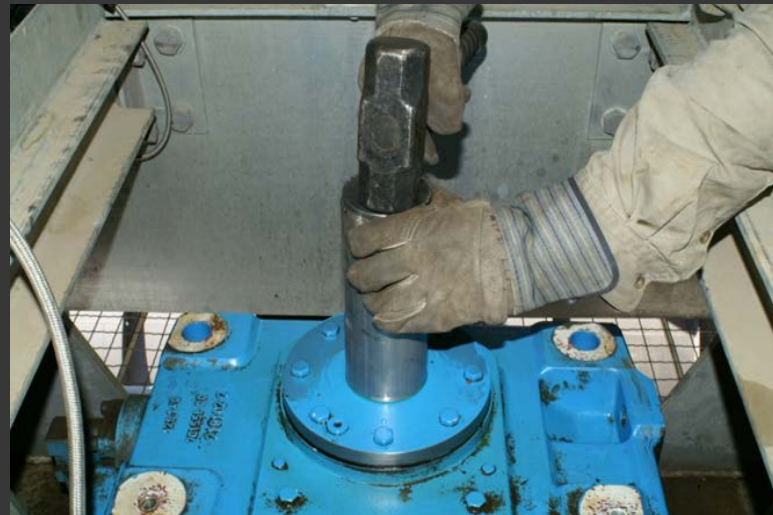
Installation of new seal with special tooling.

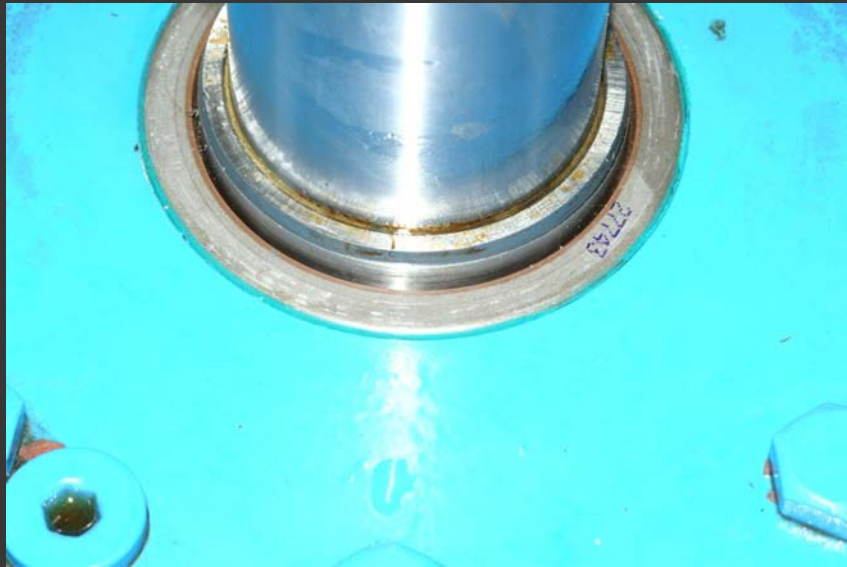
Finished installation of new seal.
