# Cleaning Air-Cooled Condensers Case Studies

ACC Users Group  
October 4-6, 2016

Mr. Willis Shook  
Conco Services Corp.

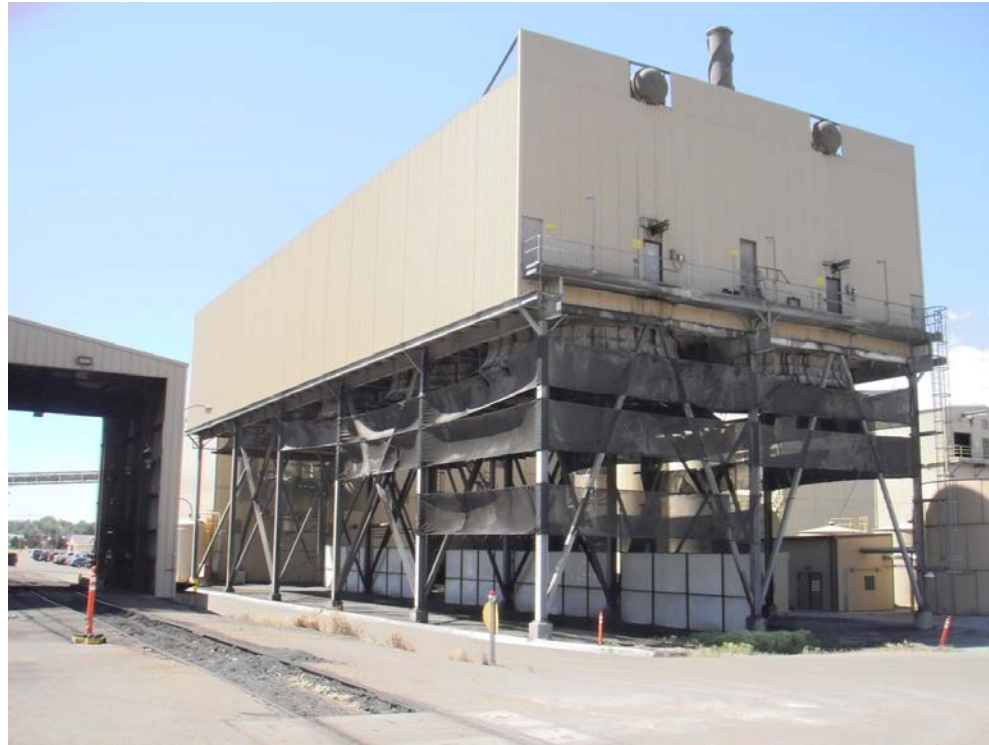
## Yellowstone Power Plant Air Cooled Condenser

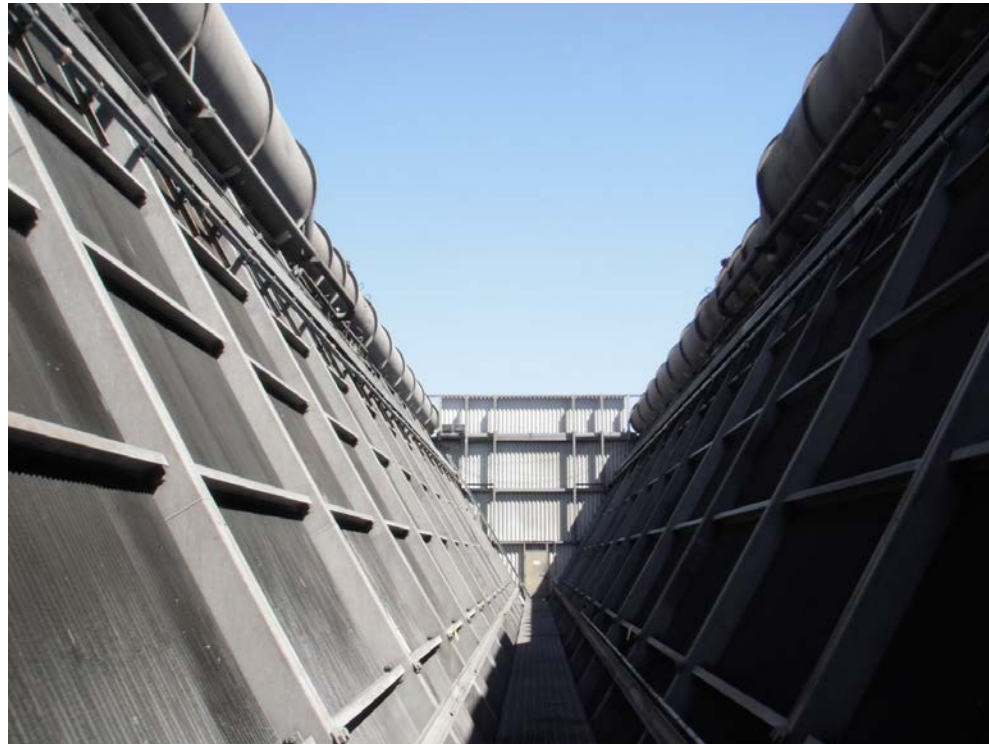
## Center of ACC

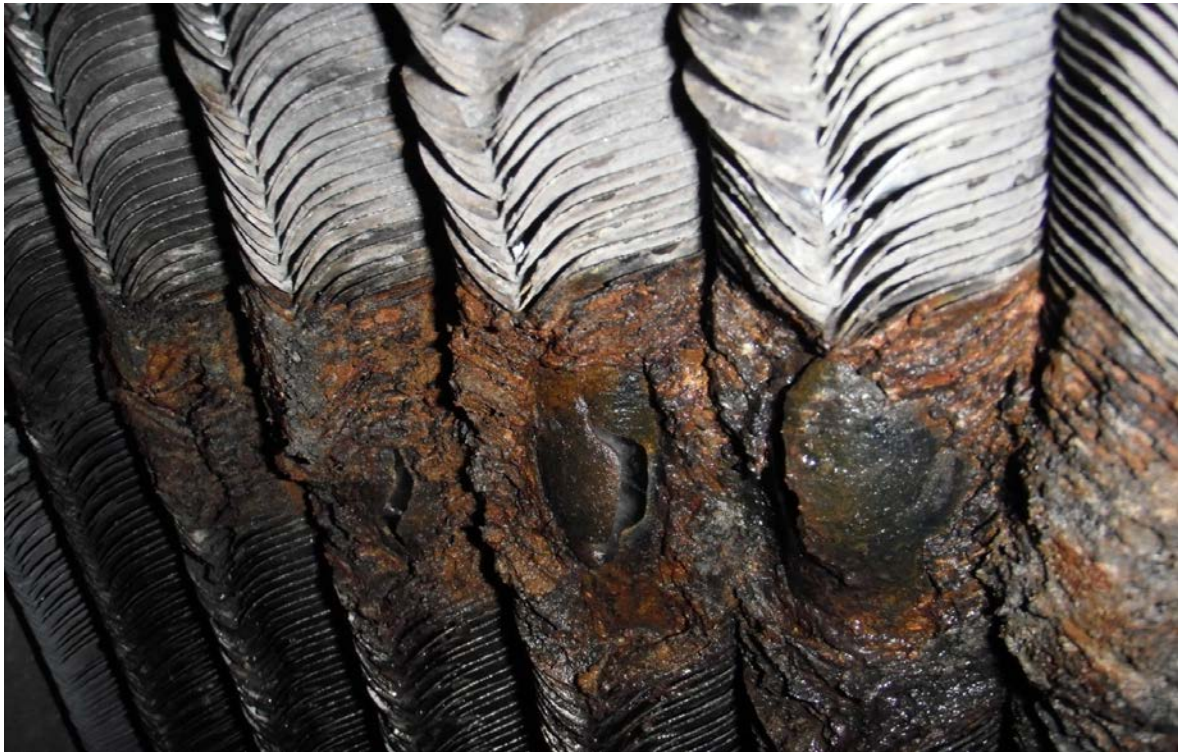
Tubes – Frozen and Degraded from  
Debris Trapped Behind Support Beams

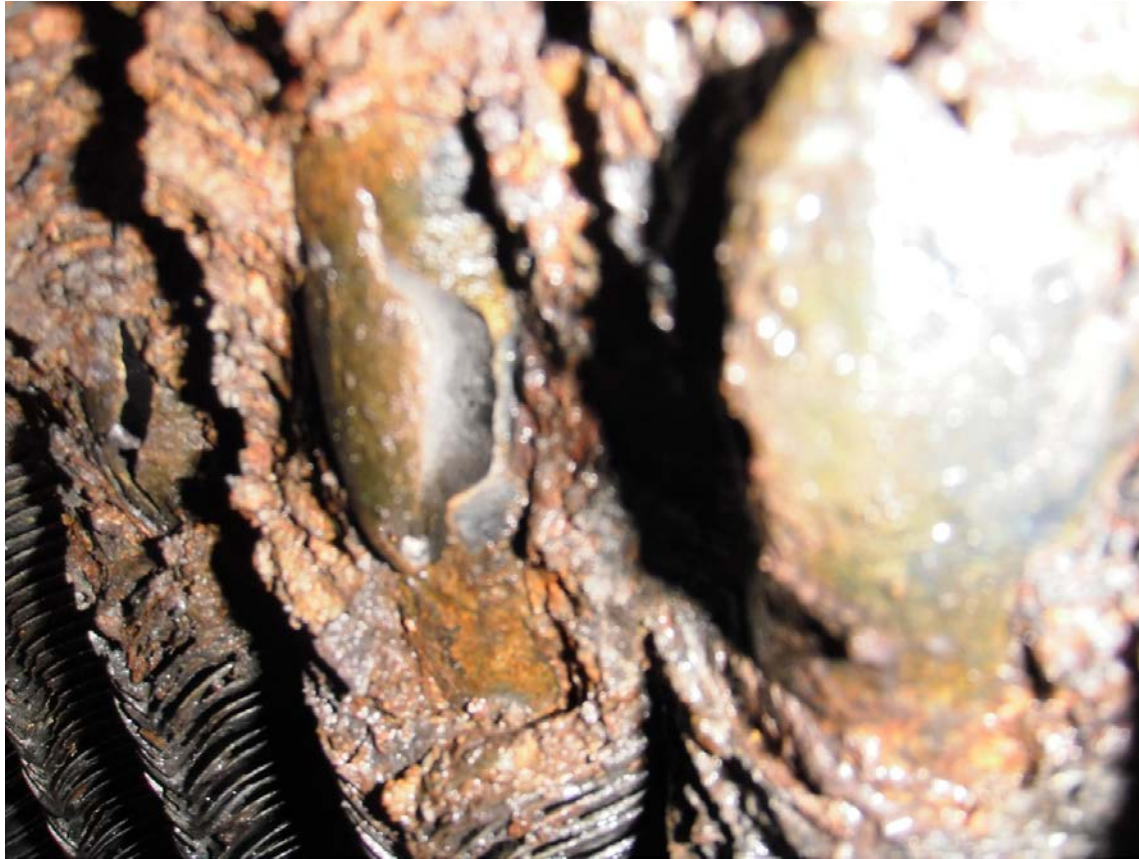
## Frozen Burst Tube

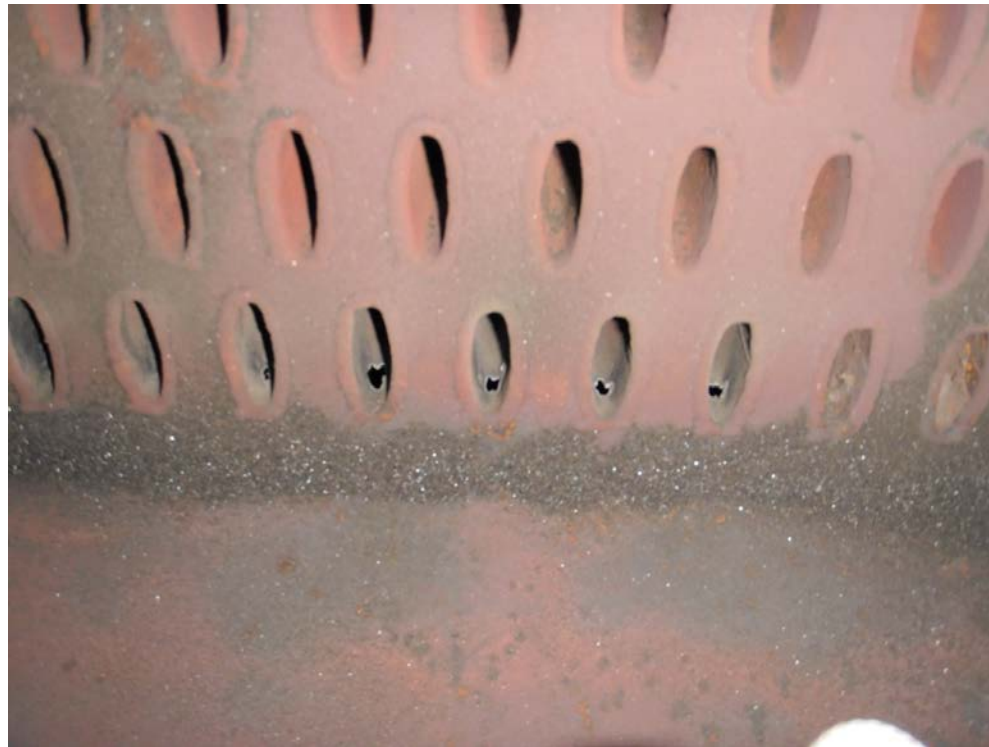
## Holes in Top of Tube Connections to Steam Header

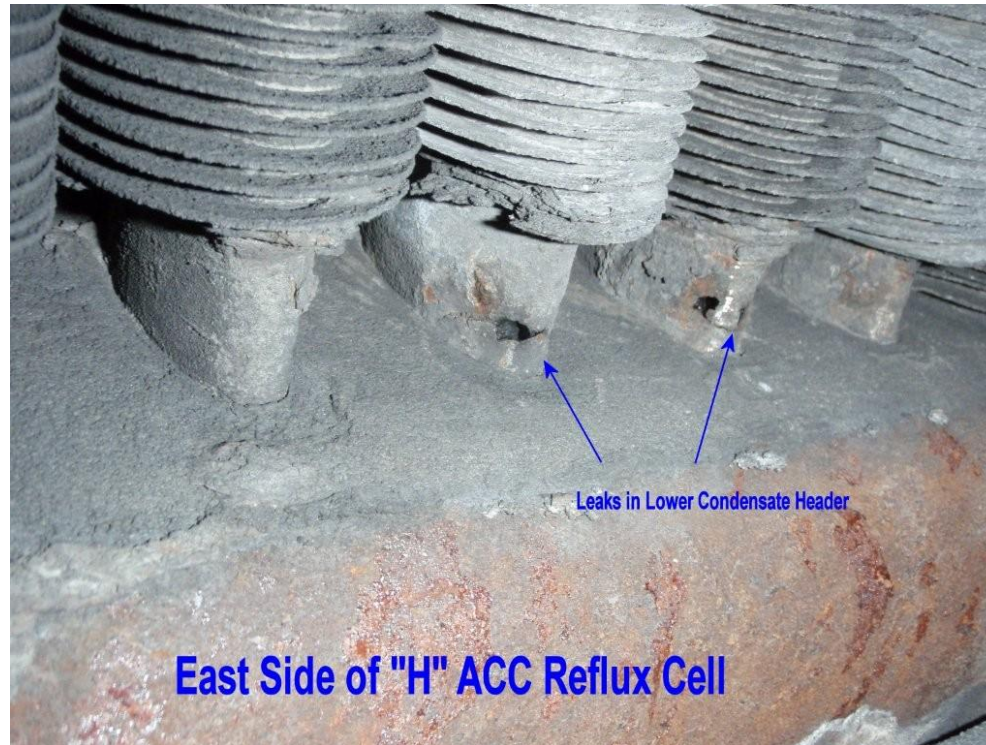
## Leaks in Tubes at Lower Condensate Header Connections

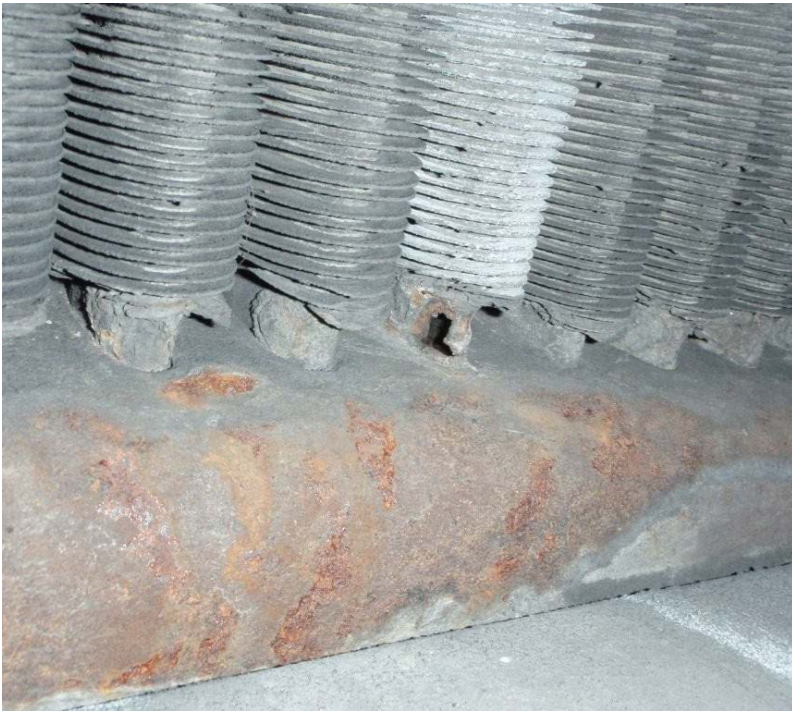
**Holes in Tube Headers**

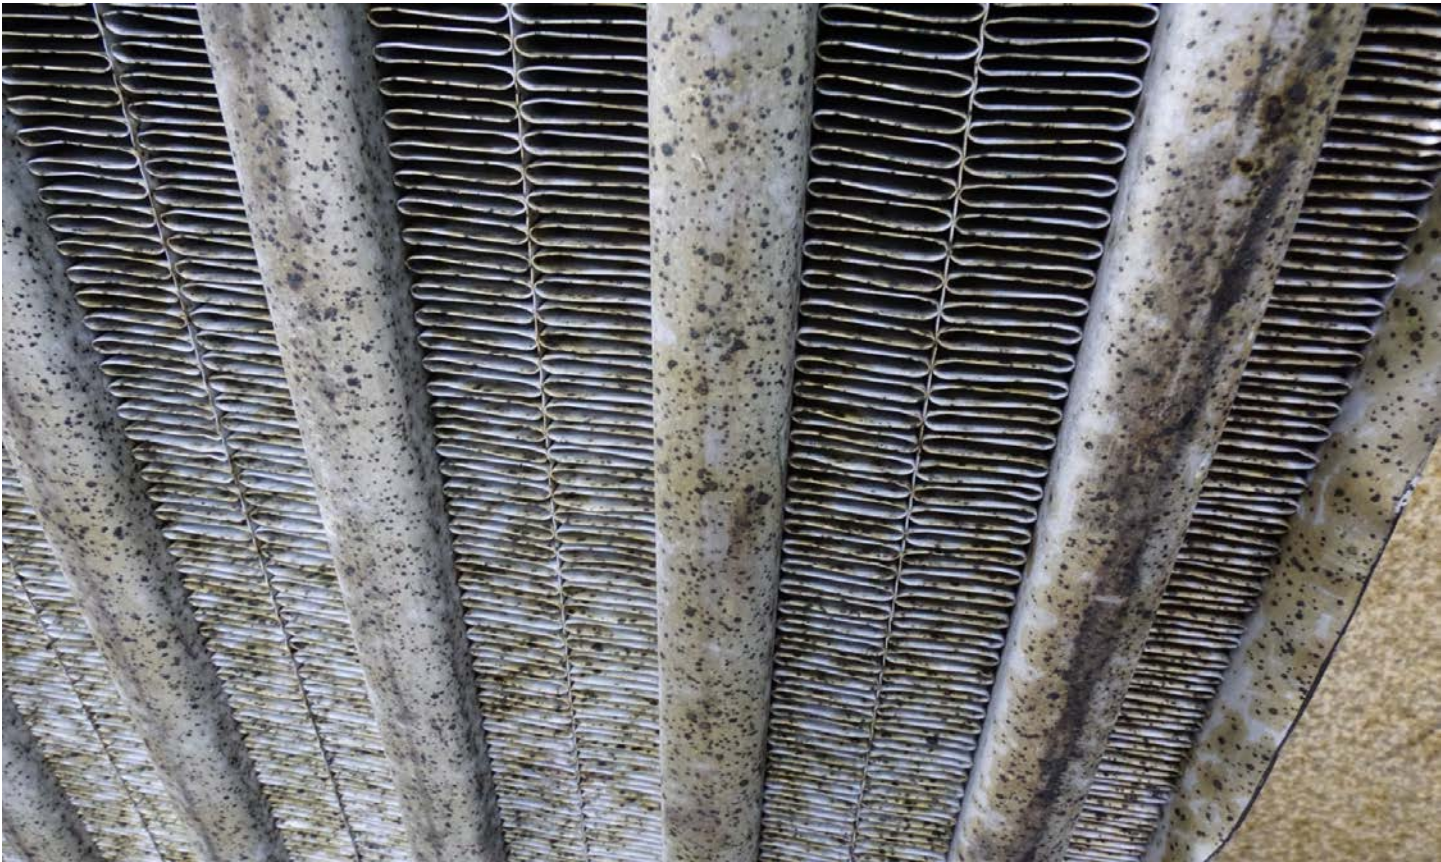
- When blockage broke free
  - Pressurized oil leaked through the Loop Seal Stack
  - Oil covered
    - Outside surface of the ACC unit
    - Surrounding areas

### Oil on Surface of Unit

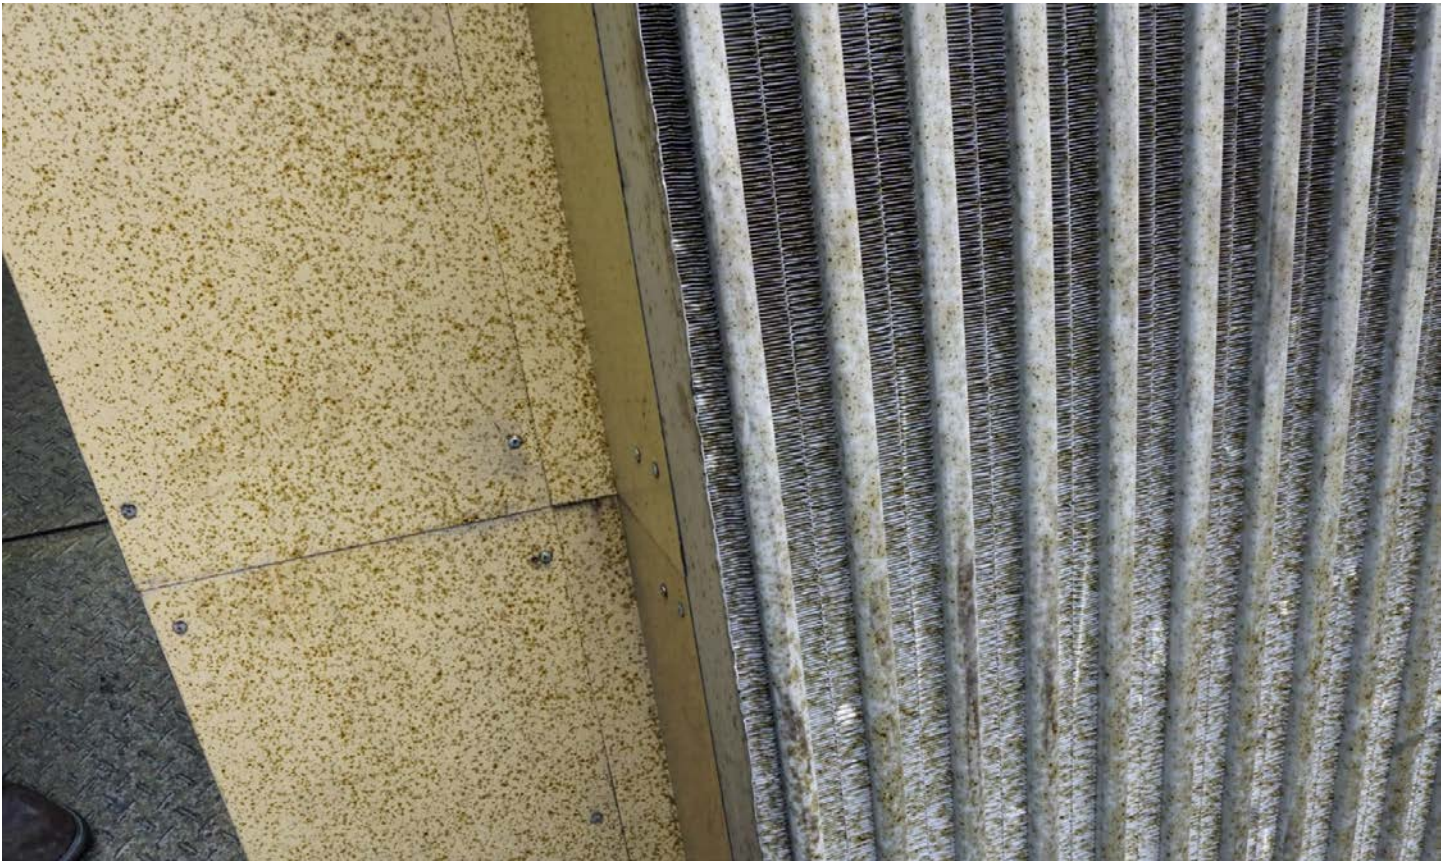
## Oil Covers Unit

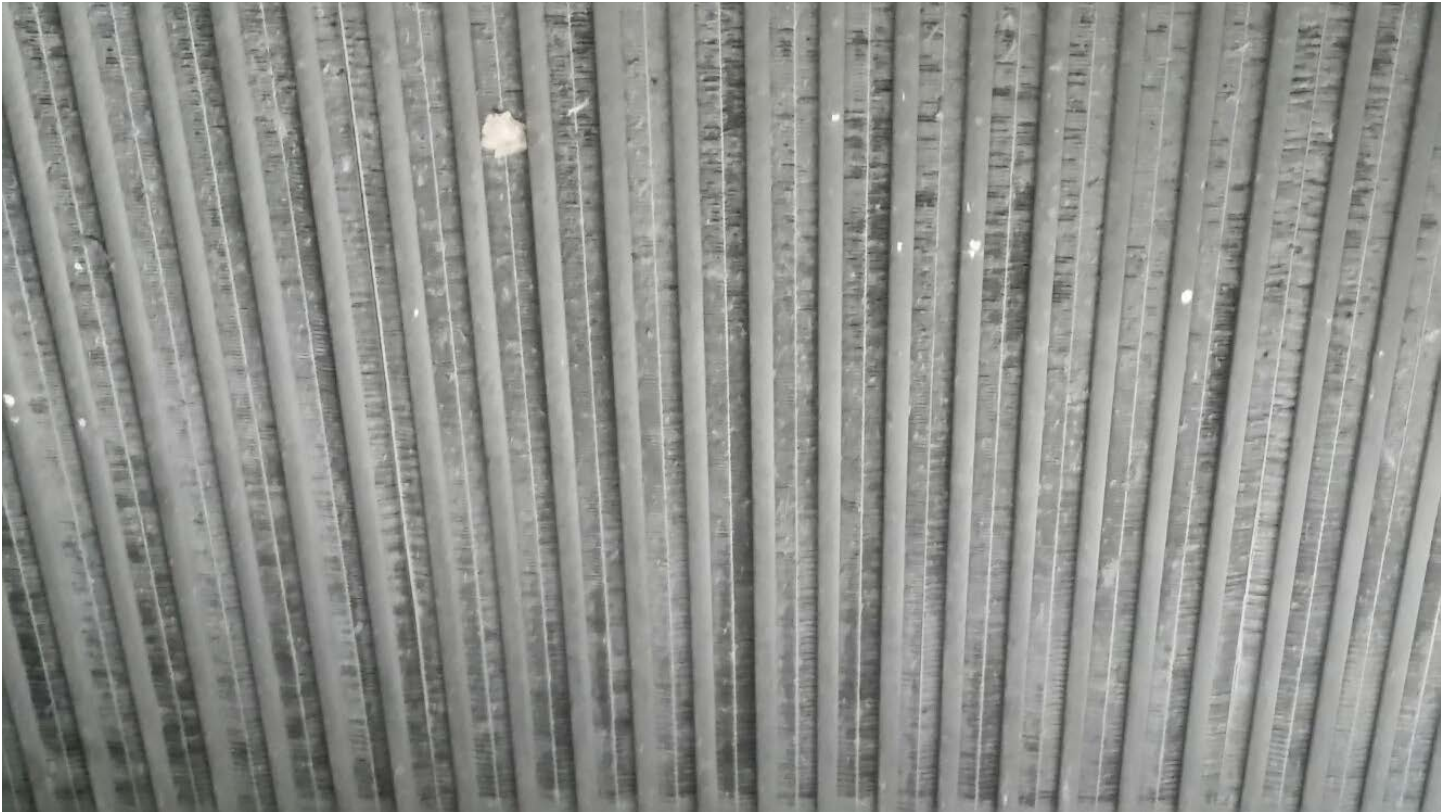
- Truck spilled fly ash near the ACC unit
- Ash sucked into the ACC fans
- Under side of fins coated with oil and ash
- Oil acted like a glue

### Ash Covers Fins Underneath Unit

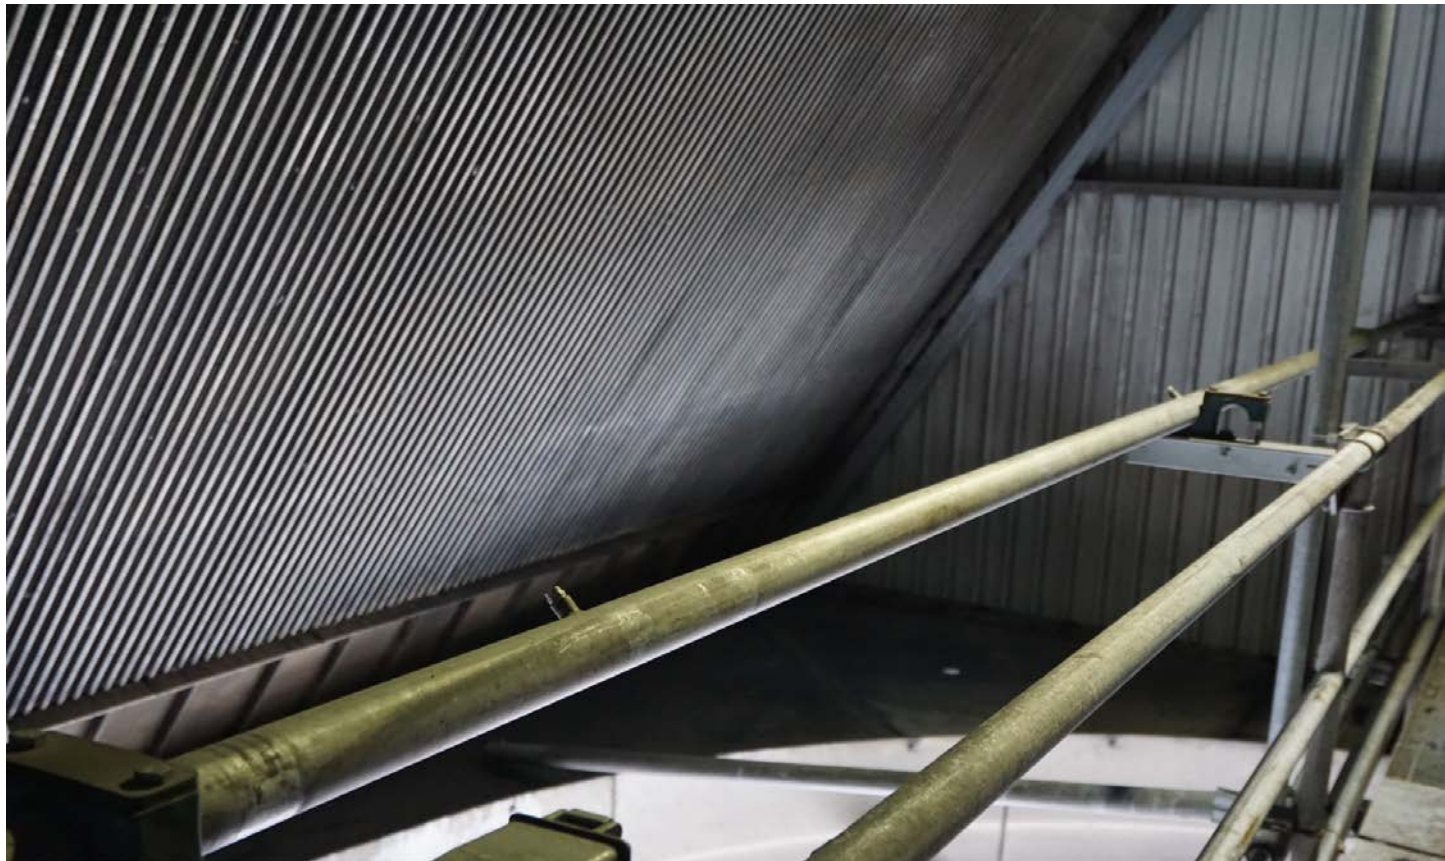
### View from Inside Unit
