ACC Vibration

ACC Users Group Conference

July 2024

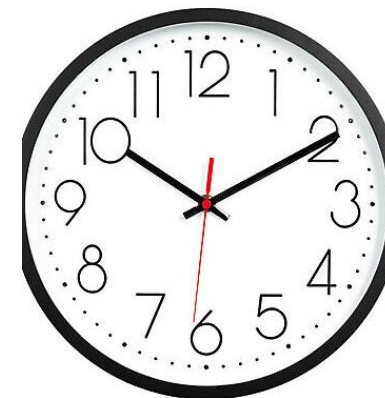
- Temporal Element
 - How long to measure?
 - Is any exceedance unacceptable?
 - Averaging allowed?
- Bandwidth filtering ($f_{\min} - f_{\max}$) ?
- Direction?

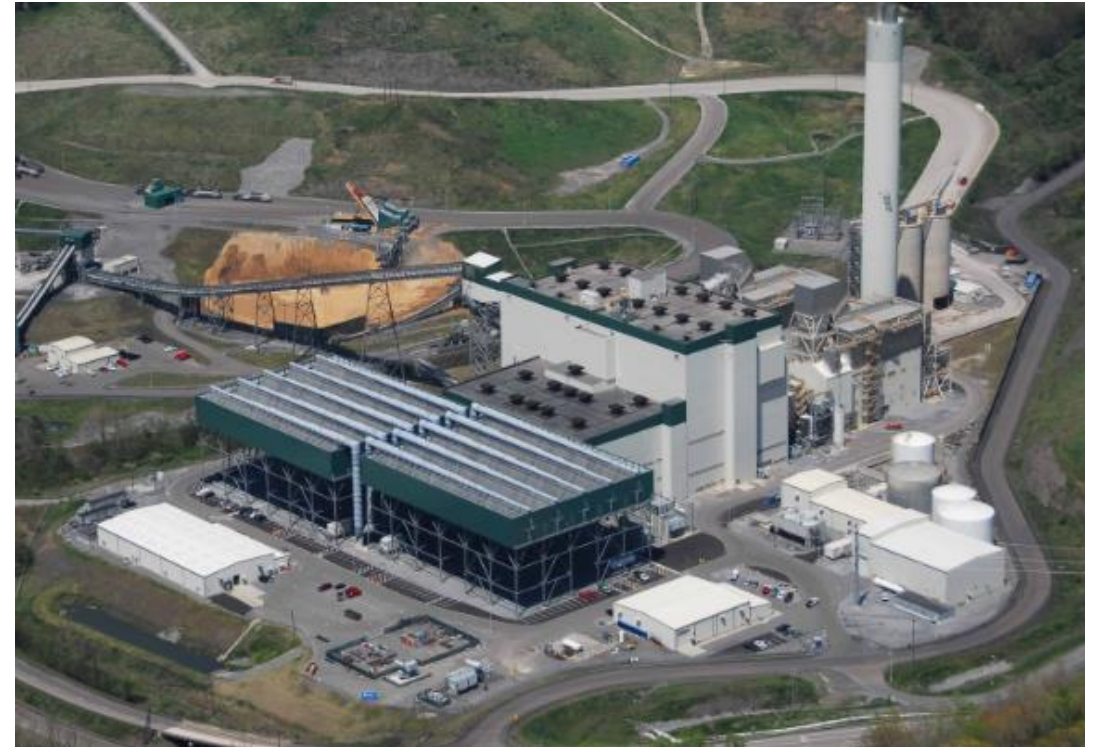
- Virginia City Hybrid Energy Center (VCHEC)
- Dominion owned and operated
- Duel fuel – coal waste and biomass
- Two (2) 30-cell ACCs with 7-blade Tecsis FRP blades

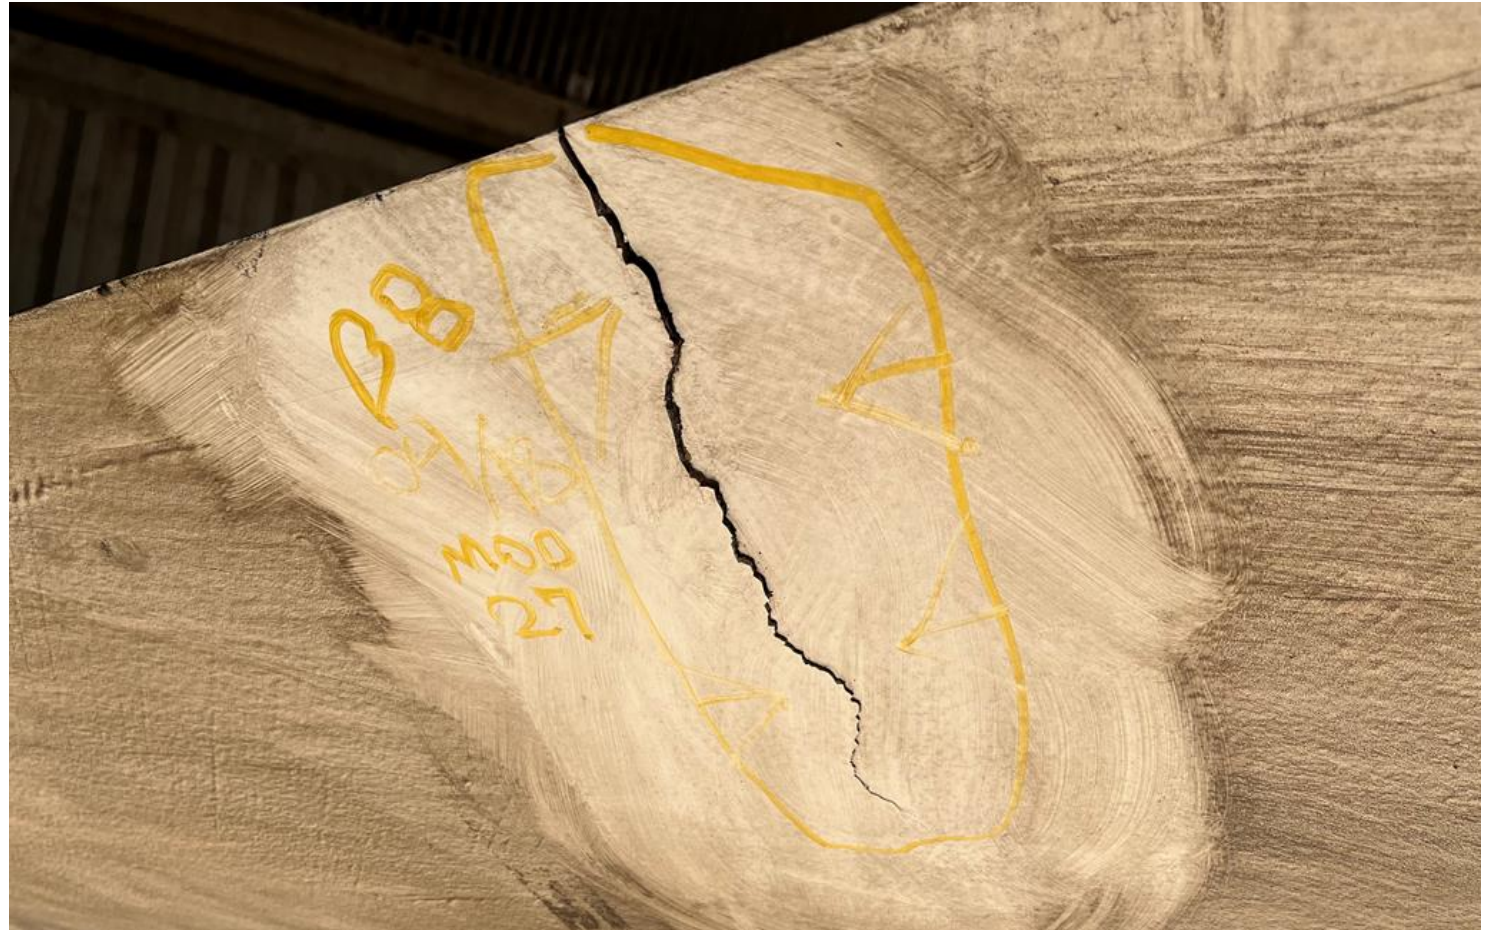
Case Study – Blade Cracking

- Blades showing signs of cracking
- Widespread cracks noticed starting in 2016

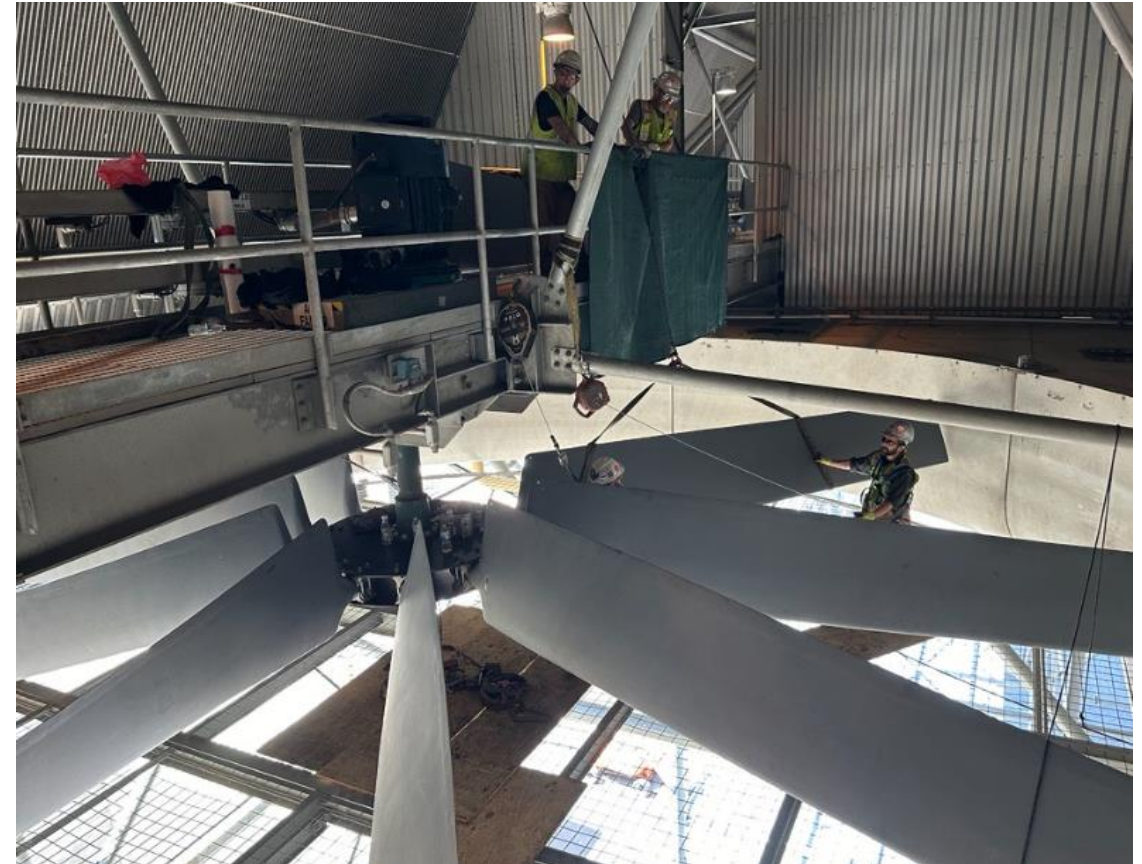
Case Study – Fan Trial

- Installed two (2) FanTR 9-blade fans in 2018
- Measured vibration monthly for 10-second duration.
- Vibration levels within acceptable limits
- Remaining 28 fans installed in 2020

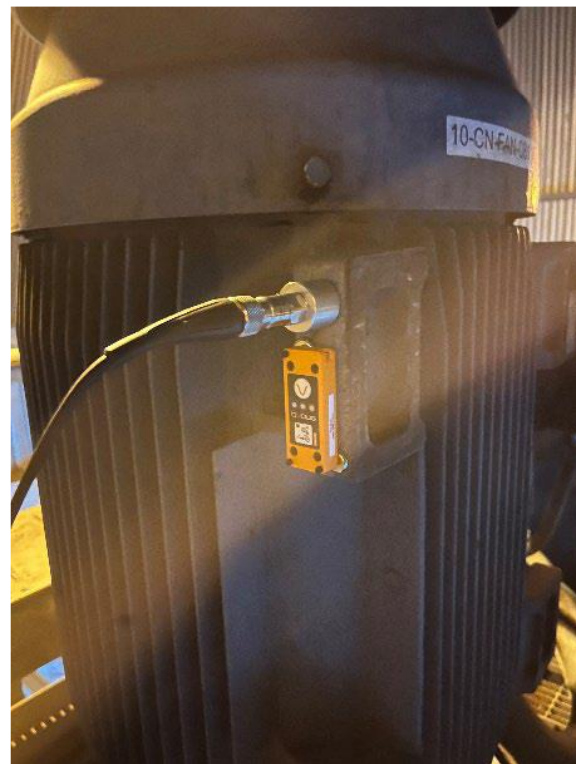
Case Study – Vibration Results

- Triaxial accelerometer on motor outboard
- Pass < 0.65 in/s, 0-pk
- **10min duration**

Street	Fan Module					
	A	B	C	D	E	F
1	Fail	Fail	Pass	Pass	Fail	Fail
2	Pass	Fail	Pass	Pass	Fail	Pass
3	Pass	Fail	Fail	Pass	Fail	Pass
4	Fail	Fail	Pass	Fail	Fail	Pass
5	Pass	Fail	Pass	Pass	Fail	Pass
