Low Noise ACC Fan Retrofit Case Study

Presented at the ACCUG 2024 Annual Conference, July 23-25, London

Jacques Muiyser, Howden Netherlands

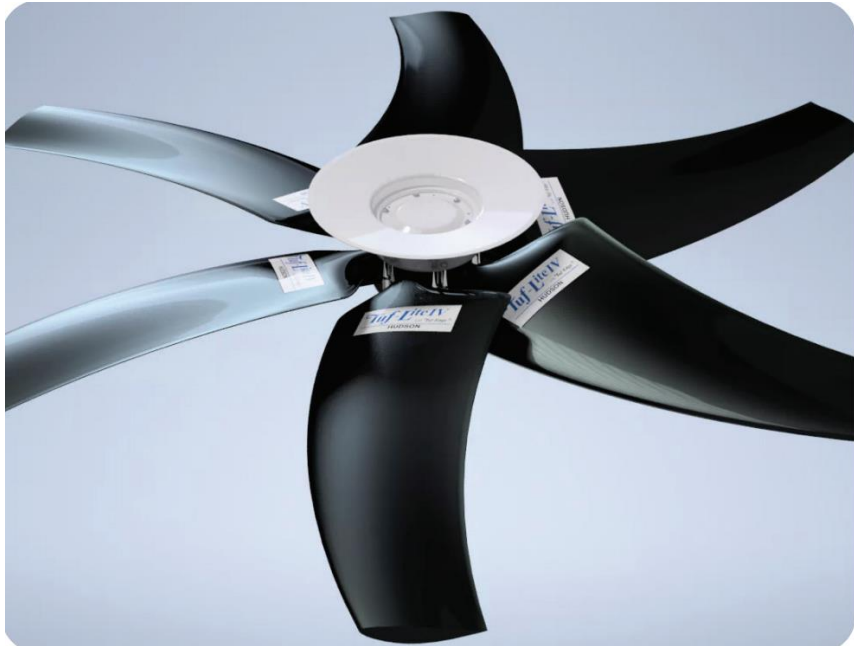
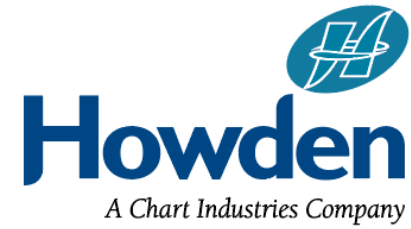
Hudson Tuf-Lite fans can be used for retrofit projects where higher efficiency or improved reliability is required. Tuf-Lite fans are strong replacements for OEM fans due to their monolithic design.

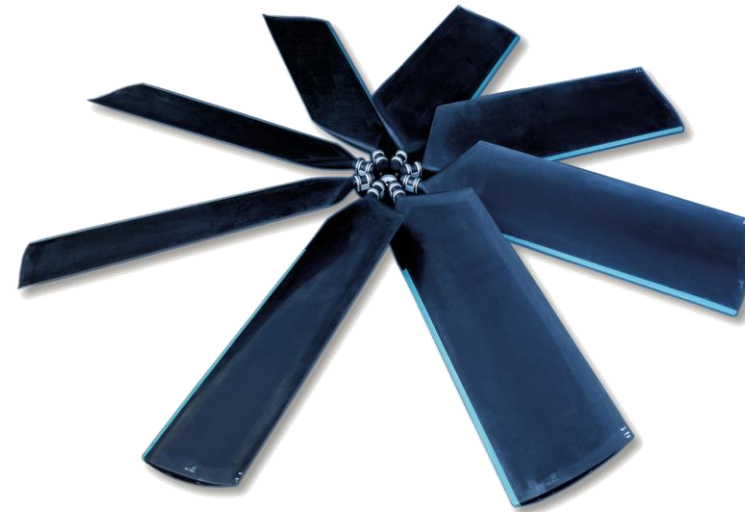
SX or SXT fans are commonly used where additional cooling capacity is needed and/or there is a desire to reduce noise levels.

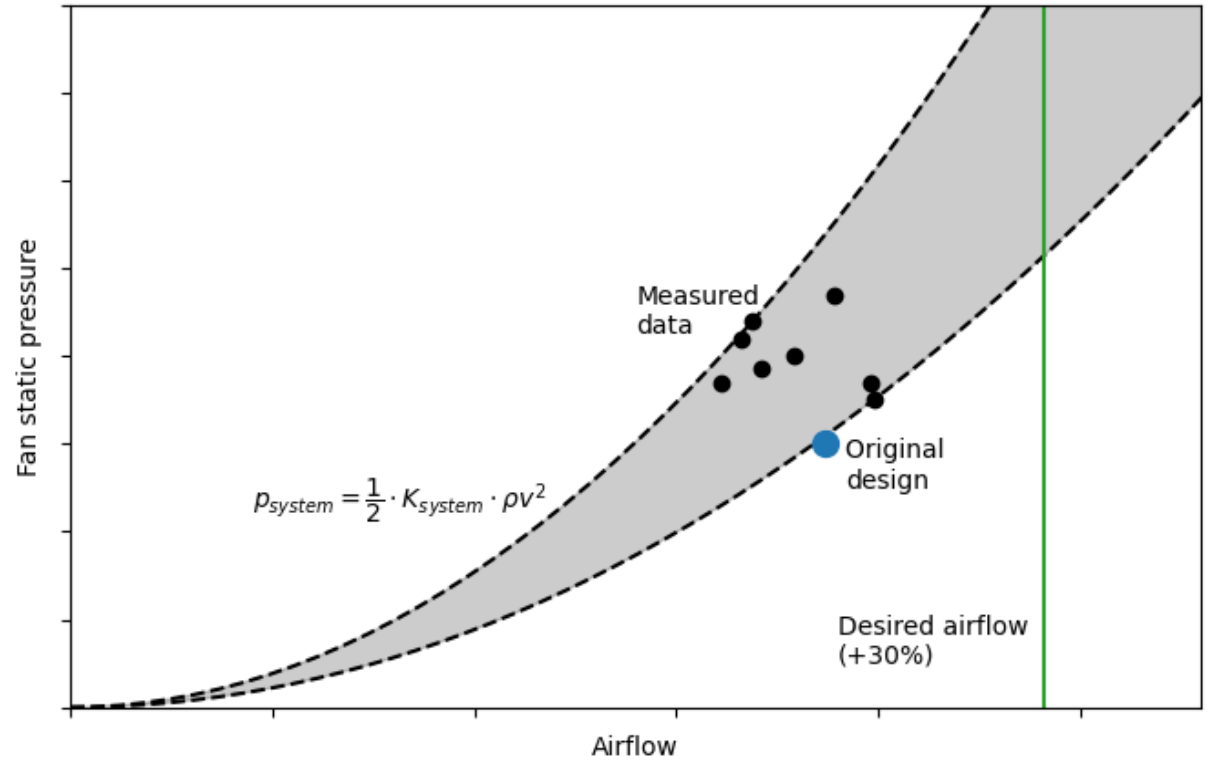
A 6116SXT5 fan was selected to deliver 30 % more flow than the existing fans.

To achieve this, the fan would be running at a higher fan speed than the original equipment.

Even so, a decrease in sound power level of 3 dBA was expected at the higher fan speed.

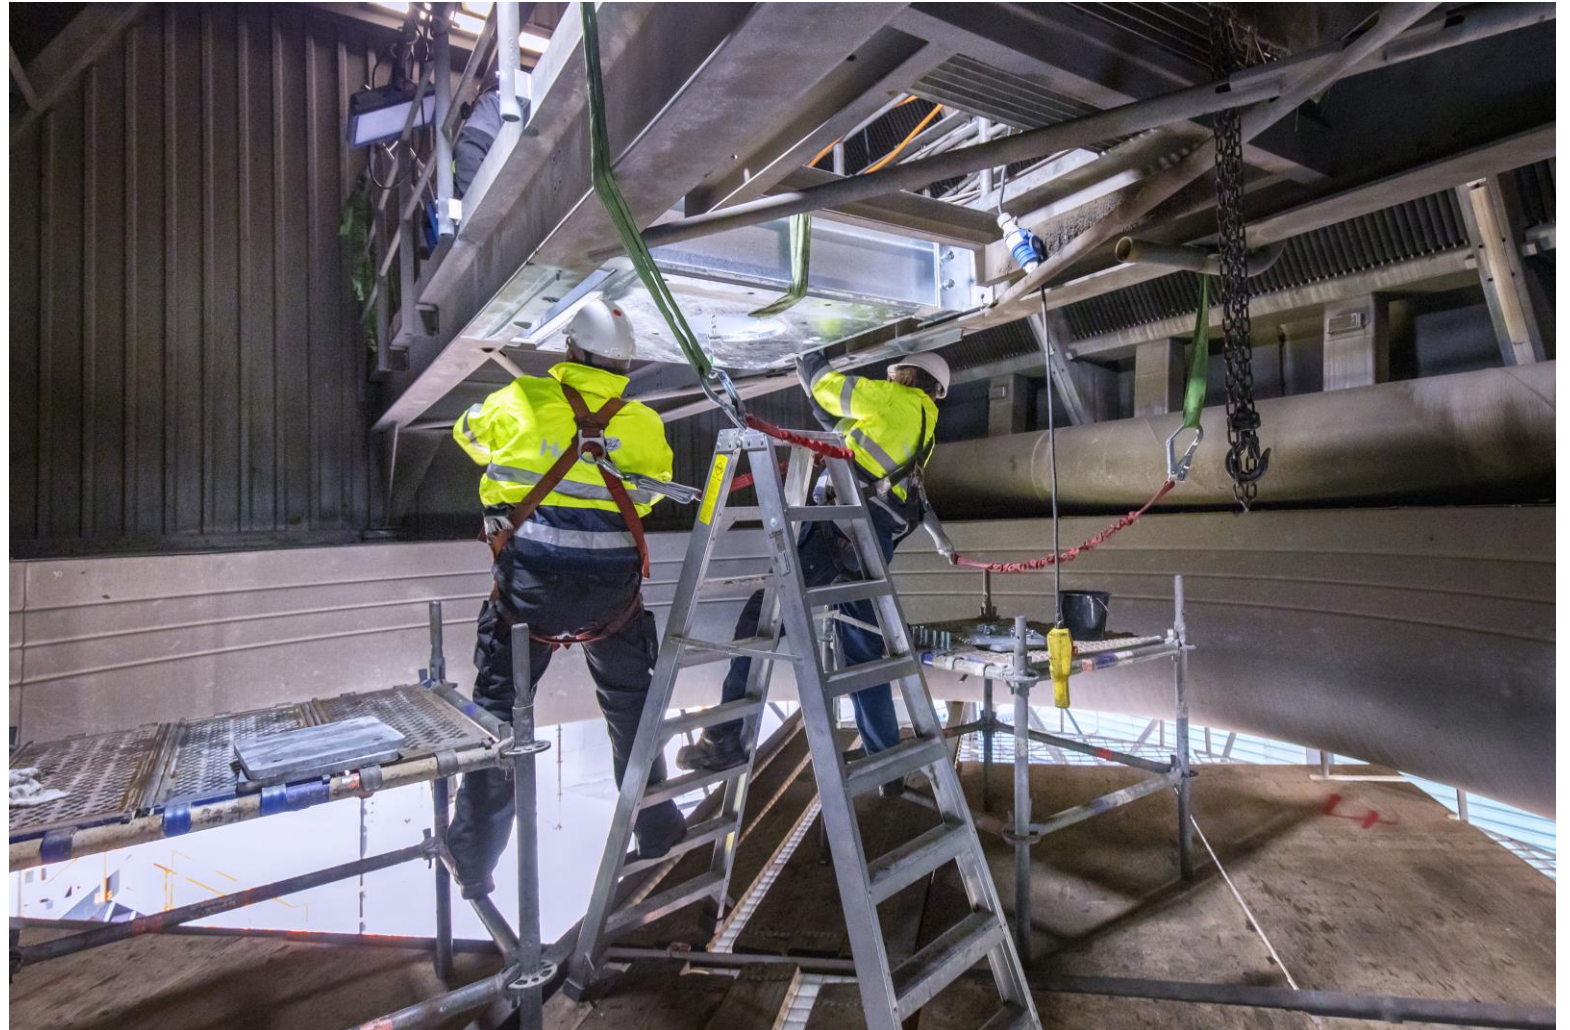
Removal of old belt-driven drive.

Installation of new motor-gearbox support being hoisted and installed.

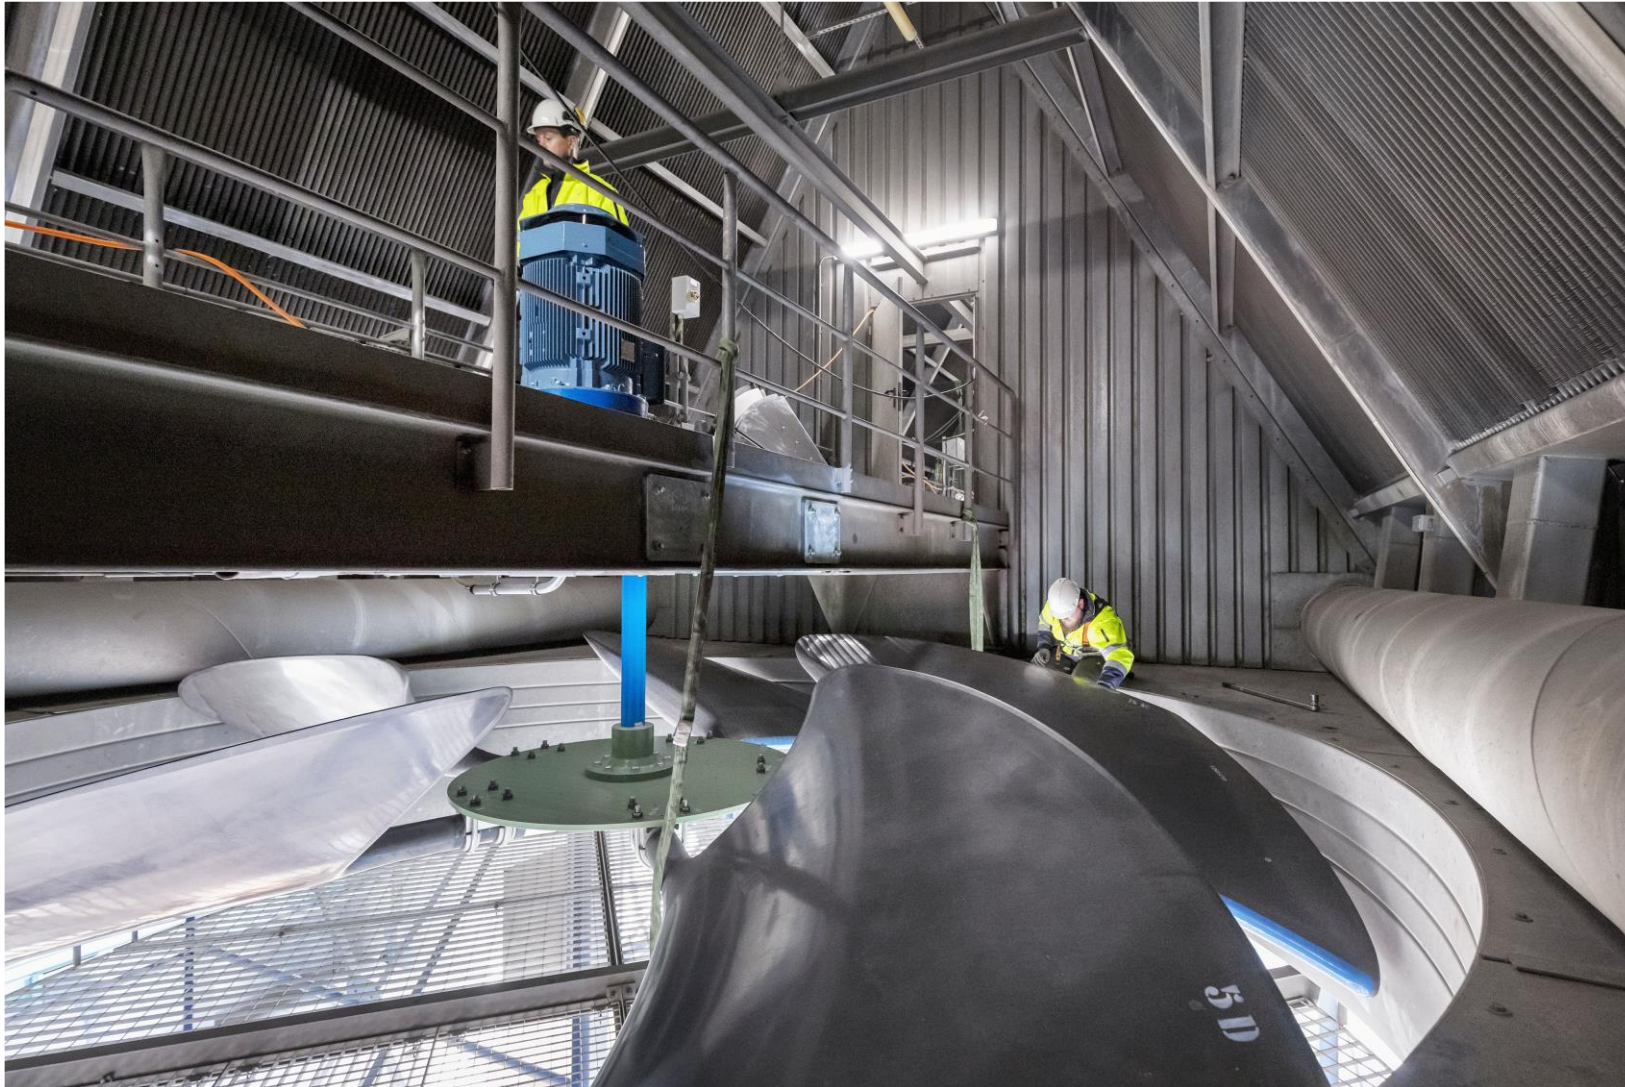
Completed installation along with the addition of VFDs for fan speed control.

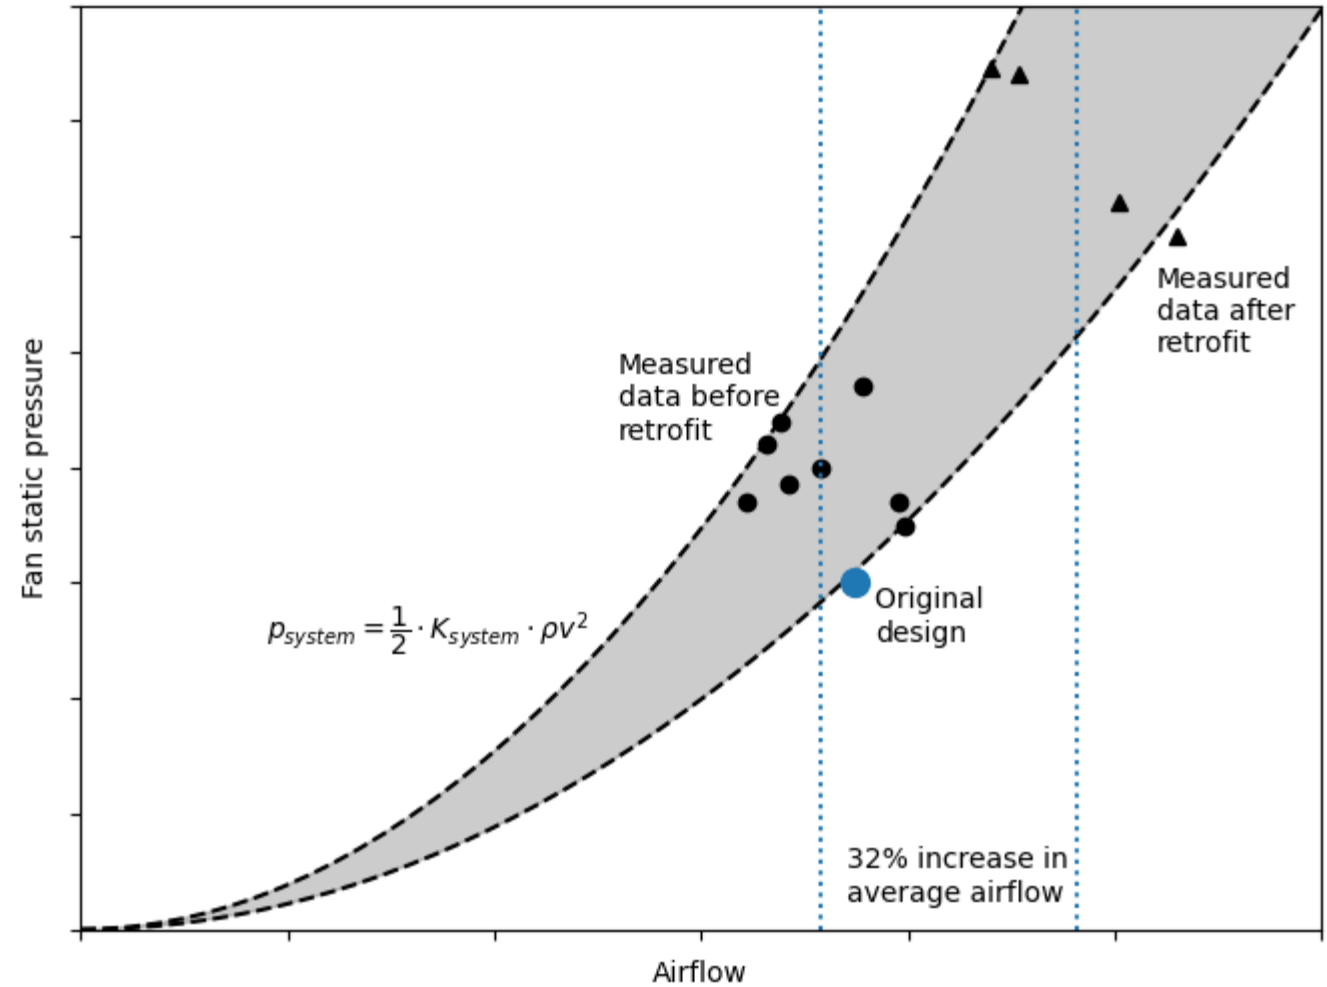
Initial performance measurements showed a higher flow rate and power consumption than predicted.

This was due to a then conservative estimation of the fan performance.

A reduction in blade angle of approximately 1° resulted in the desired increase in airflow while not exceeding the maximum available motor power.

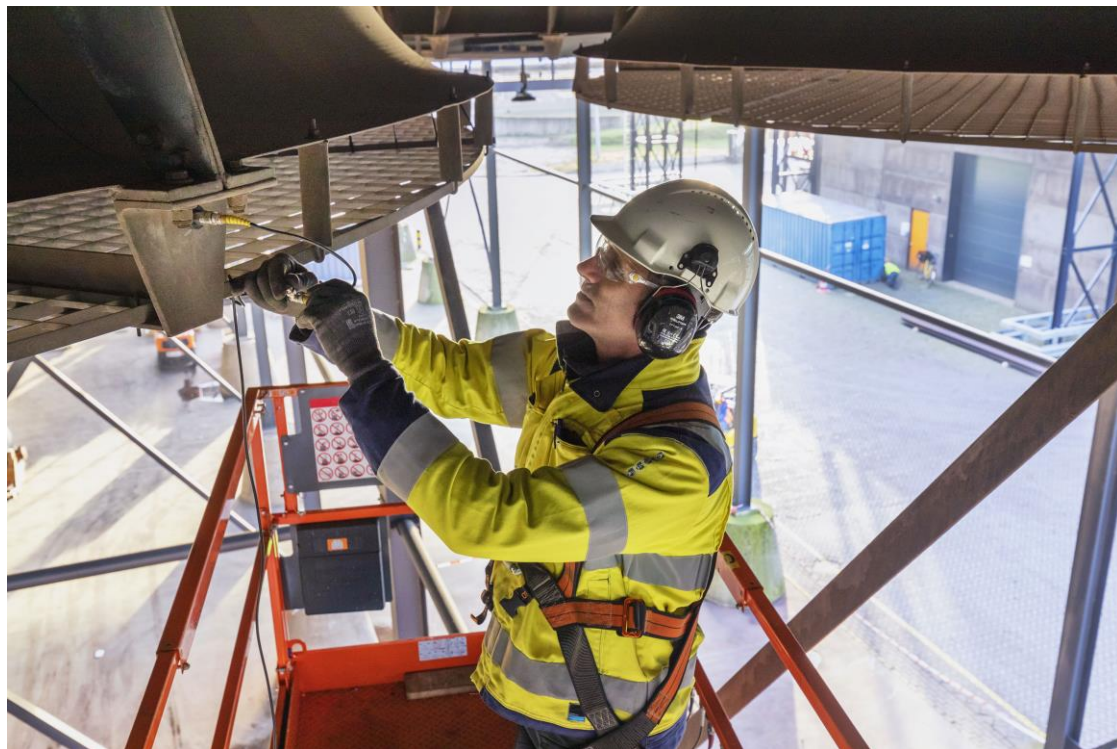
When initially running the fans, very high vibrations of the fan casing and safety grid were observed visually and subsequently measured as well.

The increased vibration levels may be attributed to the increased magnitude of the aerodynamic pulse exerted on the fan casing at BPF.

Fewer blades with a higher total aerodynamic load.

The solution was to add additional stiffening plates to the fan casing.
