ACC.03: Guidelines for Air In-leakage in Air-Cooled Condensers

Original Issue: 09/10/2024

Guidelines for Air In-leakage in Air-Cooled Condensers

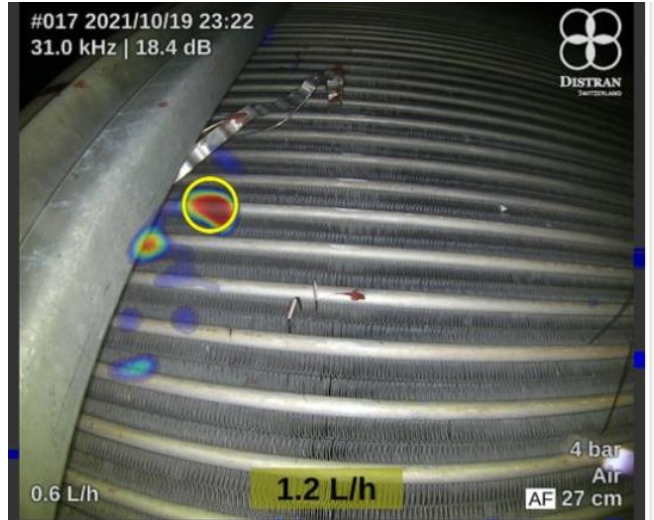
Figure 4: Acoustic detection of a leak in ACC tube

Leaks into a condenser vacuum are typically associated with a high-pitched sound that may be measurable with a sensitive acoustic receiver and earphones that help limit background noise. The acoustic system can isolate and enhance the volume at a leak; a receiver is directed towards the sound formed by air ingress at a leak point and focused until a relatively specific leak area is confirmed by maximum volume. Acoustic systems may include imaging capability that helps pinpoint the location of the leak (Figure 4). As with IR testing, it may be necessary to follow-up acoustic evaluation with tracer gas testing to confirm the precise leak location.

Finned tubing on A-frames is typically greater than 10 meters (~30 feet) in length, making access to the upper end difficult (Figure 6).^{5,7} Steam distribution headers with flanges and expansion joints are commonly impossible to access without manlifts or extensive scaffolding (Figure 7). Access challenges cause difficulty in the delivery of tracer gas to leak locations, although these challenges may be met with remote detection approaches such as acoustic systems or IR cameras (Figures 3,4).

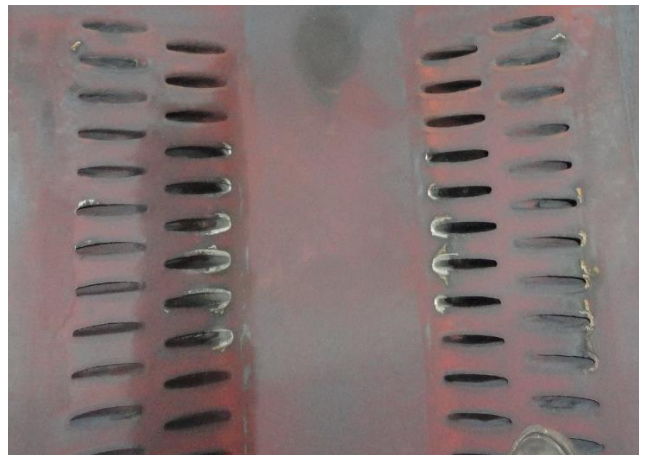
Figure 5: Finned tube entries; FAC is commonly present (bare metal areas)

Flow-accelerated corrosion (FAC) at the point where steam enters finned heat transfer tubing has been routinely identified in operating ACCs.⁶ These locations are commonly referred to as “tube entries” (Figure 5). Because the tubing is thin-walled to enhance heat transfer, the risk of through-wall corrosion is possible, whereas most other carbon steel structures in ACCs as well as WCCs being relatively thick and unlikely to experience significant thinning.

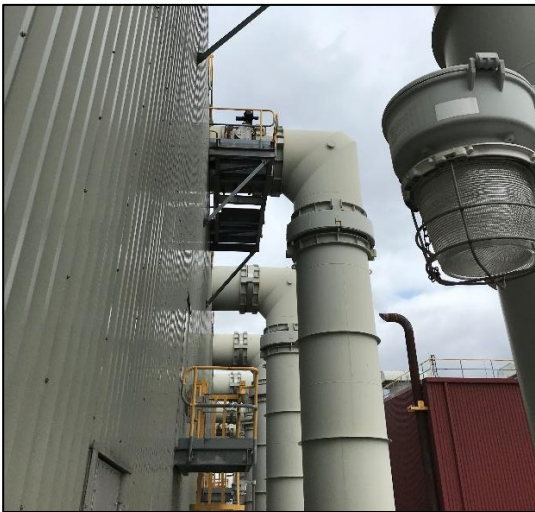
Figure 7: Access to exterior of risers for leak testing is challenging

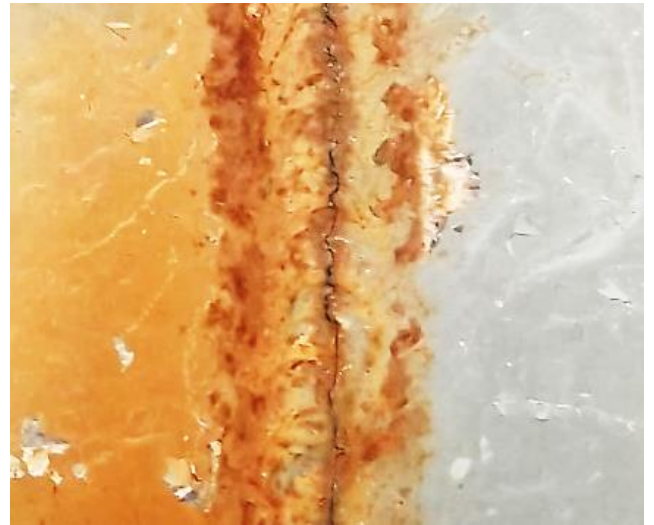
Figure 9: Crack in repair of ACC duct

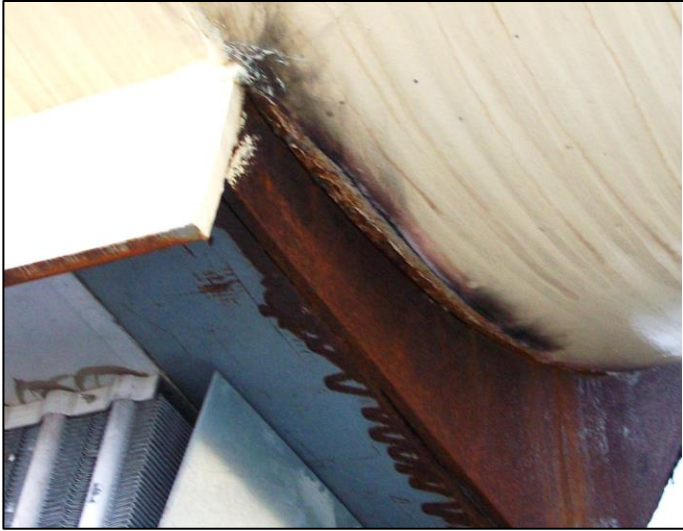
Figure 10: Attachment weld to steam distribution duct

- both ends of each finned tube to a tubesheet; these are typically precision-welded in a shop, so can be more reliable than field welds but are a potential leak location due to the large number of these welds in an ACC (Figure 8)
- sections of steam transport ducts, including those with large diameters, are welded together; there may also be supports, piping, metal ladders and other structures welded to the wall of the duct that could result in local duct wall cracking (Figure 9)
- condensate collection headers, particularly if they may have been subjected to freezing while containing condensate (Figure 10).

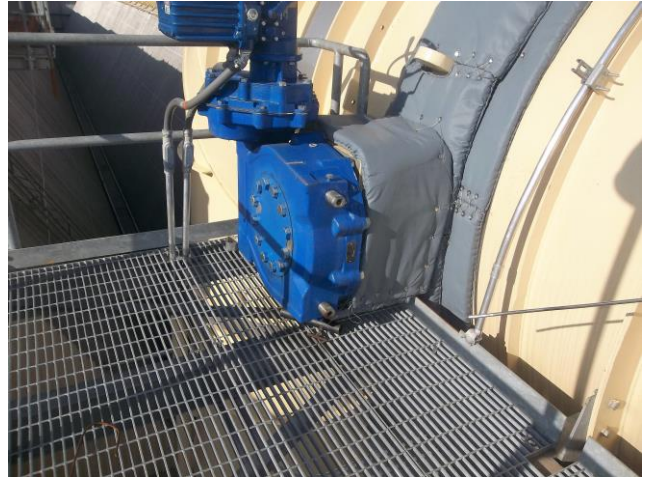
Figure 12: Duct isolation valve

Butterfly valves for riser isolation can leak around packing, especially after repeated use over an extended time frame, if not properly maintained (Figure 12).

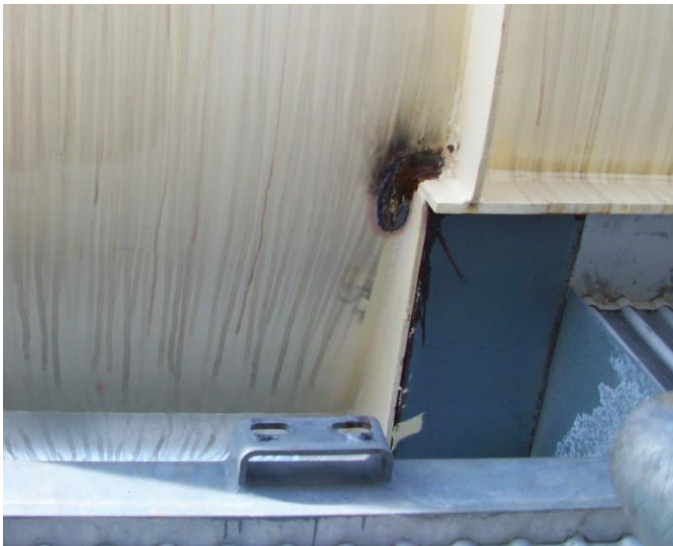
Figure 11: Local rust may indicate wall penetration.

The presence of rusted locations on external surfaces that are otherwise uncorroded may be evidence of condensate leaking through a penetration of the vacuum barrier (Figure 11).

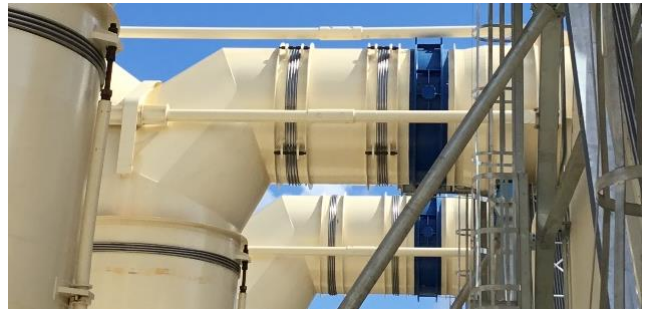
Figure 13: Flanges / expansion joints ACC risers

Thermal expansion stresses are relieved by the selective positioning of expansion joints, including the bellow-type joints typically present in riser ducts (Figures 13, 14). However, repeated flexing of the thin-walled material can result in fatigue cracking and failure. Turbine-to-ductwork expansion joints also deteriorate and leak over time, similarly to those in WCCs.

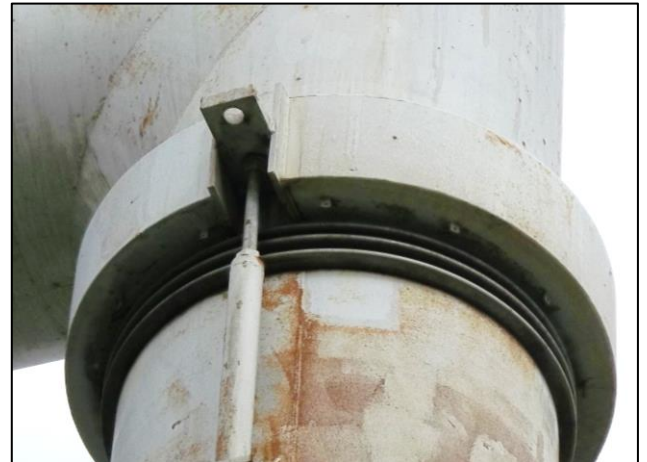
Figure 14: Leak at expansion bellows in riser duct

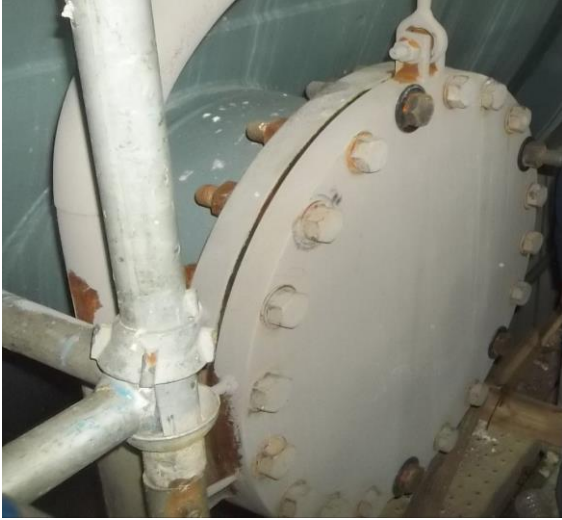
Figure 15: Manway entry cover, inadequate bolt torquing

Wherever bolts are maintaining a seal that protects a vacuum, including flanges and manways, there is a potential for loose bolts or loosening from corrosion that could allow AIL (Figure 15). The presence of vibration or thermal stresses could accelerate this process. Over-torquing bolts or flanges can result in failure / leaks as well.

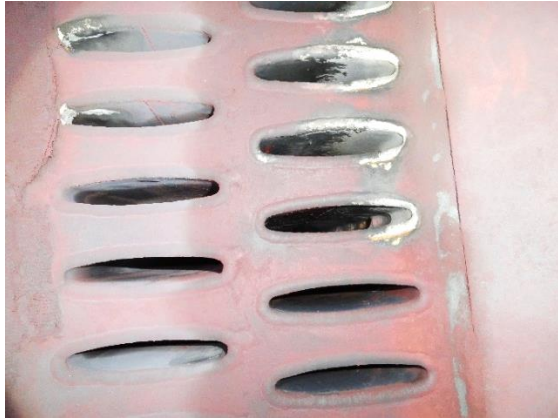
Figure 16: Significant corrosion ('bare metal') at thin-walled finned tube entries

Where wall thickness is small, primarily in the finned heat transfer tubing, through-wall corrosion can occur. In practice corrosion at the point of steam entry into the tubes has been commonly observed, although through-wall corrosion has not been frequently identified (Figure 16). Corrosion on finned tubing also can occur from the exterior when a combination of poor water quality for tube cleaning and debris accumulation allows wet material to remain on tube surfaces for an extended period (Figure 17). In humid areas, water may condense from air and remain on the upper regions of dephlegmator tubes, which are cool due to the air removal process (Figure 18). This issue is also exacerbated by debris accumulation in the area. Access to the upper end of tube-to-tubesheet connections may be challenging but the area is important to evaluate.

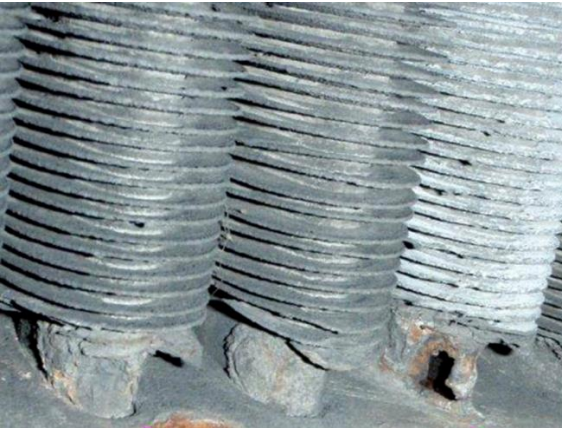
Figure 17: Through-wall exterior corrosion at lower tube due to cleaning water quality

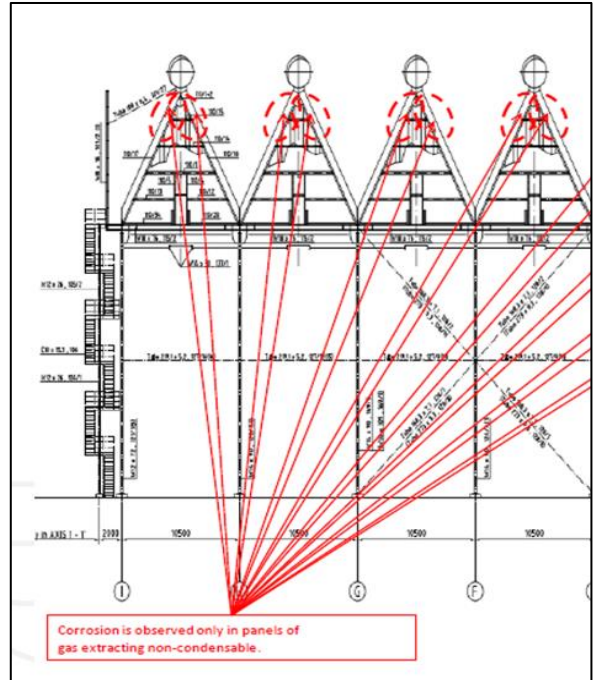
Figure 18: Through-wall corrosion due to external condensation onto cold air extraction region

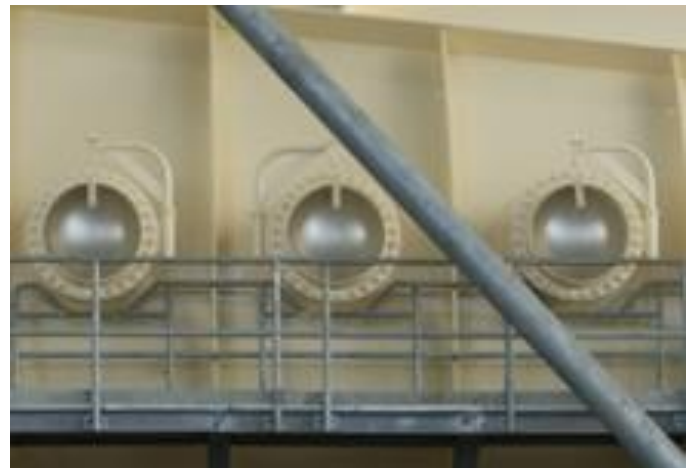
Figure 19: ACC rupture disks

The rupture disks on ACCs are typically a different design from those on steam turbines, but they may fail to seal tightly due to the presence of debris or from mechanical failure (Figure 19).

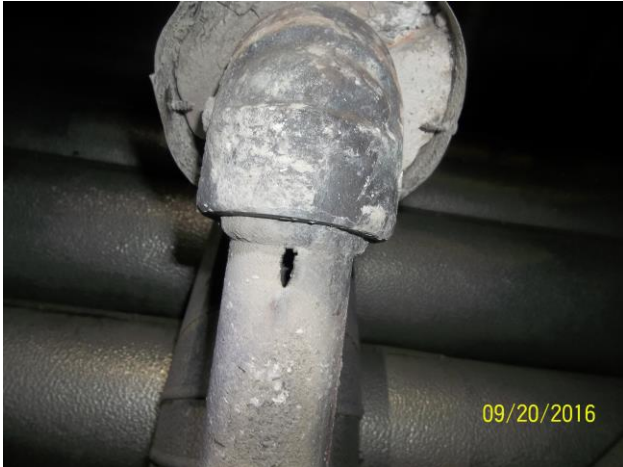
Figure 20: Leak resulting from corrosion under insulation

If insulation is not sealed adequately from atmospheric moisture, water can accumulate and corrode carbon steel piping over an extended period (Figure 20).
