2017 ACC USER GROUP

NV ENERGY – TRACY GENERATING STATION

OVERVIEW

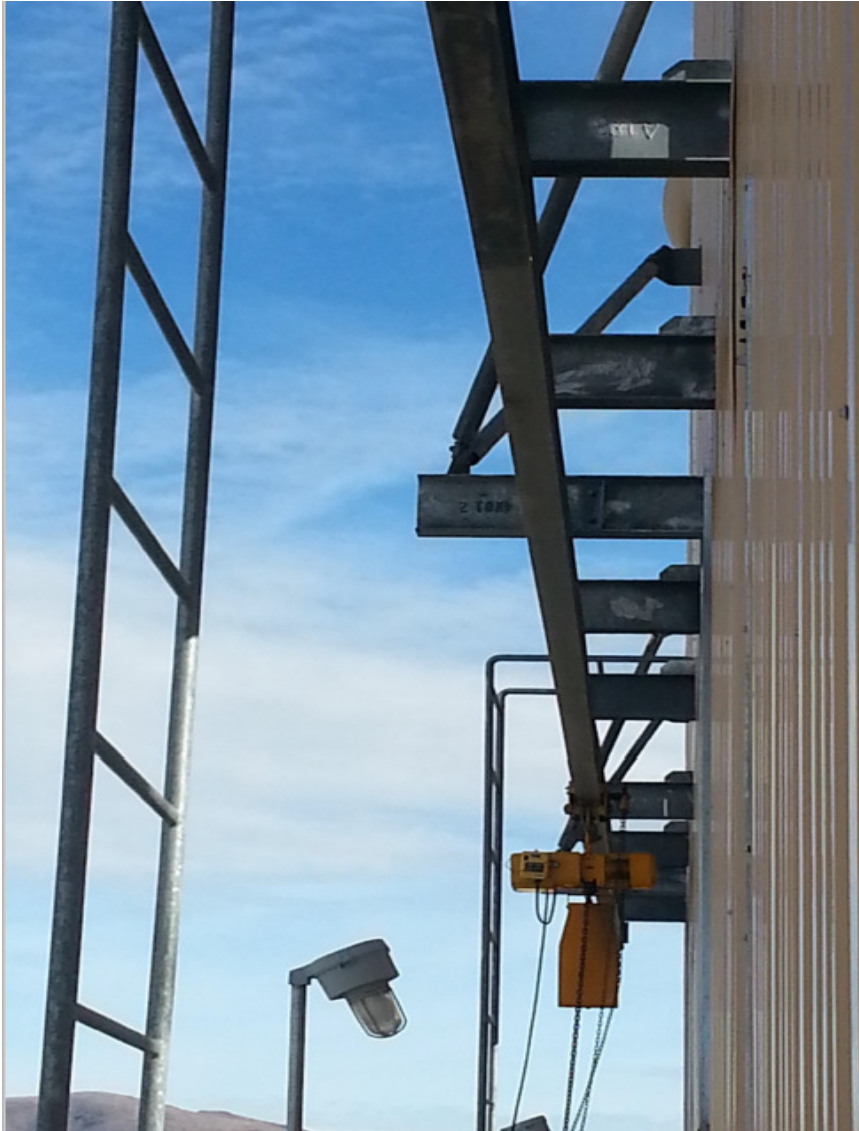
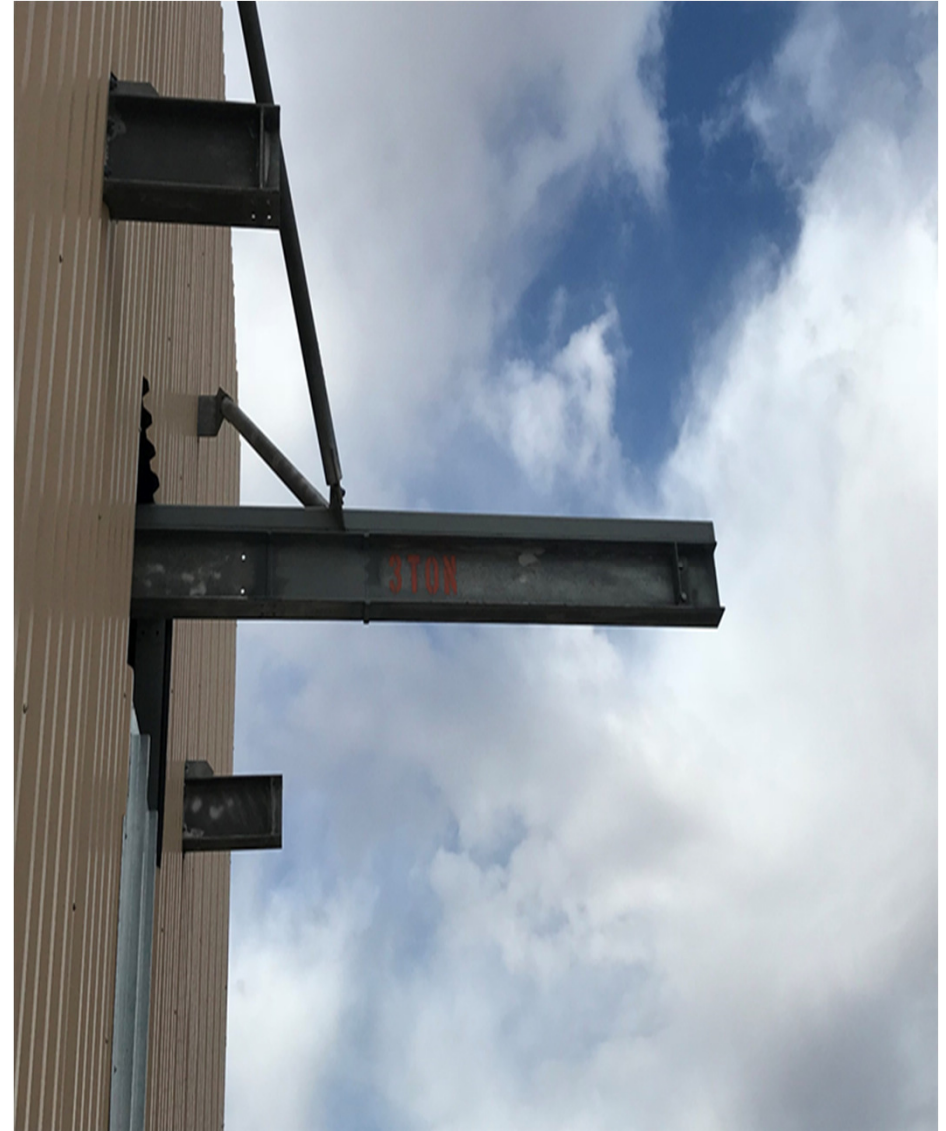
Old Versus New Trolley Design

- Gearboxes:
 - 20 new gearboxes will be installed on Street 2, 3, 5, 6
 - 750 horsepower rated gearboxes
 - Requires larger hoists (2 Ton → 3 Ton)
 - Requires low profile hoist/rigging to lift new boxes over running motors
- Hoists
 - Old design had an east-west hoist to lift from the ground to elevation, then a transfer was required to run north-south down the ACC streets.
 - Six new hoist were installed that lift directly from ground to the ACC street. Does not require a load transfer.
 - Door & I-beam modifications required

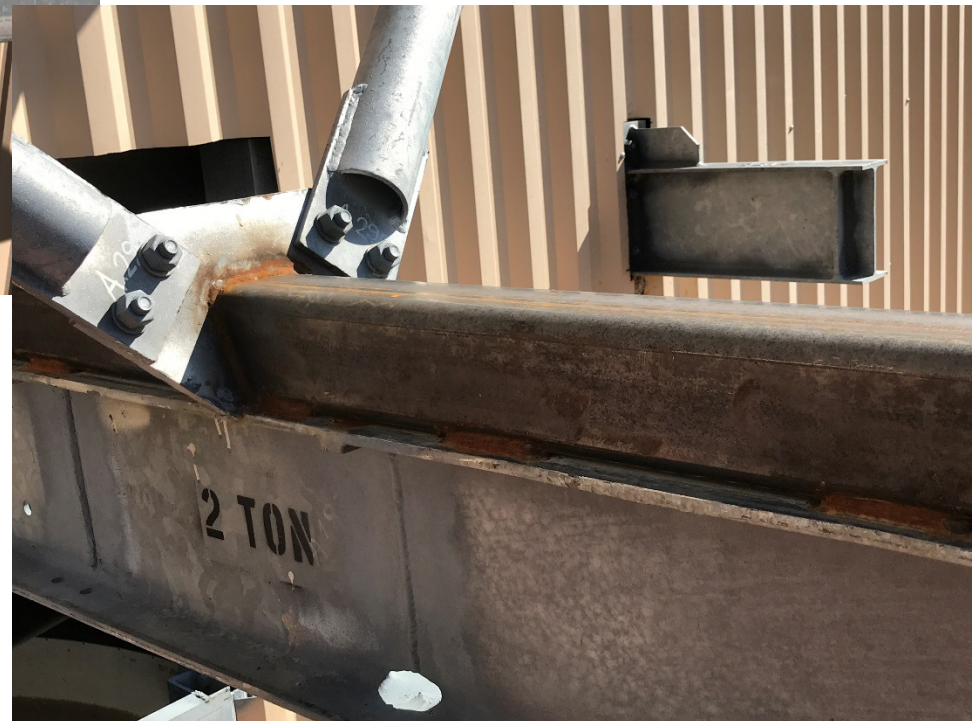
HSS 4x4x3/8" Stich
Welded I-Beam
