# Virginia City Hybrid Energy Center (VCHEC)

## Air In-Leakage - Experience Report

2023 ACCUG Richmond, VA  
June, 2023  
Presented by **Sam Dunning**

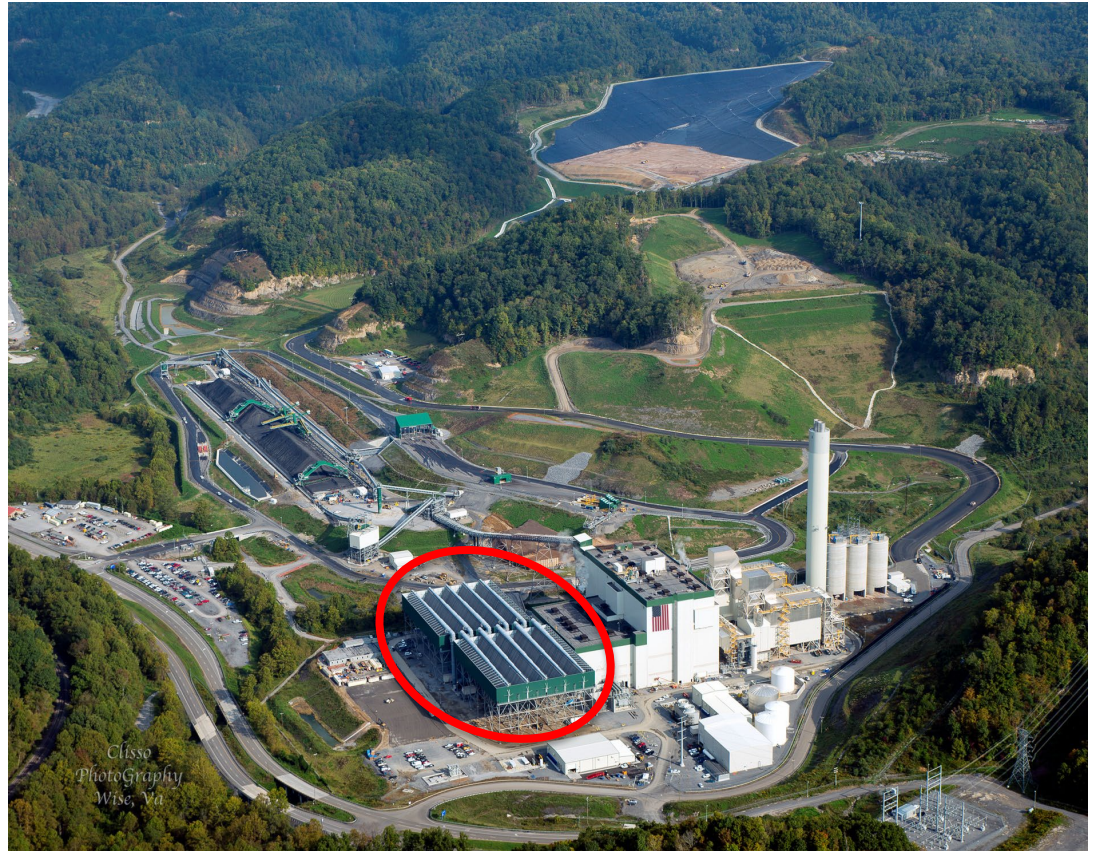
- OEM – SPG Dry Cooling
- 60 Fans
- 10 streets of 6 bays
- 36' diameter fans

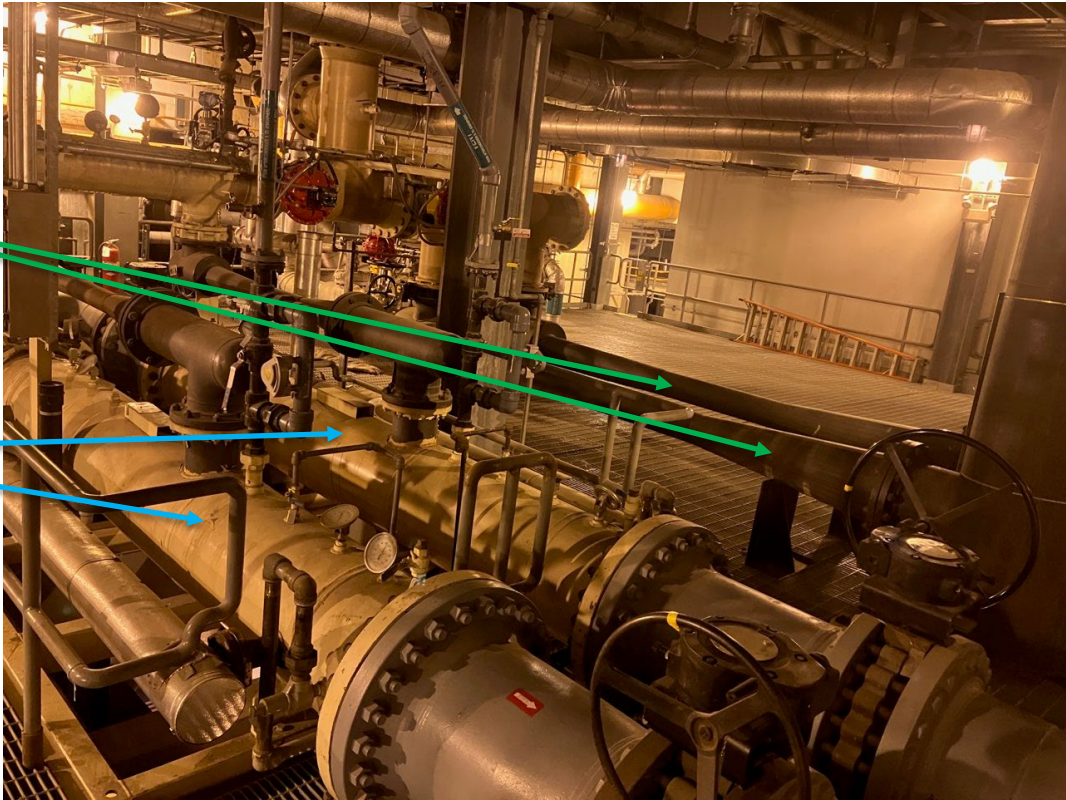
Hogging  
Ejectors

Holding  
Ejectors

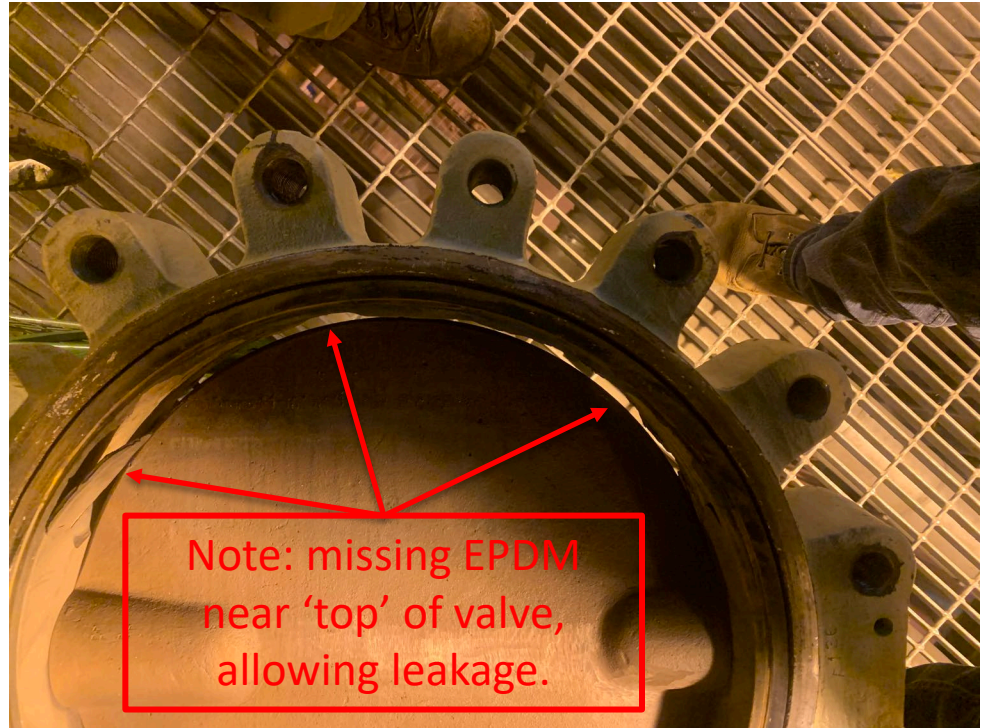
- A large leak was found in the isolation valves to the hogging ejectors
- The hogging ejectors discharge to atmosphere and the leakage through the isolation valves allowed air to be pulled back in through the discharge side of the out of service hogger
- Inspection of the valves' internals showed the rubber (EPDM) seated valves had lost over half of the seal creating a cumulative fist sized leak area. The rubber had become severely brittle, and the adhesive used to hold the seal was deteriorating
- Additional valves in the same service were inspected and all were experiencing similar types of failure at the valve seats

- EPDM-seated valve was removed from service.
- Valve shown closed.

EPDM: Ethylene Propylene Diene Monomer

- ASAP, replaced valves 'in kind'.
- At a later outage, replaced valves with metal-seated valves.

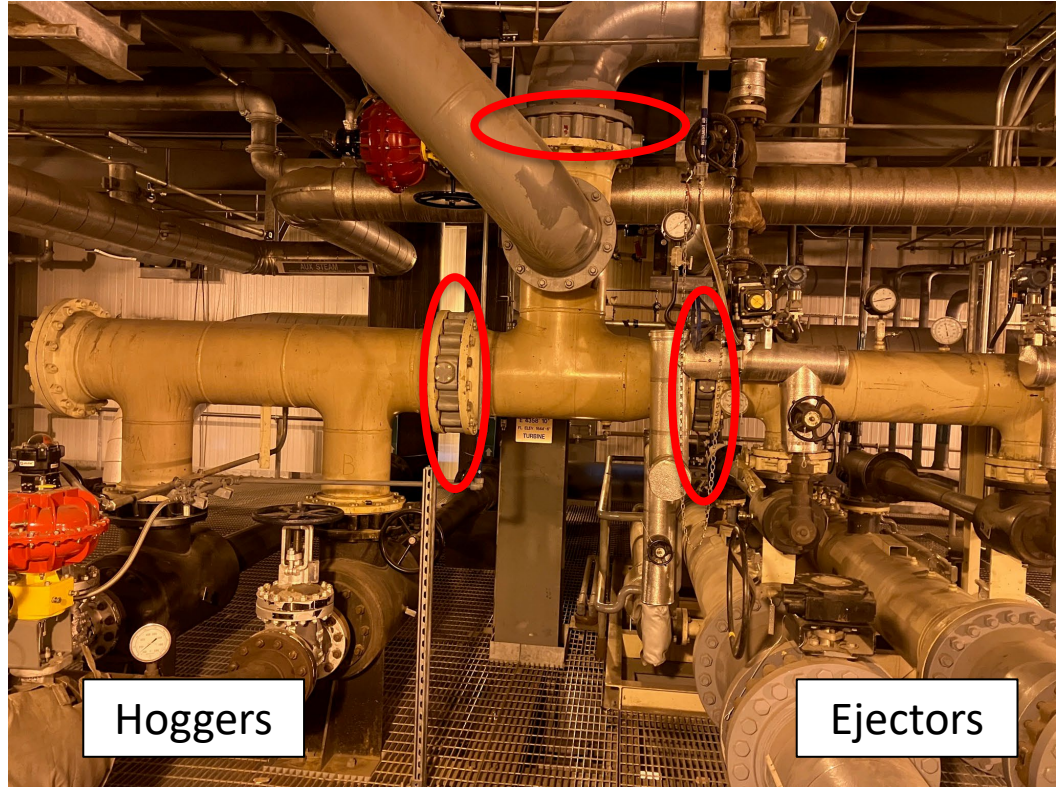
Valves that were replaced in the non-condensable gas piping from the ACC to the hoggers/ejectors

Hoggers

Ejectors

- Equipment that is rubber lined in vacuum service should be scrutinized before approving for installation. Specifically, the seat design of the seal severely limits the level of vacuum valves can be rated for. Most valve manufacturers only allow for “light” vacuum service which is not adequate for levels experienced by power plant condensing systems.
- High performance butterfly, including triple offset styles should be considered for the vacuum service conditions.
- If rubber lined/seated valves are currently in vacuum service, inspections should be considered to determine the integrity of the rubber. This should be done periodically and more frequently as valves age.
