ACCUG: Corrosion and Cycle Chemistry

Fossil, Combined Cycle/HRSG and Industrial Plants
Review of History over Last 20 Years

Barry Dooley

ACCUG 2024
23rd and 24th July 2024
London, UK

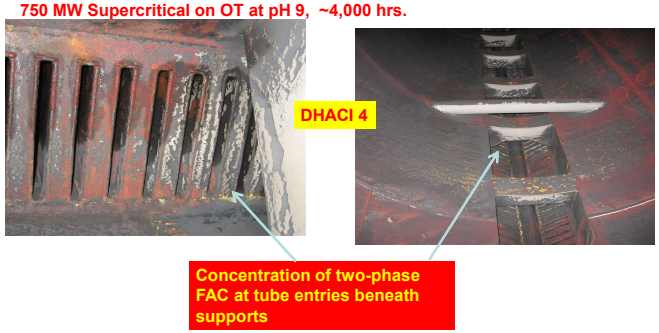
Inspections Worldwide show the same Features

750 MW Supercritical on OT at pH 9, ~4,000 hrs.

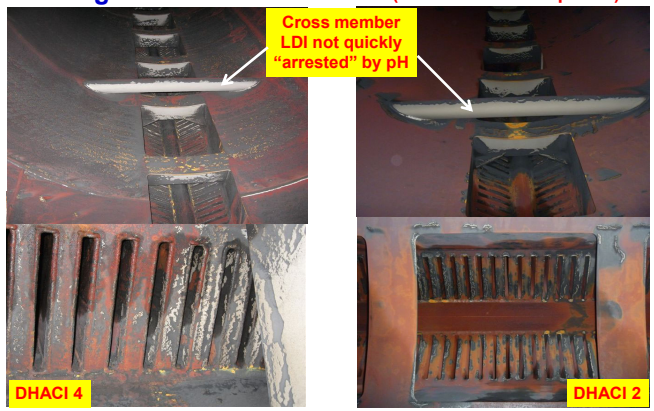
Damage takes time to Arrest (after 2 Years with pH 9.8)

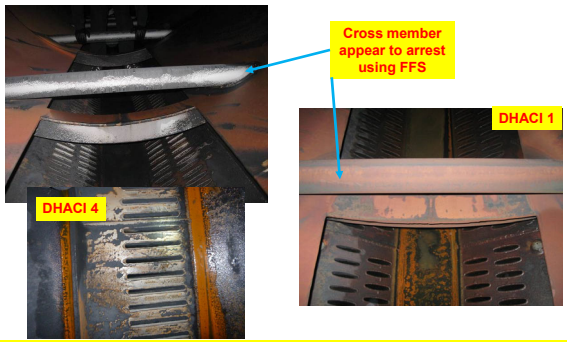
ACC Two-phase FAC can be "Arrested" with FFS (both FFA and FFP)

(Significant Reduction in DHACI for FAC at Tube Entries in ACC Accompanied by Significant Reduction in Total Iron in Condensate)(But word of caution on FFS – see later)

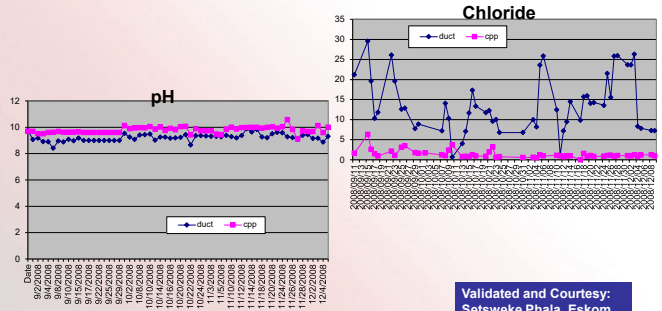
The Liquid in ACC Upper Ducts

(Lower pH and higher chlorides)

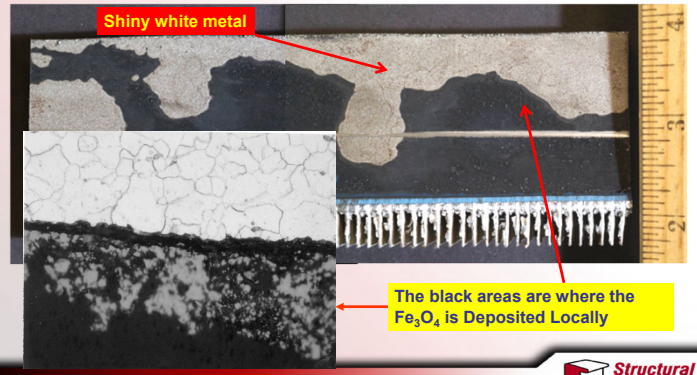
Inside diameter surface of an ACC Tube

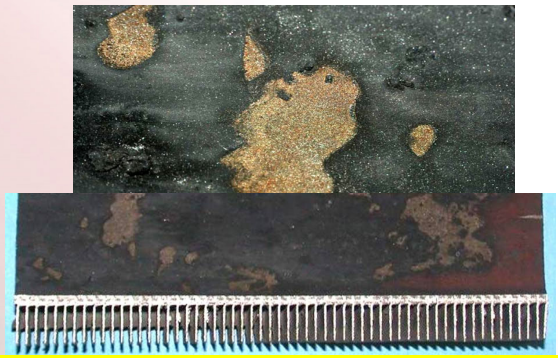
Another Tube Showed the Same Features

6 inch section of ACC tube and detail of the surface showing black deposits and white "bare" metal areas. Note some Fe_3O_4 has turned red

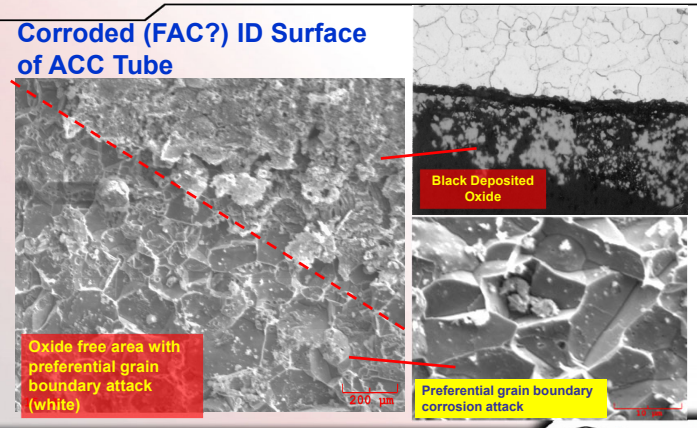
Corroded (FAC?) ID Surface of ACC Tube

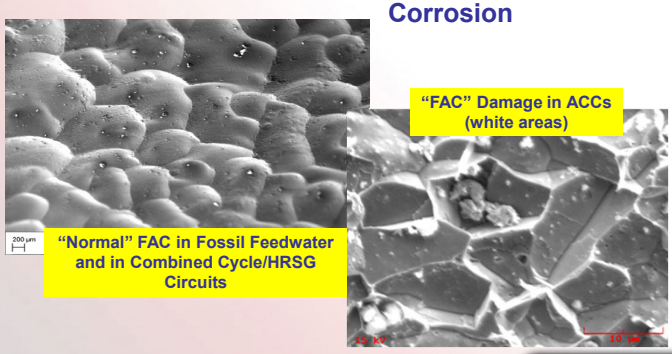
Typical Microscopic Appearance of FAC and ACC Corrosion

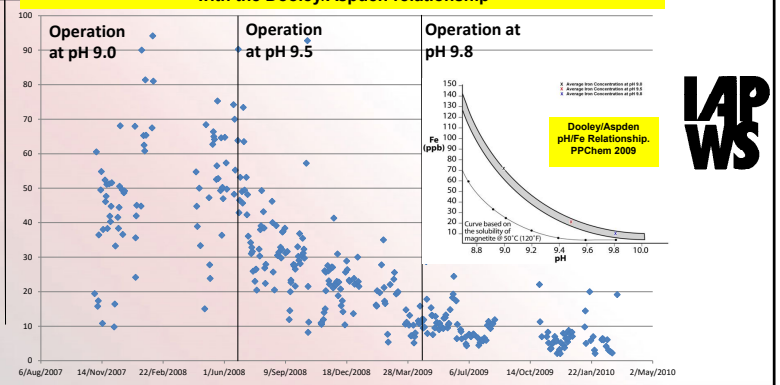
Plant Improvements in ACCs (reduction of total iron) are Directly in Agreement with the Dooley/Aspden relationship
