Corrosion in Air Cooled Condensers - Understanding and Mitigating the Mechanisms

Setsweke Phala, Denis Aspden, Dr Francois du Preez, Hein Goldschagg and Keith Northcott Eskom Johannesburg, South Africa

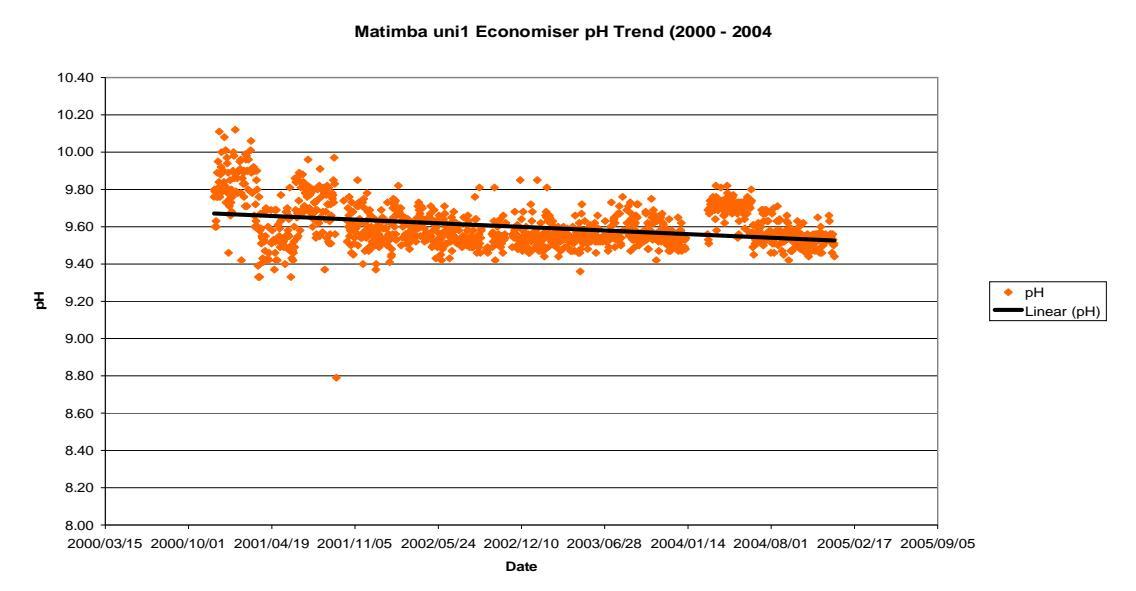
Figure 3: Matimba unit 1 pH trend (200 -2004)

The station was commissioned under All Volatile Treatment, AVT(R) with condensate pH ranging from 9.2 -9.4 during the first few years after commissioning. A decision was taken to increase the steam water cycle pH to 9.7 in the late nineties to help assist with reduction of severe corrosion that was seen in the ACC ducts. Due to problems experienced in early 2000 with condensate polishing plant resin cross contamination and early chloride leakages when the CPP resins are at the end of life, the steam cycle pH was controlled between 9.4 - 9.6 to help minimise the chloride leakage from the CPP. No inspection of the ACC ducts prior to the change in order to assess the extent of corrosion was done. The pH conditions at the time are as illustrated in figure 3 below.

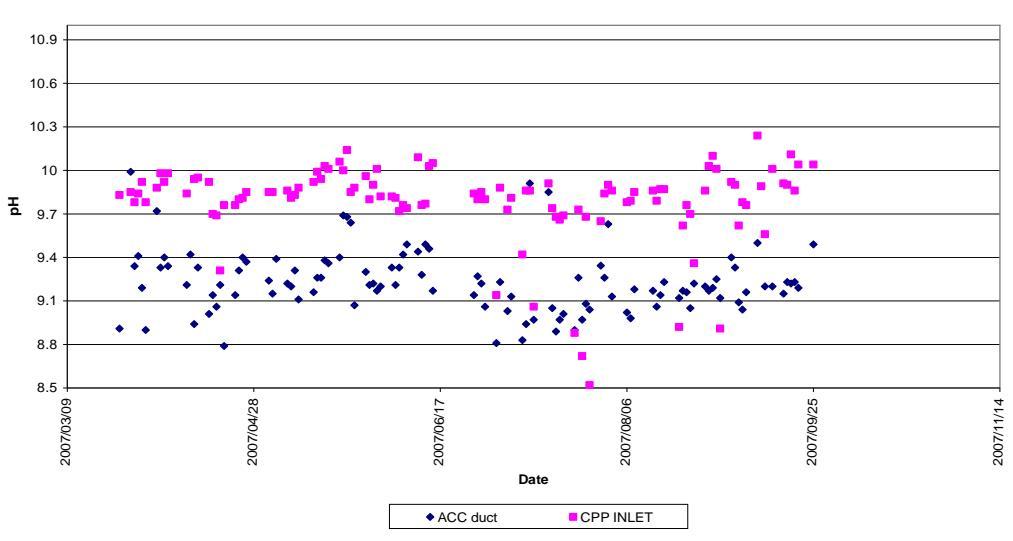
Figure 11: pH of condensate collected from the ACC duct and CPP inlet on unit 1. (Nov 2007)

Based on the condensate drainage marks shown in figure 3, it was decided to install a sample point in that location to drain off and be able to analyse a sample of the initial condensate in the steam distribution duct. A drain line was fitted on one of the steam distribution ducts of unit 1. This sample pH and ionic impurity concentrations were analysed and compared to that of the condensate at the inlet of the CPP. The pH and chlorides results are as on figure 11 and 12 below.

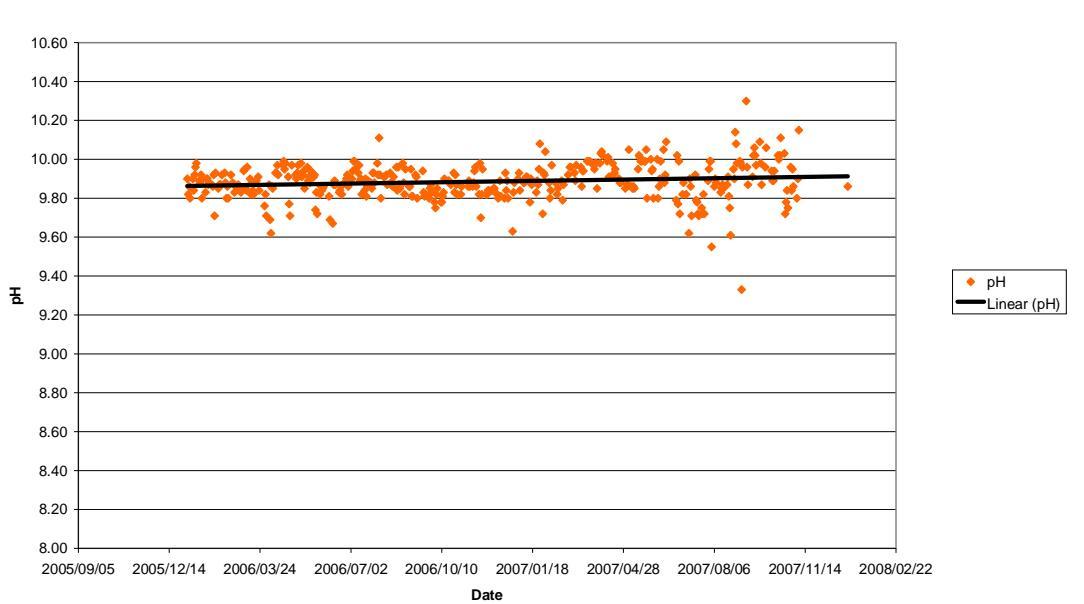
Figure 13: Matimba unit 1 Economiser pH trend (2006 – 2007)

Between 2006 and current the steam pH was raised and maintained at 9.6 - 9.8 as on Figure 13.
