# Assessing and Controlling Corrosion in Air-cooled Condensers

*Ninth International Conference on  
Cycle Chemistry in Fossil and  
Combined Cycle Plants with Heat  
Recovery Steam Generators*

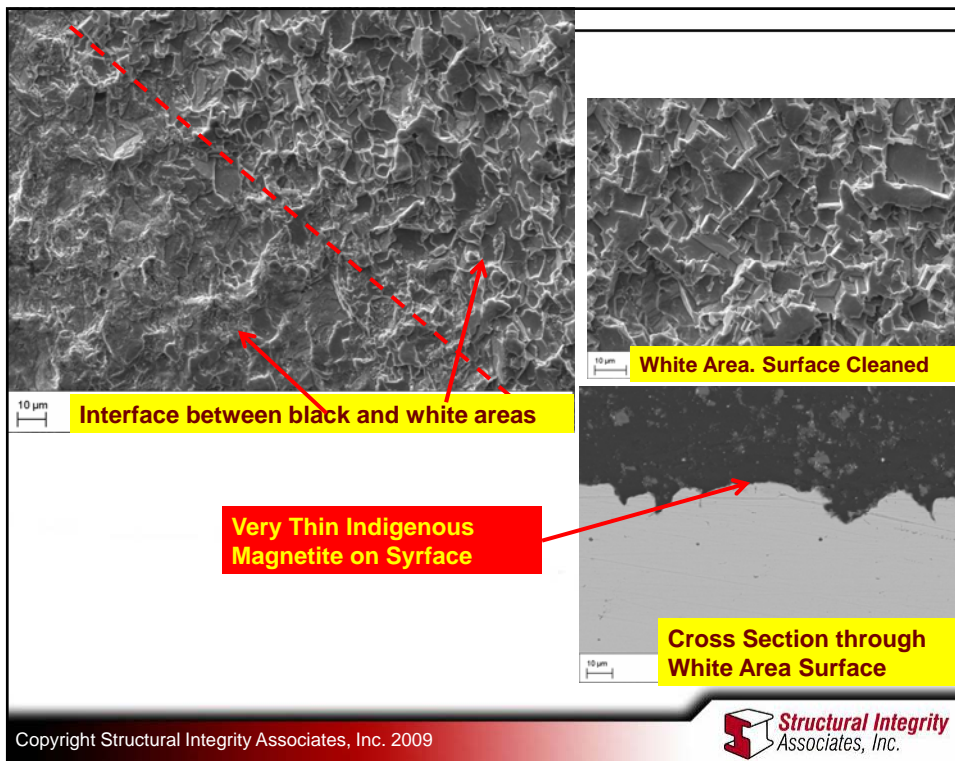
### Inside diameter of second ACC tube analyzed

6 inch section of ACC tube and detail of the surface showing black deposits and white "bare" metal areas
