# Kogan Creek Power Plant's Air Cooled Condenser

Update For ACC User Group  
September 2011

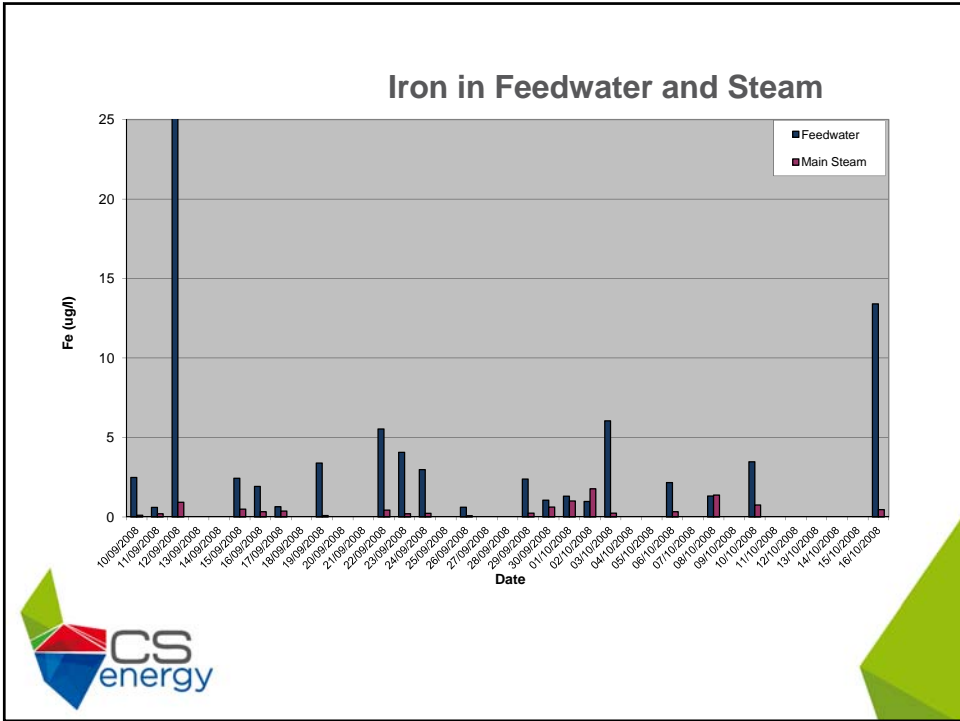
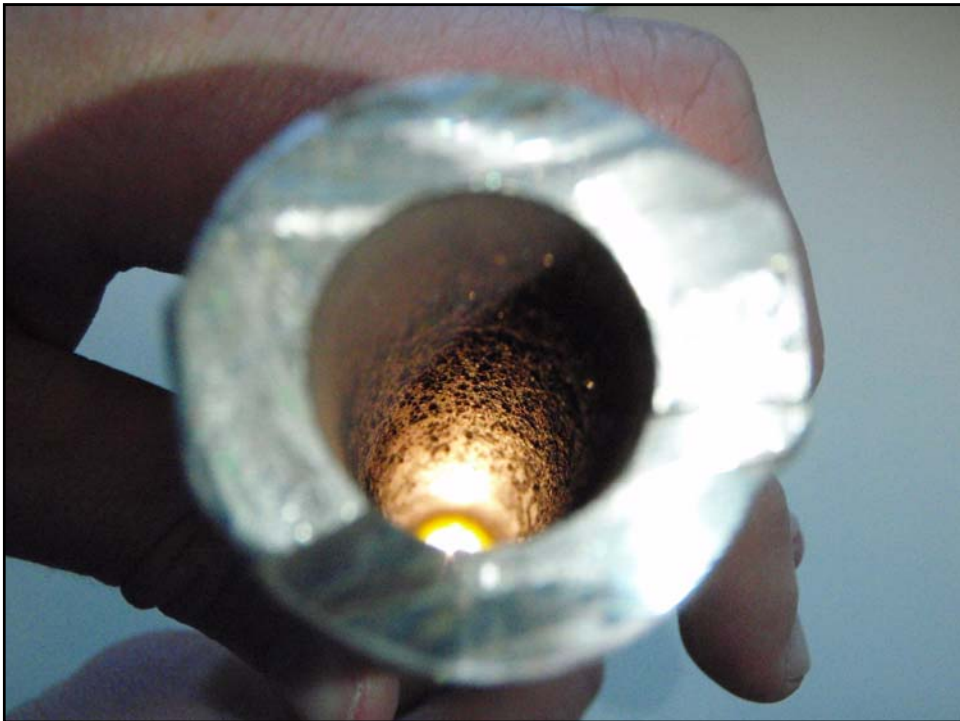
- Prior to the replacement of condensate filter elements in 2008, a significant amount of Iron entered the boiler through the feedwater
- Concerns were held with respect to deposits forming in the boiler
- Concerns also about the potential for Iron deposits on the turbine
- Sampling indicated very low levels of Iron in steam, confirming concerns about boiler deposits
