DRY FORK STATION

Plant Report

2012 ACC Users Group

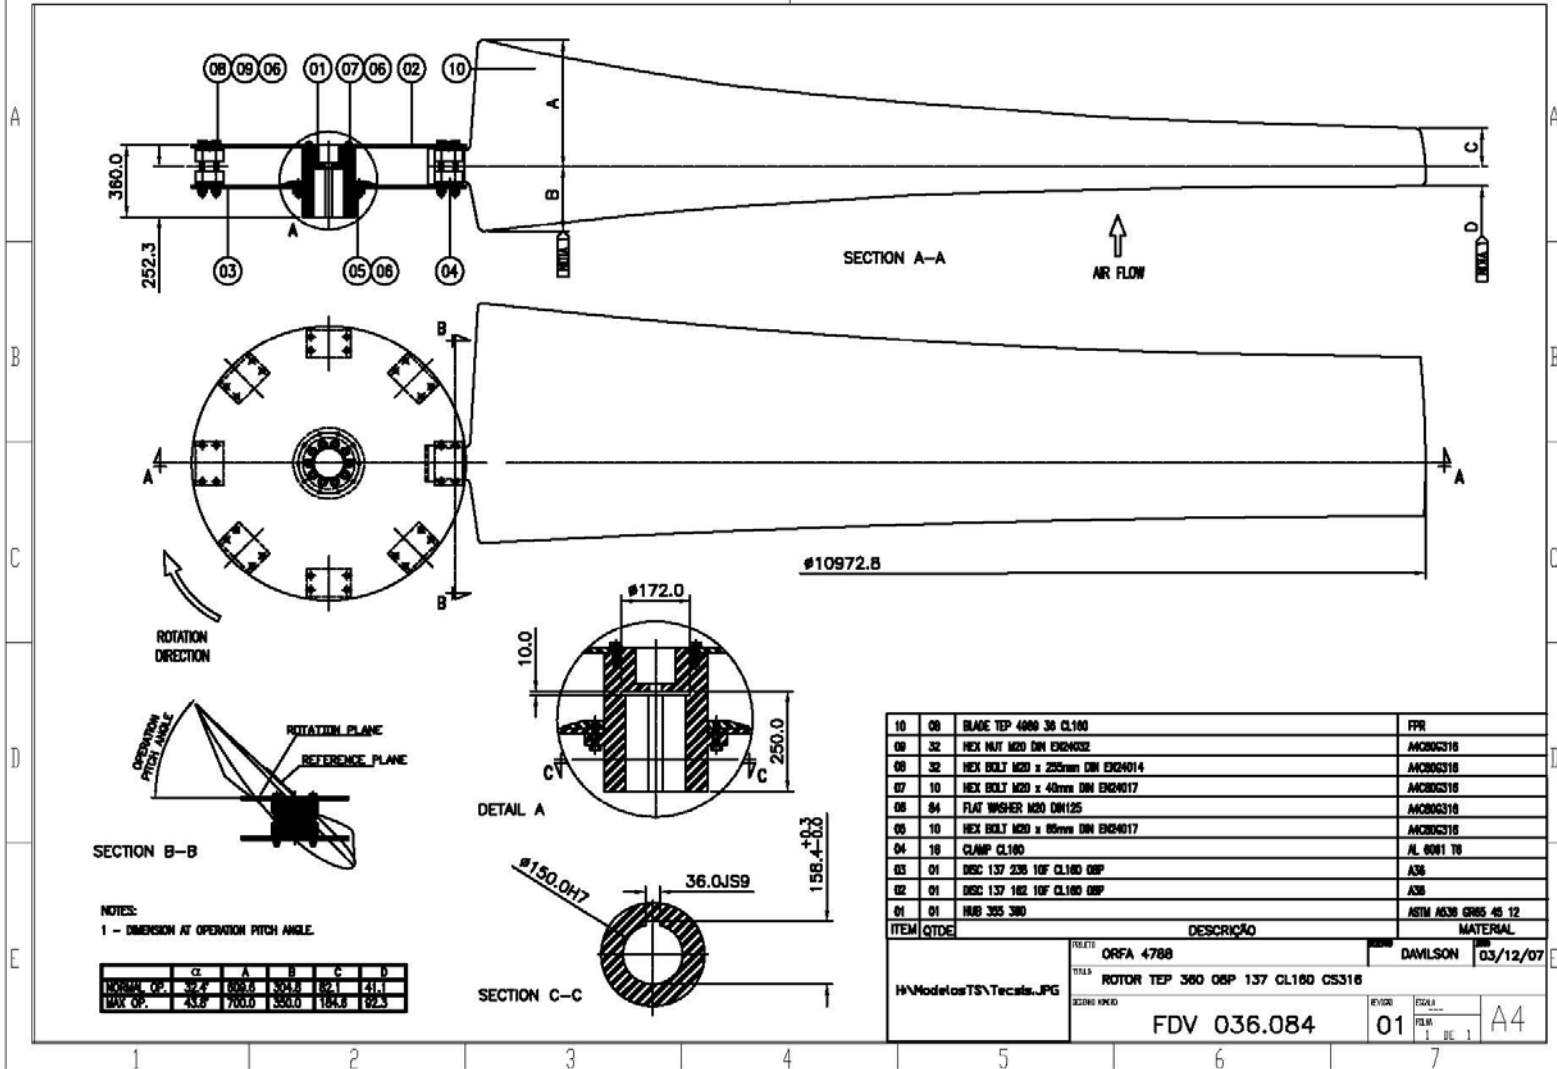
- Mechanical Maintenance problems
 - Fan hub failures
 - Bolts falling out of hubs
 - Hub threads being stripped during installation
 - Fan blades being crushed due to over torquing
 - Motor Bearing failures in all 45 motors
 - No O&M manuals for gearboxes
 - Leaky shaft seals around gearbox input shaft

- Fan hub failures
