By David Rettke
Maintenance Specialist
WALTER M. HIGGINS III
GENERATION STATION
PRIMM NEVADA

WHAT IS THE CONDITION OF YOUR ACC SYSTEM?

HOW TO DISCERN THE CONDITION OF YOUR ACC SYSTEM ACCURATELY AND EFFECTIVELY,
USING CONDITION BASED MAINTENANCE, ROOT CAUSE ANALYSIS, AND OTHER PROACTIVE
MAINTENANCE APPROACHES.

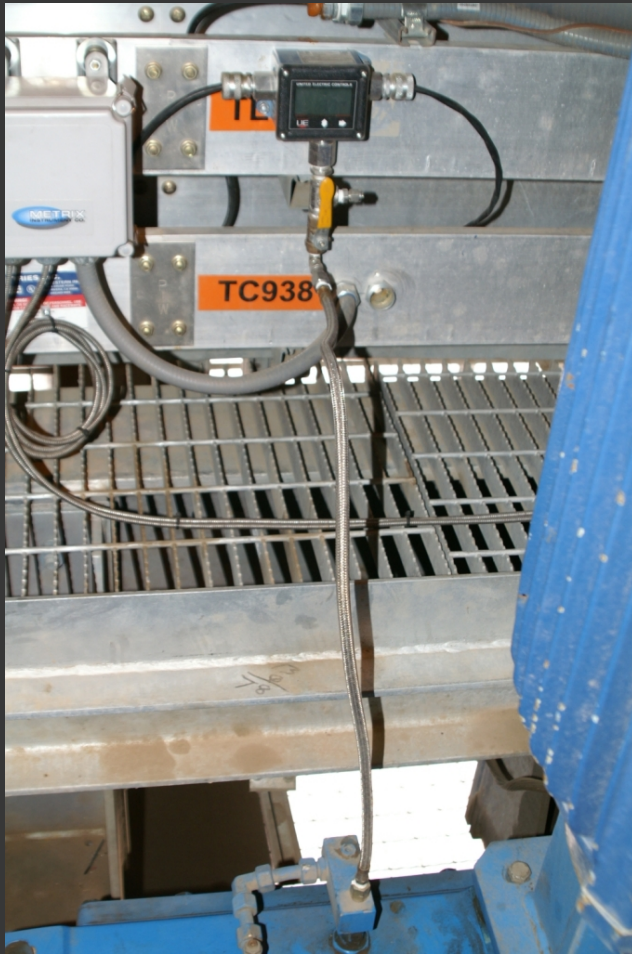
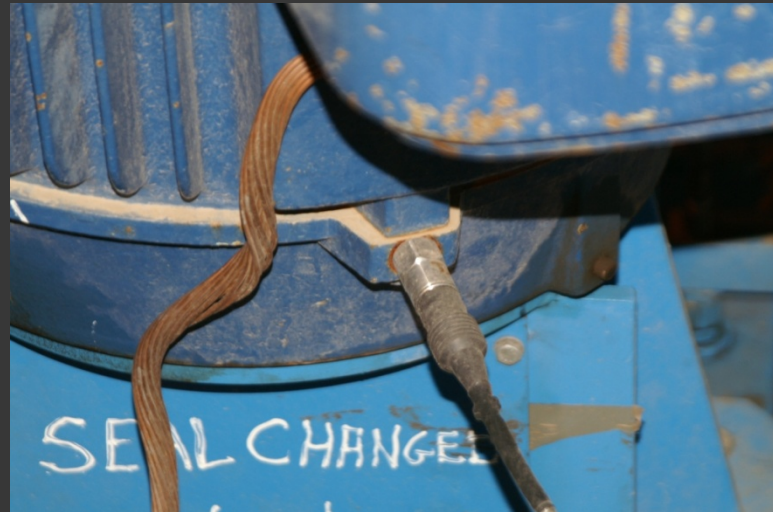
Oil pressure and vibration

- We found a need to monitor vibration and oil pressure remotely.
- It was determined that one accelerometer on the motor and one on the gear-reducer would monitor vibrations sufficiently enough for a warning as well as sending data to PI
- Oil pressure is monitored through a digital pressure gauge that allows data to be sent to PI.
- PI screen for ACC is utilized during weekly walk-down inspections so trends can show a need for closer inspection on equipment.

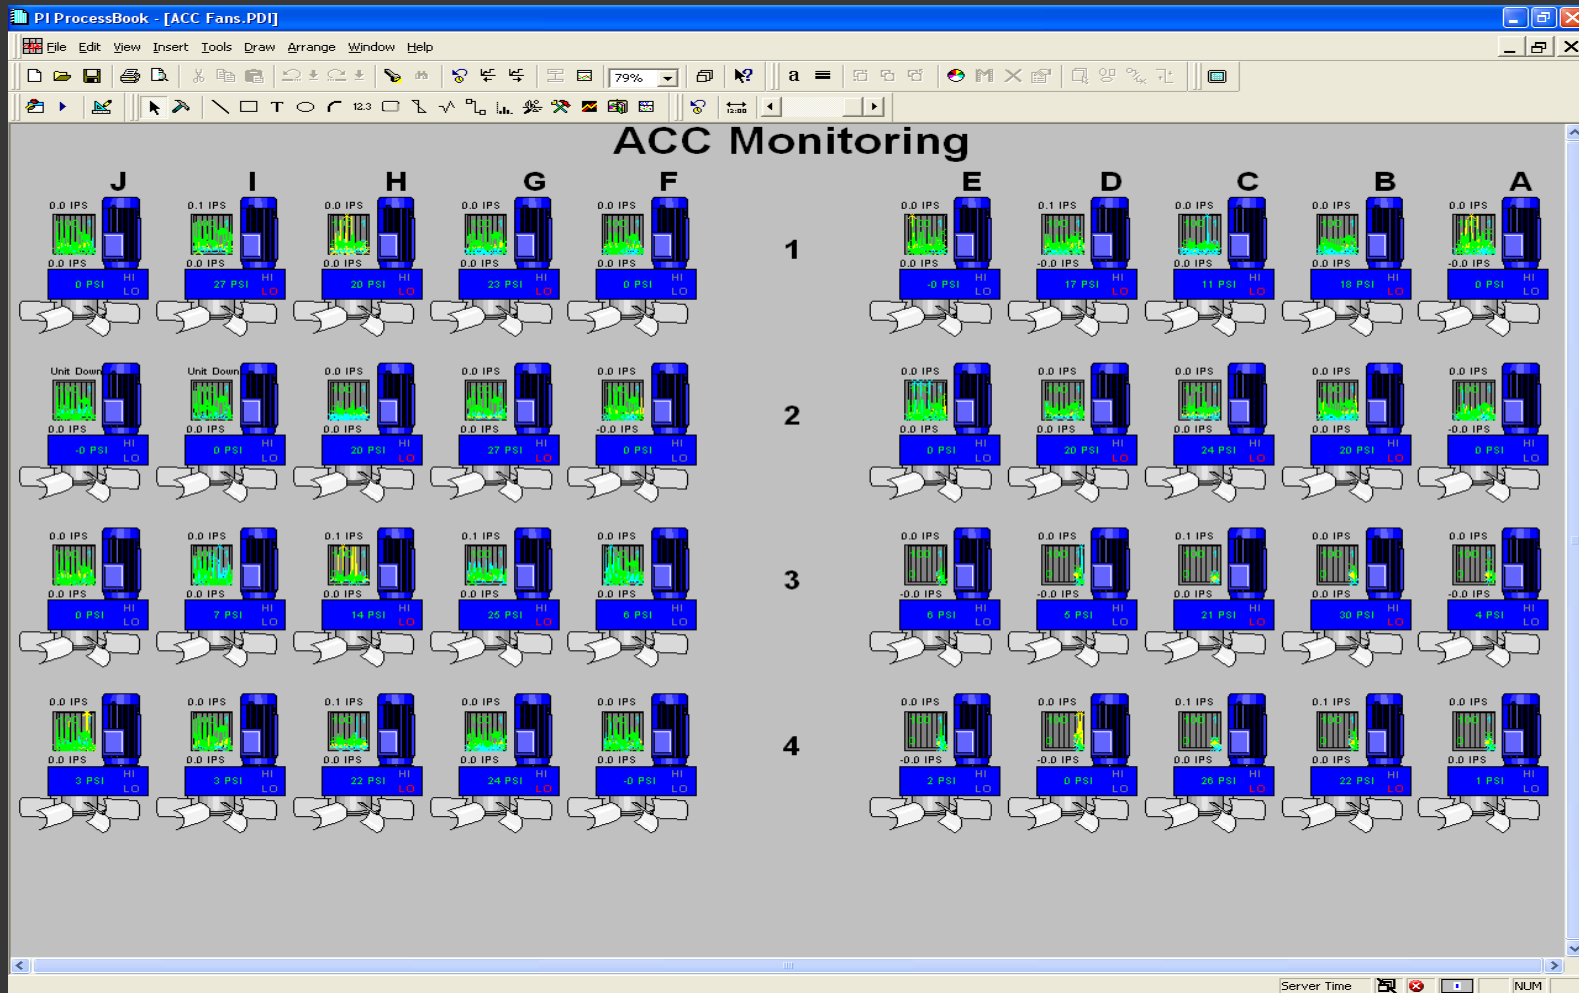
PI screen for ACC

- Right after installation of the oil pressure/vibration units we caught a gear-reducer oil pump failure.
- We've trended eight gear-reducer filter clean/change's. (as seen in next slide)

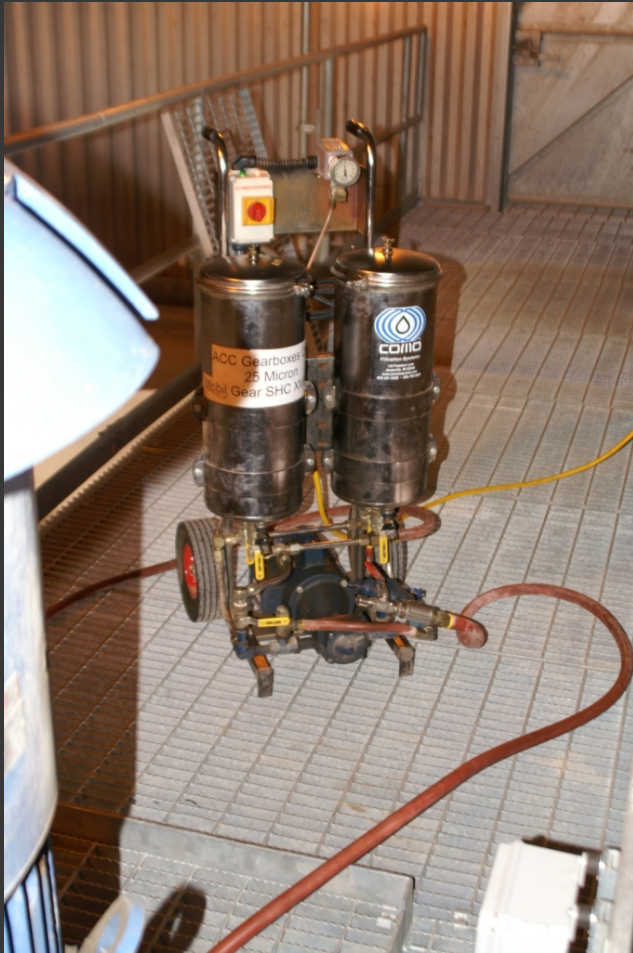
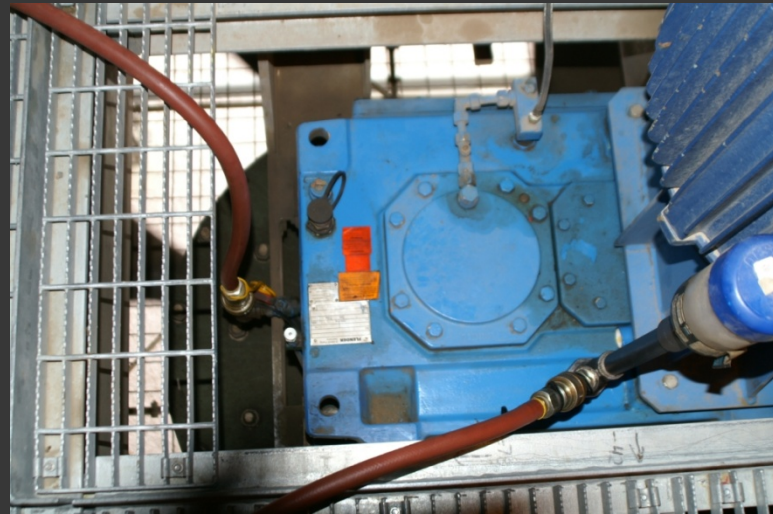
Filtering lube oil

- The COMO oil filtering unit removes water as well as final filters to 25 microns.
- It handles the Mobil gear oil SHC XMP ISO 320 well, though this lube is very 'stiff', (high viscosity) even when warm.
- We filter long enough to allow for a minimum of eight 'changes' of lube.
- We now plan to change the oil out at the five year mark due to physical changes in the chemical makeup of the oil.

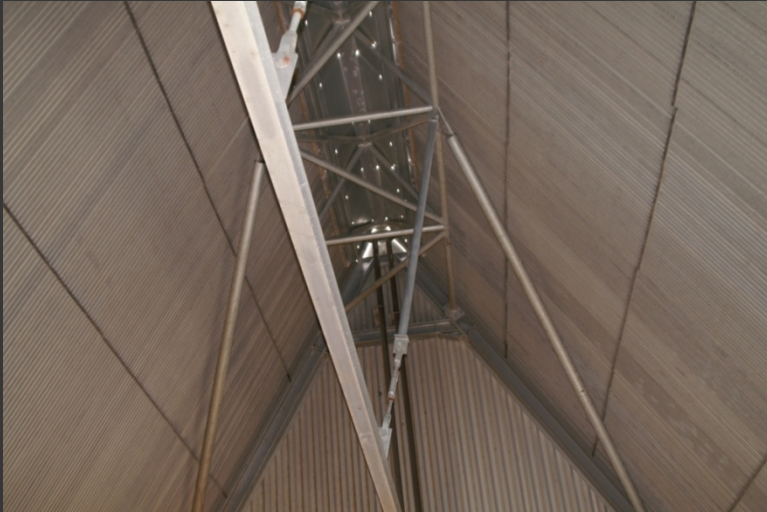
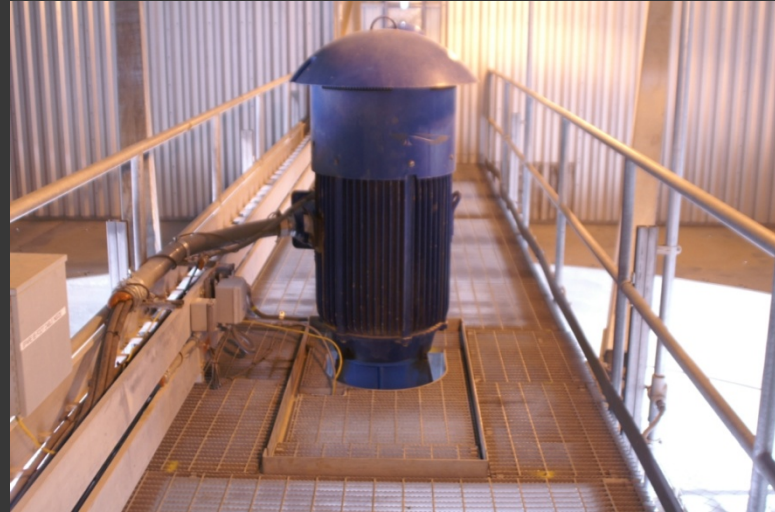
Weekly Walk-down inspections

- ⦿ Inspection of structure and equipment has caught many issues over time.
- ⦿ Puts maintenance specialist 'on deck' for visual checks
- ⦿ Helps determine solutions to various issues that come up.
- ⦿ Insures reliability
