NORTH BATTLEFORD ENERGY CENTRE

Air Cooled Condenser Maintenance and Vibration Issues and Solutions

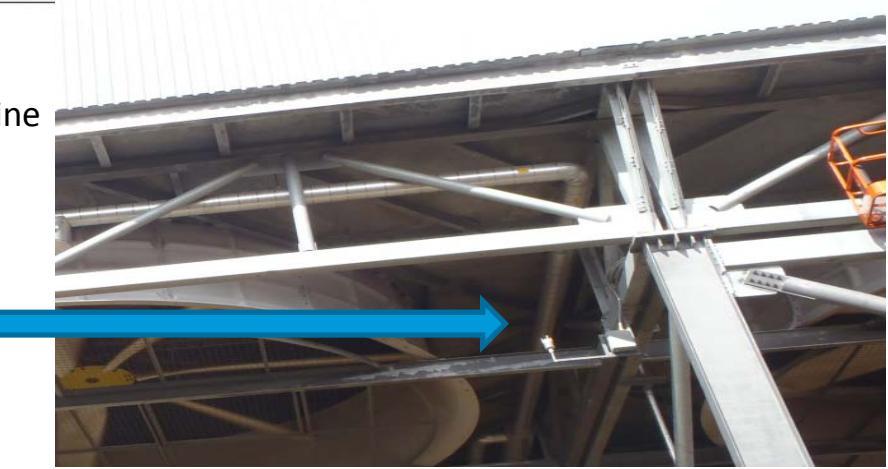
- Probe Mounted on Gear Box
 - **Y-Axial Direction** X-Lateral Direction Actual Condenser has 7 blades per fan

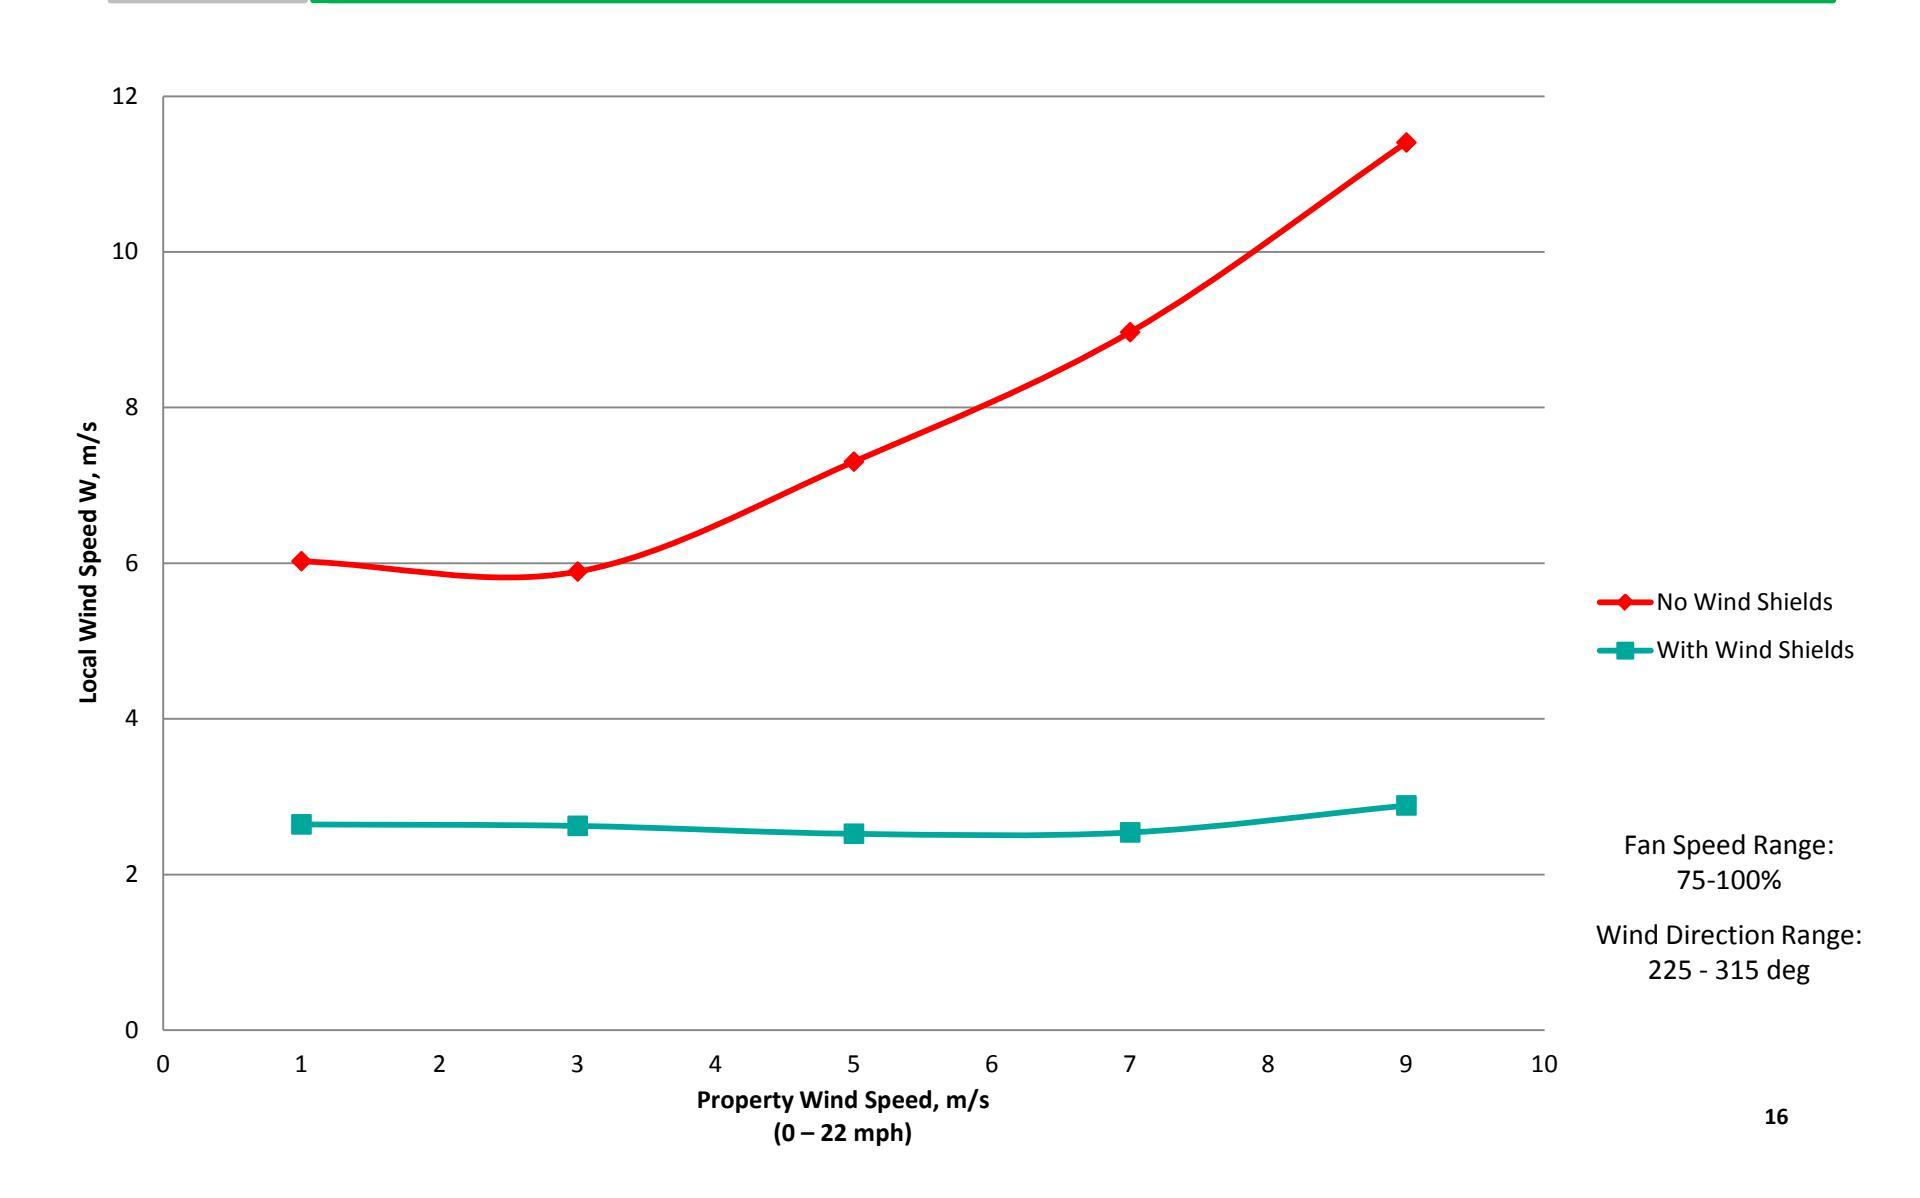
Influence of Wind Shield on Air Flow Speed under ACC

- **ZERO** fan trips since installing wind screen
- Horizontal vibration levels have been reduced approximately 25% and spikes reduced dramatically
- Axial vibration levels have increased slightly on average, likely due to changes in axial loading
- Axial vibration is now closely correlated to fan loading
- Negligible thermal performance impact observed
