Protecting An Air-Cooled Condenser from Hail Damage An Innovative Solution

ACCUG - LAS VEGAS
WESTIN HOTEL : October 2-4, 2017

Yellowstone Power Plant

Presented by Daniel Burns, Burns Engineering Services

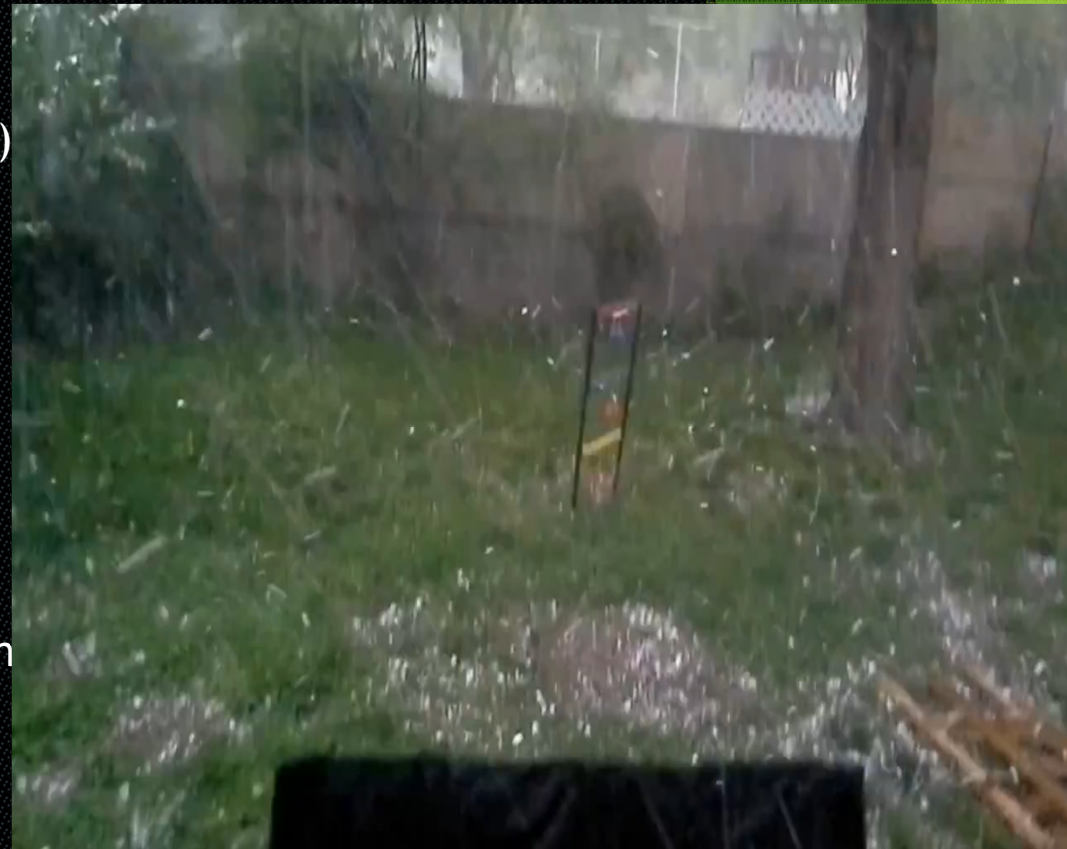
Hail Storm - May 18, 2014 Billings, Mt.

Most damage to buildings (roofs, windows, siding)
cars, and to the city's largest ACC.
In all, more than 30,000 claims.

- ▶ Hail typ. Marble to Golf ball in Size,
- ▶ Max. Diameter found @ ~2.5"
- ▶ Storm resulted in over ~\$500 Million of claims
in and around Billings
- ▶ Almost 1/1000 th's of ALL Storm Damages from
this one small ACC !
