ACC gearboxes – Eskom's experiences of the last 20 years

ACC Users Group 2017

October 2017

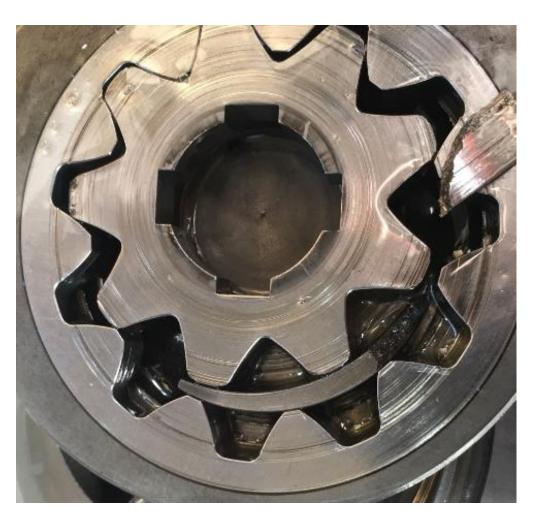
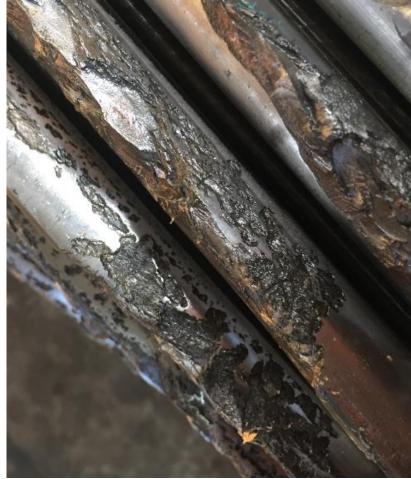
Gearbox failures

- Matimba gearbox failures
 - 48 gearboxes procured in 2009
 - 8 months later first catastrophic failures
 - Multiple problems:
 - Micro pitting
 - 40% of oil pumps failed
 - Similar trends at Medupi experienced already
