Andrew Howell
ACCUG 2018
Colorado Springs, Colorado
October 8-11, 2018

# Fort Nelson Stainless Steel Air-Cooled Condenser

# First internal inspection (September 2017)

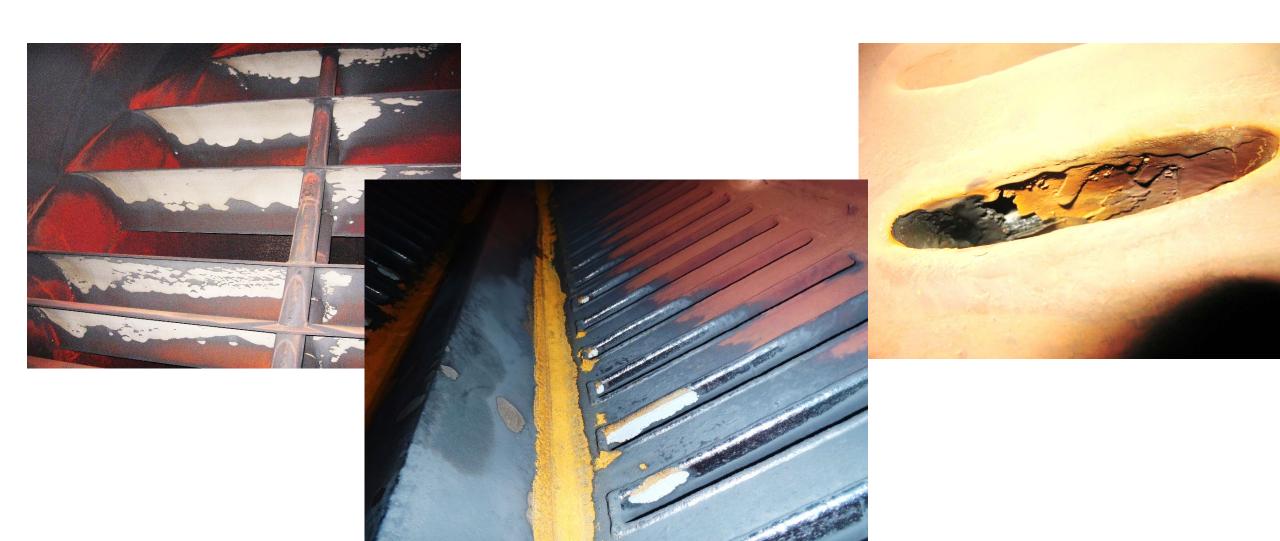
### Corrosion mechanism - ?????

flow + corrosion + carbon steel

clearly corrosion that is accelerated by flow -

- but not identical to traditional FAC:
  - temperature
  - microstructure

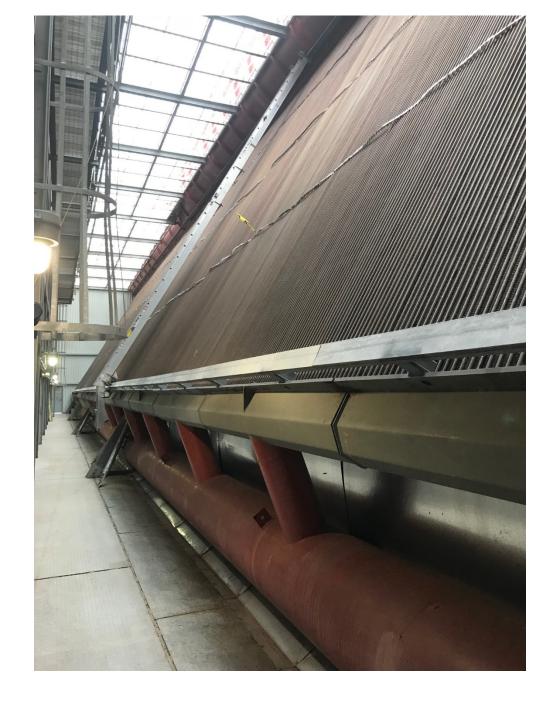
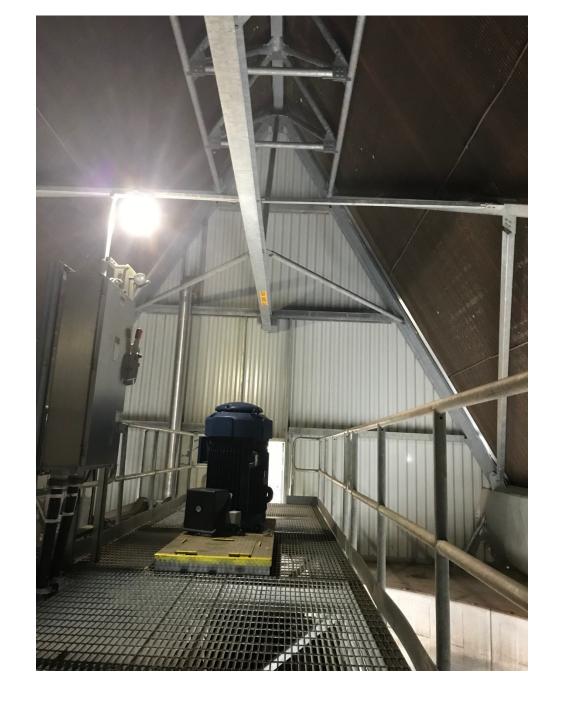
- ACC commissioned 2012 as part of conversion to combined cycle
  - plant was offline for 20 months with HRSG problems (overlapped the internal inspection)

2017 Internal Inspection: Steam Turbine Exhaust Main Duct carbon steel
