10th Annual ACC User Group Meeting

A Vacuum Leak Odyssey

Presented by Don Wright

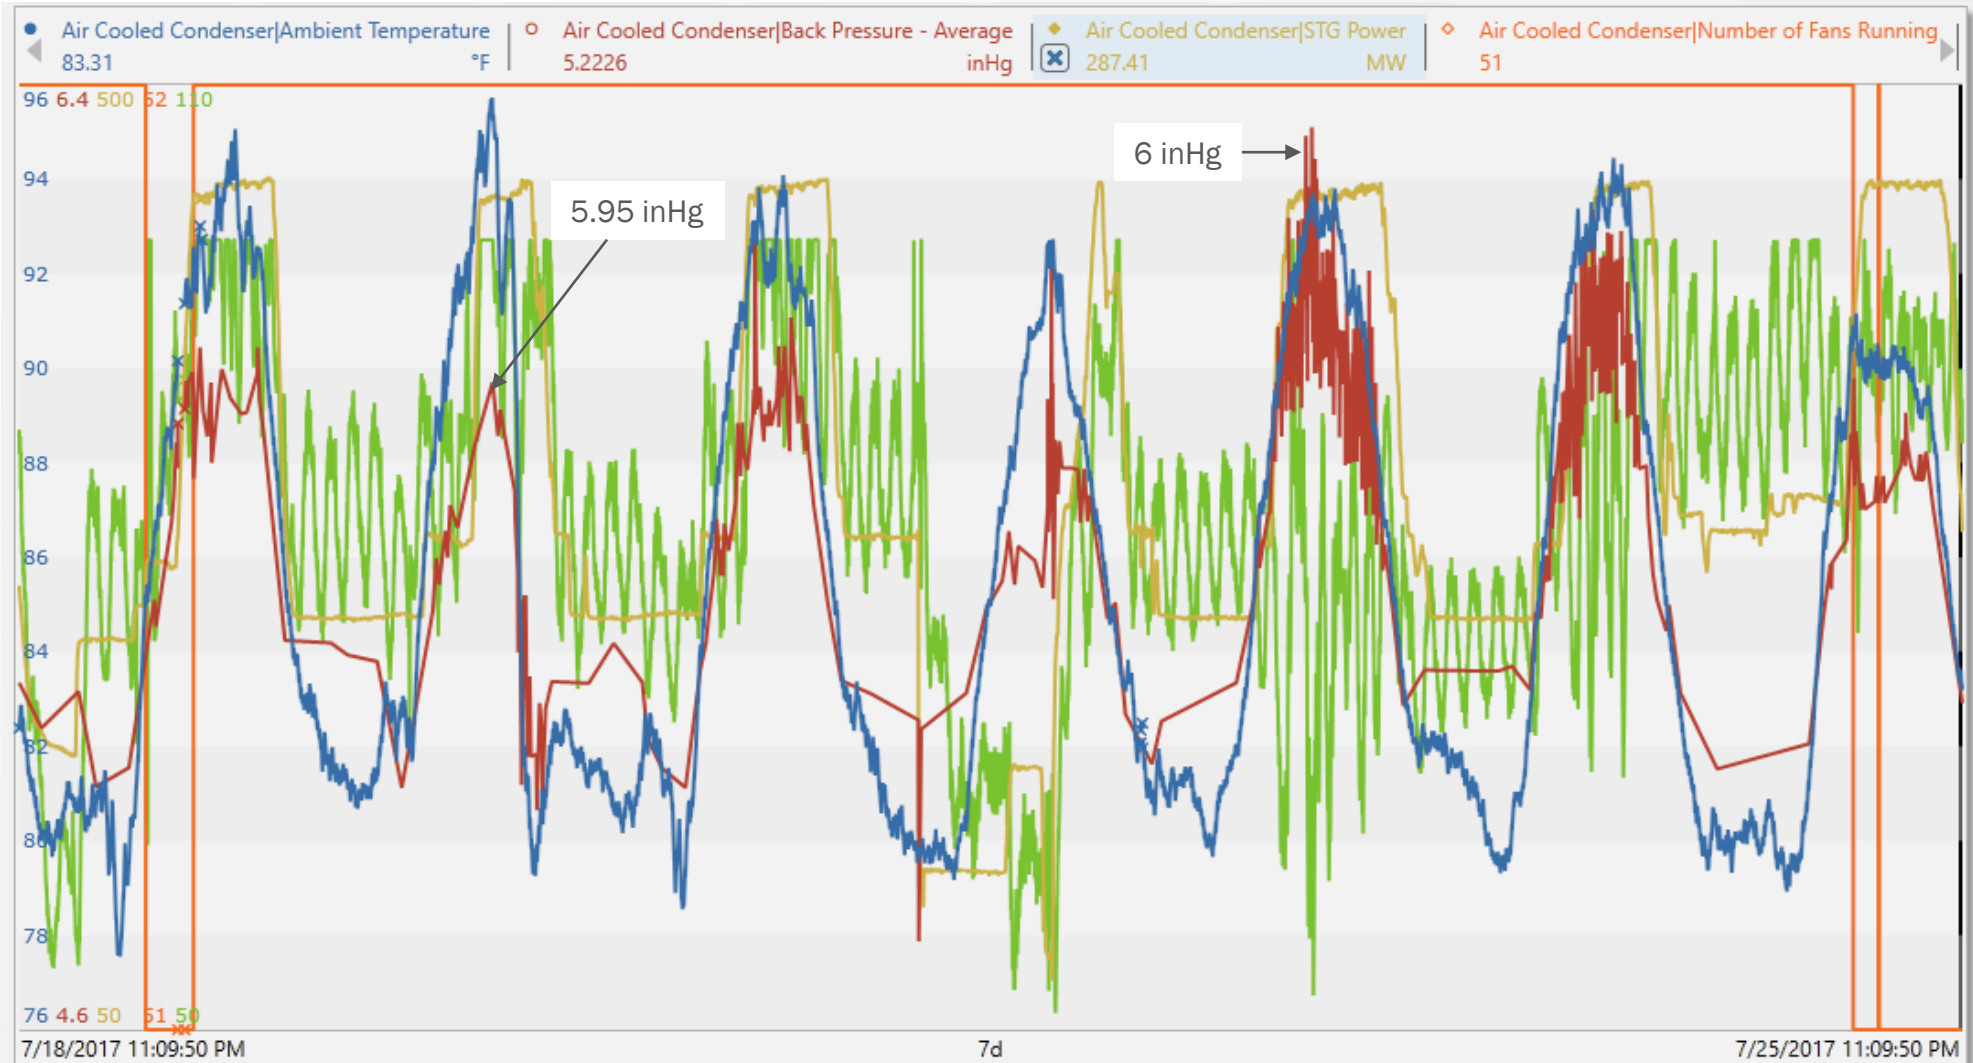
Summer 2017 Data

Problem - Summer of 2017

Vacuum above design curve 1-1.5 inHg

Dissolved Oxygen 60 – 100+ ppb

Hoggers intended for startup were running constantly to maintain vacuum

50+ fans running 24/7

Thermography reveal large cold areas in many streets

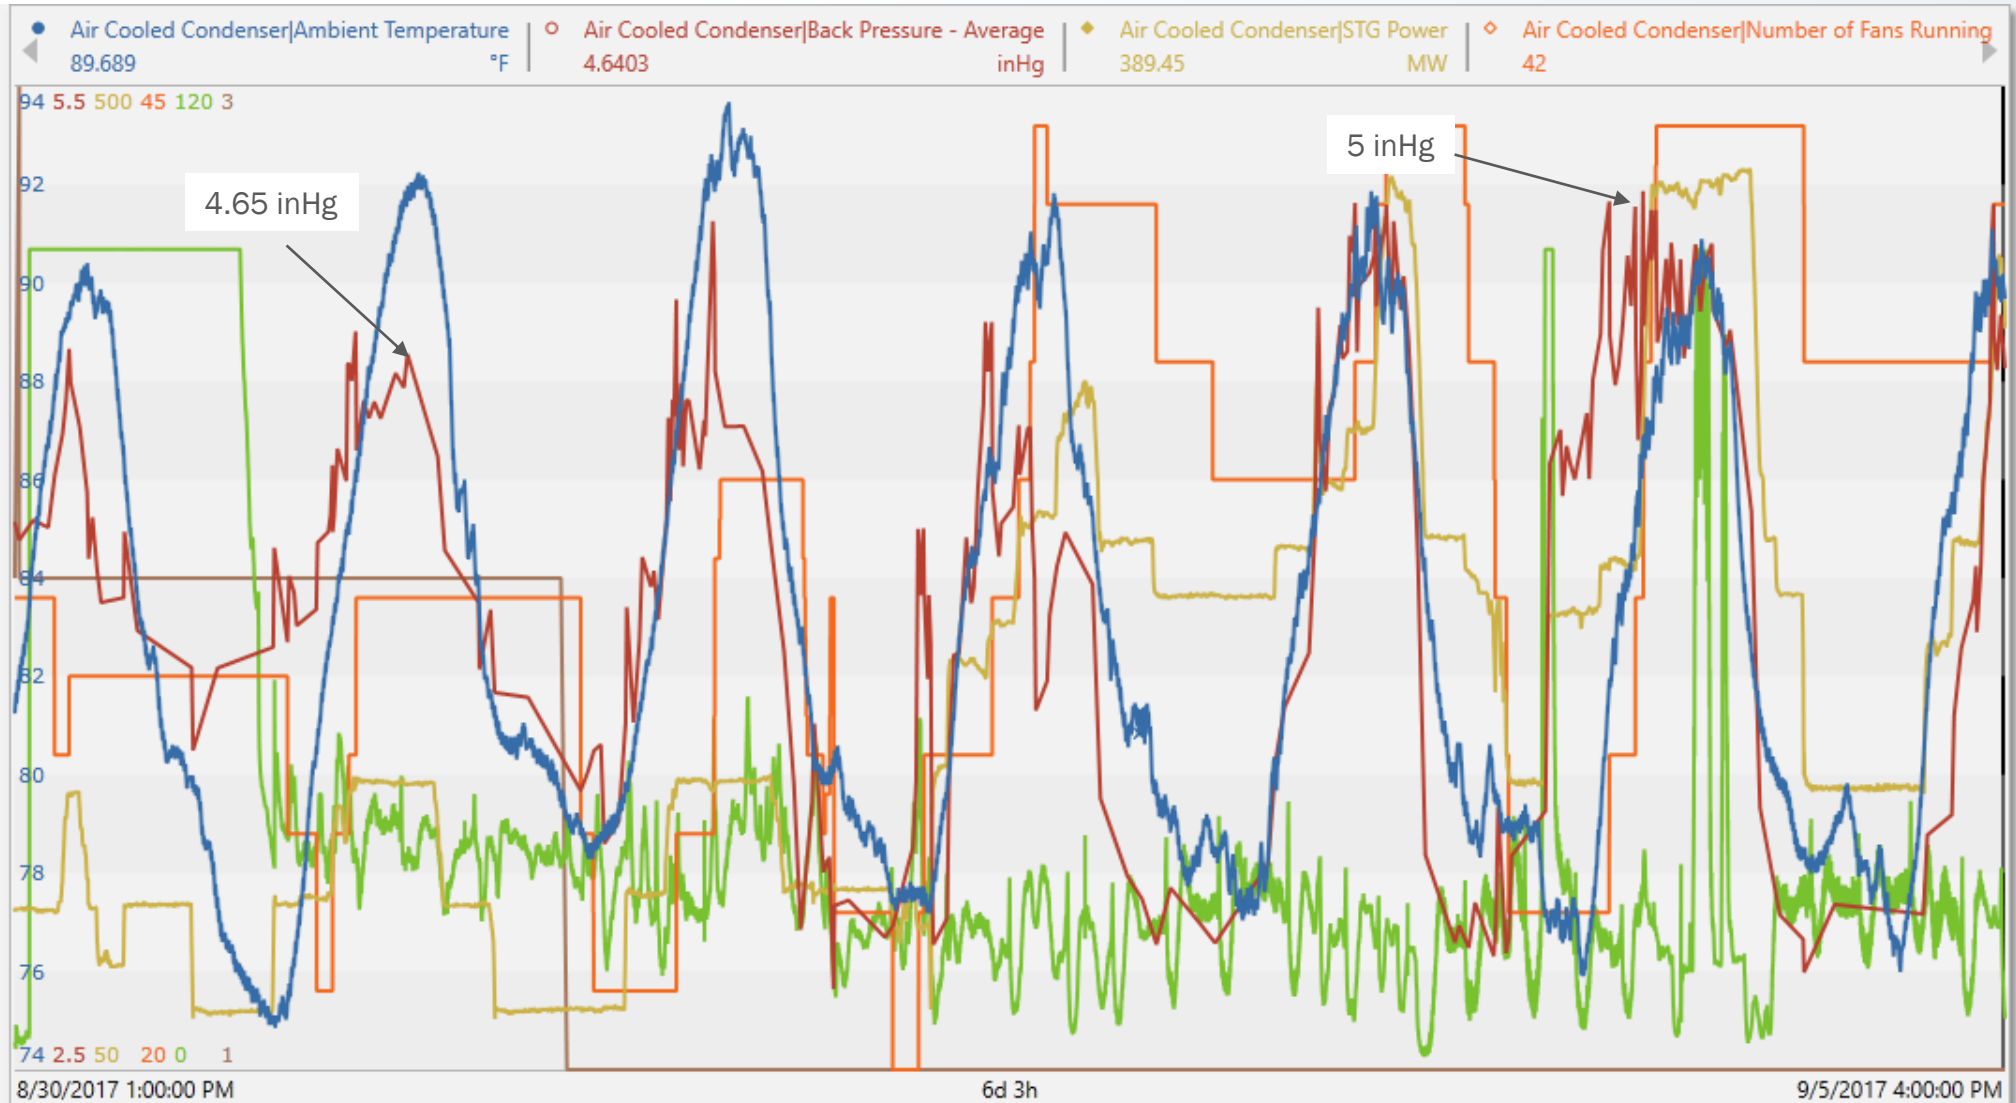
Post Hurricane Harvey

- Plant shutdown for several days due to flooding and drying out equipment
- After restart vacuum & DO improved significantly
- Initial thought was some further walkdown and tightening of valves just prior to event accounted for improvement
- Thermography showed good temperature ACC distribution
- Significant reduction in number of fans running
- Still running hogger to maintain vacuum
- SJAE still had no visible discharge

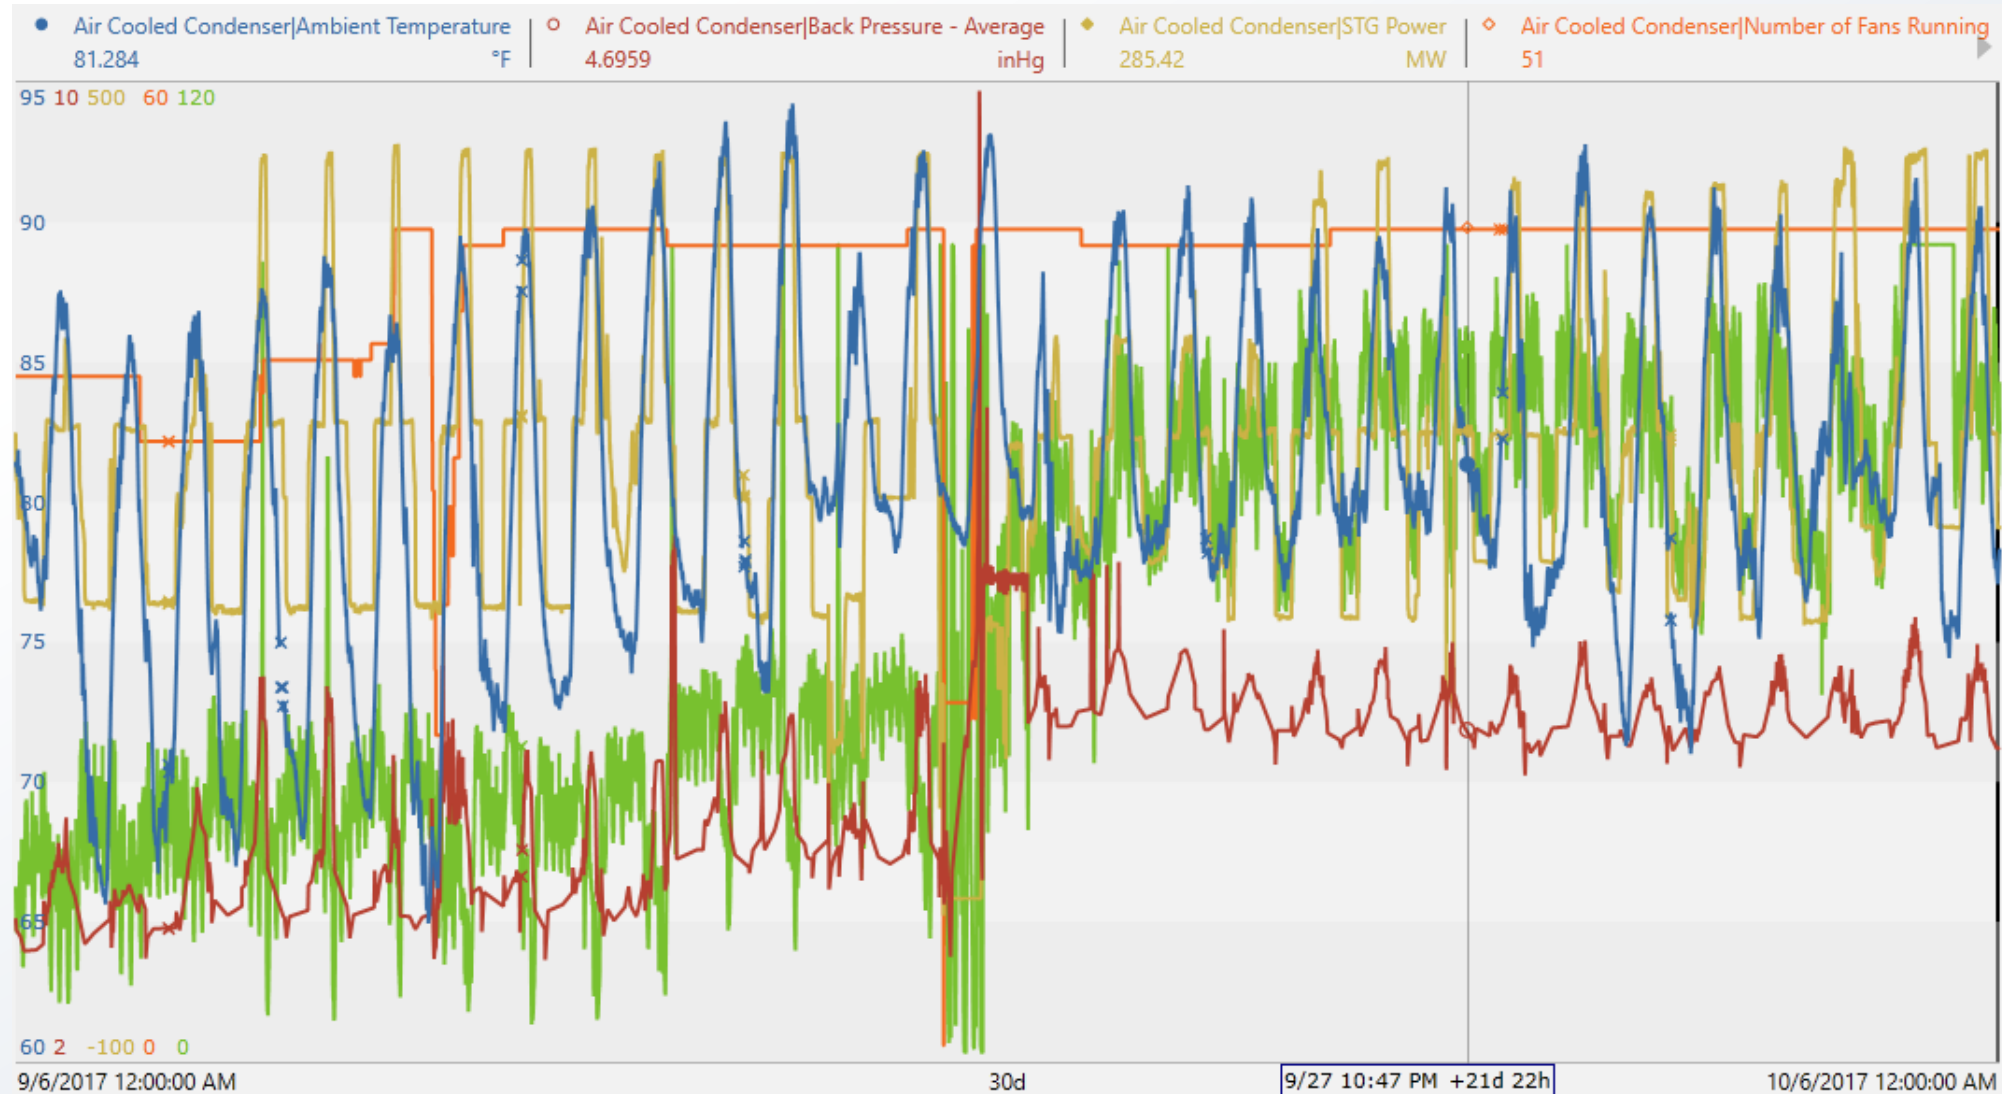
Vacuum & DO degraded to similar condition before Harvey

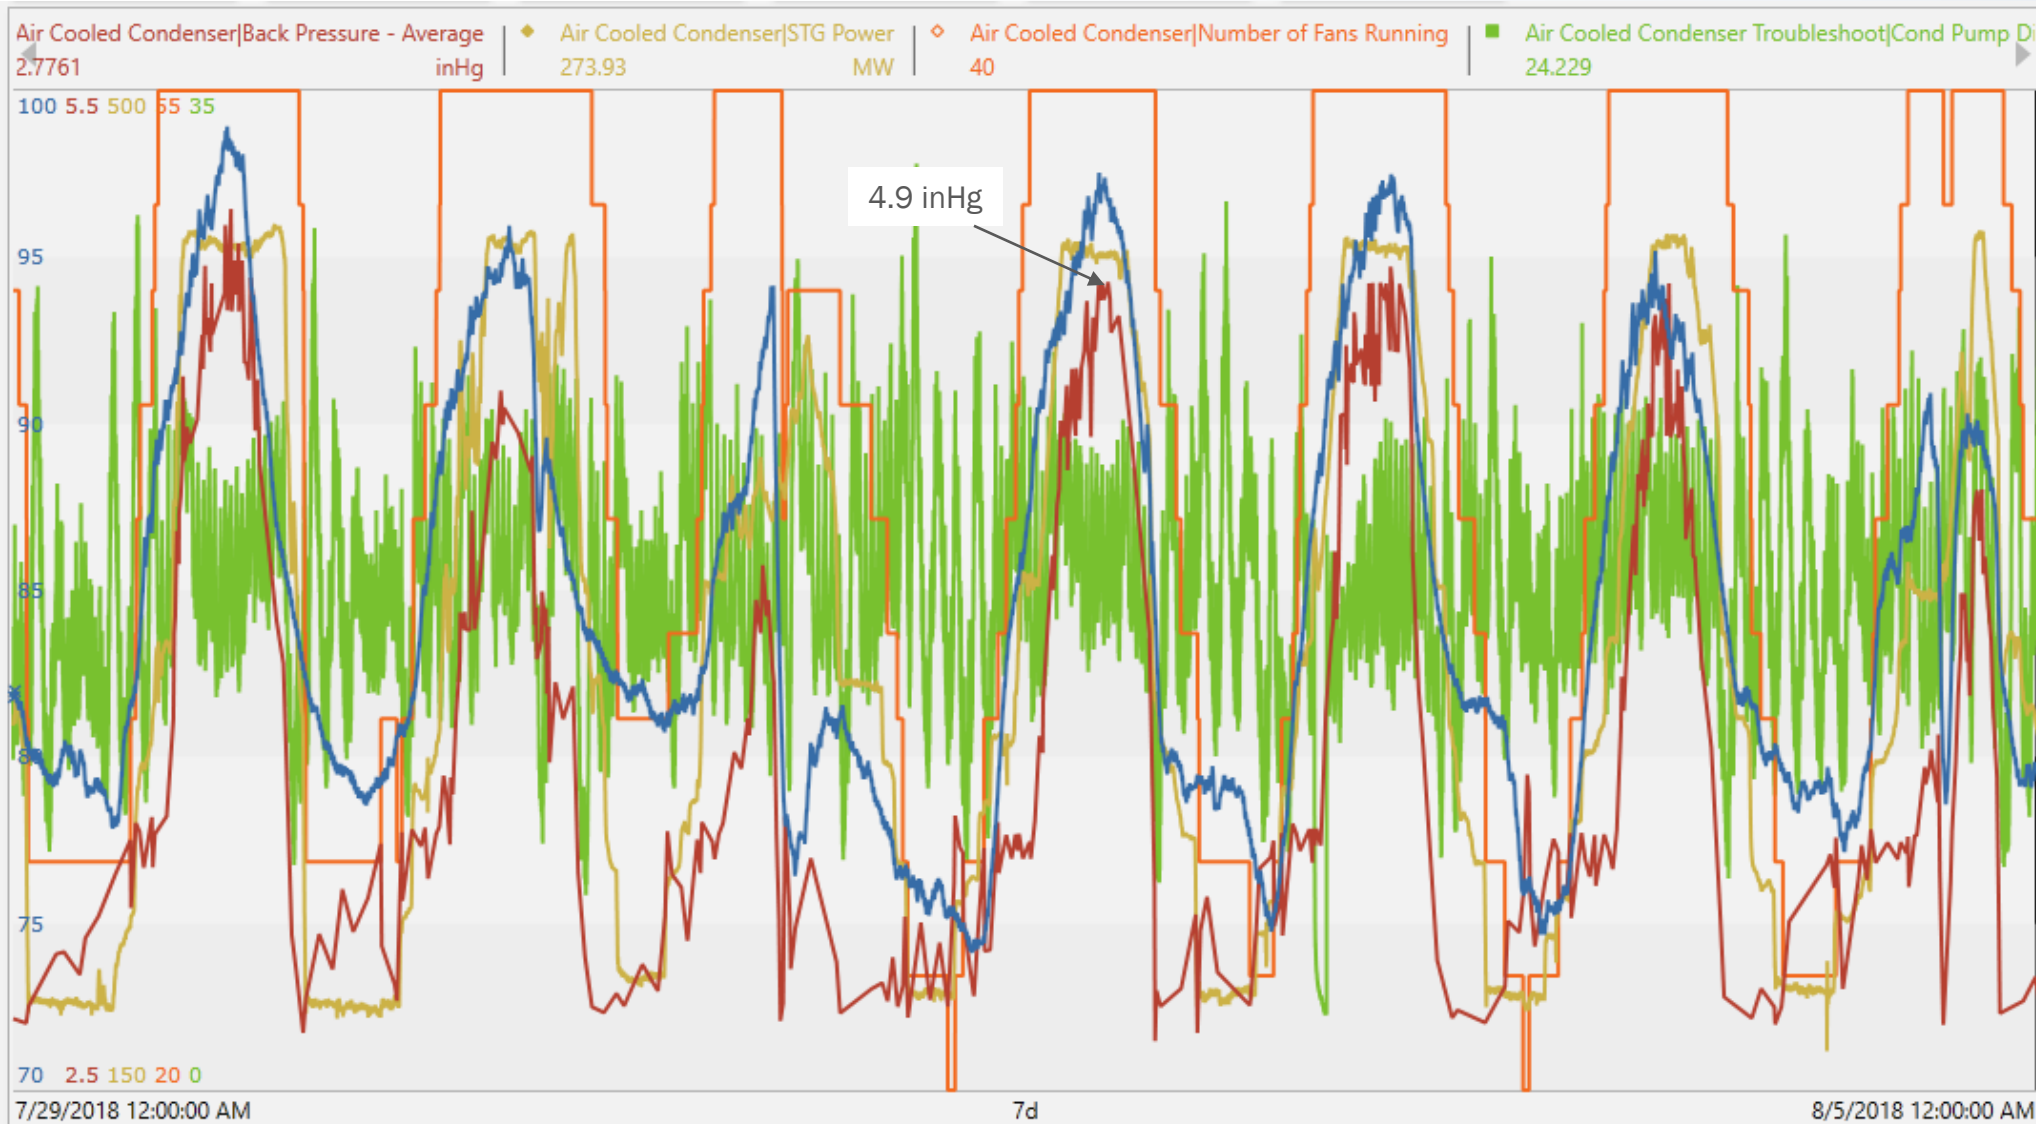
Plant Data Summer 2018

- All Major leaks repaired during the outage
- Minor leaks still remain (ACC tube/header ??)
- No Hoggers needed to maintain vacuum
- Single SJAE maintaining vacuum near design
- DO (15- 30 ppb) reduced but still slightly elevated
- Fans cycling as expected between 50 – 100% during the summer
