KOGAN CREEK UPDATE

4TH ANNUAL ACC USERS GROUP
MEETING – 25 – 26 SEPT 2012

August 2011 Outage (3 ½ Years since commissioning)

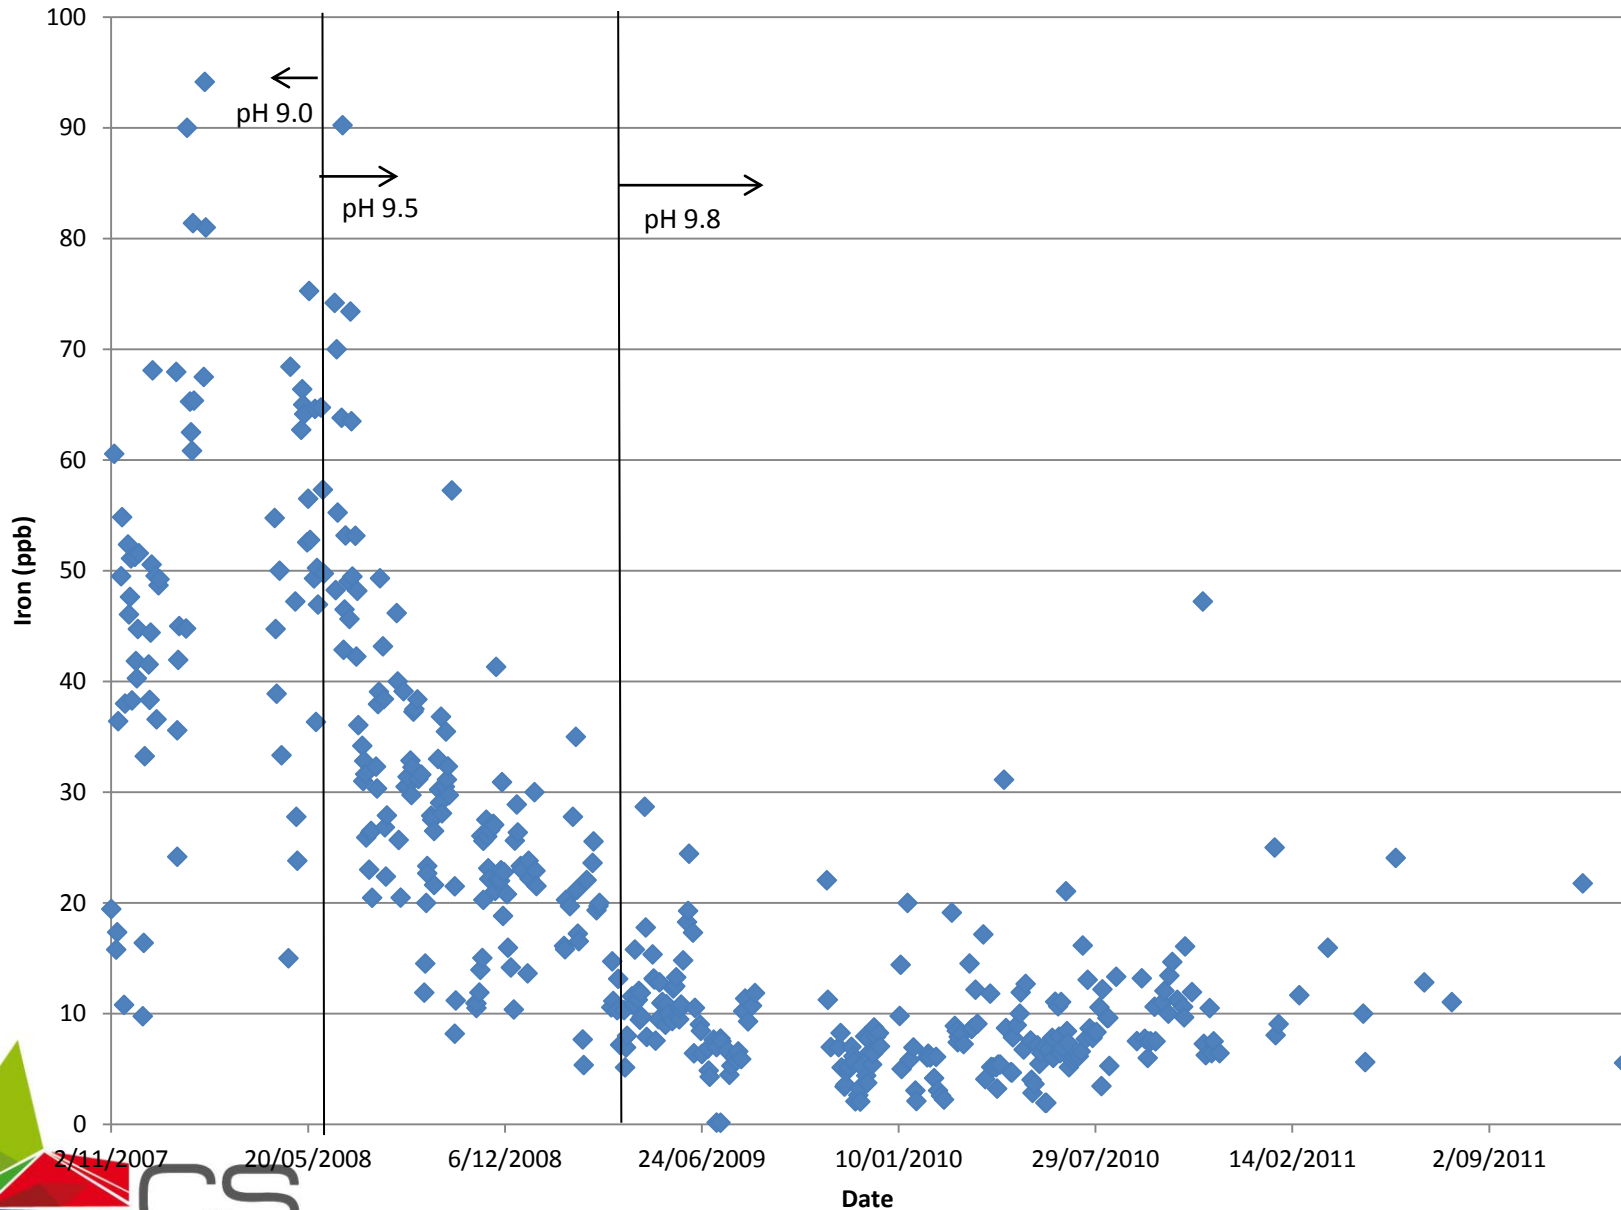
Kogan Creek - Condensate Before Pre-filters Iron Monitoring

Date	pH	Average Iron before prefilters	Average iron after prefilters	Average iron after polishers	Comments
Commissioning	9.0	72ppb	35ppb	12ppb	During commissioning and early operation
June 2008	9.5	22ppb	11ppb	4ppb	Polishers changed to ammonia cycle.
October 2008 (8000hr outage)	9.5	22ppb	<1ppb	<1ppb	Prefilter elements changed to from Pall spiral wound 5µm (nominal) to Graver pleated 5µm (absolute.)
April 2009	9.8	10ppb	<1ppb	<1ppb	Current operation

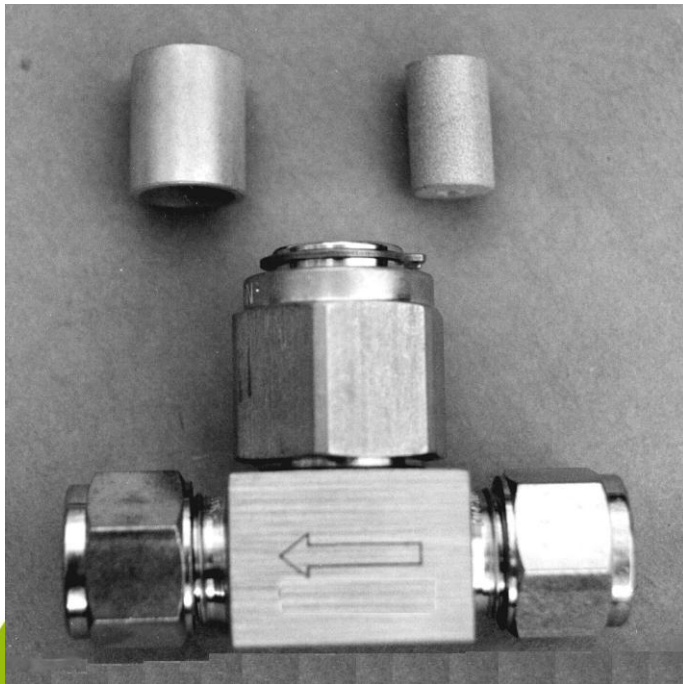
Collector

- Turbine inspection opportunities are limited and blade cleaning opportunities are very irregular.
- Hence;
 - Separate to unit cycle monitoring for Aluminium and copper levels to determining whether deposition is still occurring
 - CS Energy are also investigation the use of deposit collectors and / or converging sampling nozzles as a possible real time method to measure deposition.
- Operating experience is sought from other plant owners
