ACC fan dynamics

Jacques Muiyser

Development Engineer Howden Netherlands

Power Generation Engineering - Dominion Energy

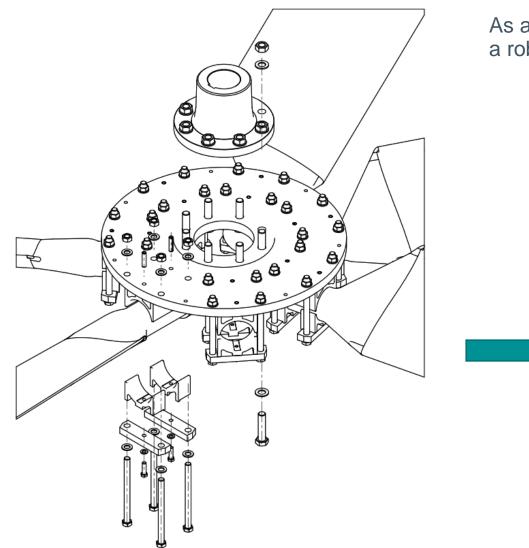
Dominion Energy, Brunswick County VA

As a result, close collaboration between a vendor and user resulted in a robust solution for existing fans experiencing issues.

To reduce the effect of bolt preload loss and eliminate fatigue failure of the bolts it was decided by Dominion Energy - Engineering and Howden to increase the rigidity of the blade clamping bolts by adding a secondary hub ring.

The hub-ring consists of a ring connecting all of the clamping pieces, thereby increasing the bolted joint rigidity and reducing the effect of cyclical loading. This prevents bolts loosening and eventual failure.

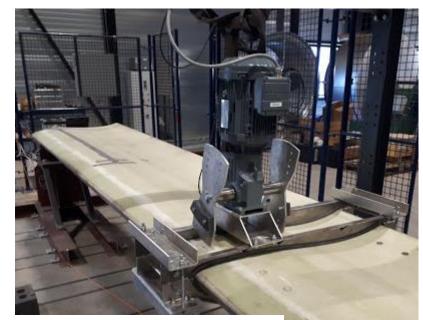
Dynamic testing rig used to investigate blade and bolt loads for a single hub vs. hub-ring assembly.

Motor with eccentric mass used to impart dynamic loads when driven by a VFD

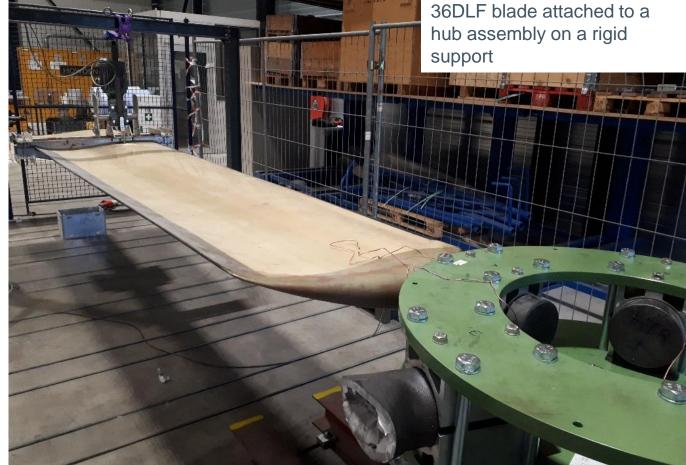
Fan blade and bolts instrumented with strain gauges. Strain gauges on bolts are used to measure bolt bending. Load cells placed under on the nuts to measure axial loads.

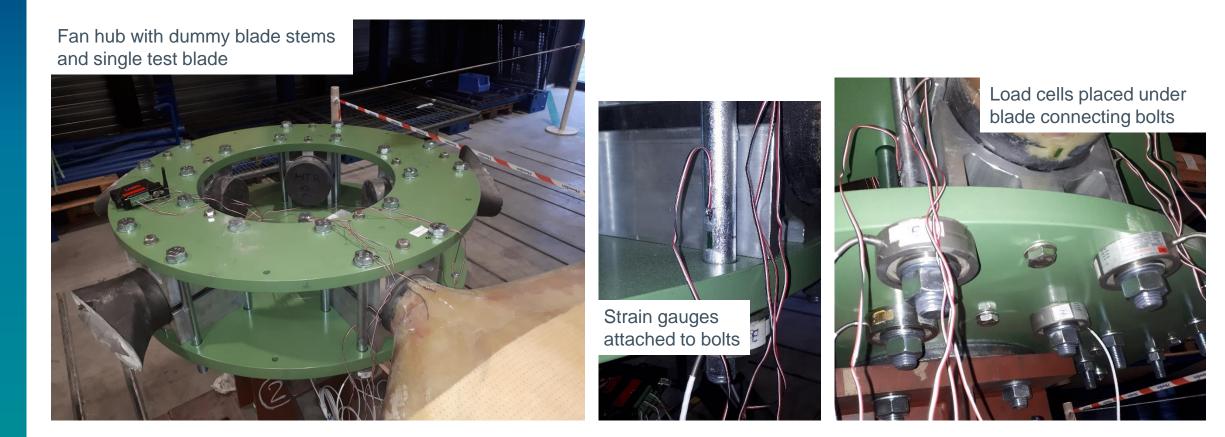
The excitation frequency is tuned to obtain the same strain amplitude on the blade.

Under these conditions the bolt loads are reduced dramatically.
