# The Latest on ACC Corrosion Mechanisms

The Lack of any Further Understanding

ACC Users Group  
Xcel Energy's Comanche Station  
Pueblo, Colorado  
28<sup>th</sup> and 29<sup>th</sup> September 2010

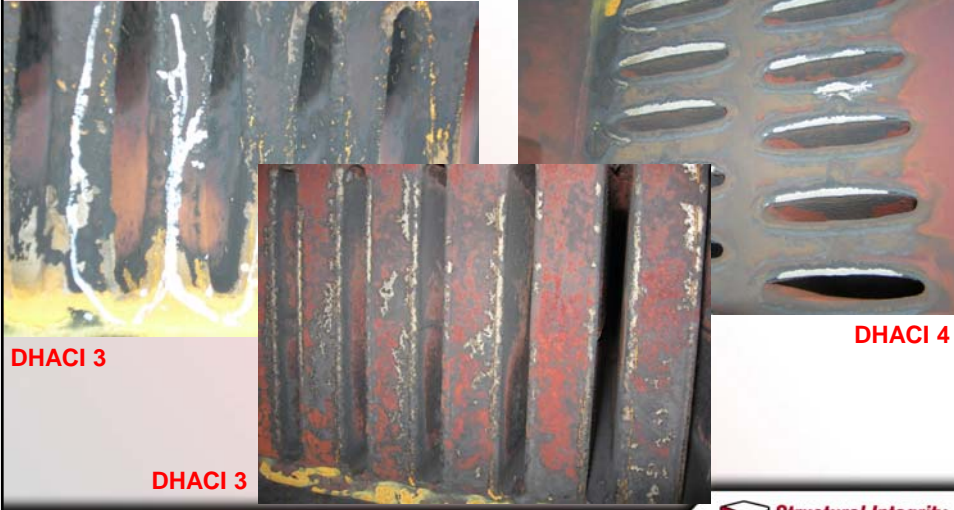
## We all Now Know what the Corrosion Looks Like

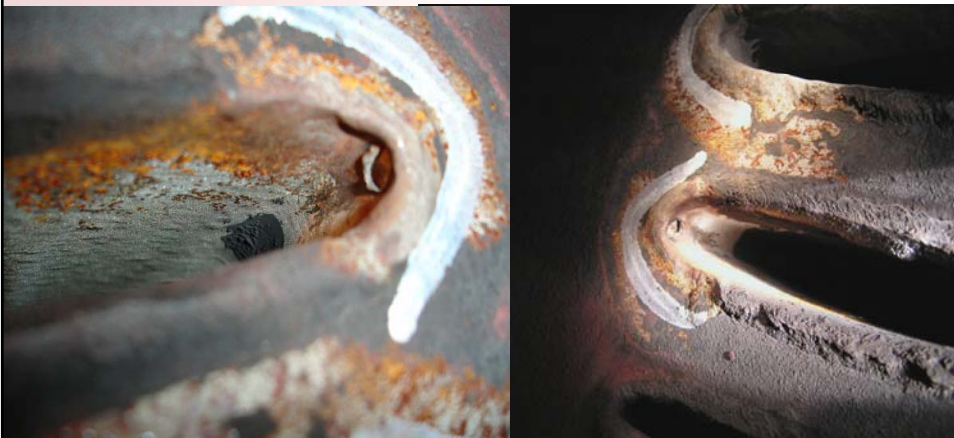
DHACI 5

## And what Holes at Tube Entries Look Like

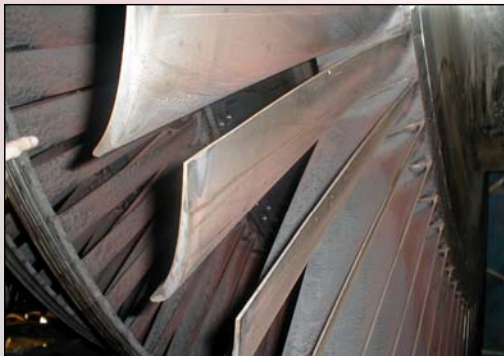
**The PTZ Environment in the LP Steam Turbine**

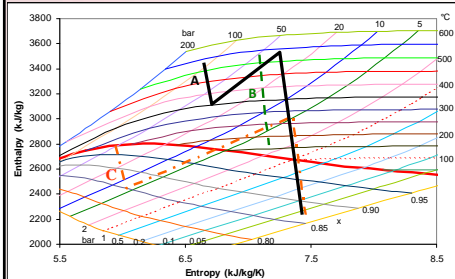
## Mollier Diagrams

**A. Fossil Reheat Turbine**  
**B. Backpressure Turbine**  
**C. Reheat Turbine in a nuclear LWR plant**

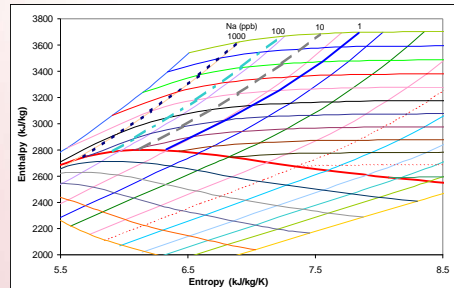
**Solubility limits of NaCl at various steam conditions**

Source: IAPWS Technical Guidance Document 2010

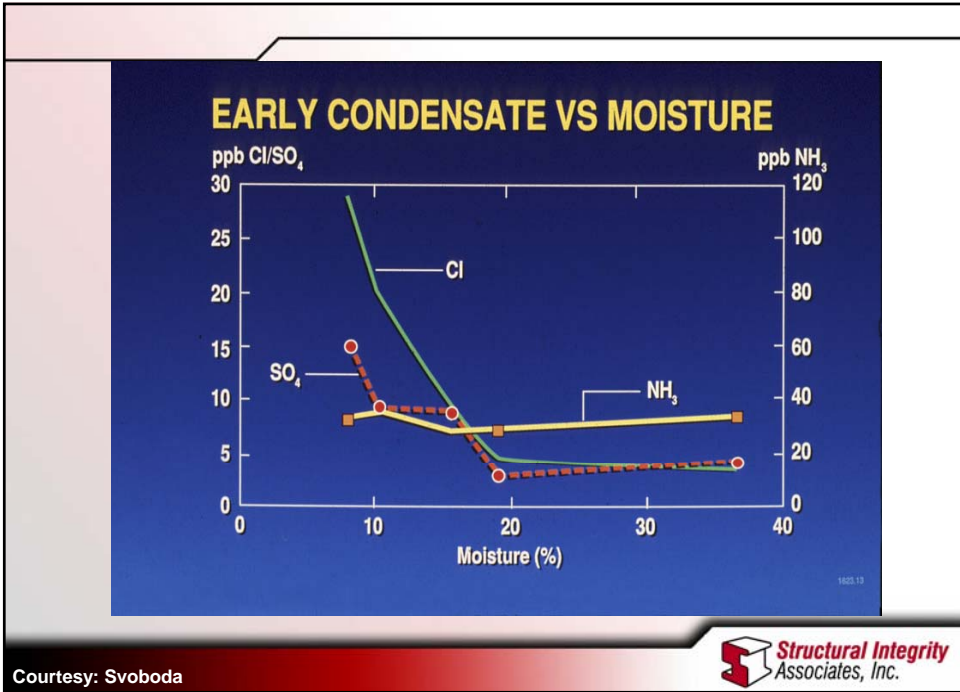
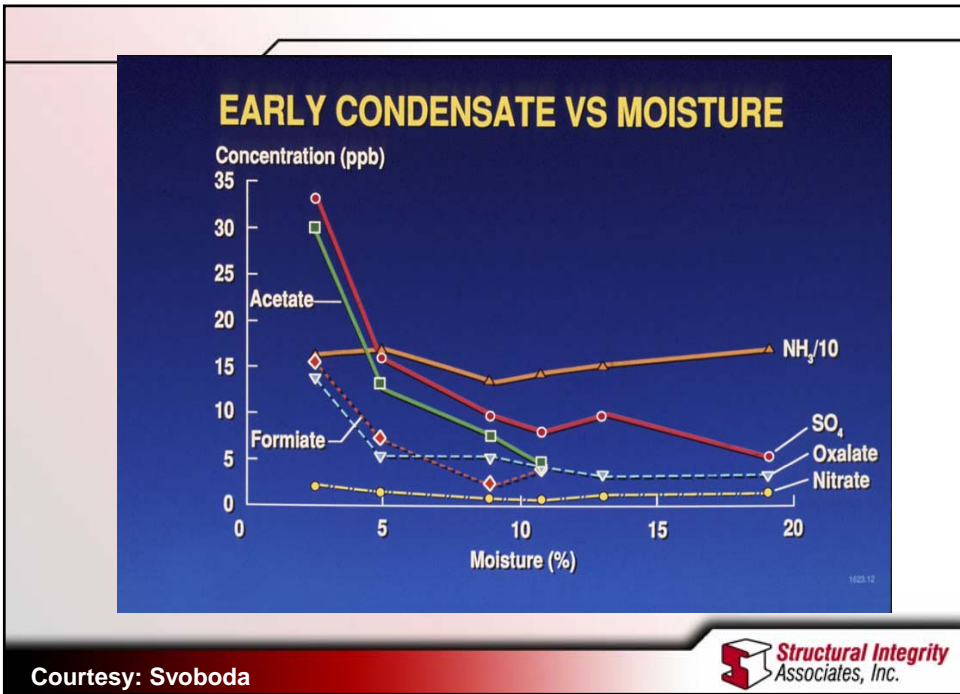
## Moisture Nucleation/Early Condensate

- **Nucleation around ions and oxides**
  - **Seeds  $10^5 - 10^{13}/\text{kg}$**
- **Concentration ratios up to 100x**
  - **Increases with decreasing moisture**
- **Effect of plant cycle chemistry**
  - **AVT and PT > OT**
  - **<< 5ppb  $\text{O}_2$  in the moisture**
- **Droplets are charged**

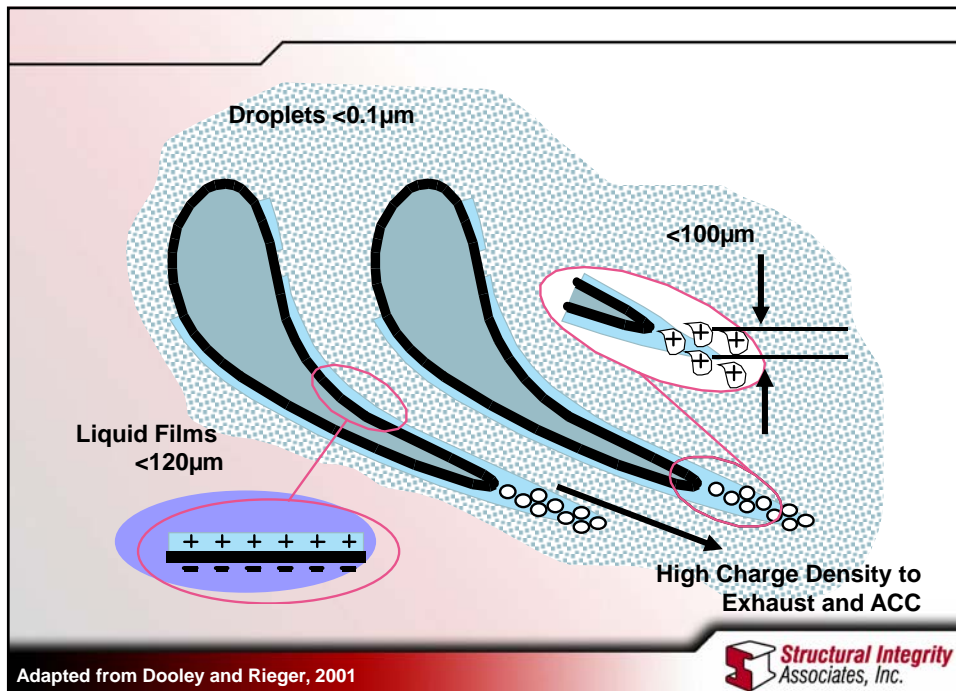
## Liquid Films on Turbine Surfaces

- Range up to 100 - 120  $\mu\text{m}$ 
  - Very variable profile on surfaces
  - Dependent on chemistry
  - OT < AVT and PT
- Concentration factors 10x > Droplets
- < 5ppb  $\text{O}_2$  in LF
- LF are charged

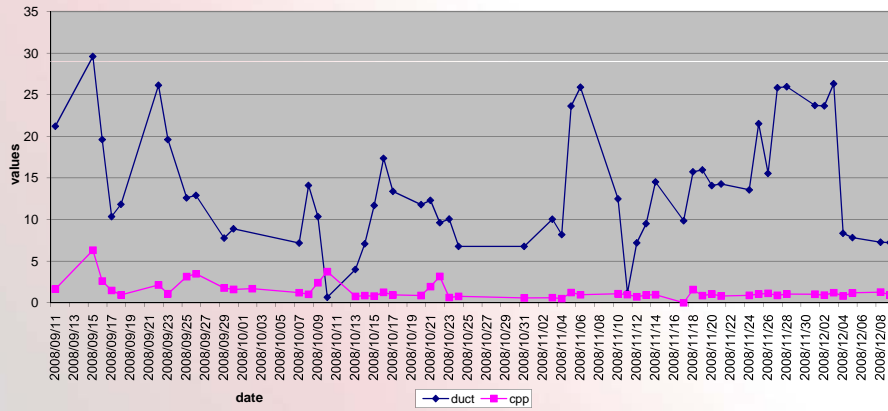
## The Liquid in ACC Upper Ducts

chlorides

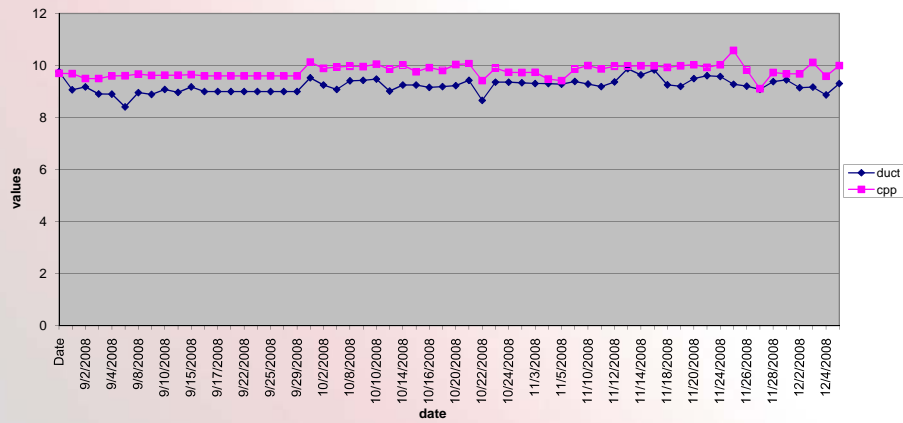
## The Liquid in ACC Upper Ducts

pH

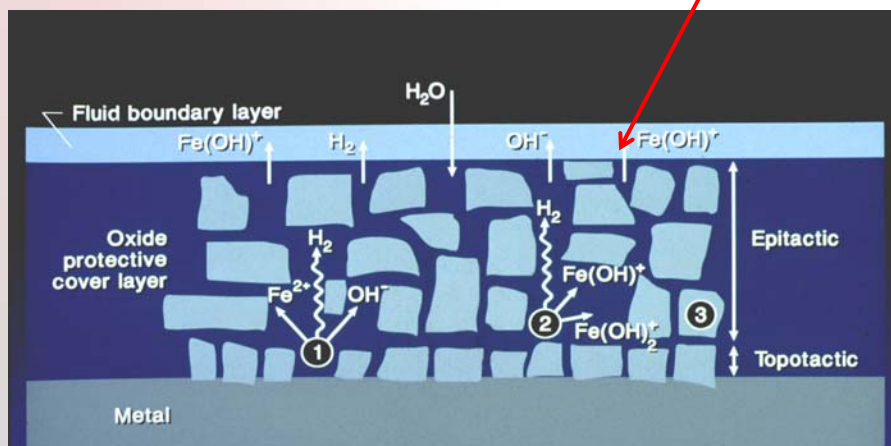
## Growth of Magnetite on ACC Surfaces

$\text{Fe}_3\text{O}_4$  is semi-protective because of saturation here

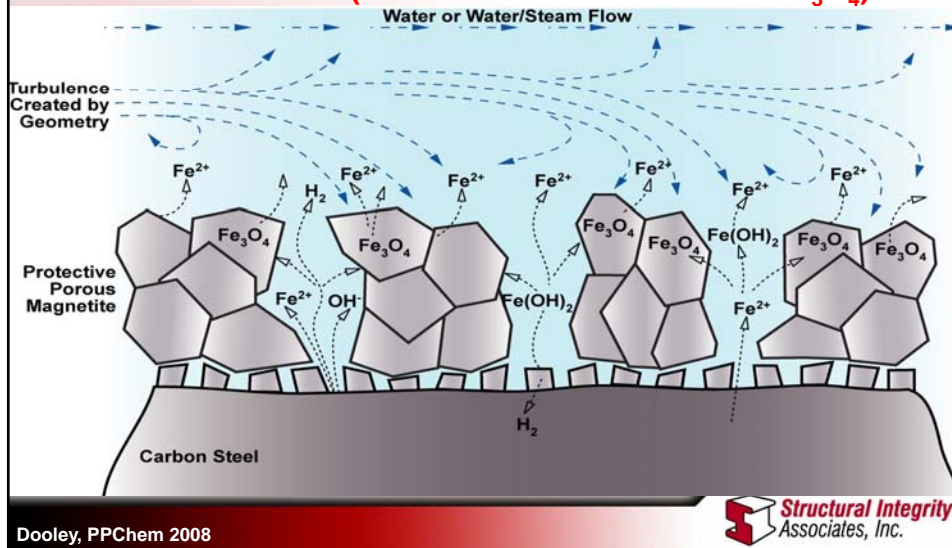
## Two-phase FAC in Flowing Turbulent Flow at ACC Tube Entries (Removes the Saturation of $\text{Fe}_3\text{O}_4$ )

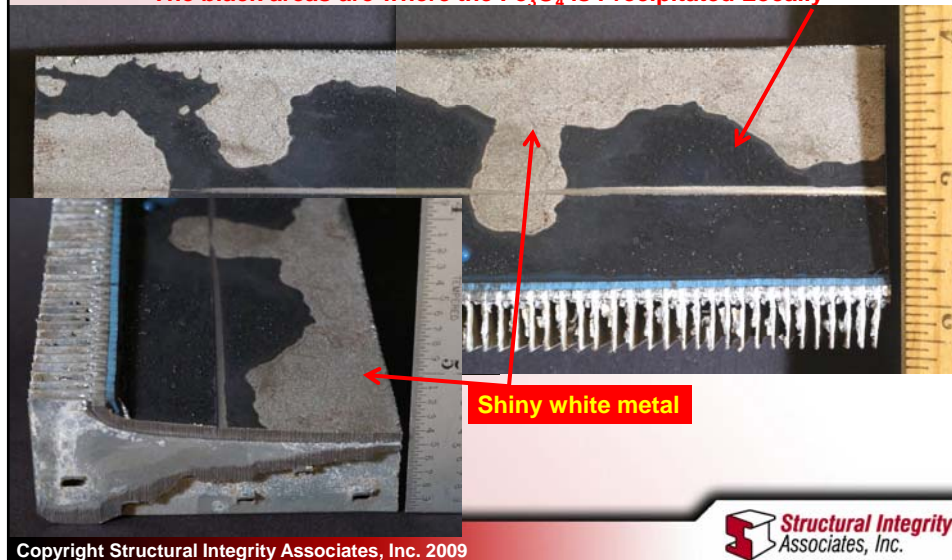
## Inside diameter surface of an A-Frame ACC Tube

The black areas are where the  $\text{Fe}_3\text{O}_4$  is Precipitated Locally

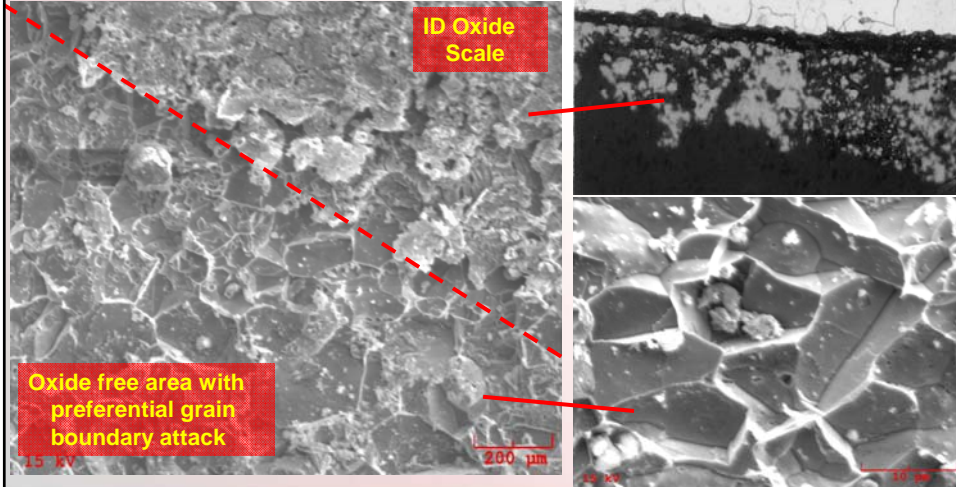
## Corroded (FAC?) ID Surface of ACC Tube

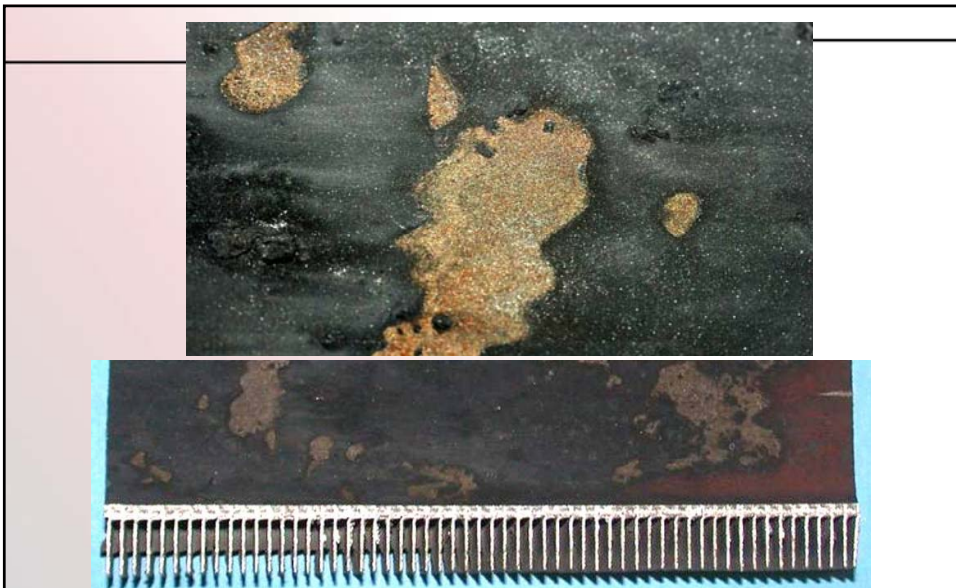
6 inch section of ACC tube and detail of the surface showing black deposits and white "bare" metal areas

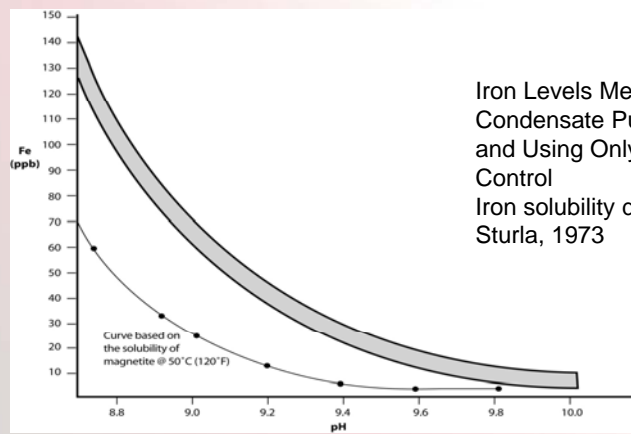
## Dooley/Aspden pH Versus Iron Relationship

Iron Levels Measured at  
Condensate Pump Discharge  
and Using Only Ammonia for pH  
Control  
Iron solubility data extracted from  
Sturla, 1973
