ACC Corrosion/FAC and Cycle Chemistry

International ACC Conference
Xian, China
13th – 16th October 2015

Barry Dooley

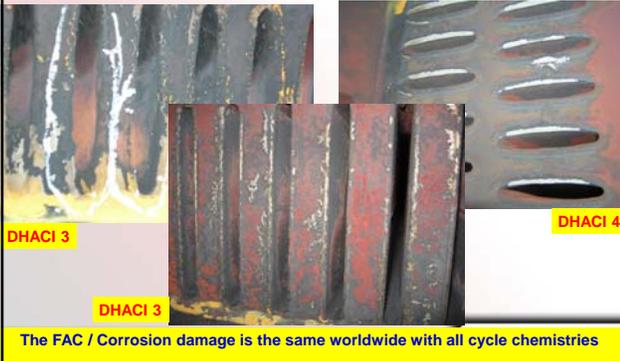
We know what the Corrosion Looks Like

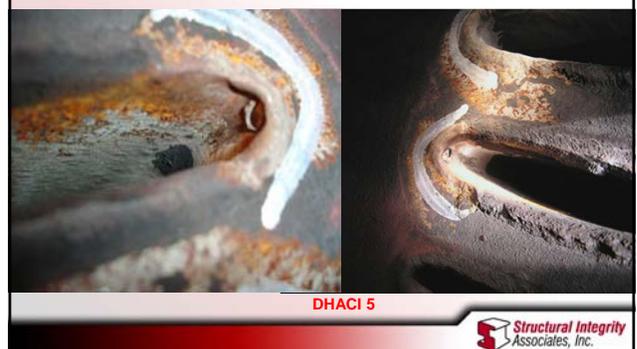
and what Holes at Tube Entries Look Like

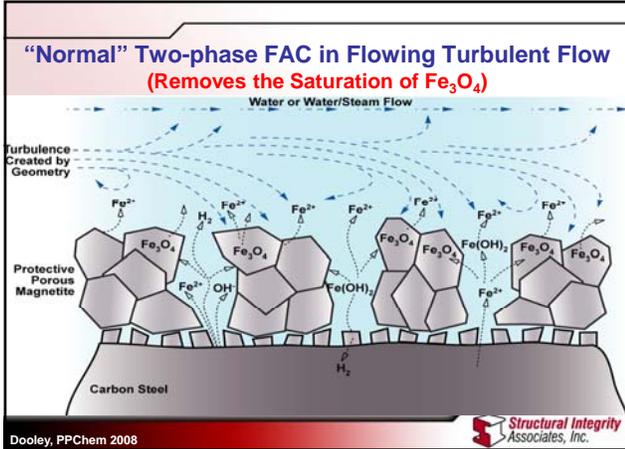
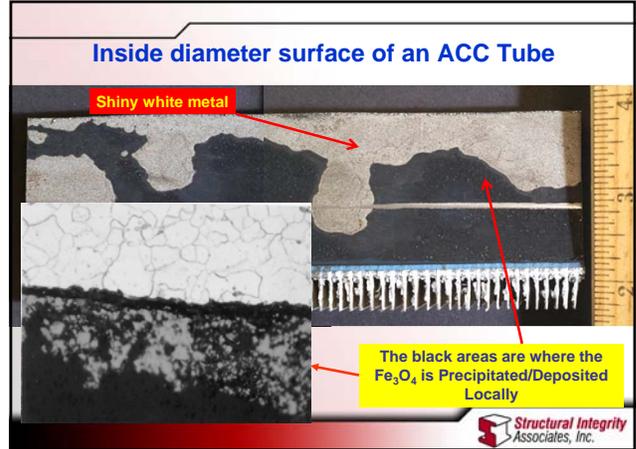
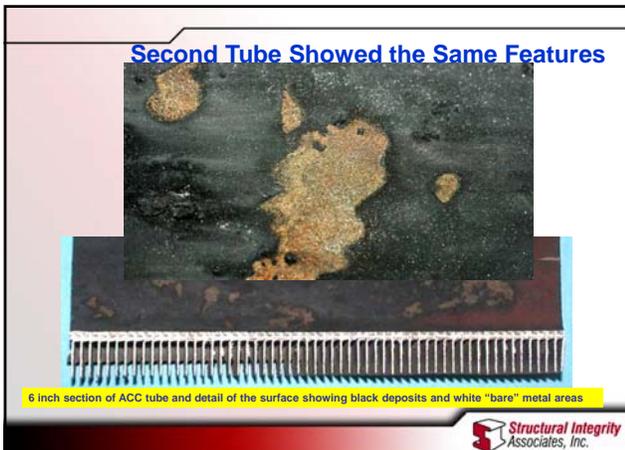
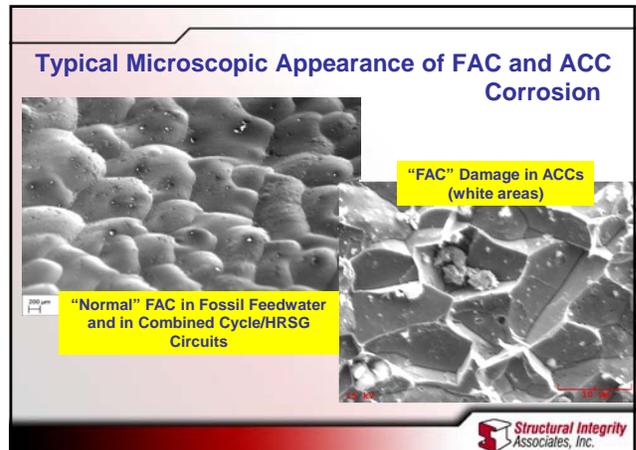
So is the ACC Corrosion Mechanism Low Temperature Two-Phase FAC?
 which is
 Dependent on Removing the Saturation of Fe_3O_4 at the Surface and Precipitating/Depositing it Adjacently

(Two ACC Tubes with damage (white areas) have been analyzed)

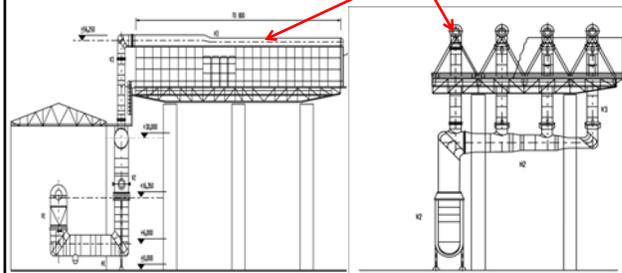
To Understand the Corrosion Here we need to Understand the Environment in the PTZ

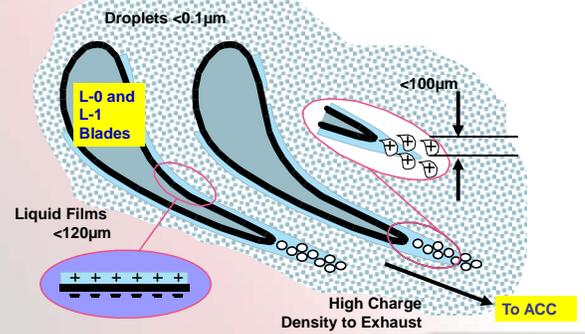
Generation of the ACC Environment is in the PTZ

Generation of the ACC Environment

Heterogeneous droplet Nucleation and Liquid Films on ST Blades
 (Droplets and Liquid Films in the ACC vary from 0.1 – 50 microns and don't contain any oxygen until during shutdown)
