Introduction for ACC FAC and Cycle Chemistry Session

Barry Dooley ACCUG 2018 Colorado Springs, USA 9th – 11th October 2018

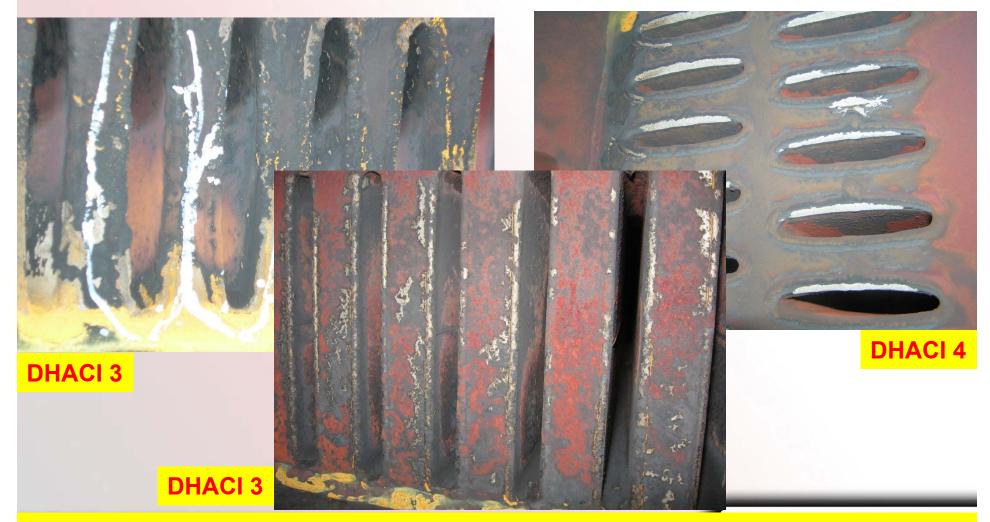
We know what the Corrosion Looks Like

The FAC / Corrosion damage is the same worldwide with all cycle chemistries and plant types

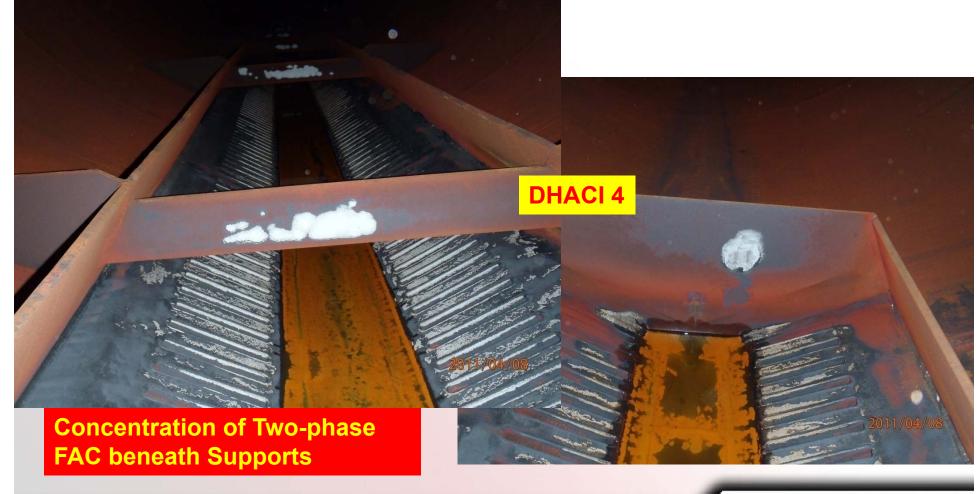
Inspections Worldwide show the same Features Combined Cycle with ACC after ~ 15,000 hrs, pH 9.1.

DHACI – Dooley, Howell Air-cooled Condenser Index

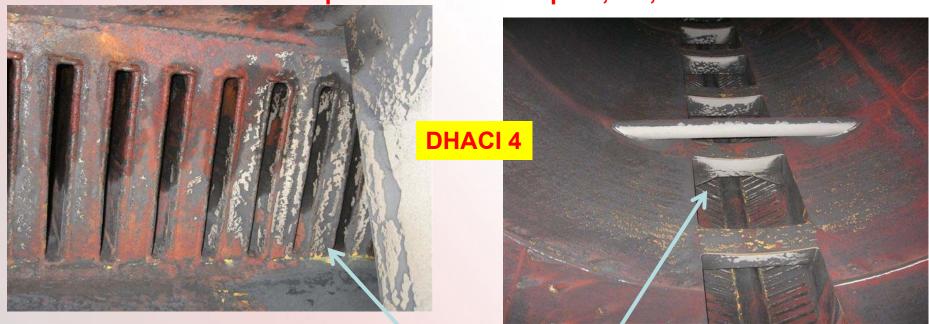
Inspections Worldwide show the same Features 750 MW Supercritical on OT at pH 9, ~4,000 hrs.

Concentration of Two-phase FAC beneath Supports
